STAMP Tag Deploying Form

STAMP Tag #0001 Photo courtesy Mr. Edward McCawley. Ms. Zarina McCawley is providing scale.

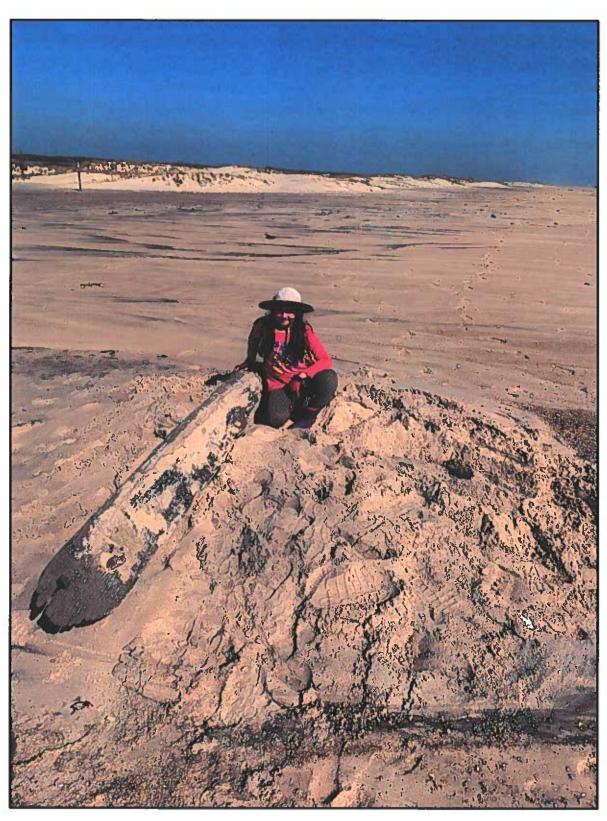
7.	Deterioration: What does the level of deterioration seem to be?		
	☐ No deterioration ☐ Partially deteriorated ☐ Heavily deteriorated		
8.	Exposure: Check the best choice for how exposed the wreckage is: Completely exposed Partially exposed Nearly covered

12.	Length/Width/Thickness of timber:		
	Length: 8' (//) Width: - (10) Thickness: (10)		
	Orientation: N-5		
	Diameter of wooden fasteners: / Nell (_)		
	Distance between 2 fasteners:
