### STAMP Tag Deploying Form

1. Tagged by: Susan Langley & Roger McGraw
2. Tag Number(s) (####): 0026
3. Date: Jan 29/24 Time: 11:30:12:30 am pm  
Tide level:  High  Medium  Low dropping but full moon.
4. Name of wreck (if known): N/A
5. Description: How did the wreckage reach its present position?  
 Float  Uncovered  Other \_\_\_\_\_

3" thick - 13 1/2" max wid  
± 19' long hull plank -  
treenails - even in places (end)  
slightly staggered.

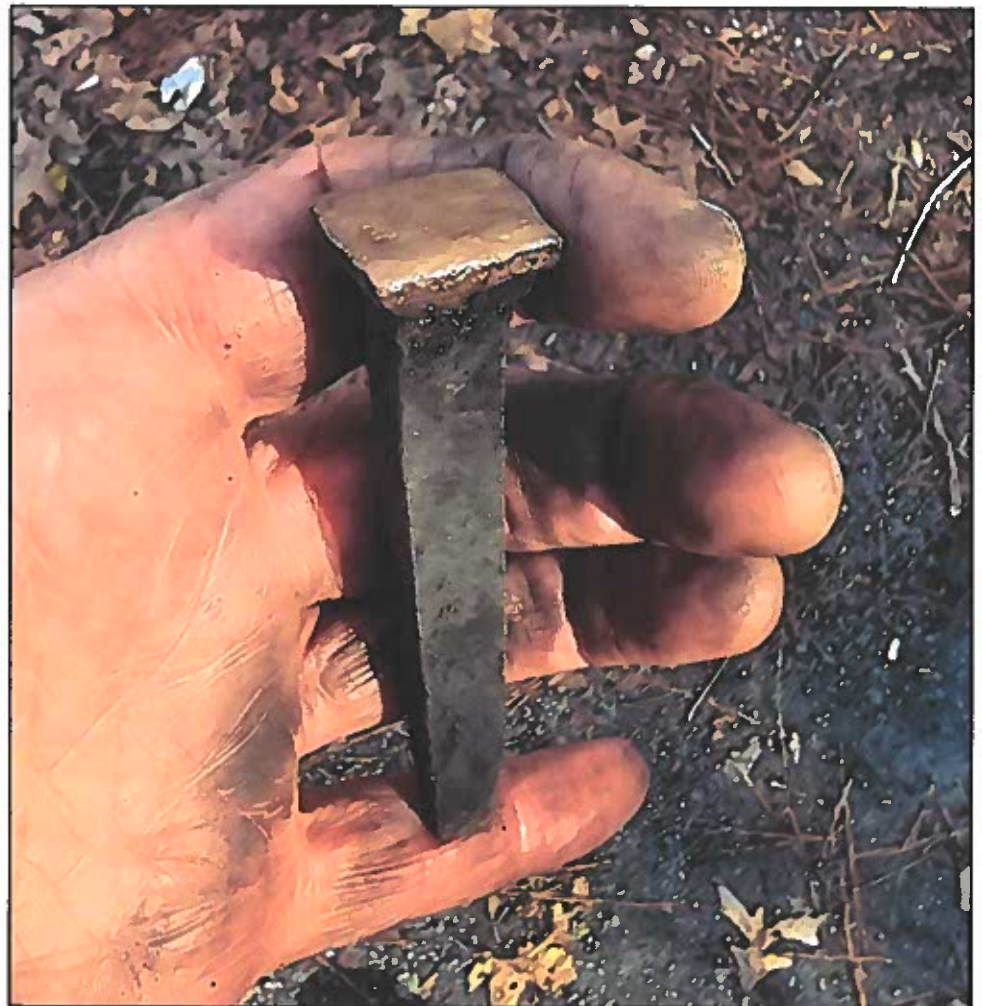
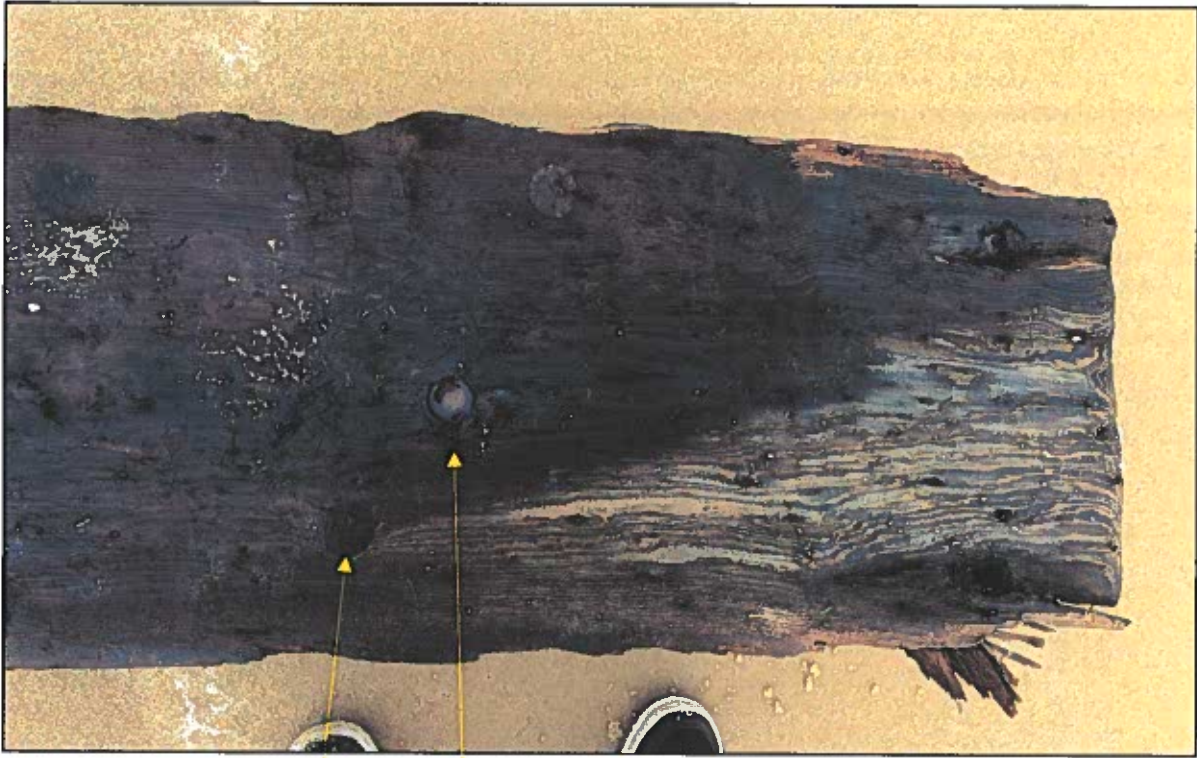
Roger McGraw  
Jan. 27, 2024

**Compare (above) to previous page (Susan Langley Jan. 29, 2024. Bottom shows another metal fitting, treenail and tack heads and holes indicating sheathing (a few are circled).**

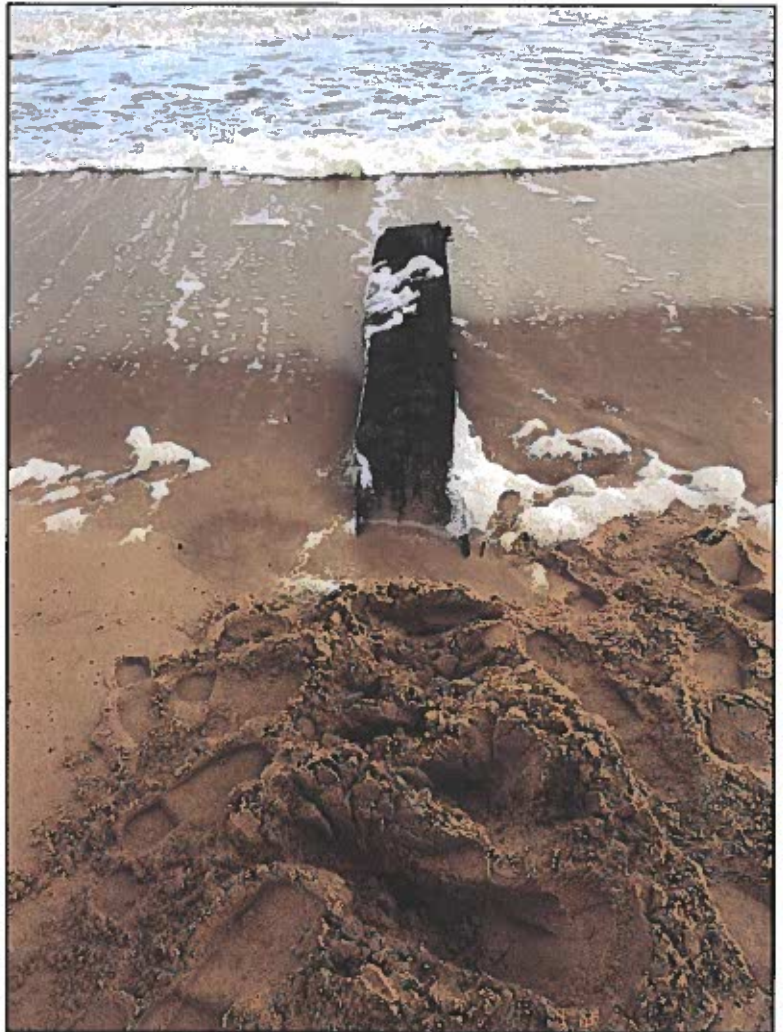
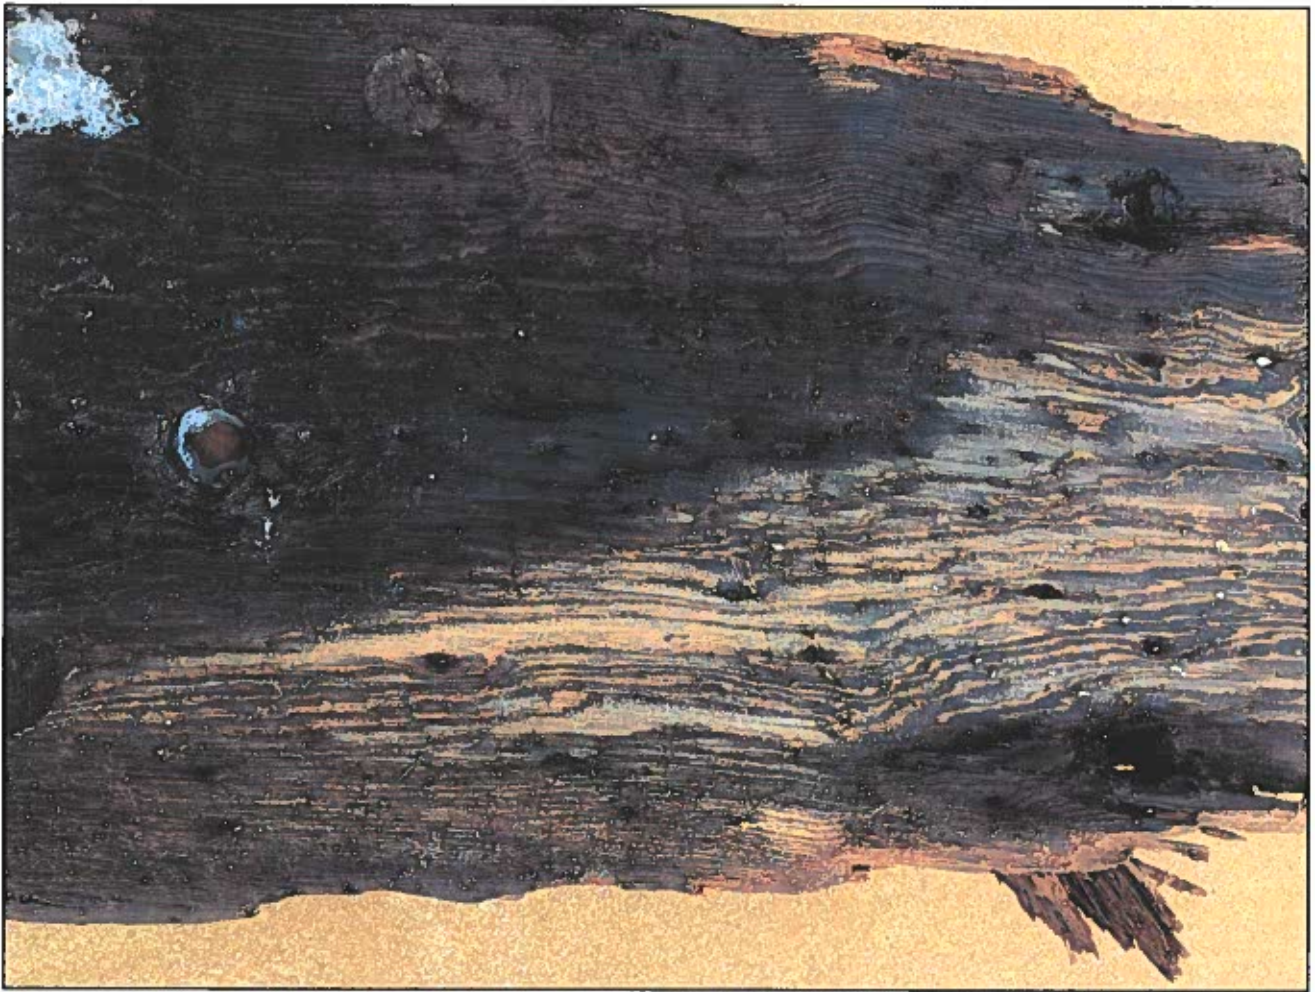
S. Langley  
Jan. 29, 2024

Sheathing tack holes (above) and details of plank end (below)  
(S. Langley Jan. 29, 2014).

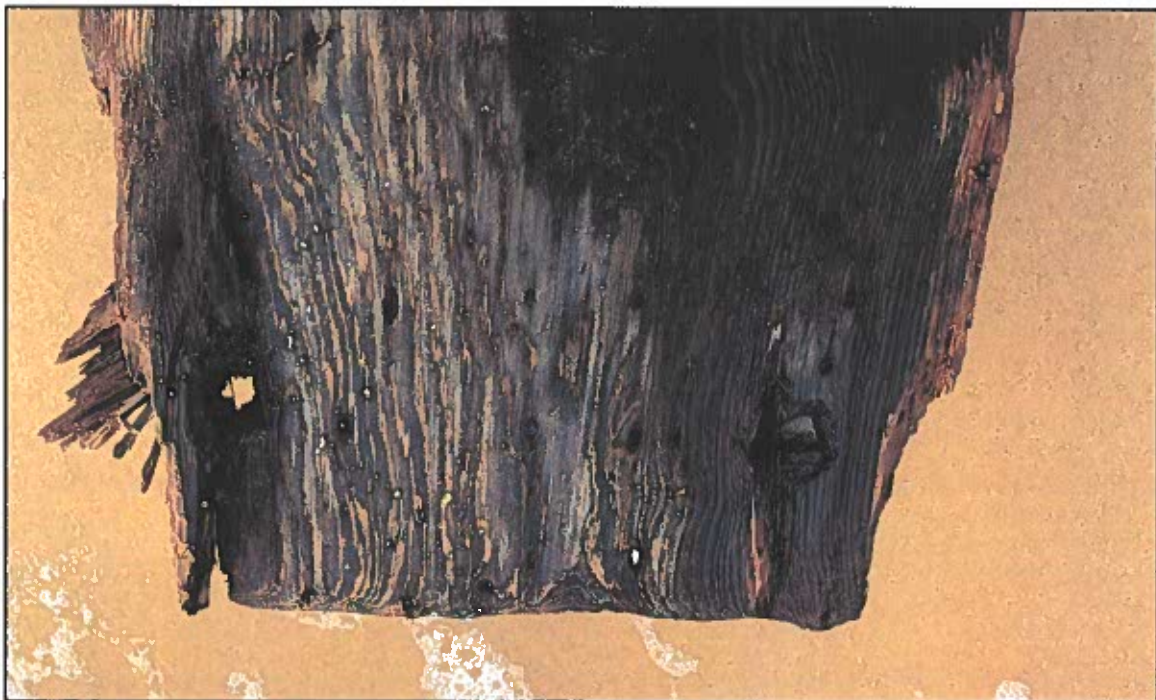
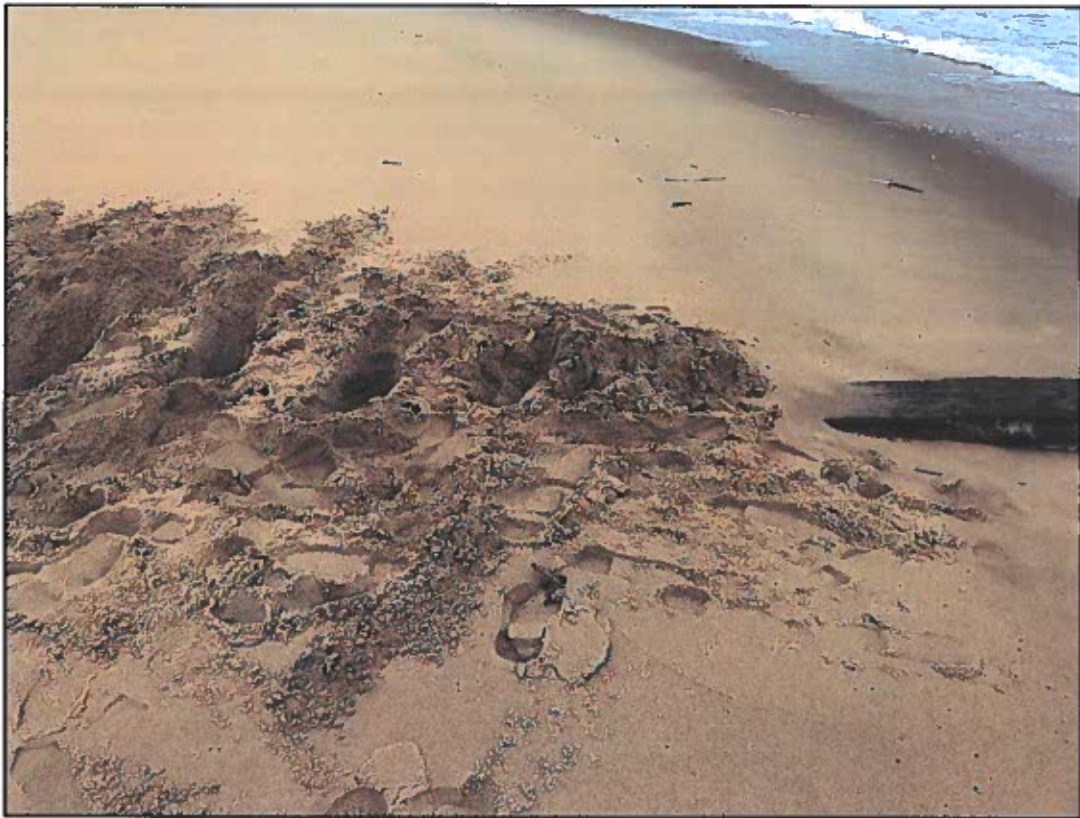
**Seeking the length of the timber; in 2 days 13 feet of the 19 foot length buried to a depth of over a foot. (S. Langley Jan. 29, 2024).**
