### STAMP Tag Deploying Form

1. Tagged by: Pamela Burgess
2. Tag Number(s) (####): MD 0024
3. Date: 8-14-2024 Time: 2:00 am ☒ pm  
Tide level: ☒ High ☐ Medium ☐ Low
4. Name of wreck (if known): \_\_\_\_\_
5. Description: How did the wreckage reach its present position?  
☒ Float ☐ Uncovered ☐ Other \_\_\_\_\_

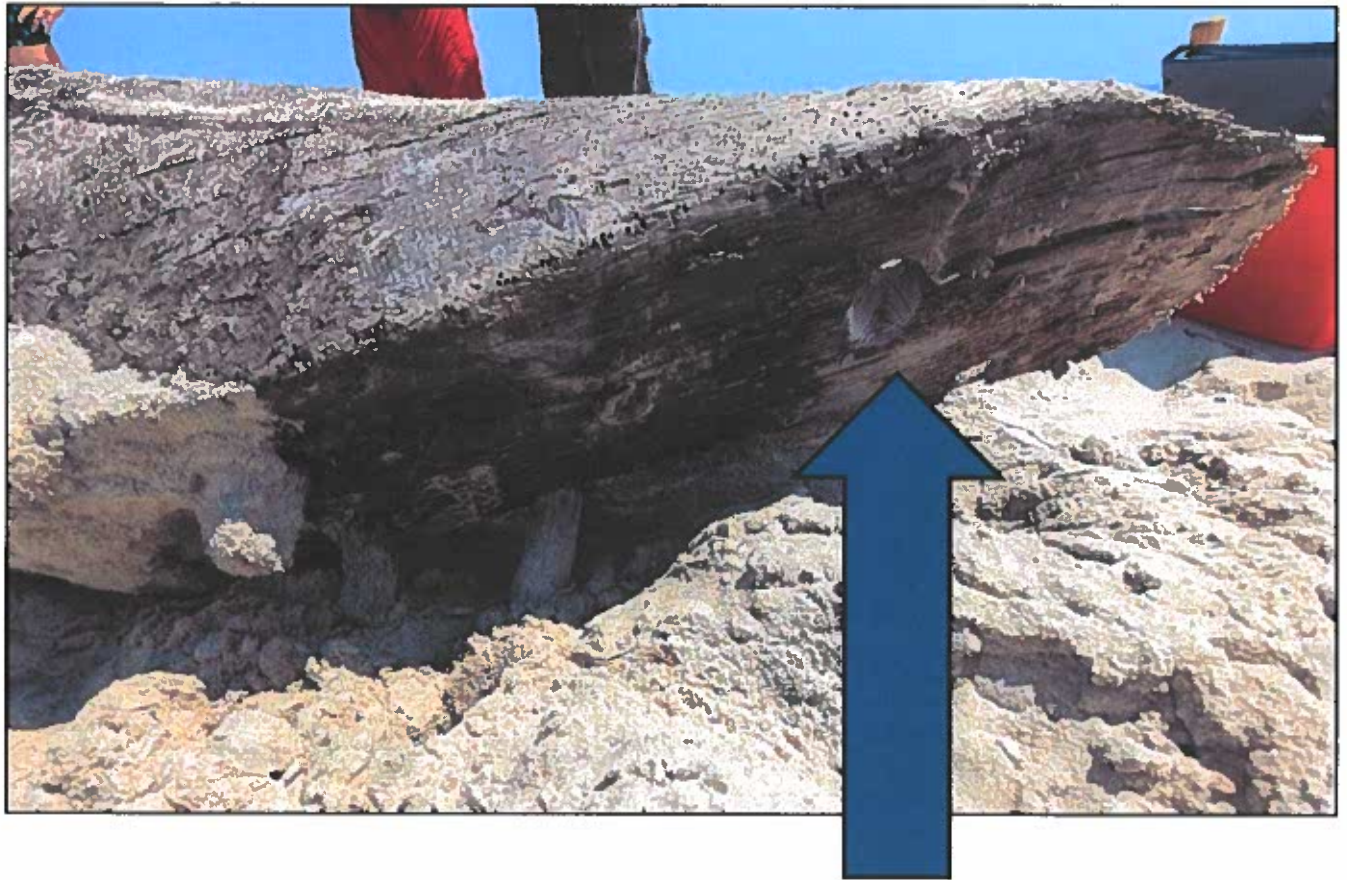
**Treenail appears to have been shimmed; this prevents it popping out under stress until the wood swells enough to hold it securely.**

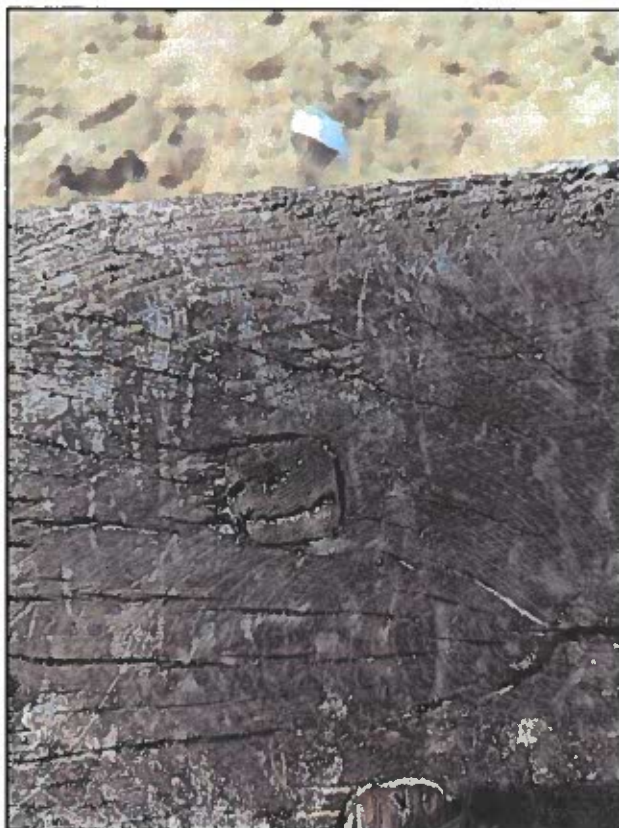
**This treenail is not shimmed and mort are not on this timber.**

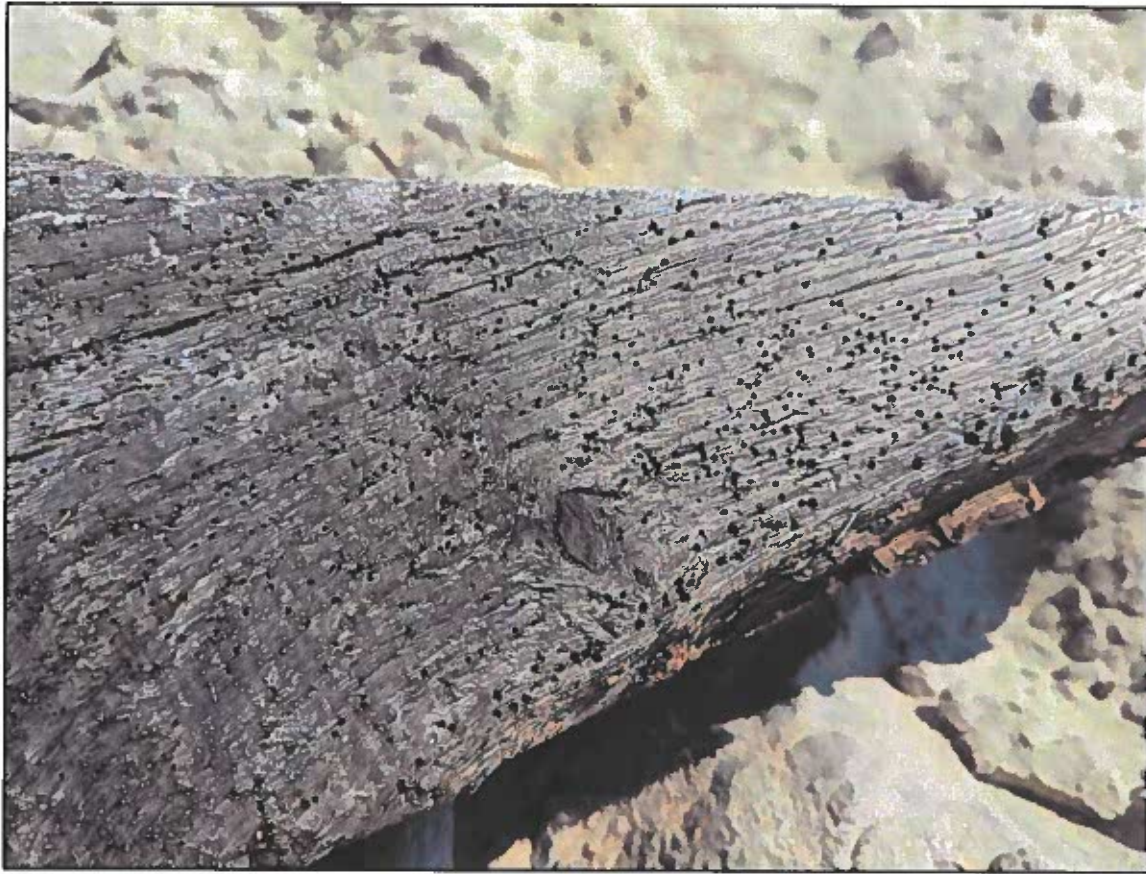
Damage by wood boring/devouring worms. These are probably by shipworm (*Teredo navalis*) although they seem small so may be made by another wood-eater the gribble (*Limnoria lignorum*).

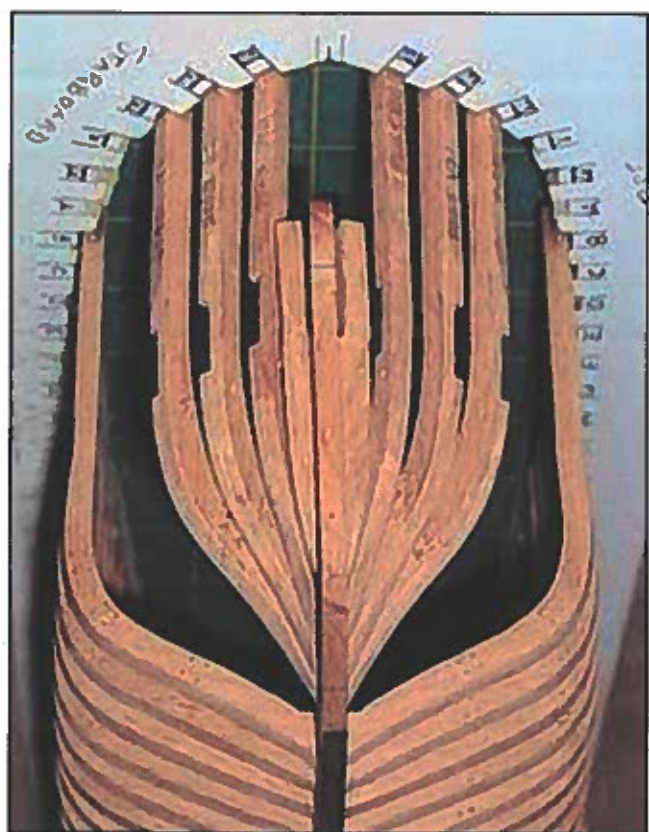
The half frames in the bow are called “cant” frames and are spaced very closely together to act as something of a shock-absorber as the vessel ploughs through waves.
