### STAMP Tag Deploying Form

1. Tagged by: Will Stegman
2. Tag Number(s) (####): MD0016, MD0015 MD0018 MD0017 <sup>4</sup> TAGS
3. Date: 12/22/23 Time: 10:50 am pm  
 Tide level:  High  Medium  Low
4. Name of wreck (if known): Not known; likely dates between mid and late 19th C 1850-1899 approx
5. Description: How did the wreckage reach its present position?  
 Float  Uncovered  Other Storm Action.

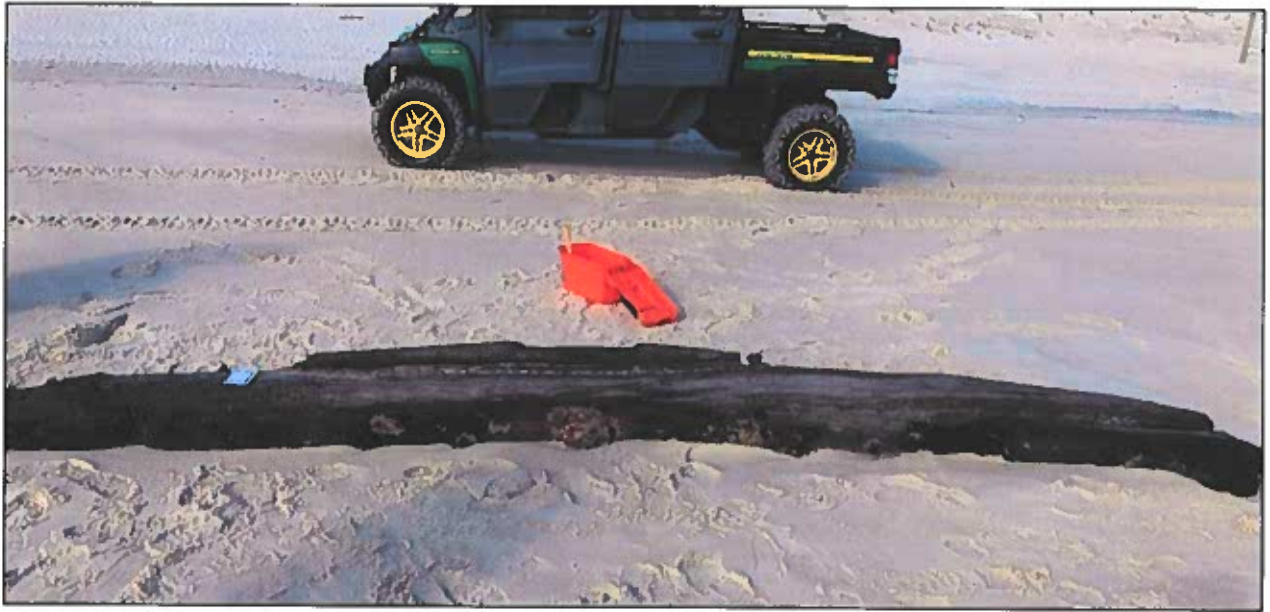
14. Comments: The insertion of the notch at the bottom to seat the timber on the keel, as a separate piece is rare but not unique. This is done as a repair or during construction if that piece of the timber has knots or might be sapwood that will decay faster than the denser heart wood of the rest of the timber.

**Keel notch attached separately (top center). Base of first futtock scarphed to floor timber (below). The floor and futtocks combine to make the ship's frames or "ribs."**

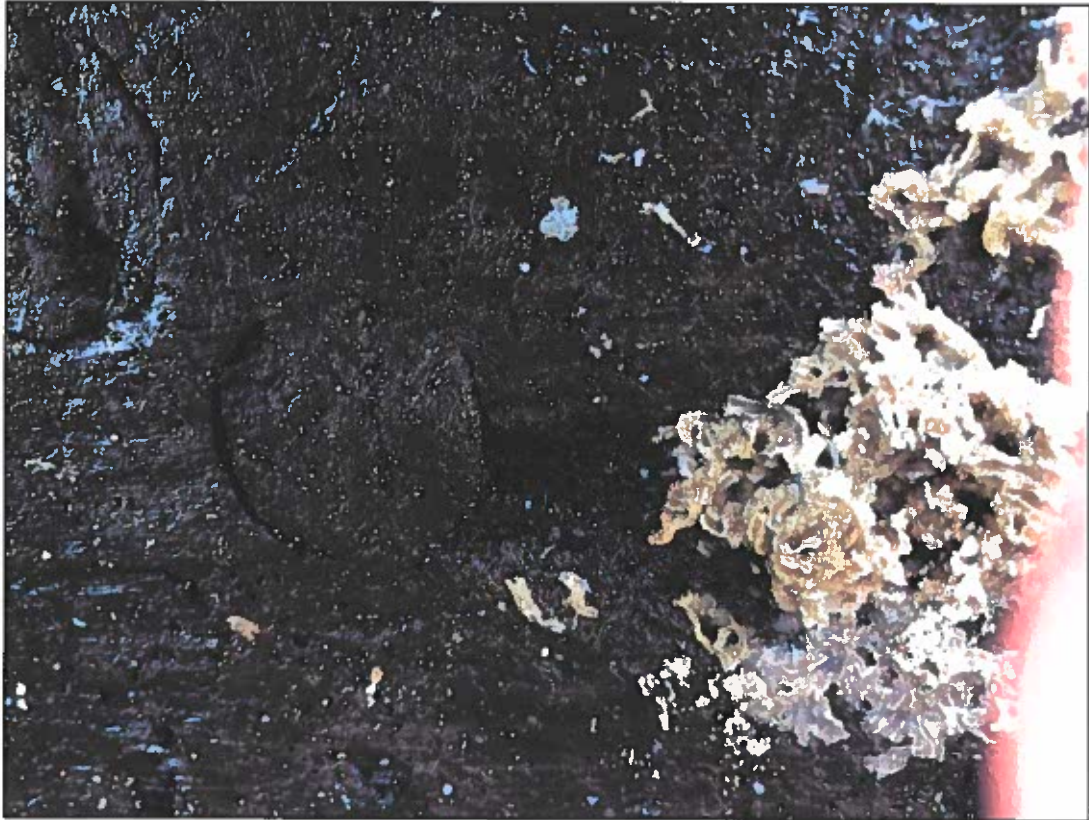
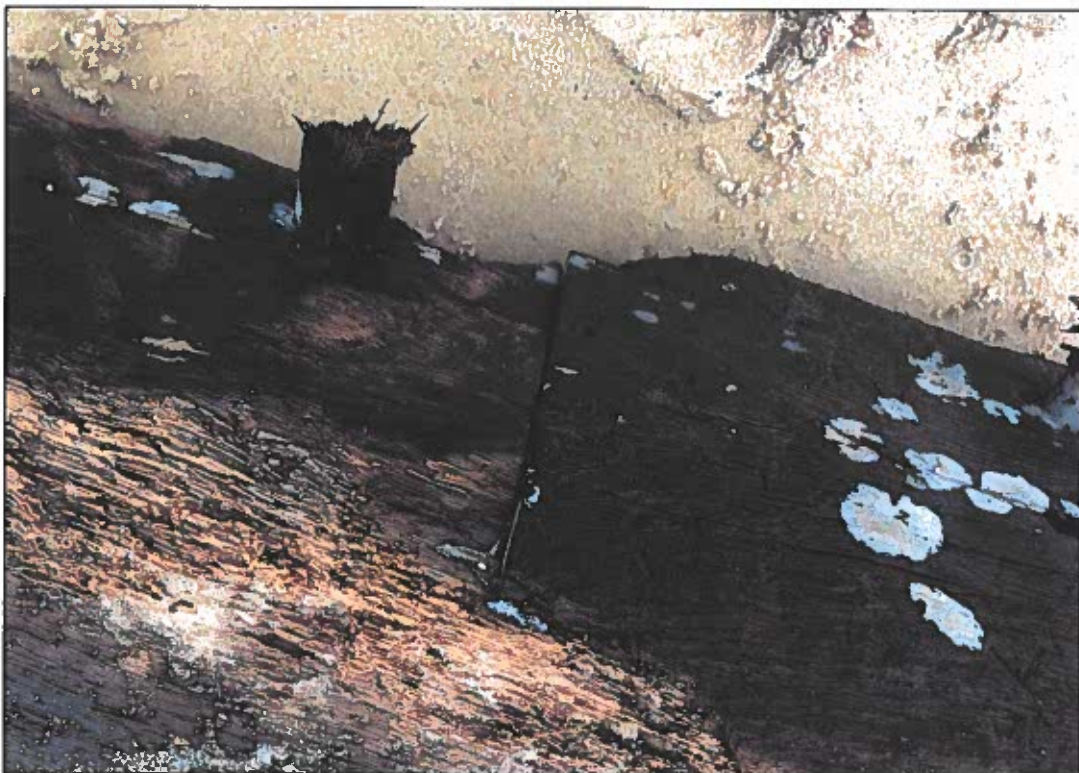
**Treenails or trunnels are wooden pegs used as fasteners instead of metal. Some lathe-turned ones have small wedges or shims driven into the top to hold them in tightly. The keel notch has been scarphed in carefully and may indicate it was done during construction versus as a subsequent repair (below)**

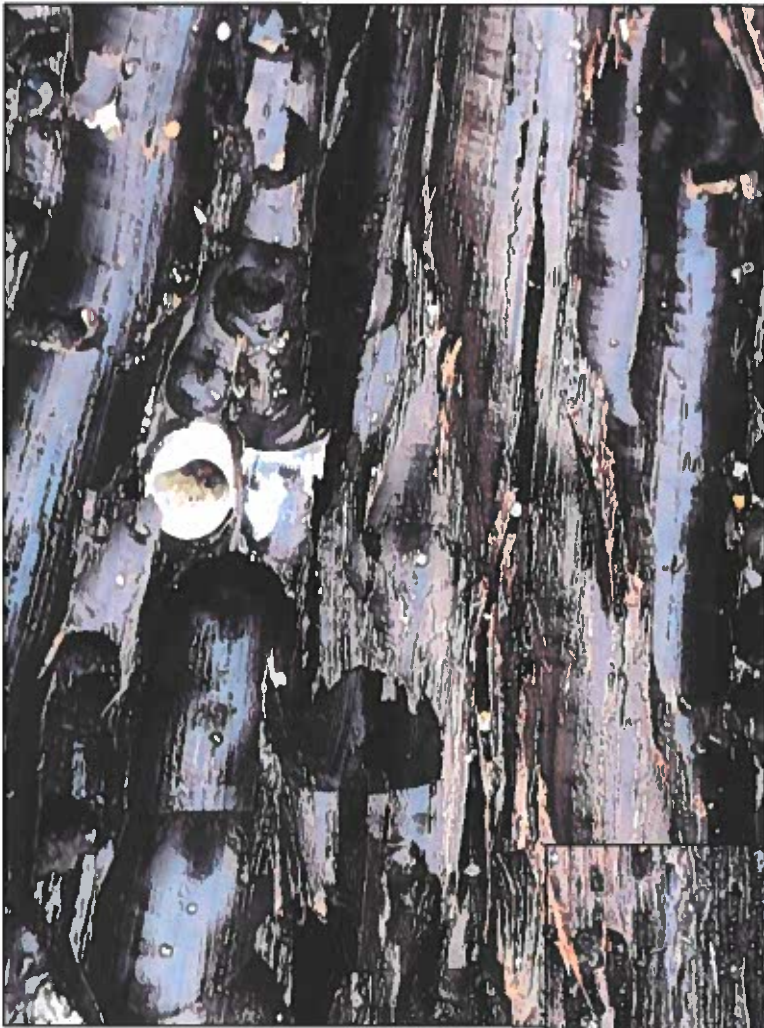
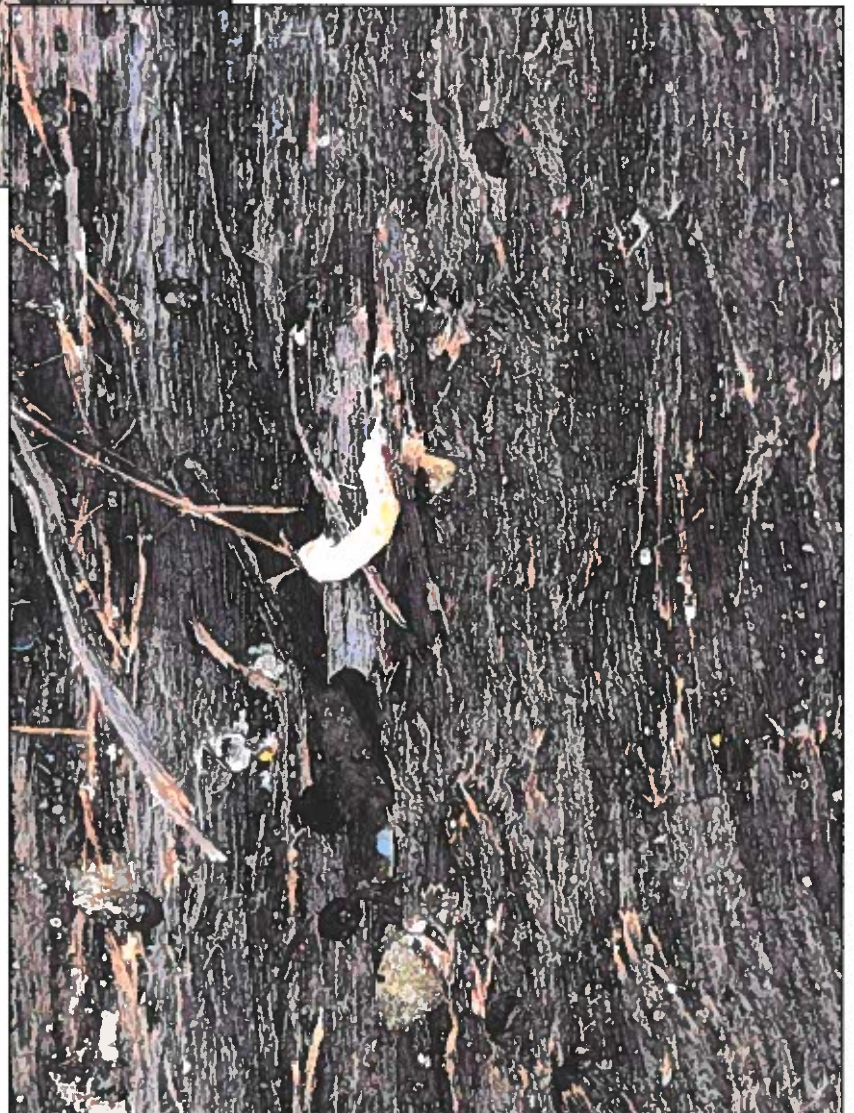
The long holes in the wood, especially those lined with calcium carbonate indicate the presence of *Teredo navalis*, a wood-eating creature that is technically a bivalve despite its "wormy appearance. It is also called a shipworm. A live specimen is seen center below; a number of these as well as evidence of there work is present on this timber. This is relatively common.
