STAMP Tag Deploying Form

1. Tagged by: Cary Vitti, Dan Rottenberk
2. Tag Number(s) (####): Test Tag 0000a and Tag 0009
3. Date: June 8, 2023 Time: 10:00 am pm
Tide level: High Medium Low N/A
4. Name of wreck (if known): N/A
5. Description: How did the wreckage reach its present position?
 Float Uncovered Other Was brought to Nature Center at Assateague State Park

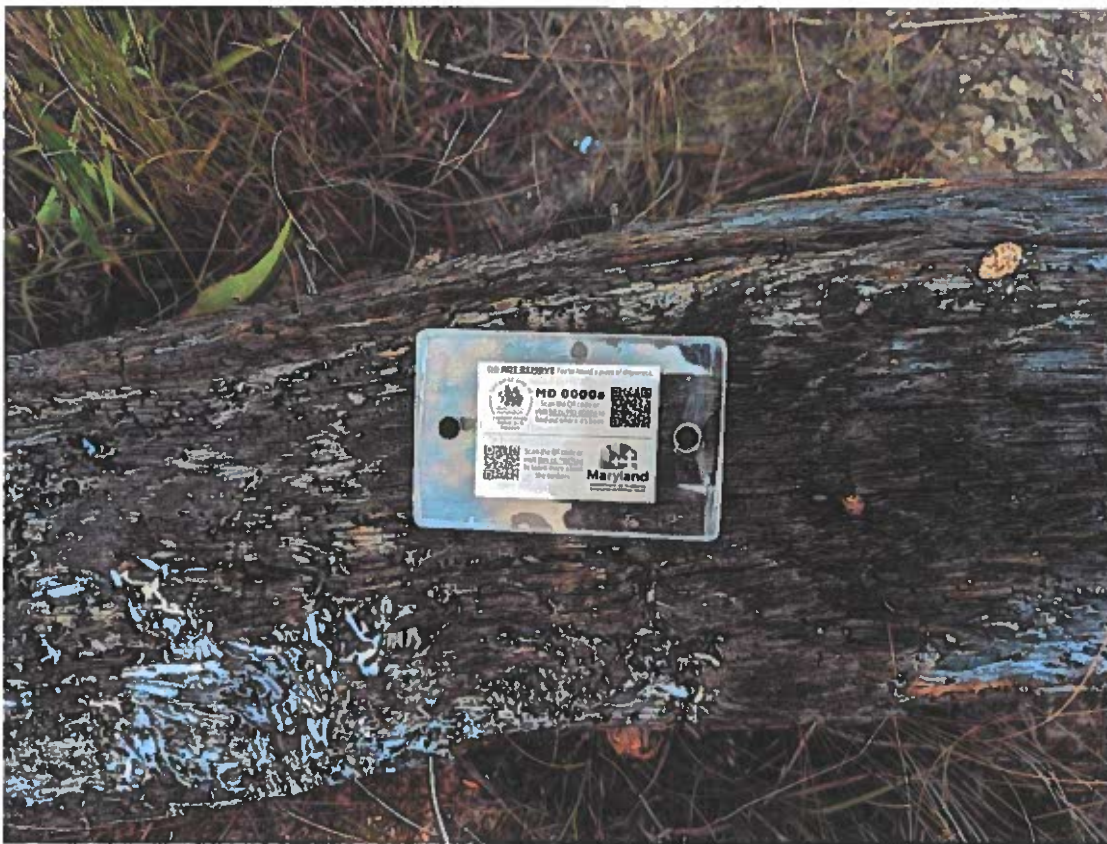
Test Tag 0000a 1

Floor timber with a scarfed piece attached by 5 treenails. Both the scarfed piece and the timber are cut abruptly on one end.

14. **Comments:** Teredo navalis (shipworm) damage, scarfed end is sawn
flat/truncated, some evidence of burning.

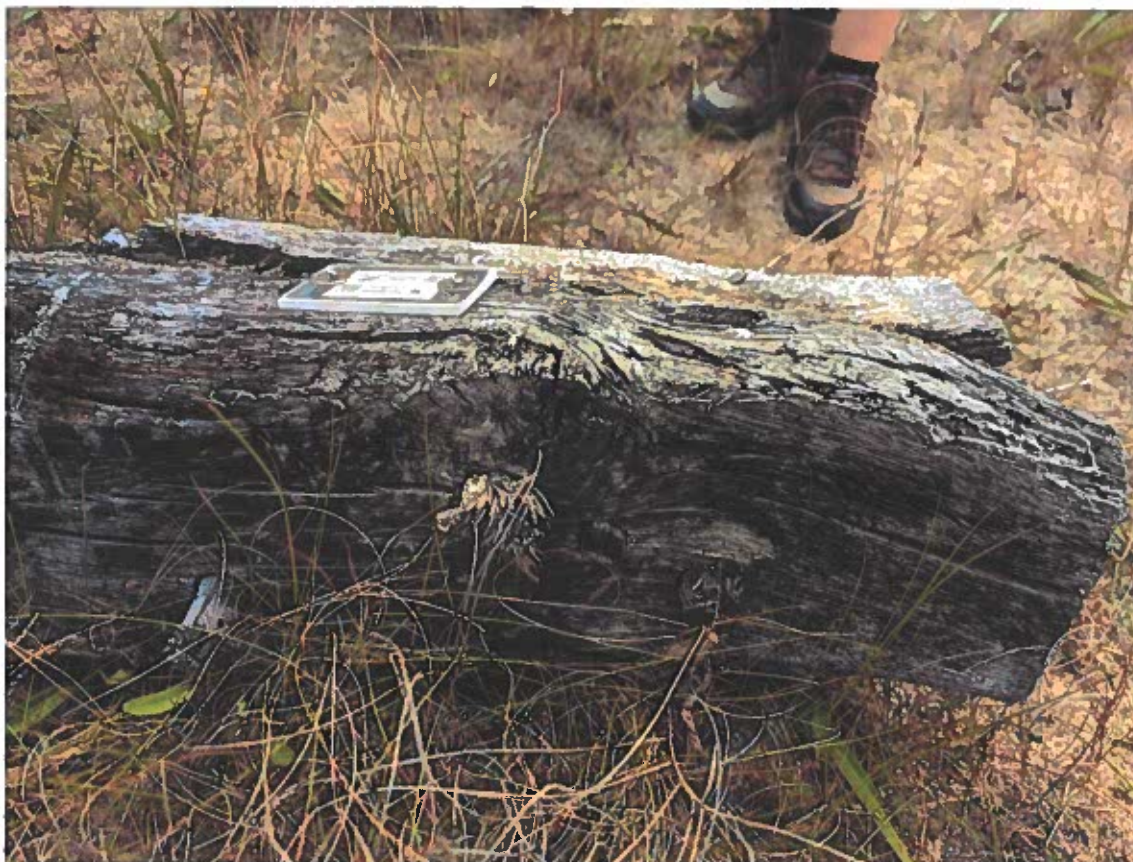
Test Tag 0000a 2 Scarf joint /treenails
