Maryland Historical Trust

Maryland Inventory of Historic Properties number: AL-11-A-145

Maryland Inventory of Historic Properties
Historic Bridge Inventory
Maryland State Highway Administration
Maryland Historical Trust

Name and SHA No. Dolly Road over Flintstone Creek/A10400 (A10410)

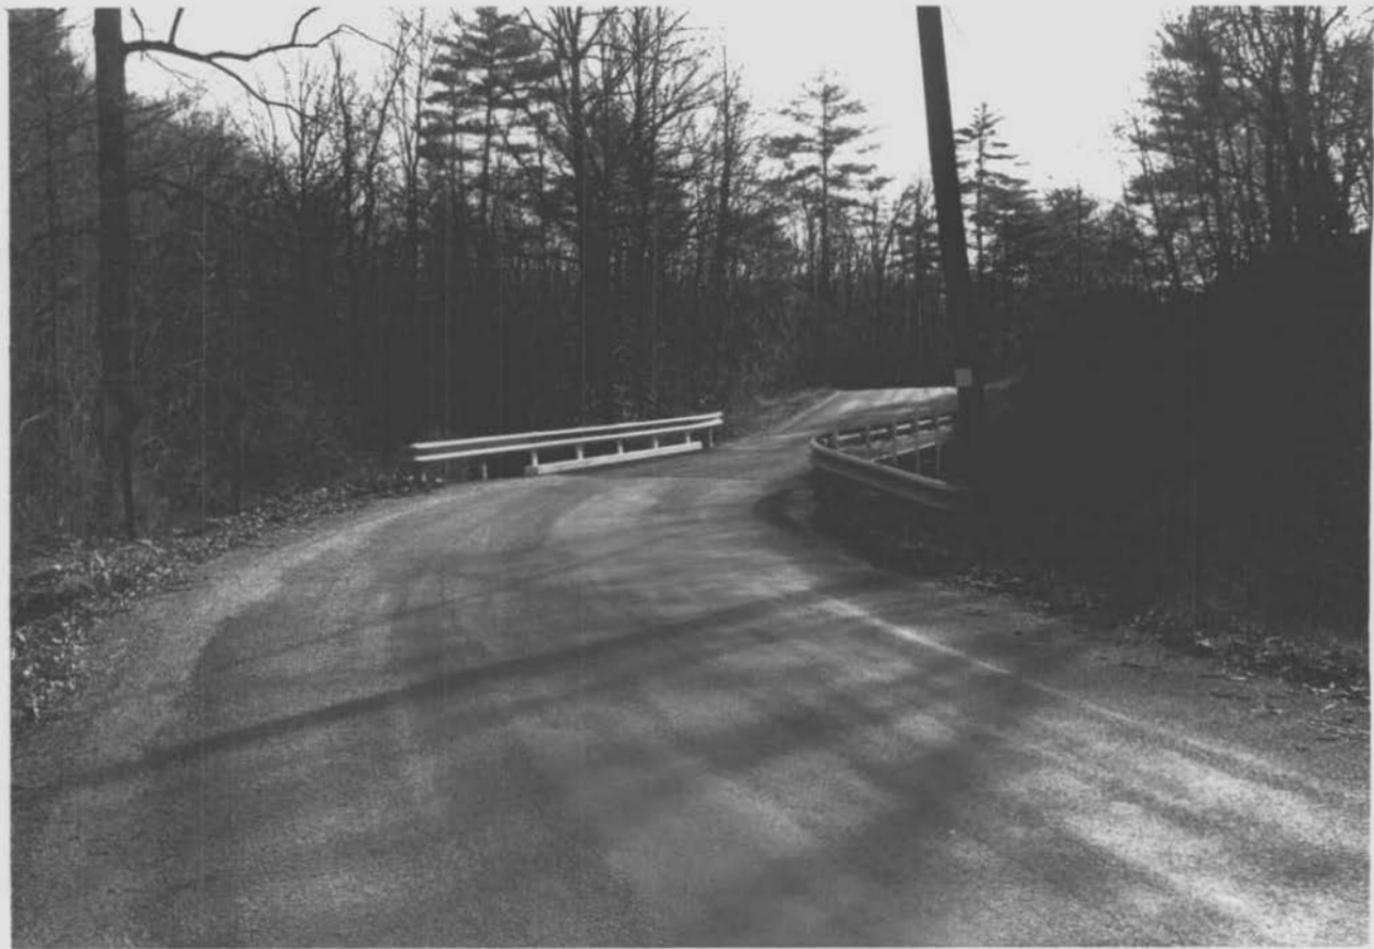
1 OF 4

EAST APPROACH

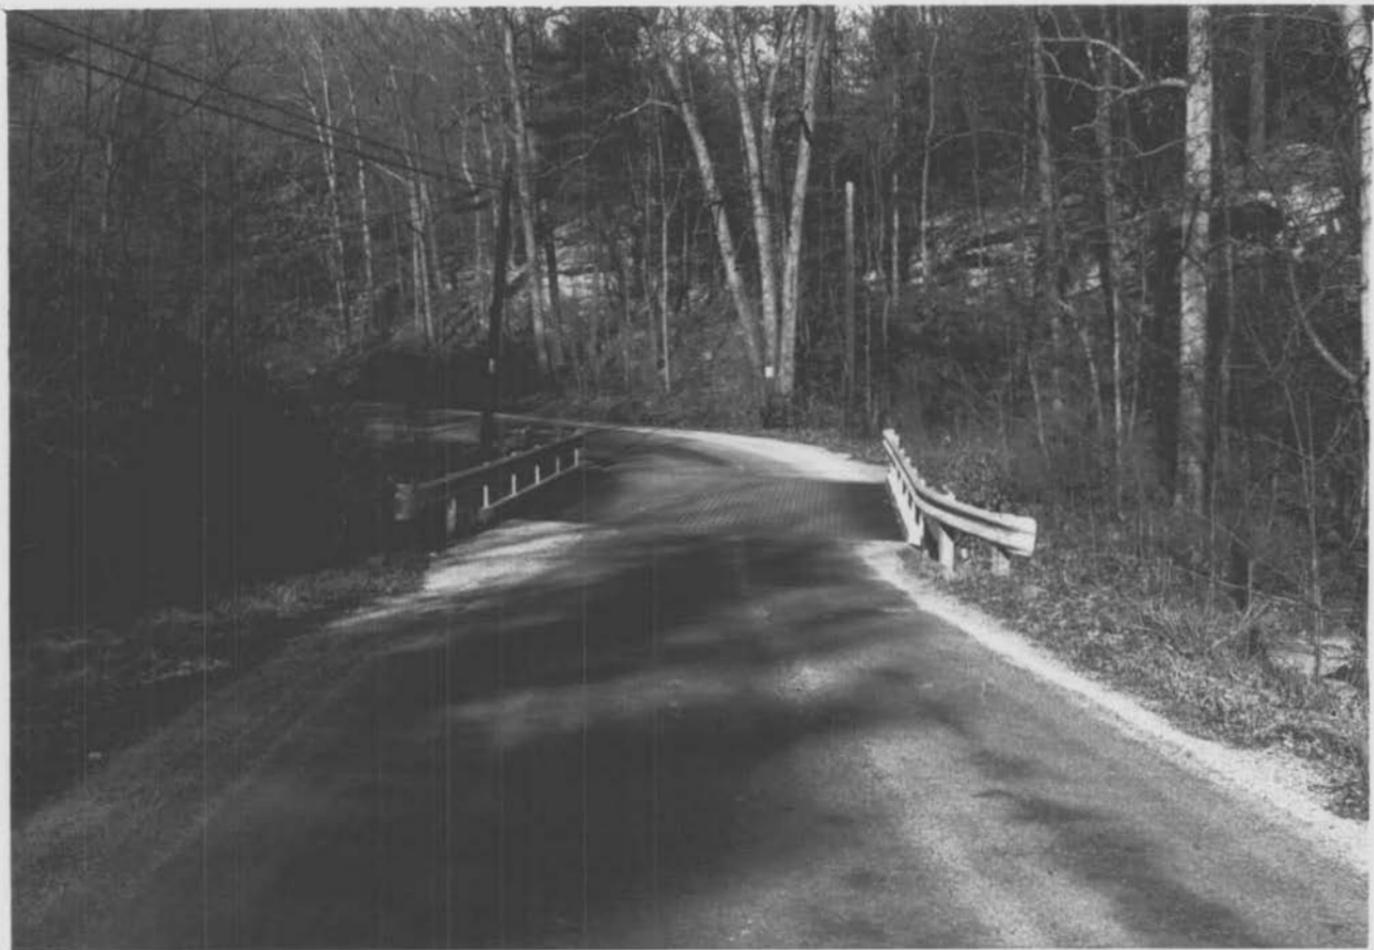
2 OF 4

WEST APPROACH

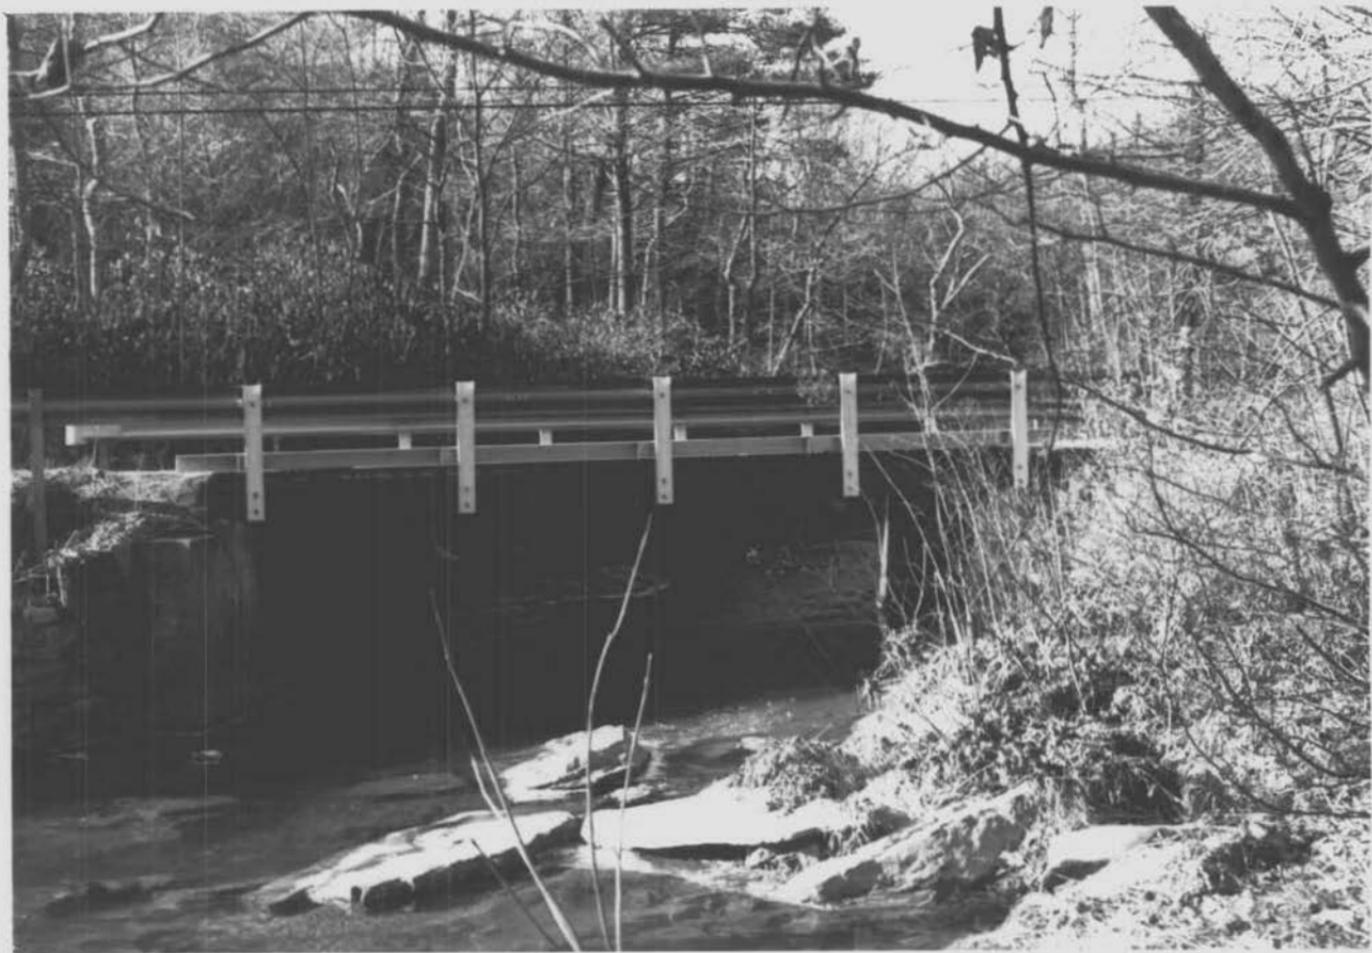
3 OF 4

NORTH ELEVATION (DOWNSTREAM)

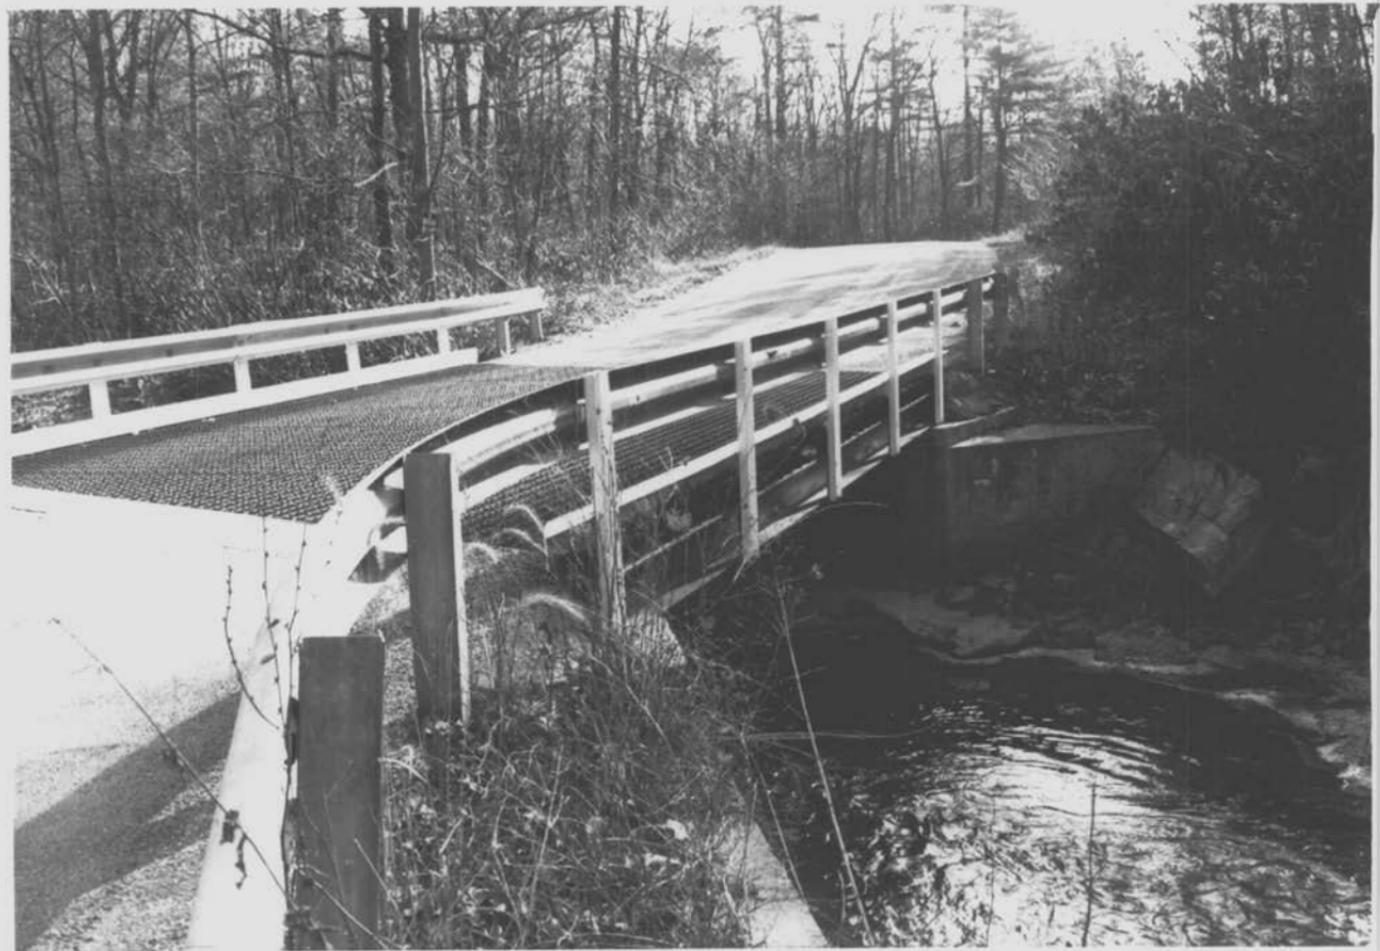
4 OF 4

SOUTH ELEVATION (UPSTREAM)
