HISTORIC PRESERVATION CERTIFICATION
APPLICATION—PART 1

1. Name of property: "THE CHIEF MILLER'S HOUSE", Rockland Village
Address of property: 1010C Falls Road
City Brooklandville County Baltimore State Maryland Zip Code 21022
Name of historic district in which property is located: Rockland National Register District

ROCKLAND: "THE CHIEF MILLER'S HOUSE"

Description of Physical Appearance.

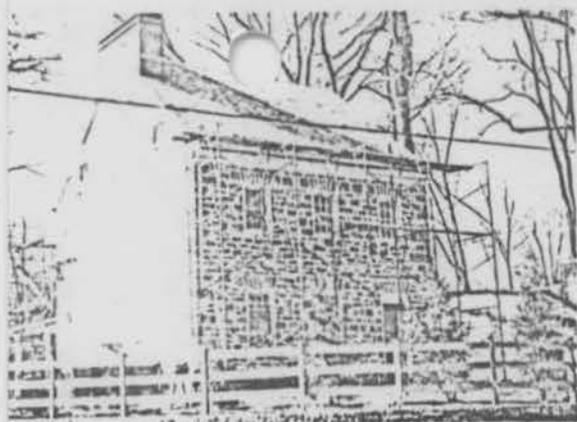
PHOTO 1: FALLS RD. ELEVATION

The walls of the stone building are composed of uncoursed and roughly squared stone masonry from Butler, Maryland, 12-16" thick. The Falls Road facade is divided into (3) bays. (3) windows on the second floor and (2) windows and (1) door on the first. (2) small square windows flank the chimney on the Old Court Road side. The north elevation has (1) small square window and (1) typical second floor window. First floor windows are 9 over 6 double hung, and second floor windows are 6 over 6. Window openings are surmounted by large, flat stone arches. Hardware on wood frames indicate shutters were present. Shutters will be re-hung during renovation. The existing front door (Falls Road) has been hacked and chopped and presently has a 2'-6" x 2'-6" piece of glass in the middle.

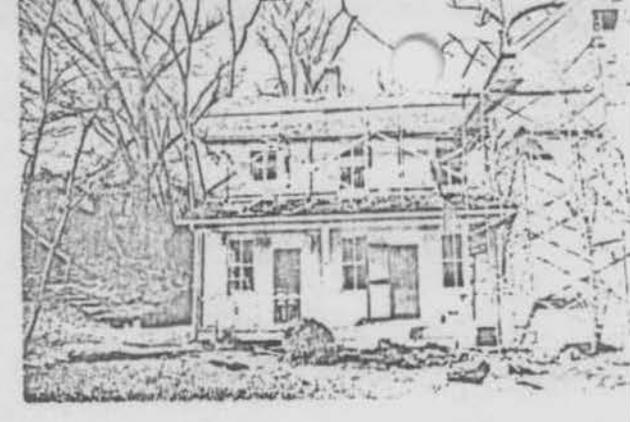
PHOTO 3: FRAME ADDITION

The (2) story wood frame addition is clad in 9" white clapboard. There is a 6'-0" x 21'-0" wood porch fronting Old Court Road. The windows are predominately 2 over 2 double hung (9), with small, square casements (3) on the second floor. Hardware indicates shutters were on all windows. Shutters will be rehung. Existing doors (2) are in fair to poor condition. The original roof was again cedar shingles. Renovation will re-install the cedar shingle roof.

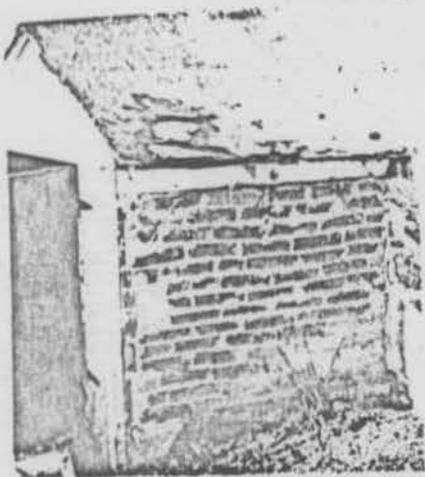
A set of stone steps between the stone building and wood frame addition allows access to basement from Old Court Road side. The door at the bottom of the stairs has been replaced with polyurethane. Also on the Old Court Road side is a coal chute with brick and plywood shed.

PHOTO 8: COAL CHUTE SHED

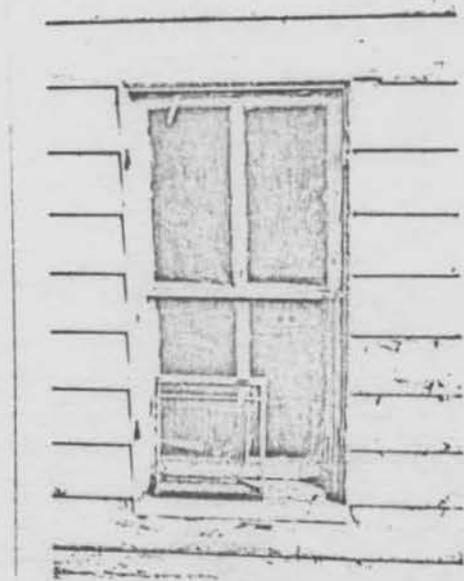
PHOTO 12: "TYPICAL" WOOD
FRAME ADDITION WINDOW.

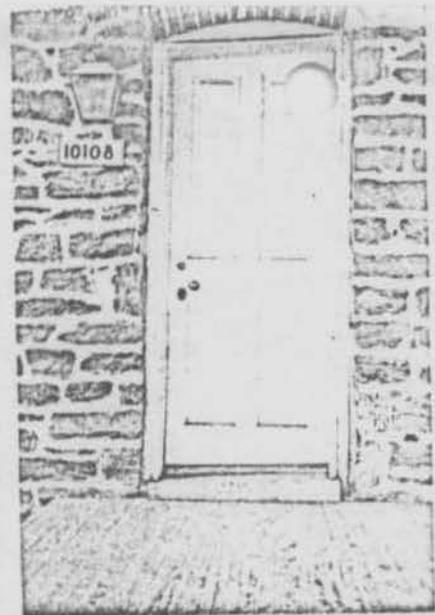
PHOTO 10: "TYPICAL" VILLAGE D
DOOR FROM 10108 TOWNHOUSE.

THESE (2) PHOTOS SHOW "TYPICAL"
ROCKLAND VILLAGE DETAILS.

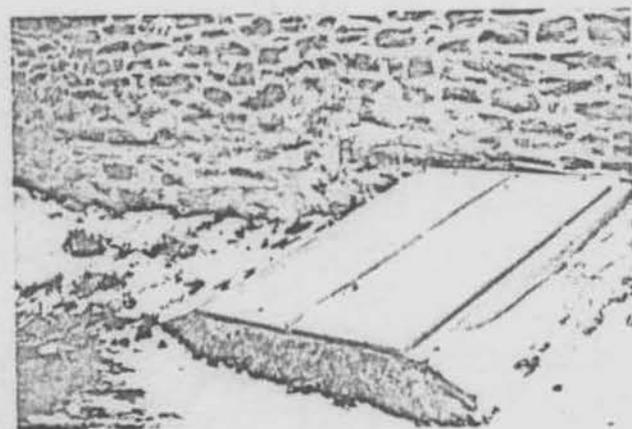
PHOTO 13: VILLAGE "BILCO" DR.
PHOTO FROM DETACHED HOUSE W VILLAGE.
