**MARYLAND HISTORICAL TRUST  
NR-ELIGIBILITY REVIEW FORM**

Property Name: Leight House Inventory Number: BA-2940  
16229  
 Address: 15920 York Road City: Sparks, MD Zip Code: 21111  
Monkton, Md. vic.

# Maryland Historical Trust Maryland Inventory of Historic Properties Form

Inventory No. BA-2940

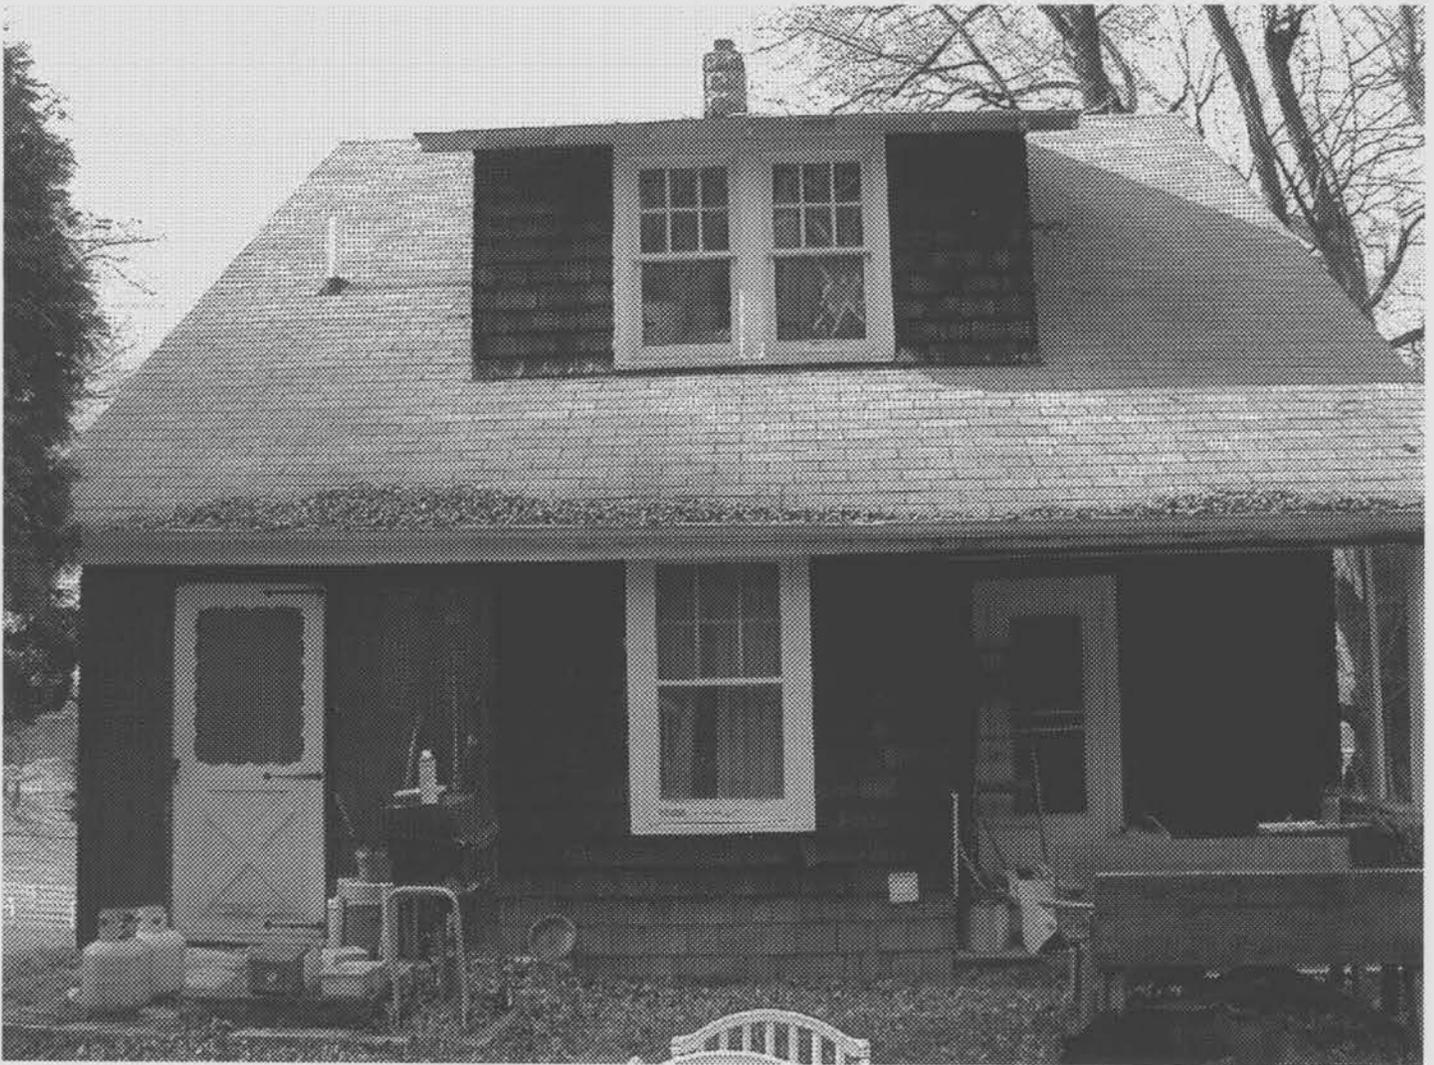
The rear shed dormer retains two abutting 6/1 light double-hung sashes. The wider front shed dormer has three, and both dormers have projecting rafters. The chimney, difficult to view due to field limitations imposed on the surveyors, appears to be rusticated block projecting from the center of the ridgeline. A bulkhead entranceway on the south façade may be an addition.

Figure 1. Rear of Gerber-O'Brien House.

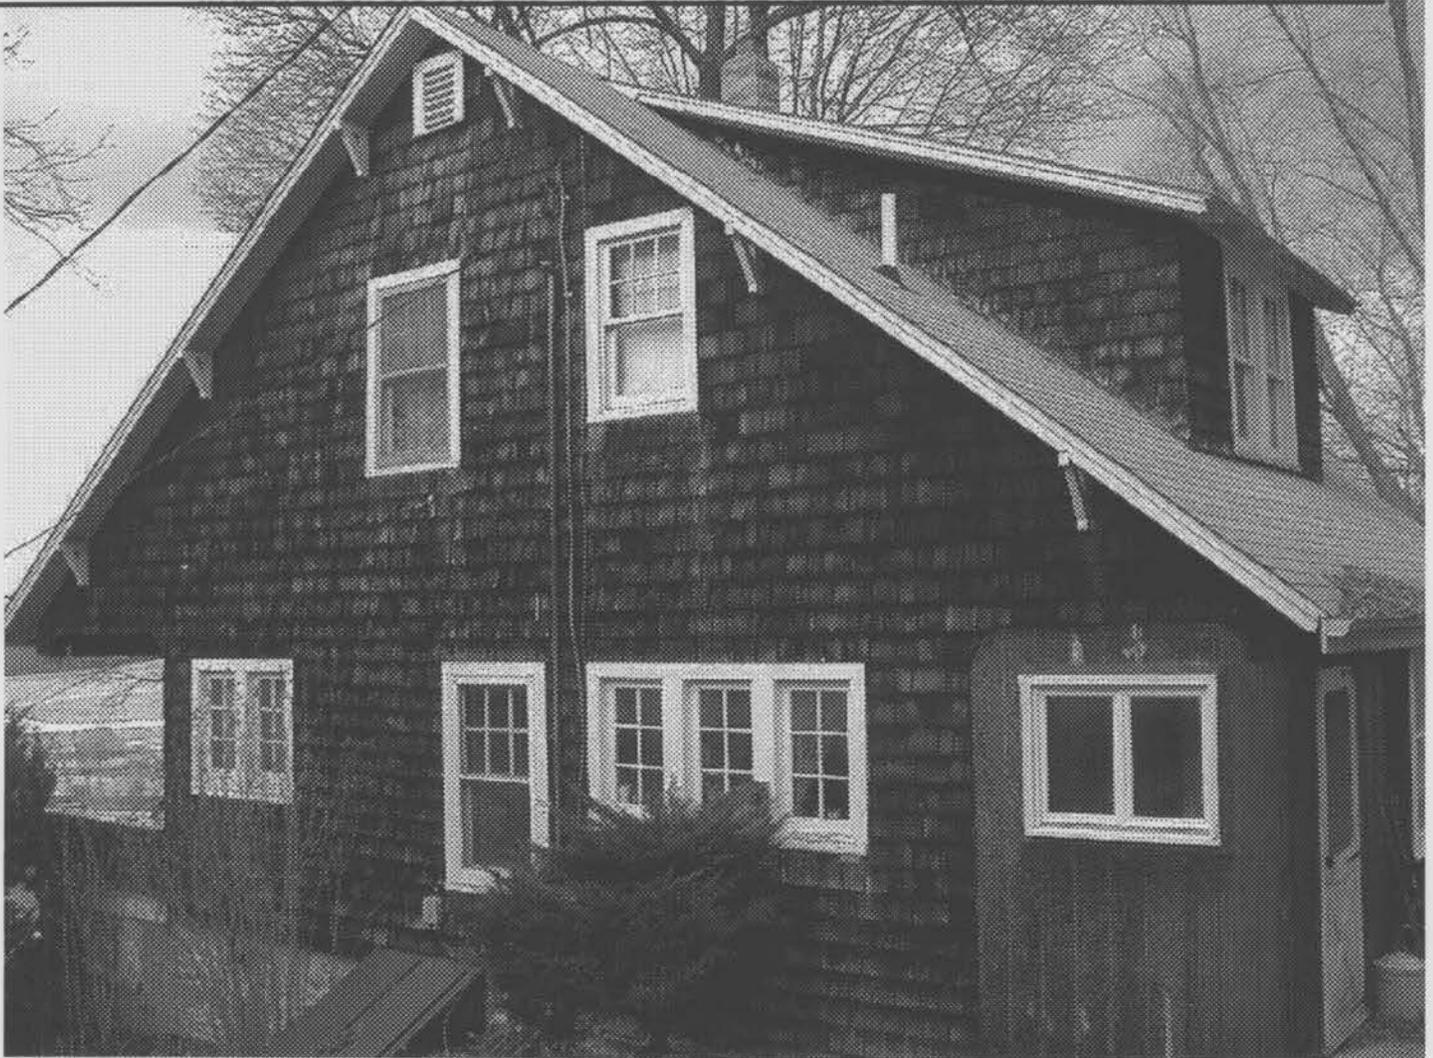
A full complement of stick brackets (6), painted white, survive beneath the eave on the south side of the building. The north façade has one pair of six light casements and one separate casement on the first floor and one double hung sash on the second floor. There are attic vents, presumably recent additions, at the apices of both gables. The shake siding may replace the original material, also likely to have been shakes. Those on the upper story, particularly around the shed dormers, are in need of treatment. Poor gutter maintenance also contributes to the deterioration of the siding and windows.

Figure 2. South façade of the Gerber–O'Brien House. Note first floor casemate windows, 6/1 light double–hung sashes, brackets beneath the eaves, and enclosed rear entry porch.

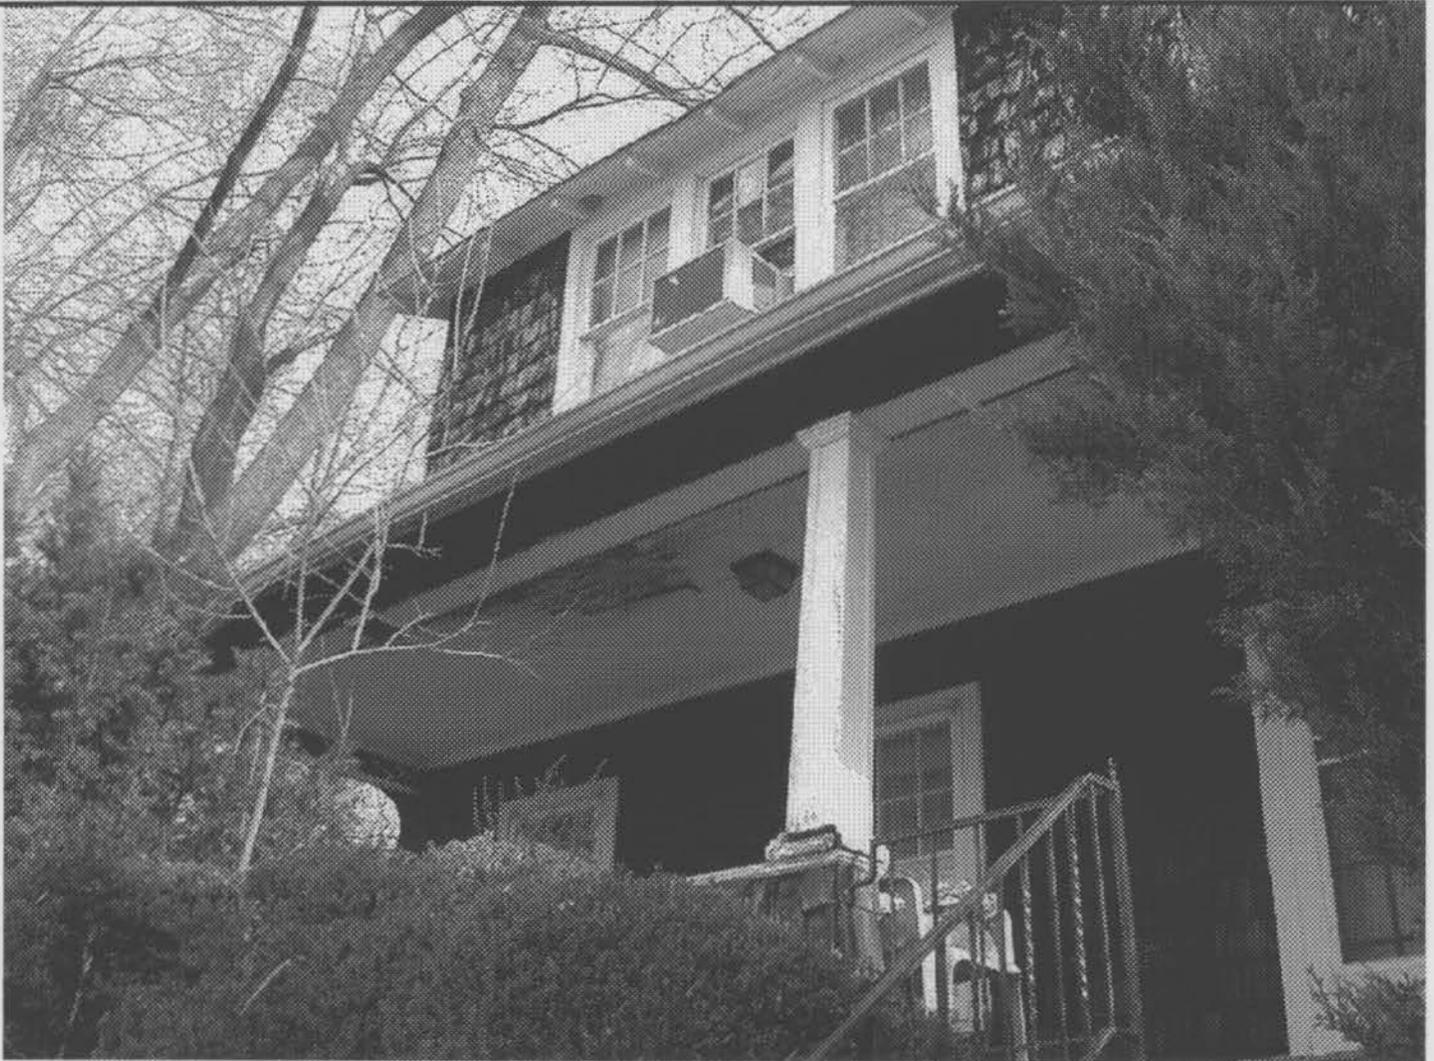
The front porch has been infilled beneath with concrete block, in contrast to the original fieldstone foundation. The beaded board porch soffit has been damaged by water and it appears unlikely that a permanent repair of the leak has been effected. The base of one tapered and paneled porch pier is rotten and the pier is askew, although the capital, restrained in its decoration, appears to be in good condition. The southwest pier is missing. Plantings around the porch have not been maintained: they obscure much of the front façade and contribute to the deterioration of the porch and siding.

Figure 3. Partial view of vegetation shrouded front façade of the Gerber-O'Brien House. Note water damaged porch soffit and decayed base of pier.

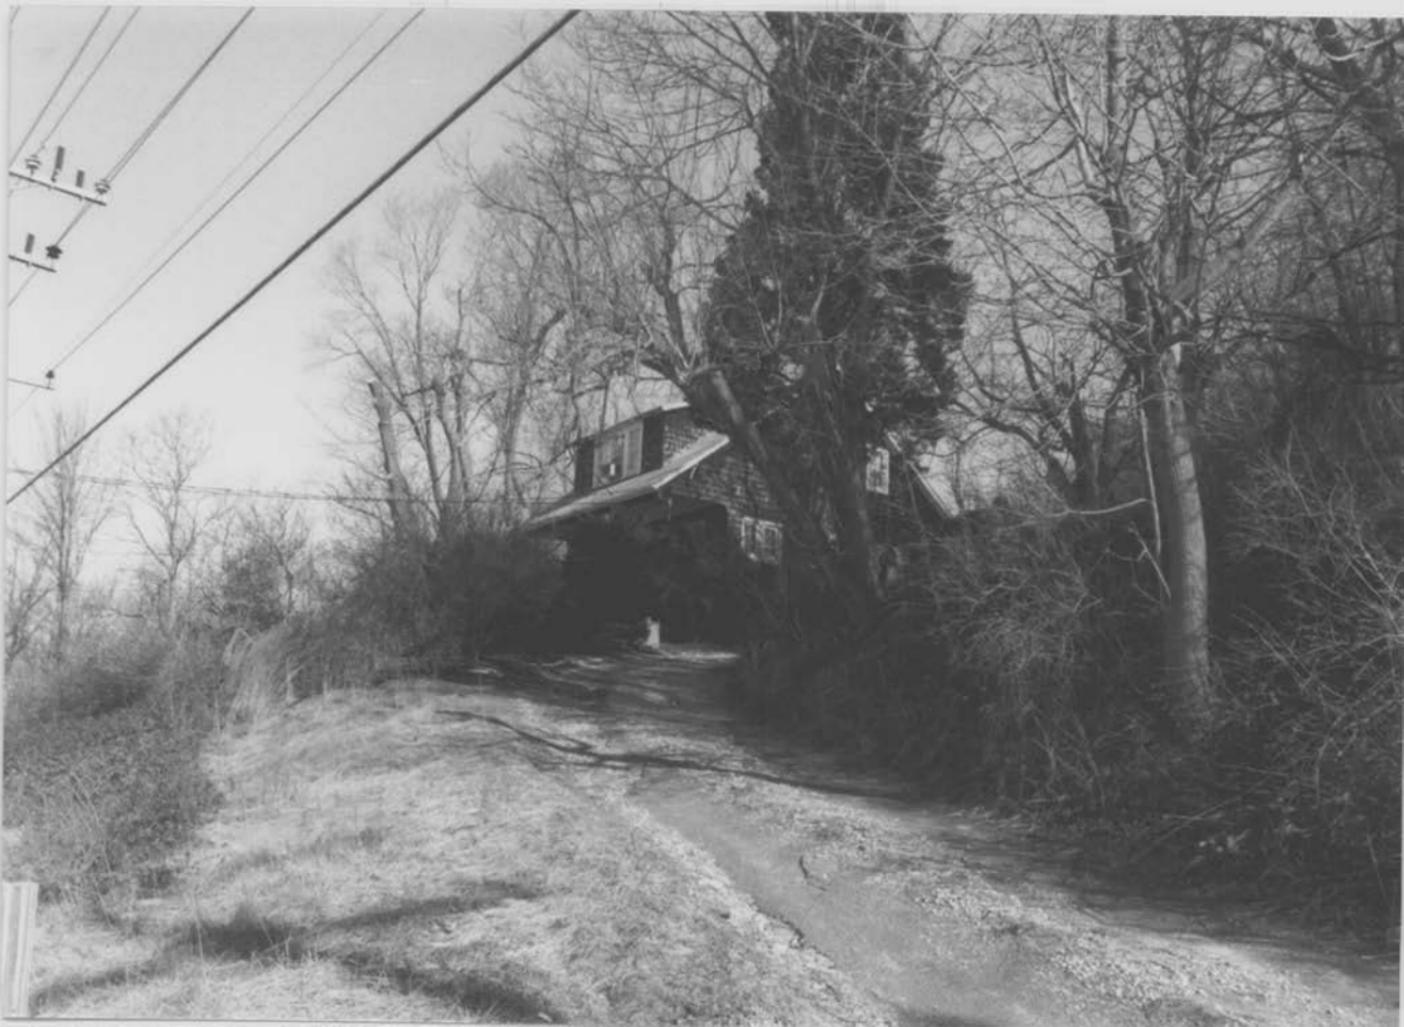
1/6

View of Leight House from York Rd. facing northeast.

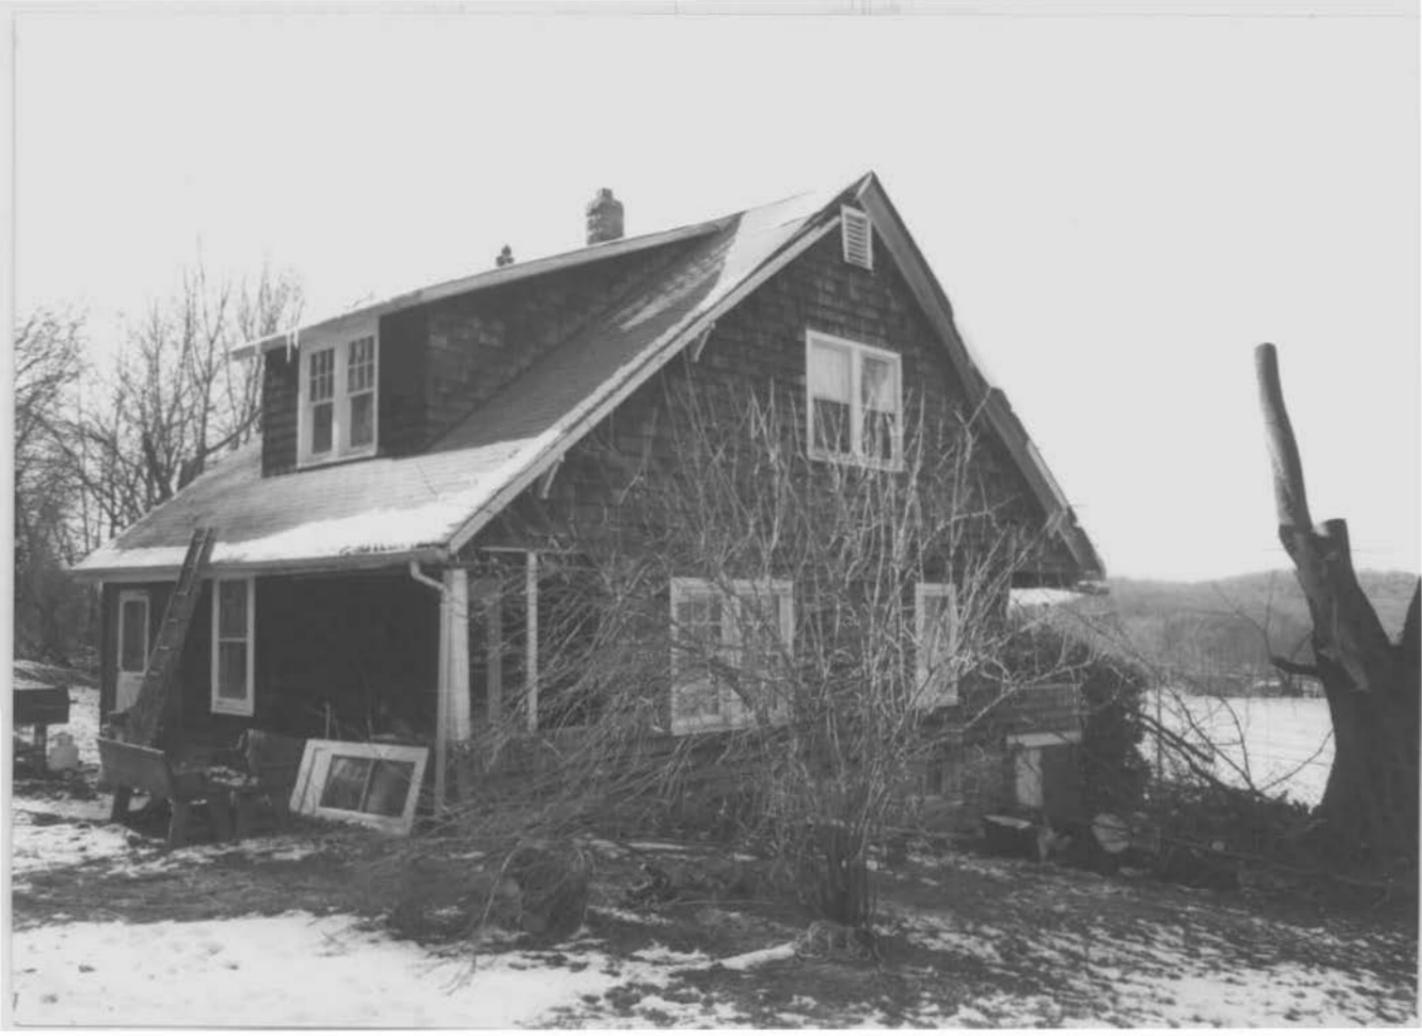
View of Leight House from yard, facing southwest,

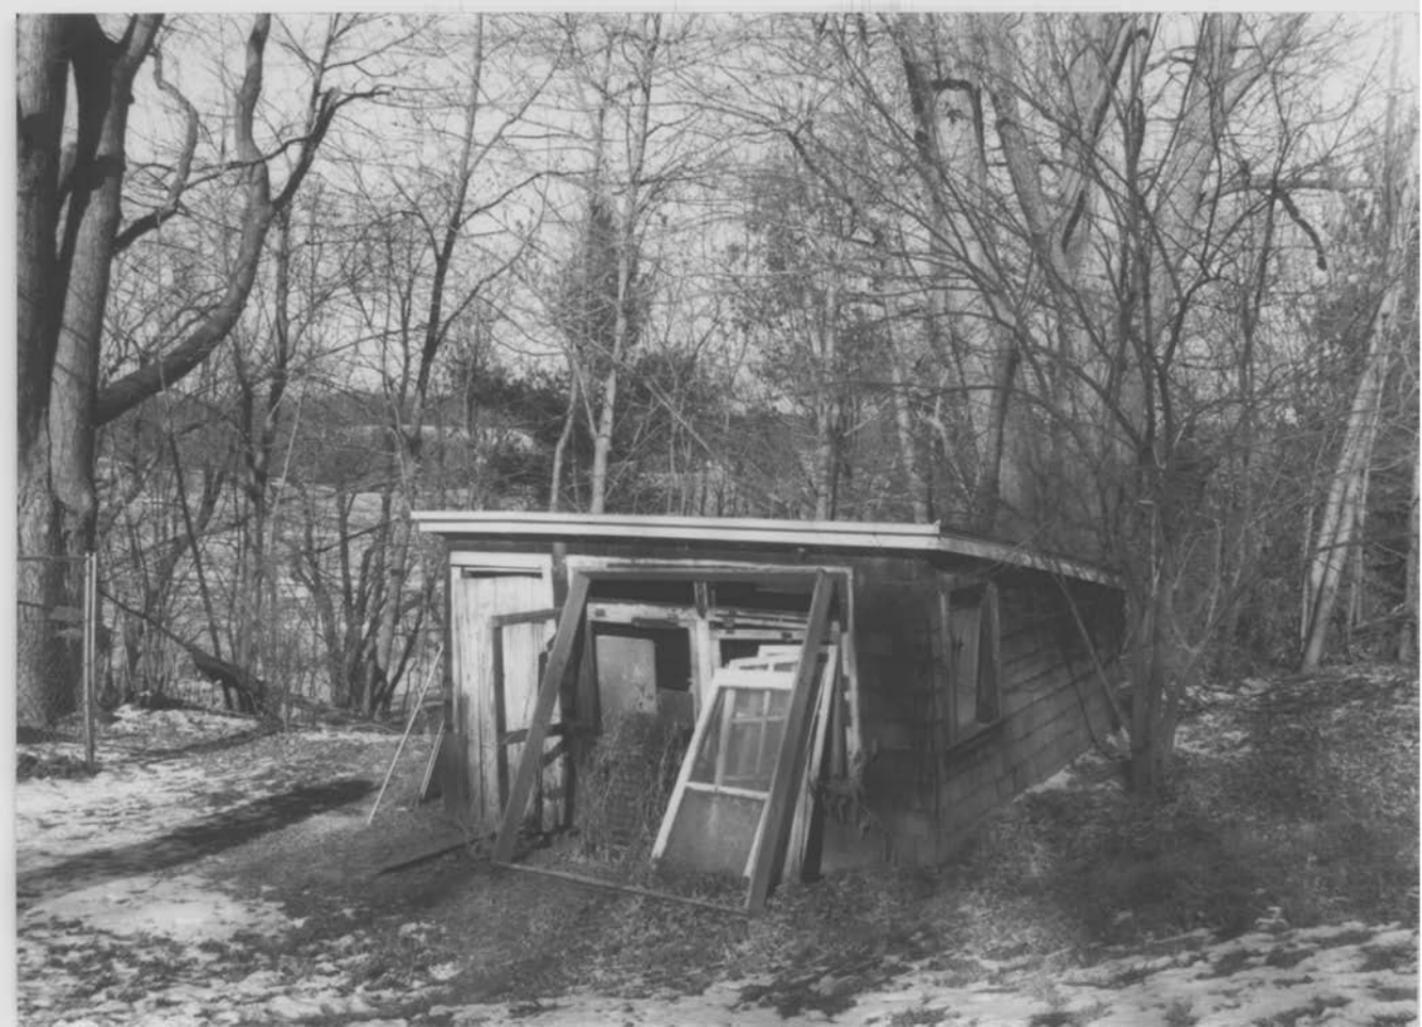
View of outbuilding on Leight House property

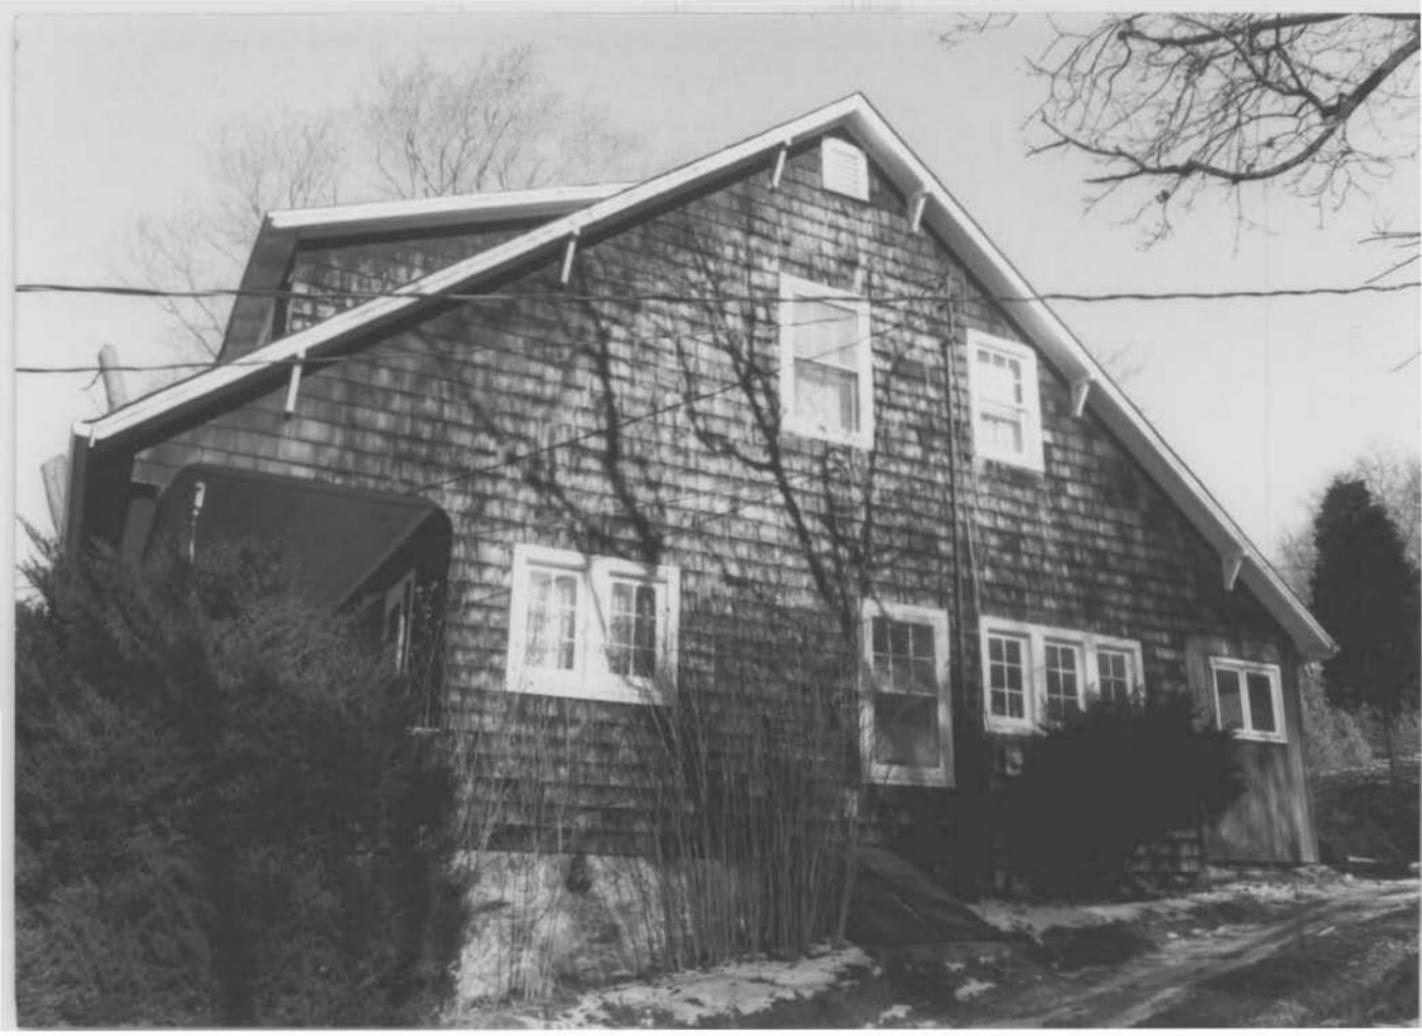
4/6

Leight House, south facade

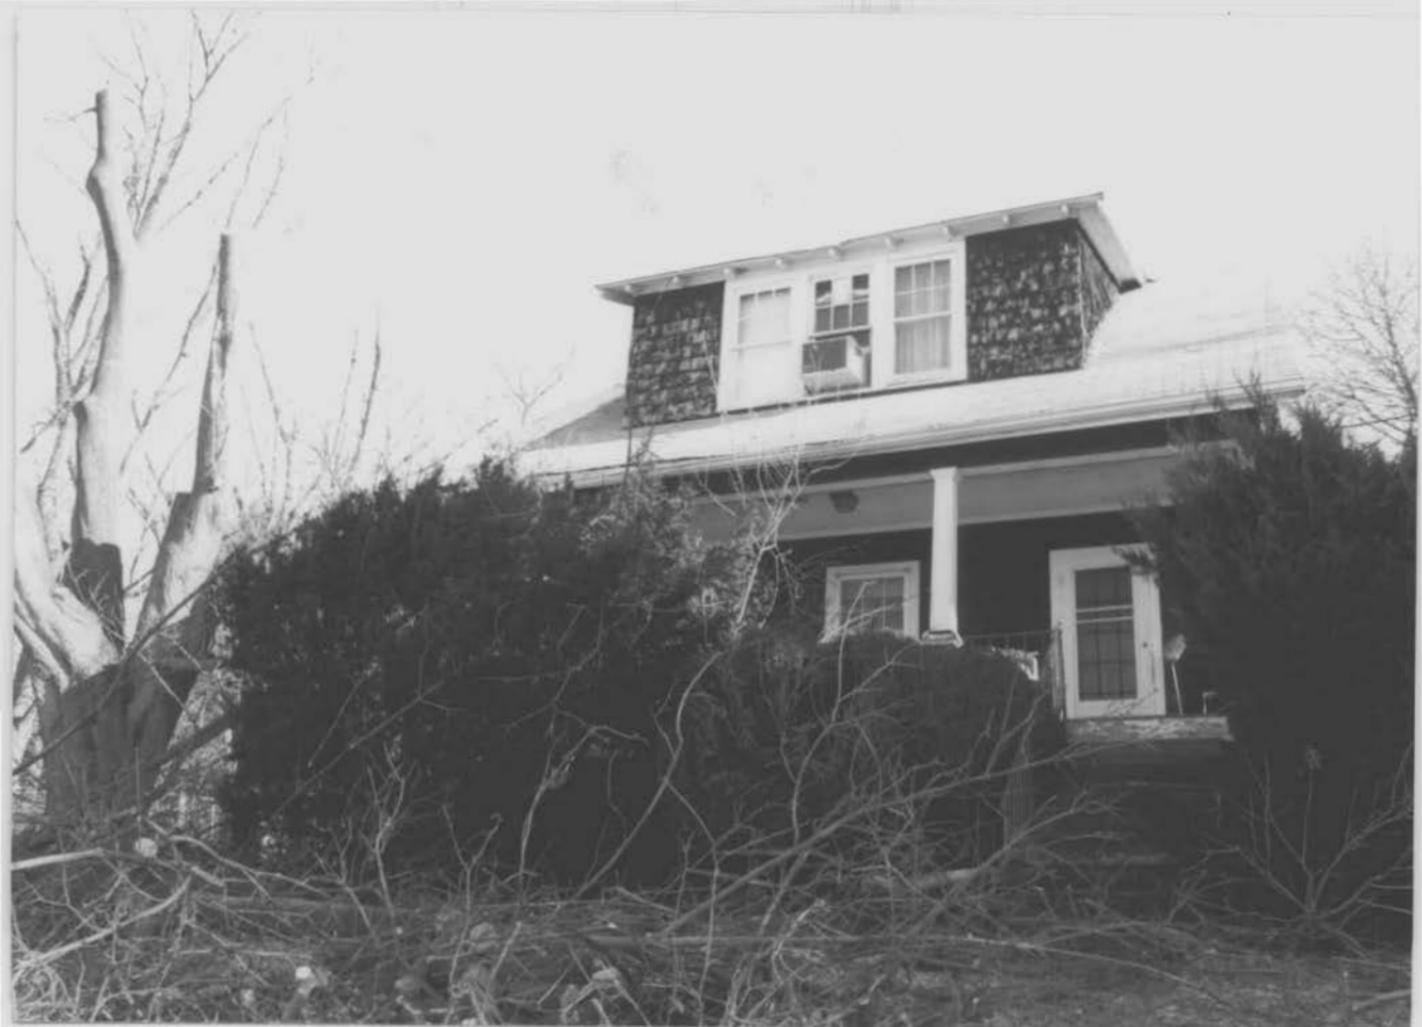
Leight House, west facade

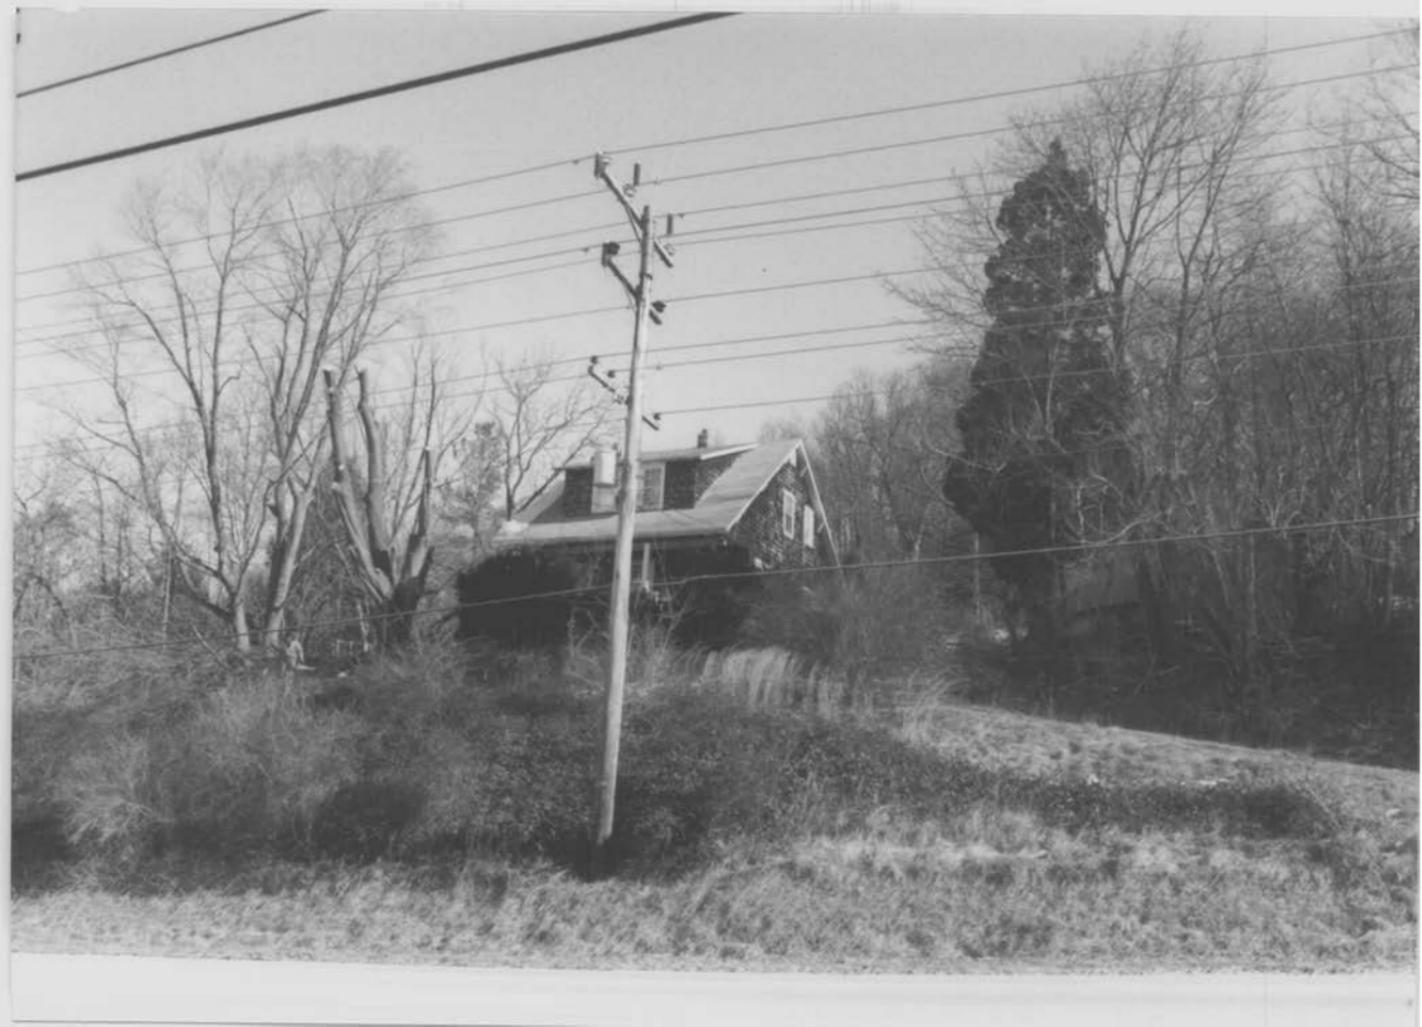
6/6

Leight House, view from York Road facing east.
