CARR-1324

Fair-Miller Farm
5133 Schalk Road One

c.1852-1857

Maryland Historical Trust State Historic Sites Inventory Form

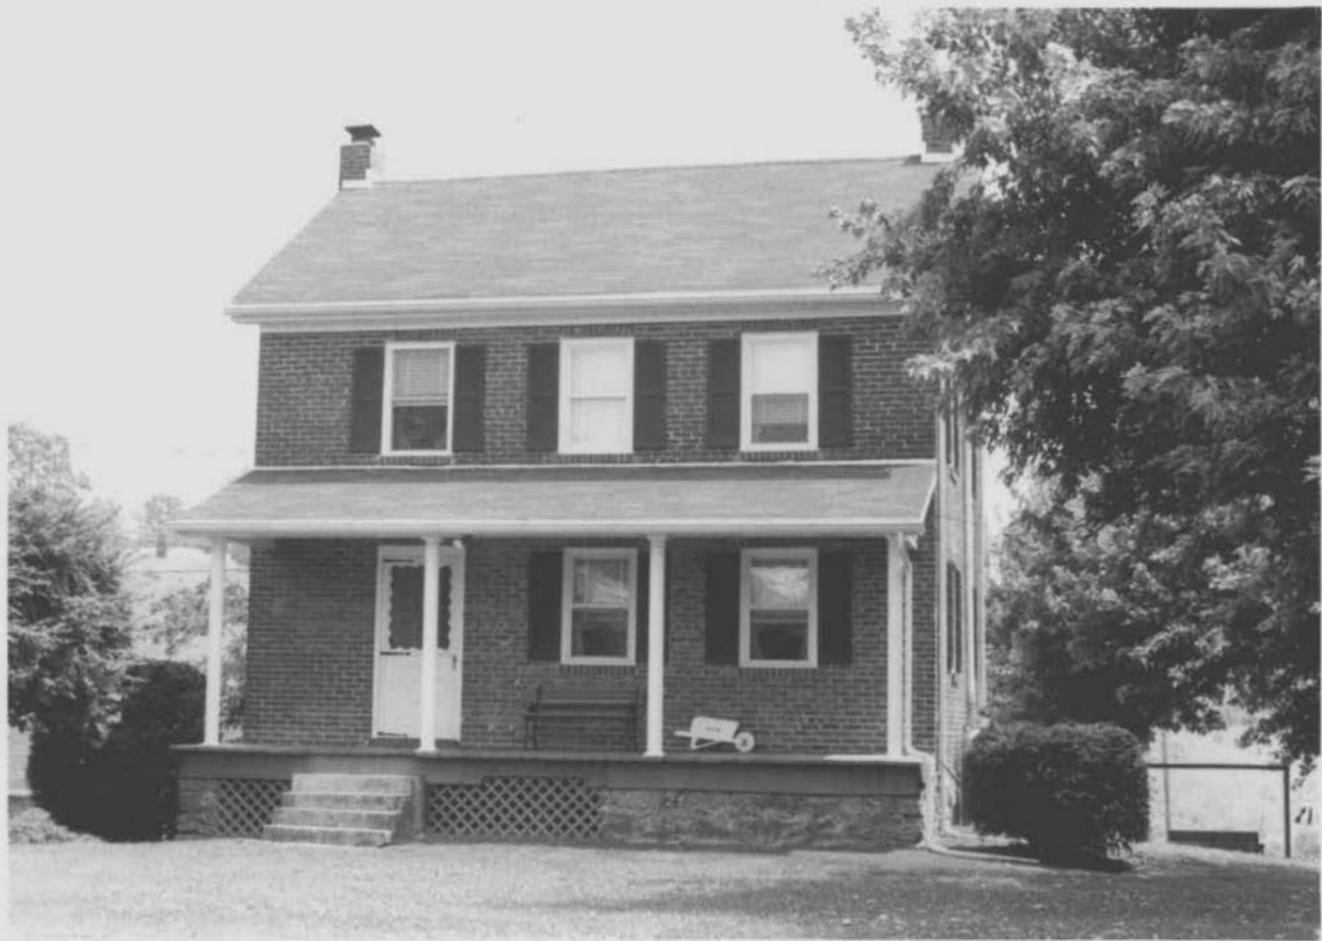
1/0

house - northwest elevation

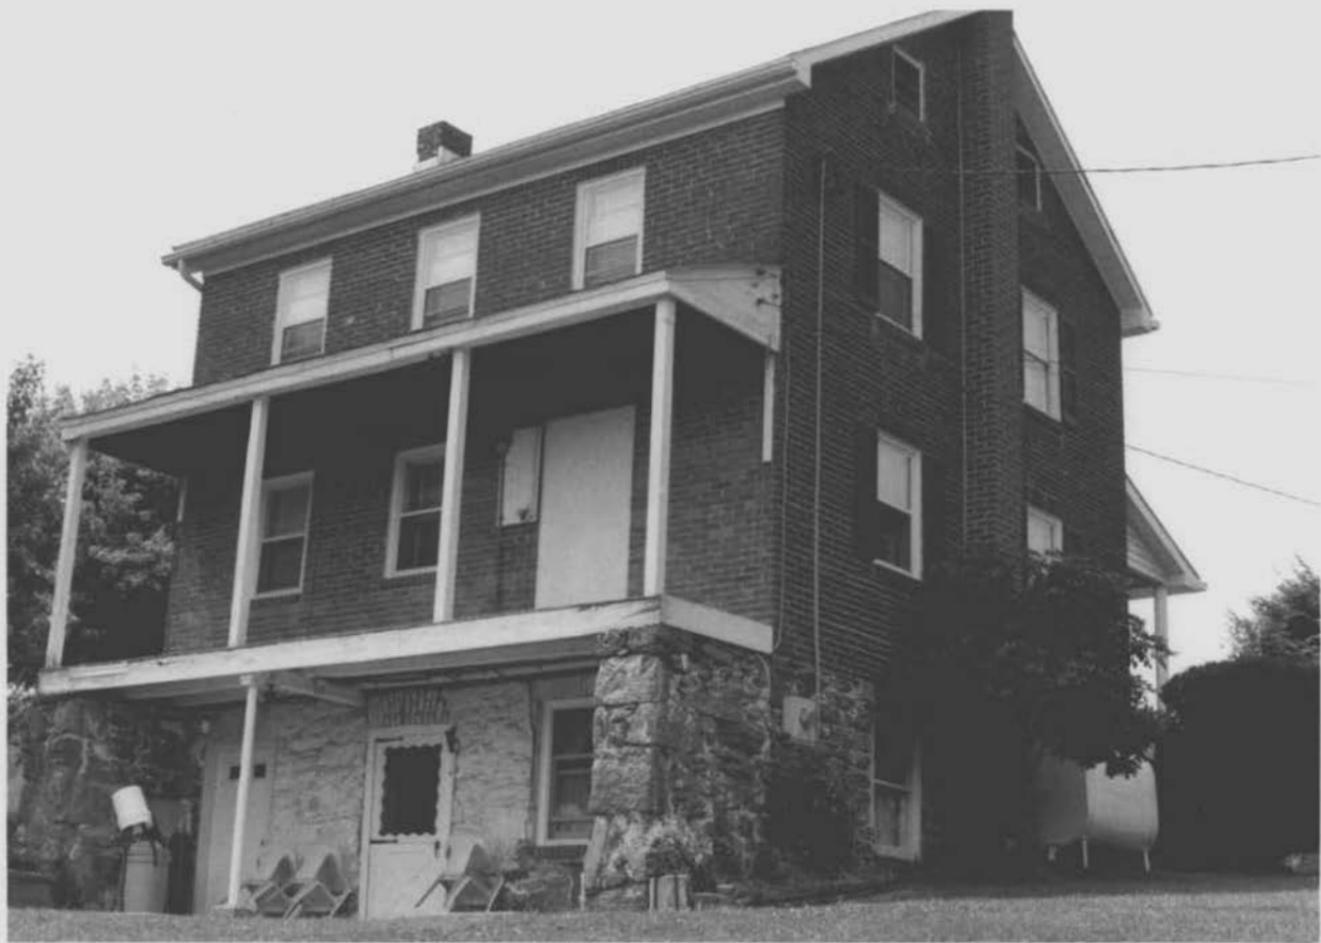
house - Southeast: northeast elevations
2/6

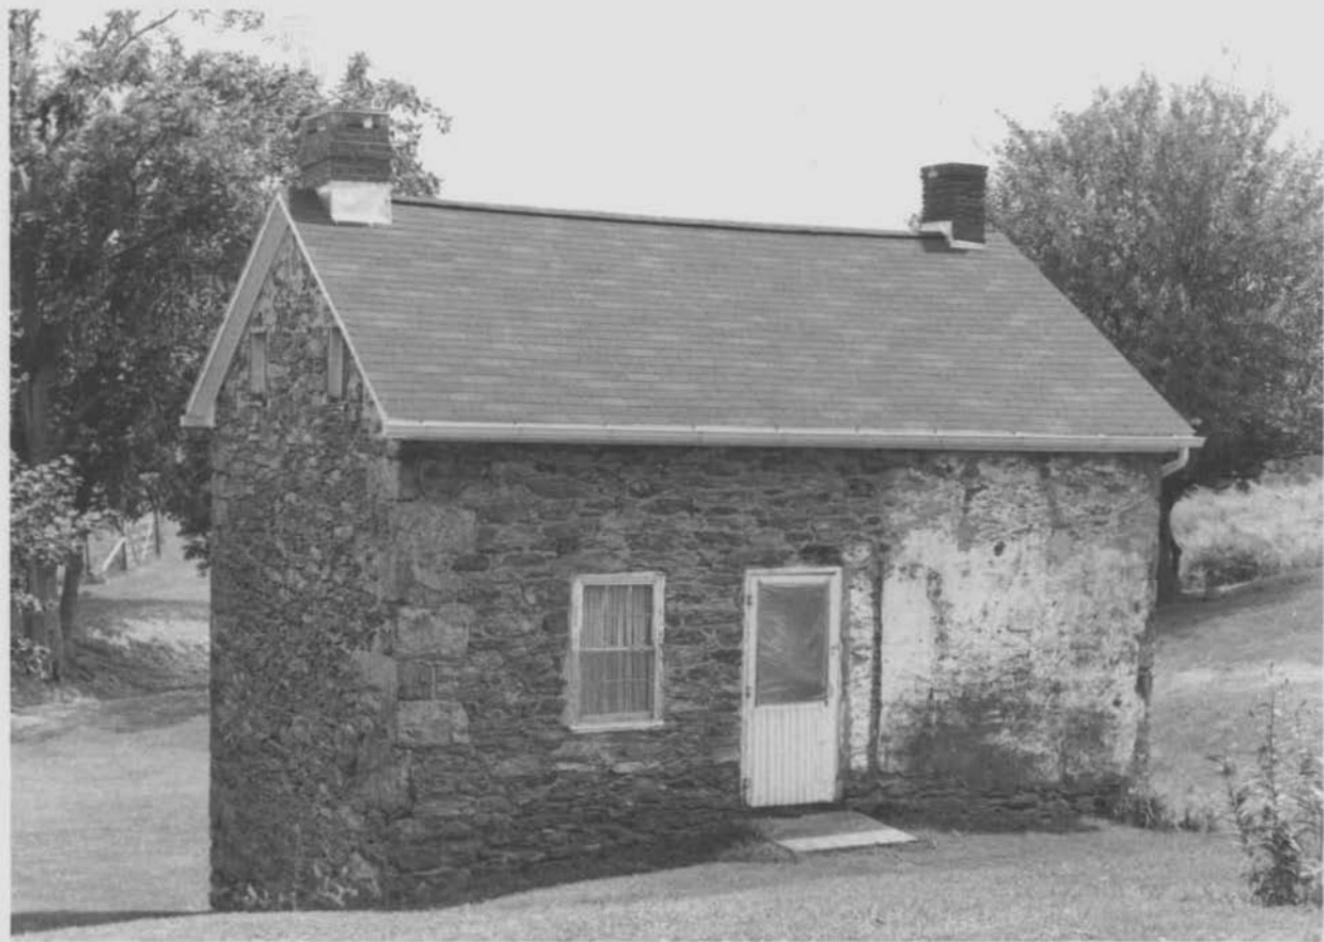
$\frac{3}{6}$

Stone house - northeast : northwest elevations

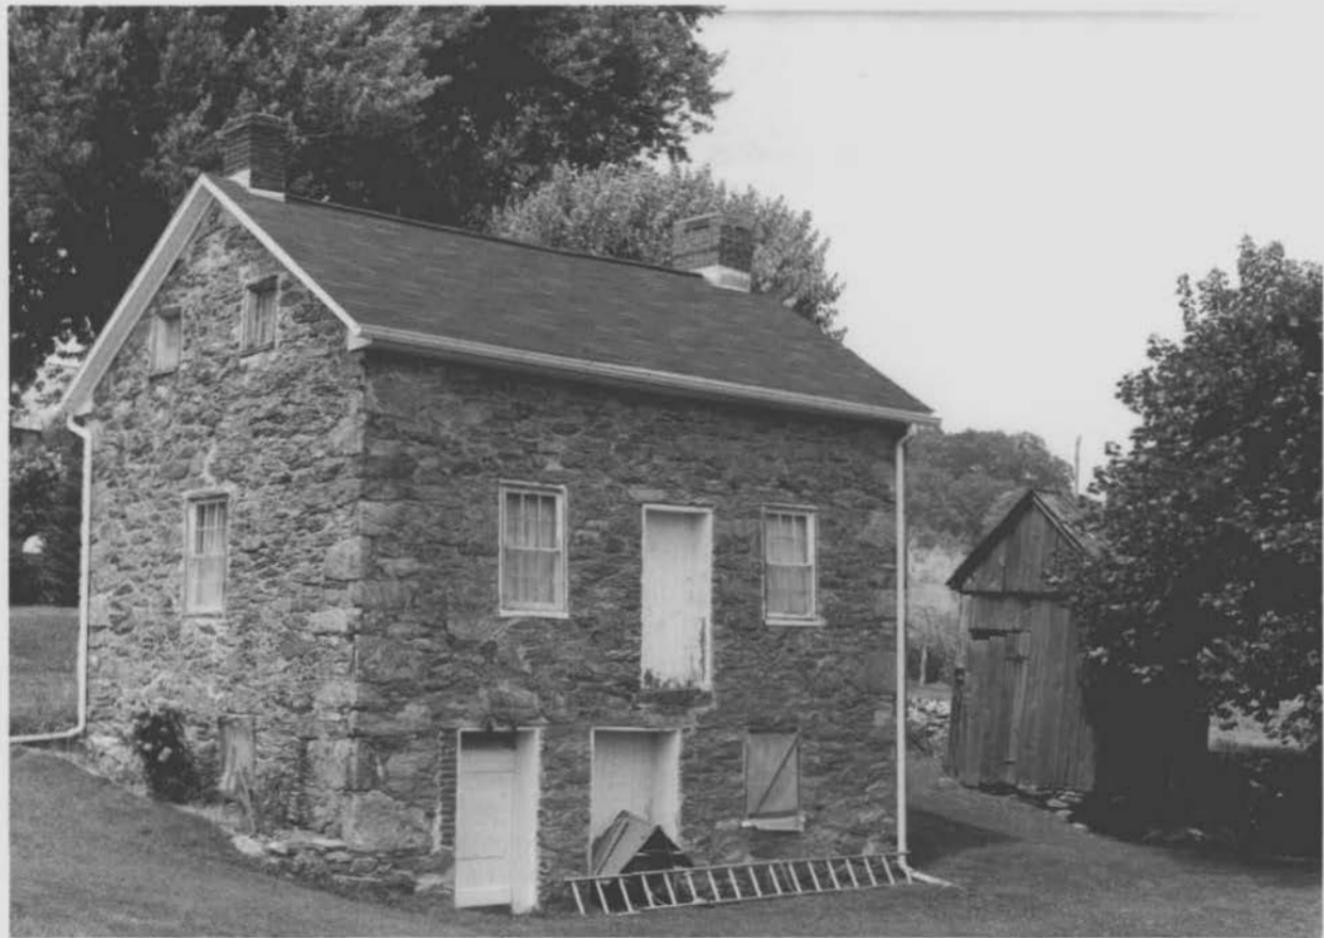
4/6

^{Stone} House - Southeast * Southwest elevations

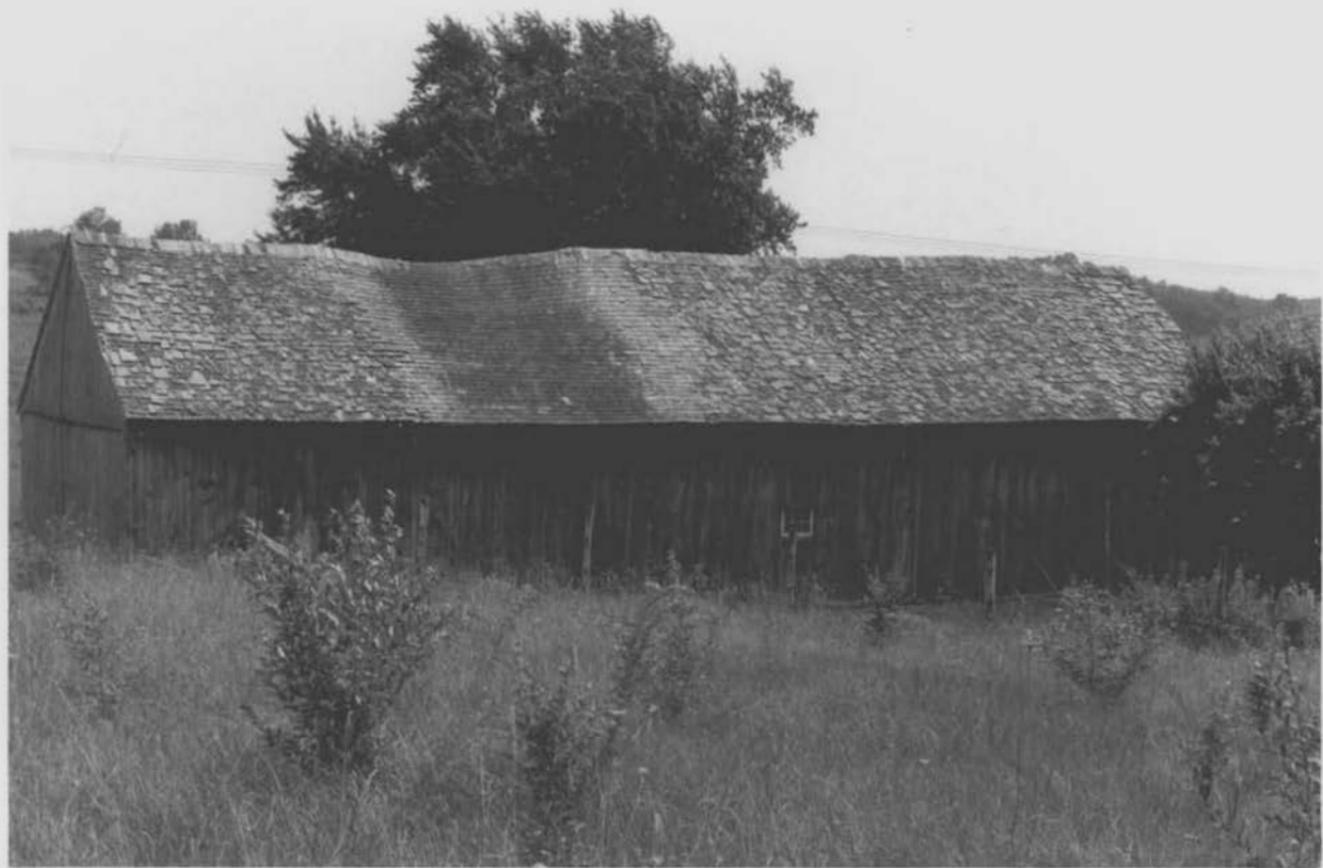
5/6

Barn - northeast: northwest elevations

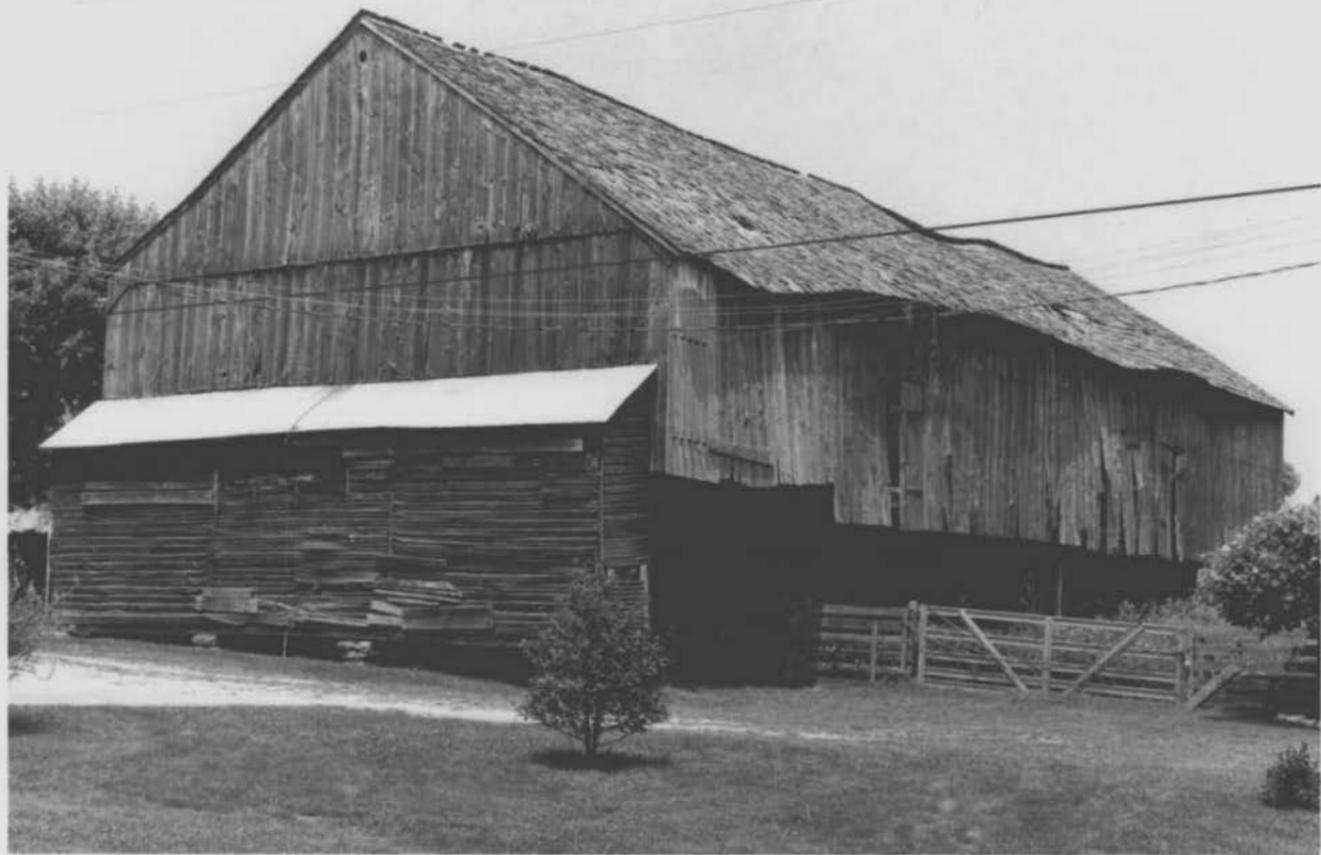
4/6

barn - southwest: southeast elevations
