CARR - 681

839 MEDFORD ROAD

FIELD SHEET--HISTORIC RESOURCES SURVEY

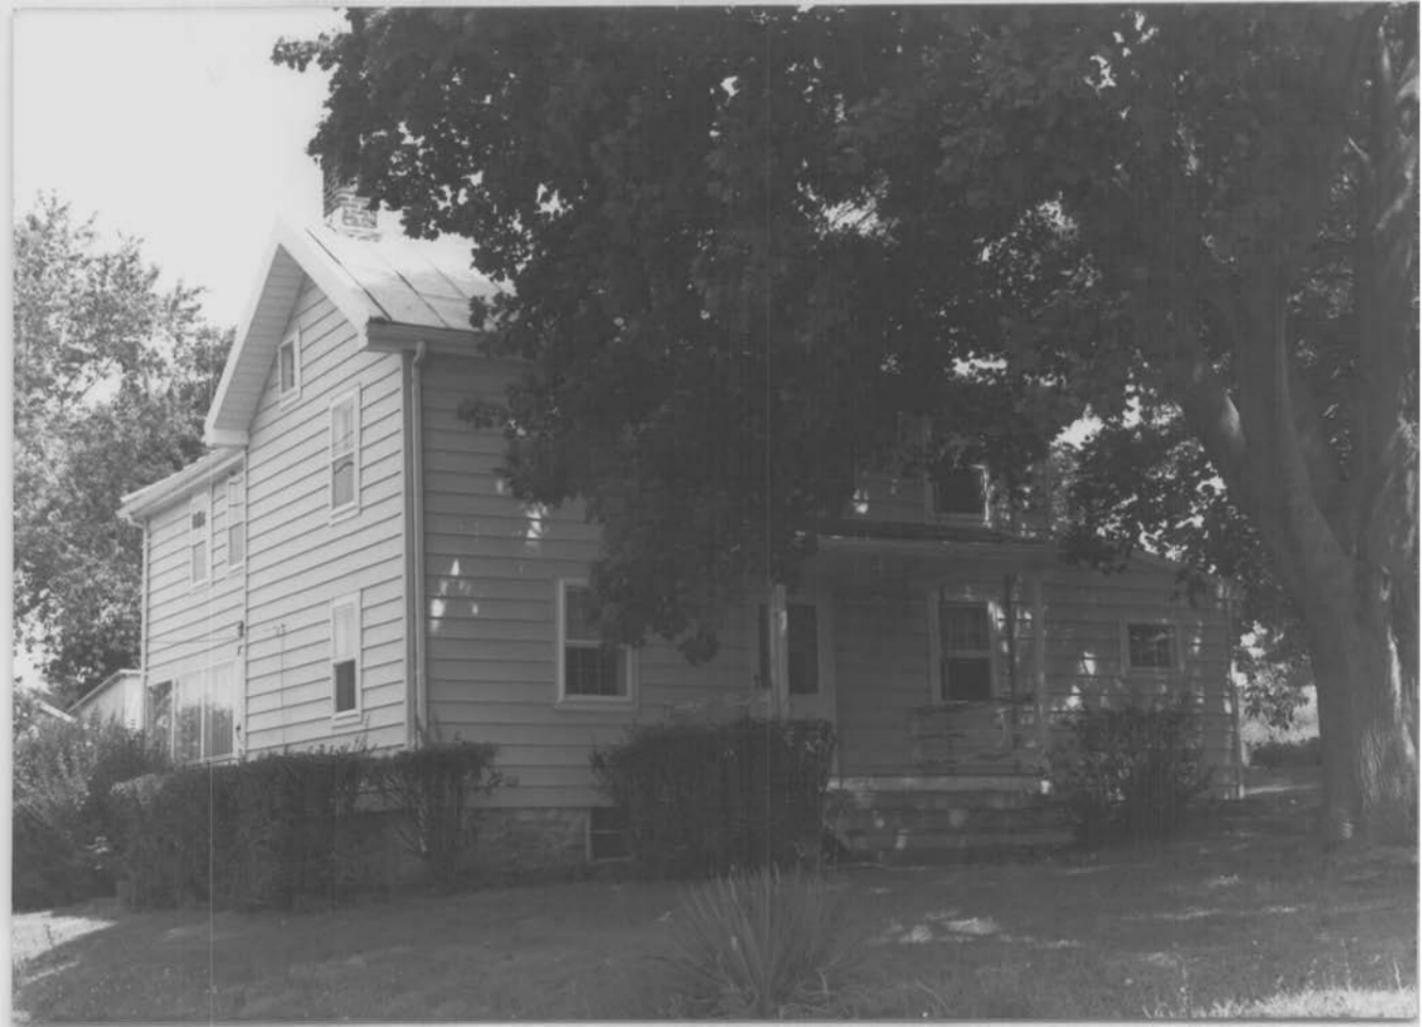
1. CARR-681 839 MEDFORD ROAD
2. Carroll County, Maryland
3. Joe Getty
4. August 1983
5. Md. Historical Trust, Annapolis, Md.
6. South and west elevations (camera facing northeast)
7. 1/1
