MARYLAND HISTORICAL TRUST  
NR-ELIGIBILITY REVIEW FORM

Property Name: Cecil County Bridge #CE008/  
Horseshoe Road over Stone Run Inventory Number: CE-1465

Project: Bridge Replacement Agency: COE/CE DPW

# Maryland Historical Trust Maryland Inventory of Historic Properties Form

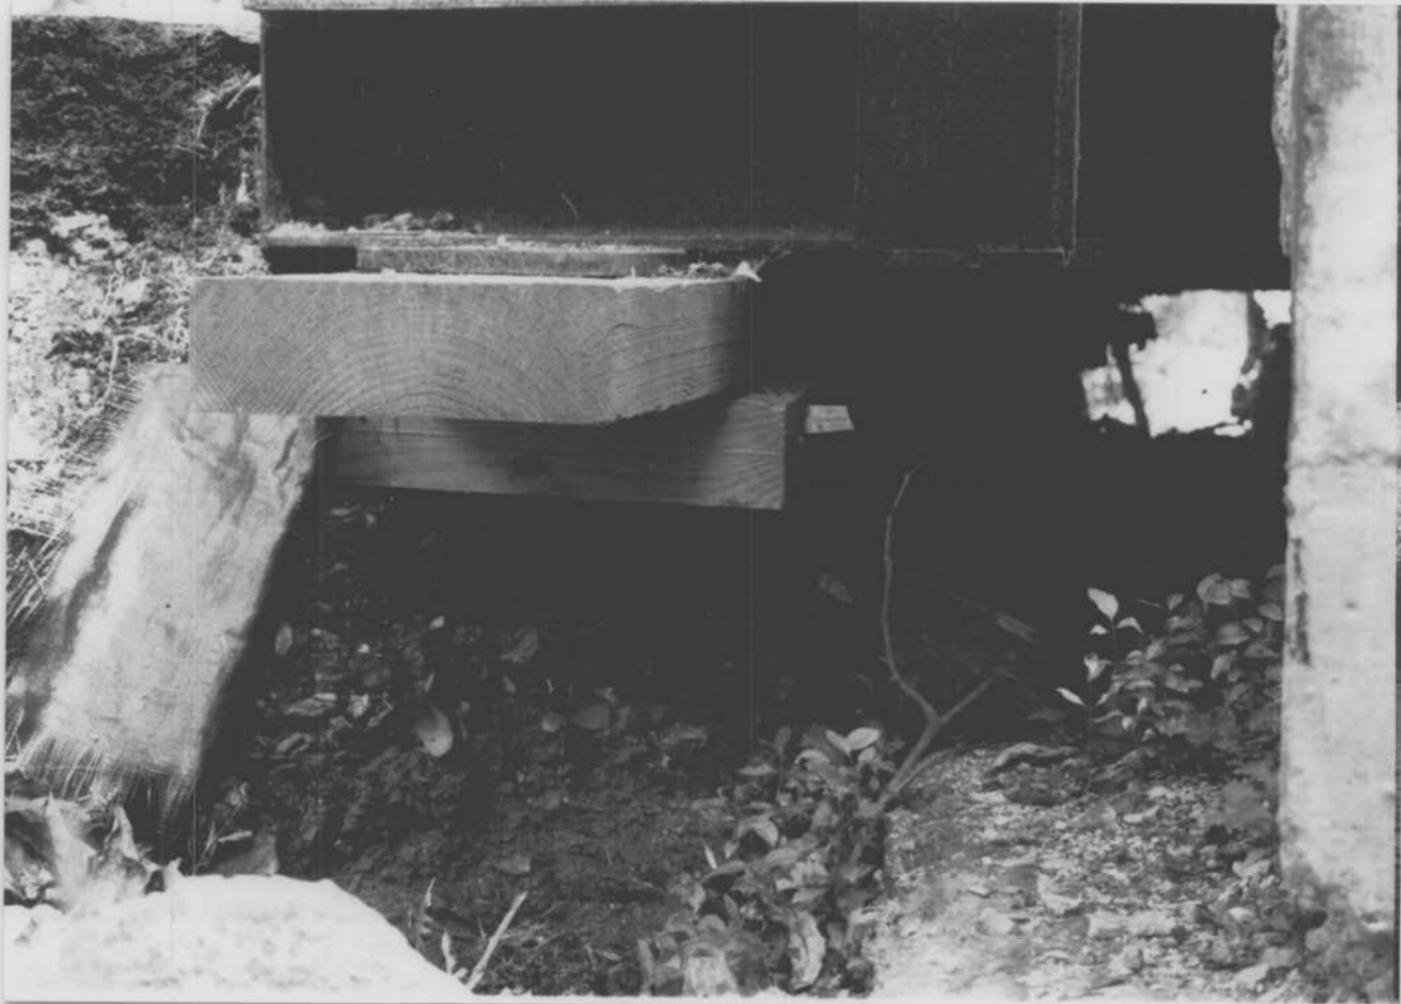
#6 of 19

View N - Area where west backwall was removed.  
Steel jumper bridge resting on wood cribbing  
behind the existing abutment. Backwall  
removed in 1997.

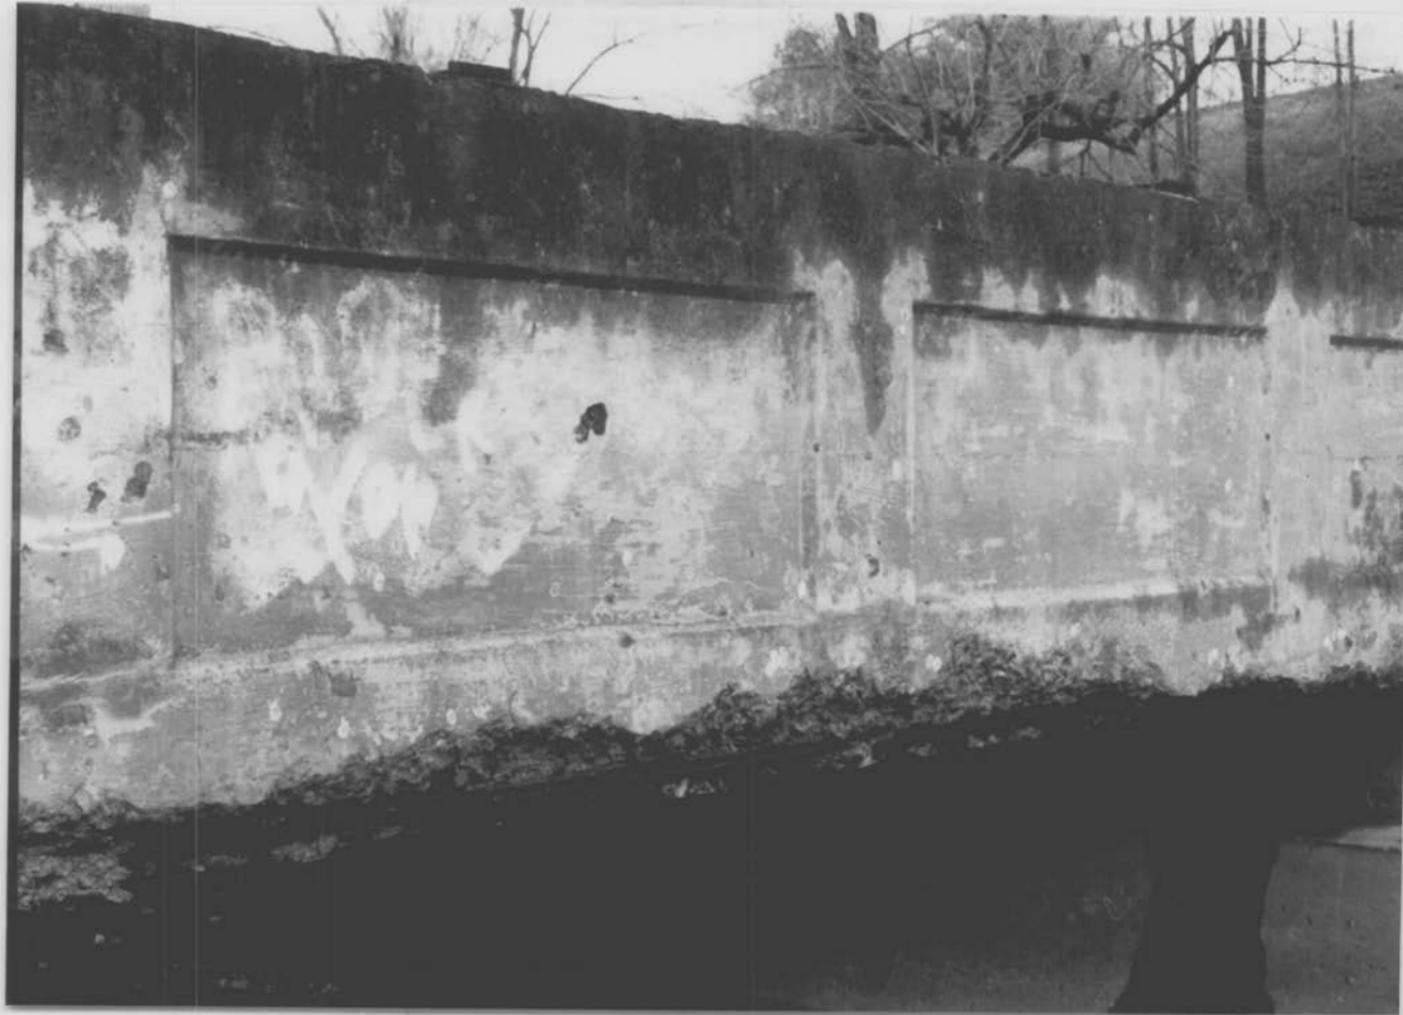
#8 of 19

View NE - Detail of S parapet/girder. Note  
deteriorated concrete and exposed  
reinforcement bar at bottom.

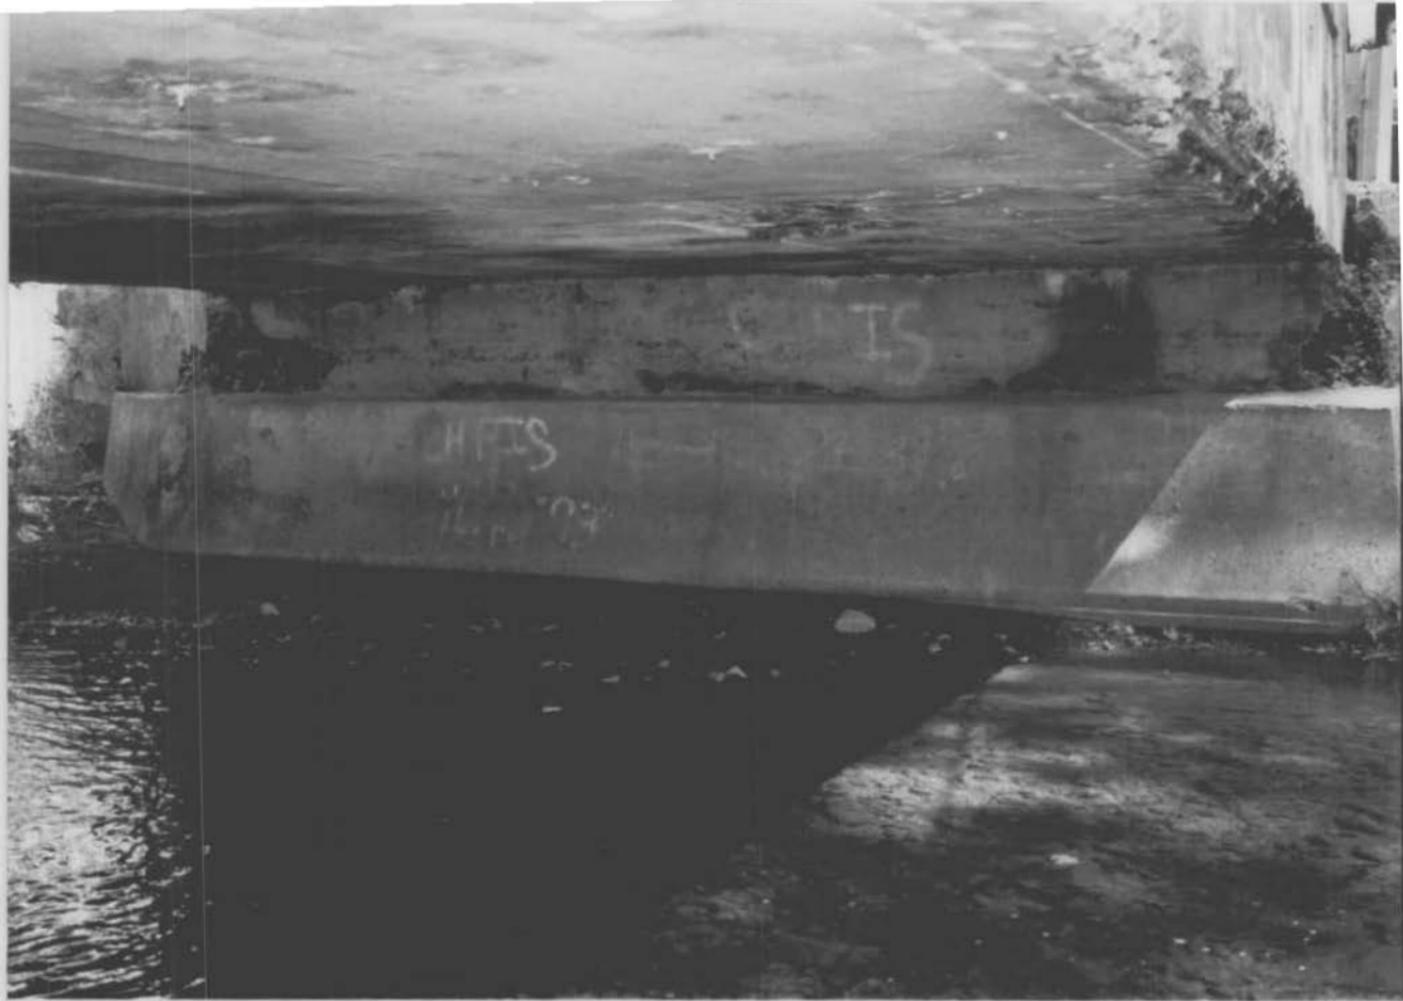
# 10 of 19

View E - Underside of concrete slab bridge and  
concrete cut-off wall installed to reinforce  
east abutment in 1985.

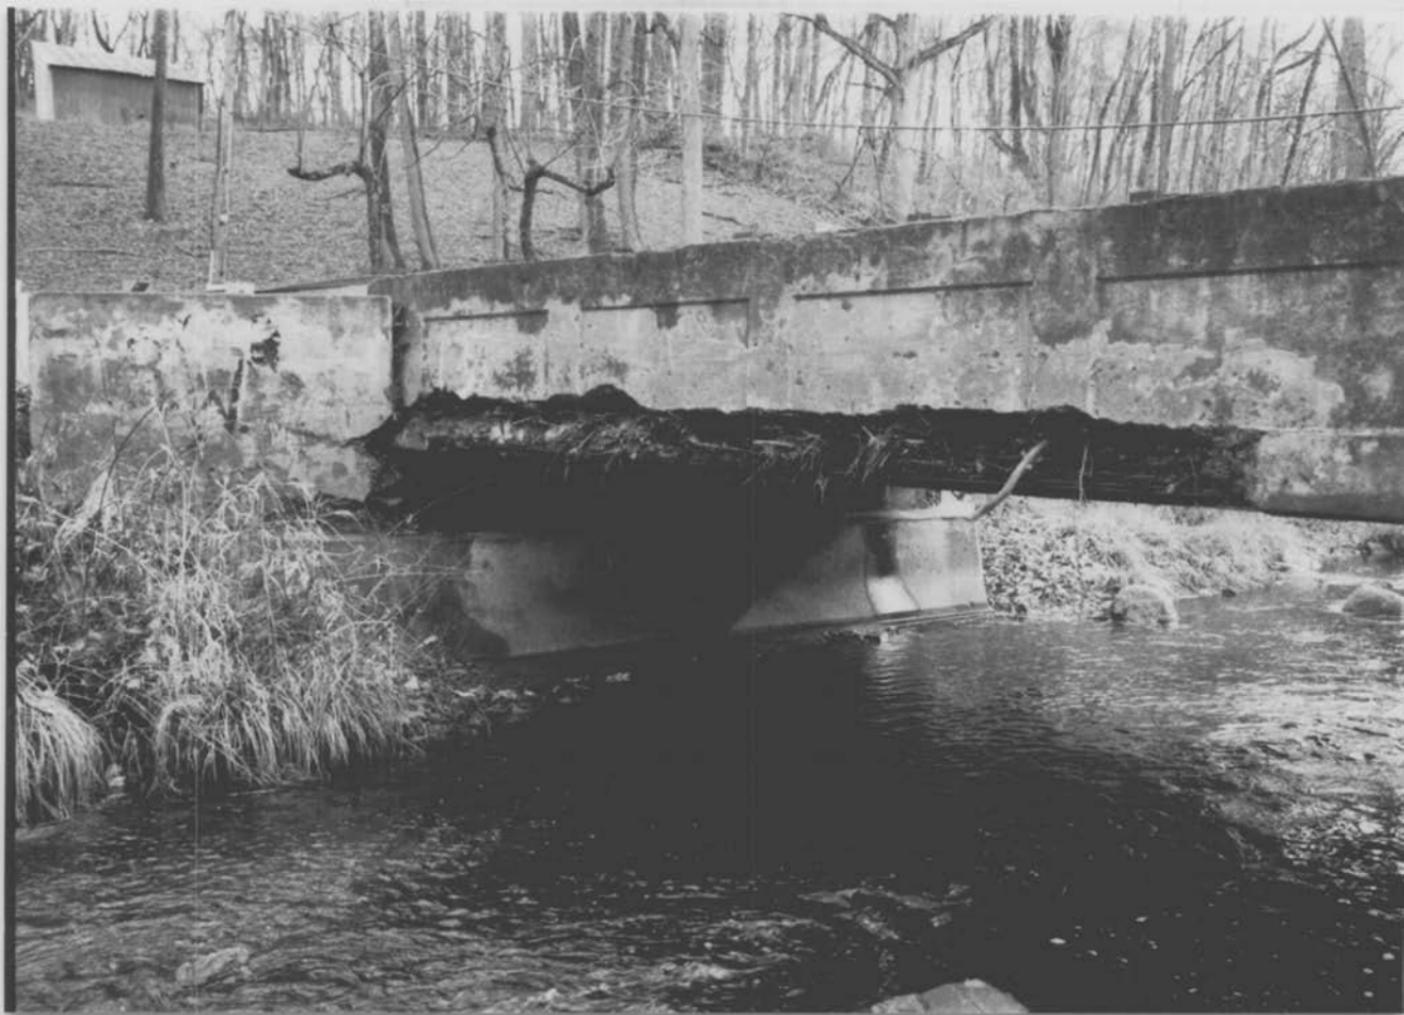
# 12 of 19

View SE - Extensive damage at bottom of N  
parapet/girder

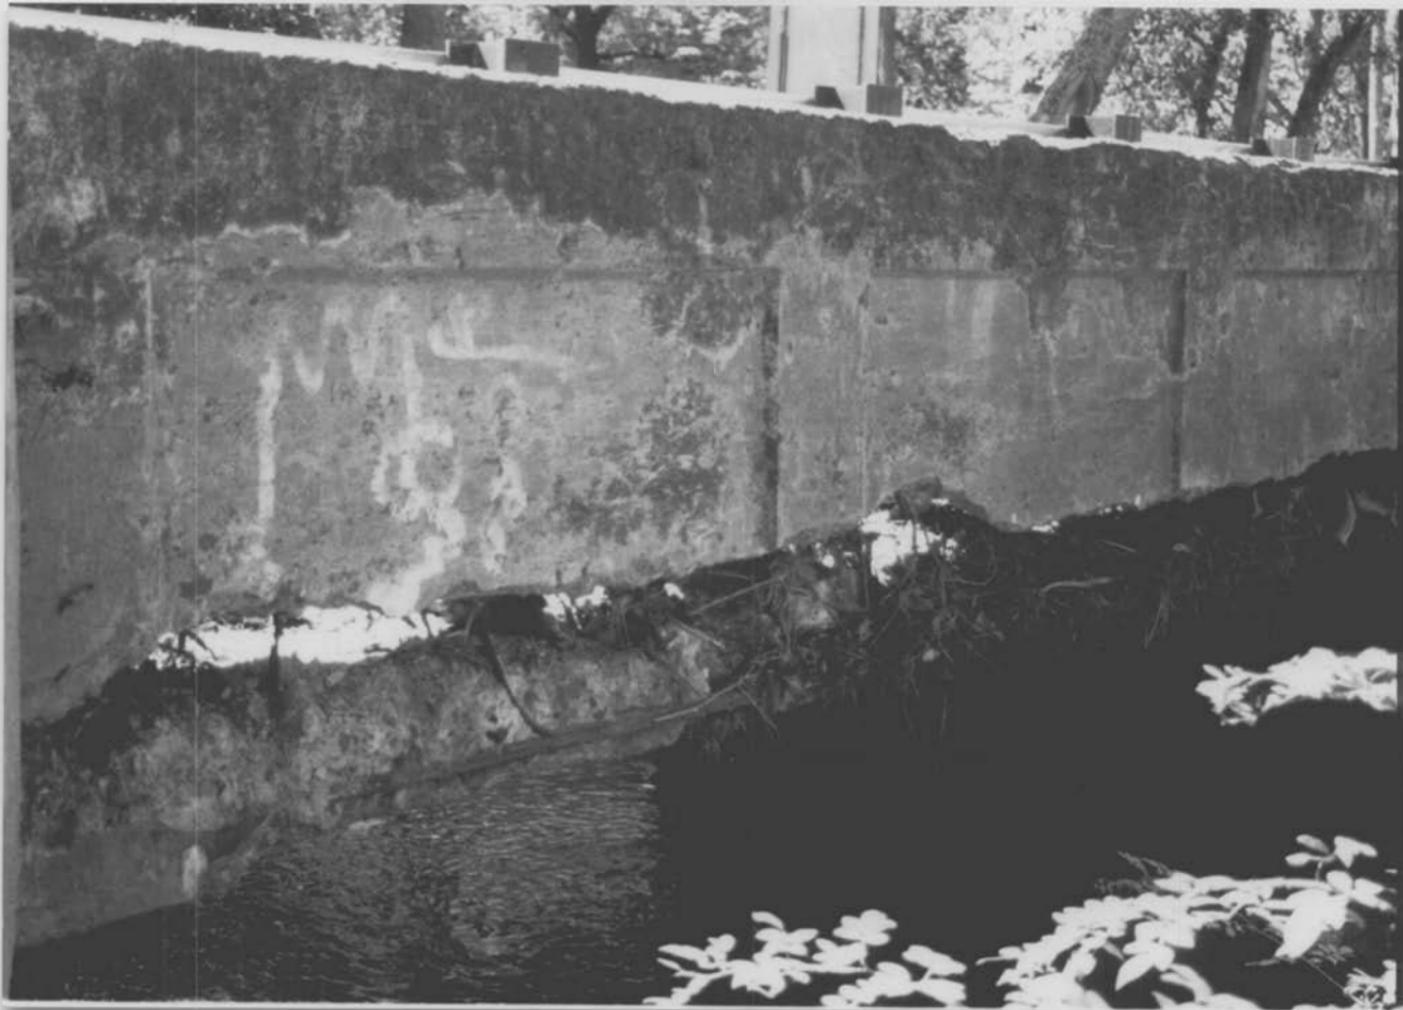
#13 of 19

View SW - Detail of damage to N parapet/girder.  
Note daylight showing through from  
S side where girder intersects the slab

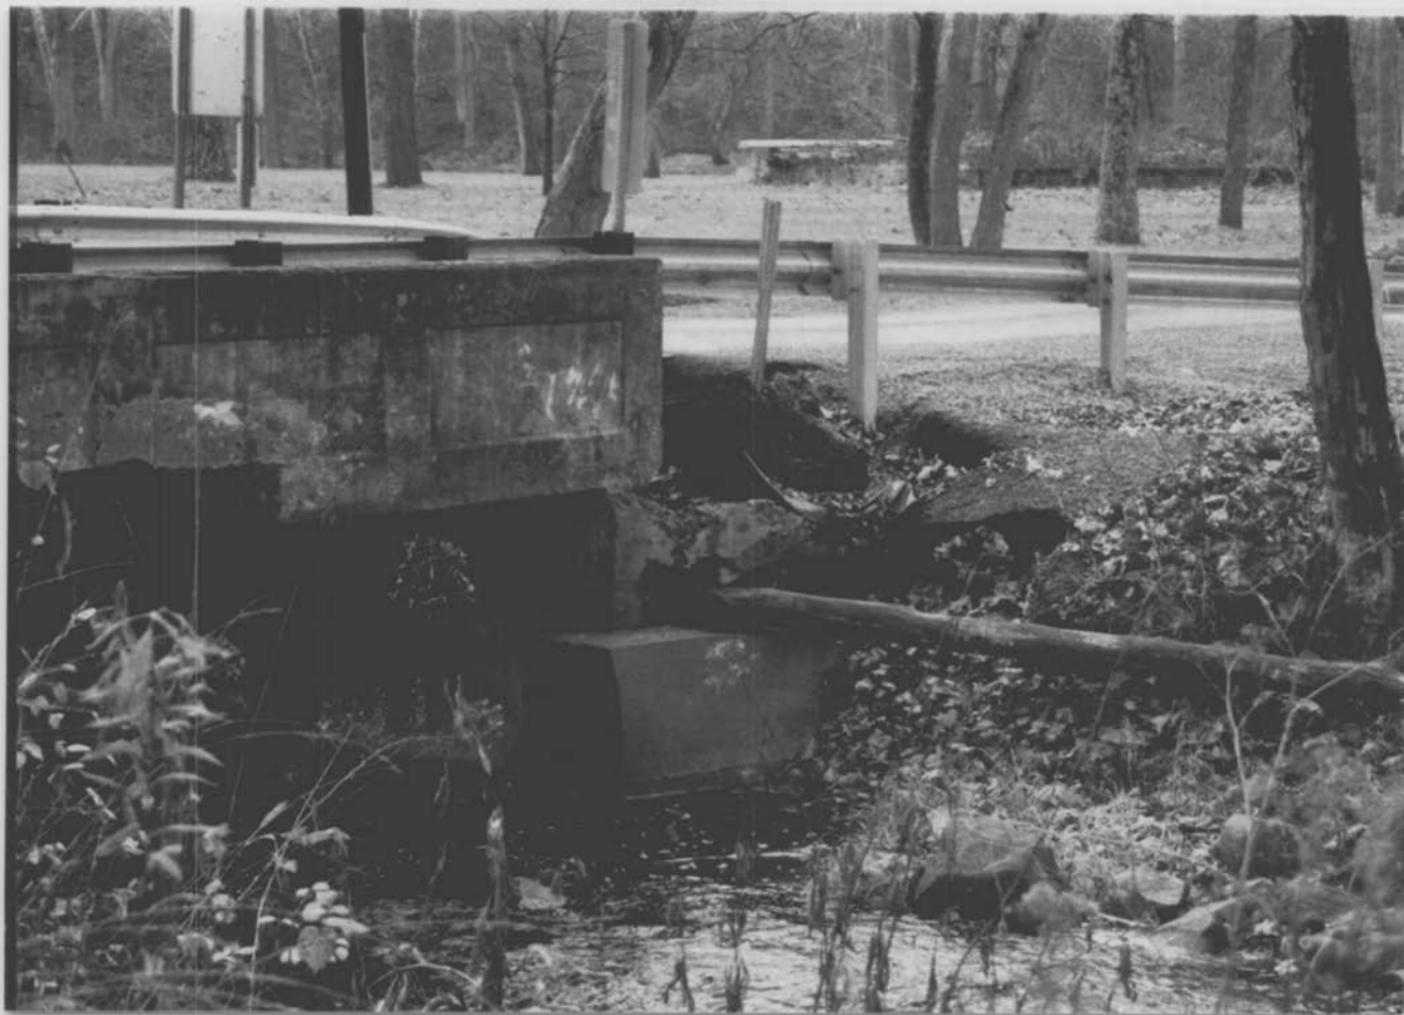
# 14 of 19

Note concrete cut-off wall installed  
in 1985

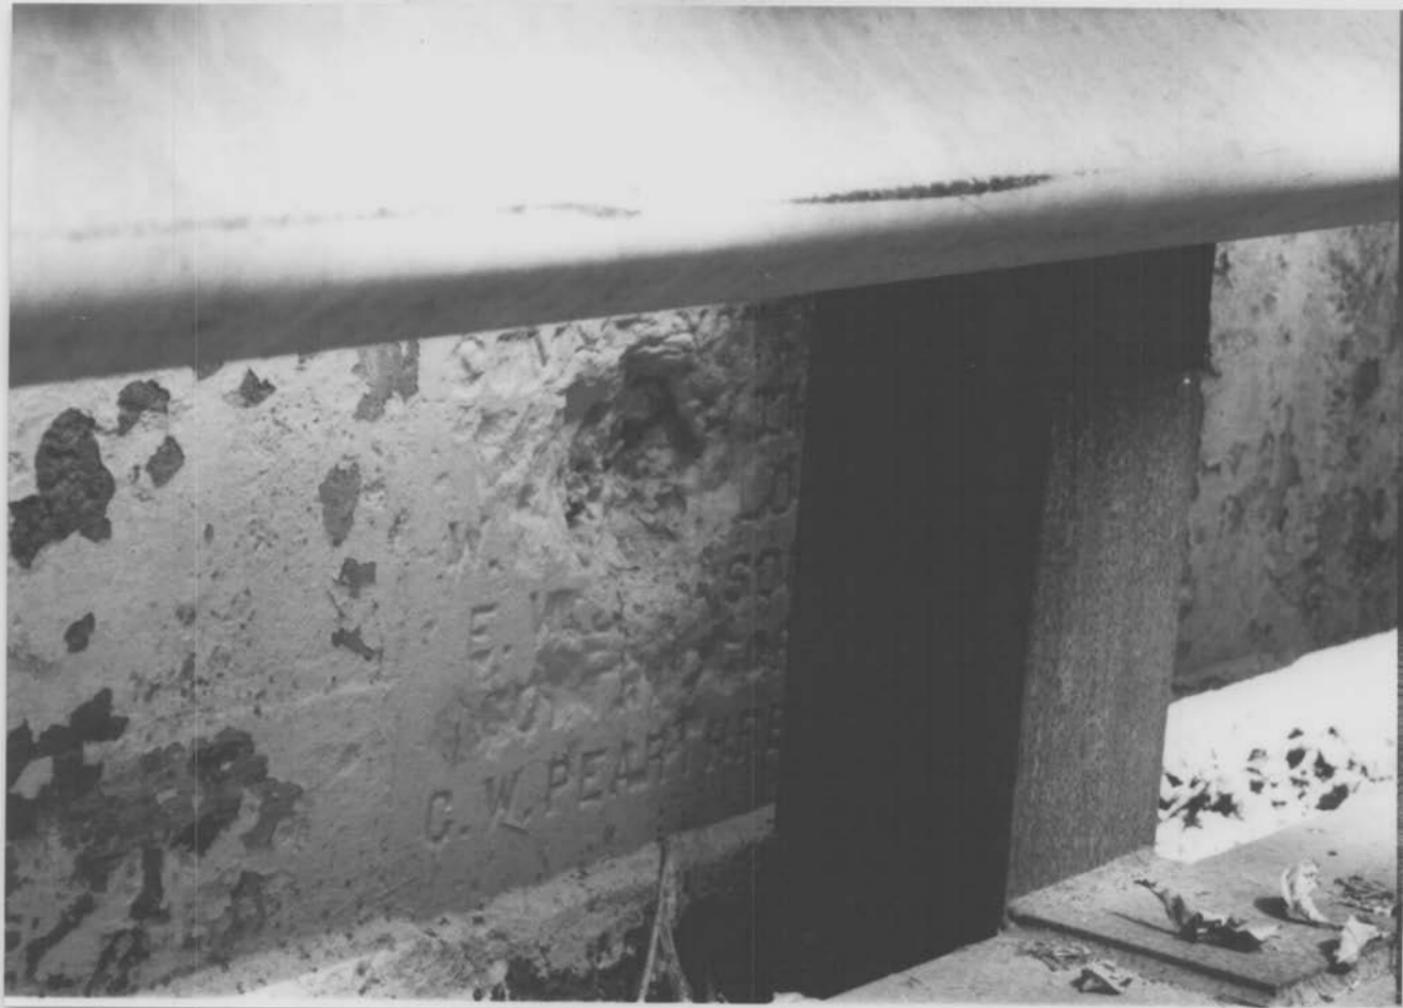
# 17 of 19

View NE - Cast builders plate on inside of N parapet showing extensive spalling.
