# Maryland Historical Trust State Historic Sites Inventory Form

historic Pullen's Neglect

and/or common Orchard's Cove Farm

Survey No. D-645

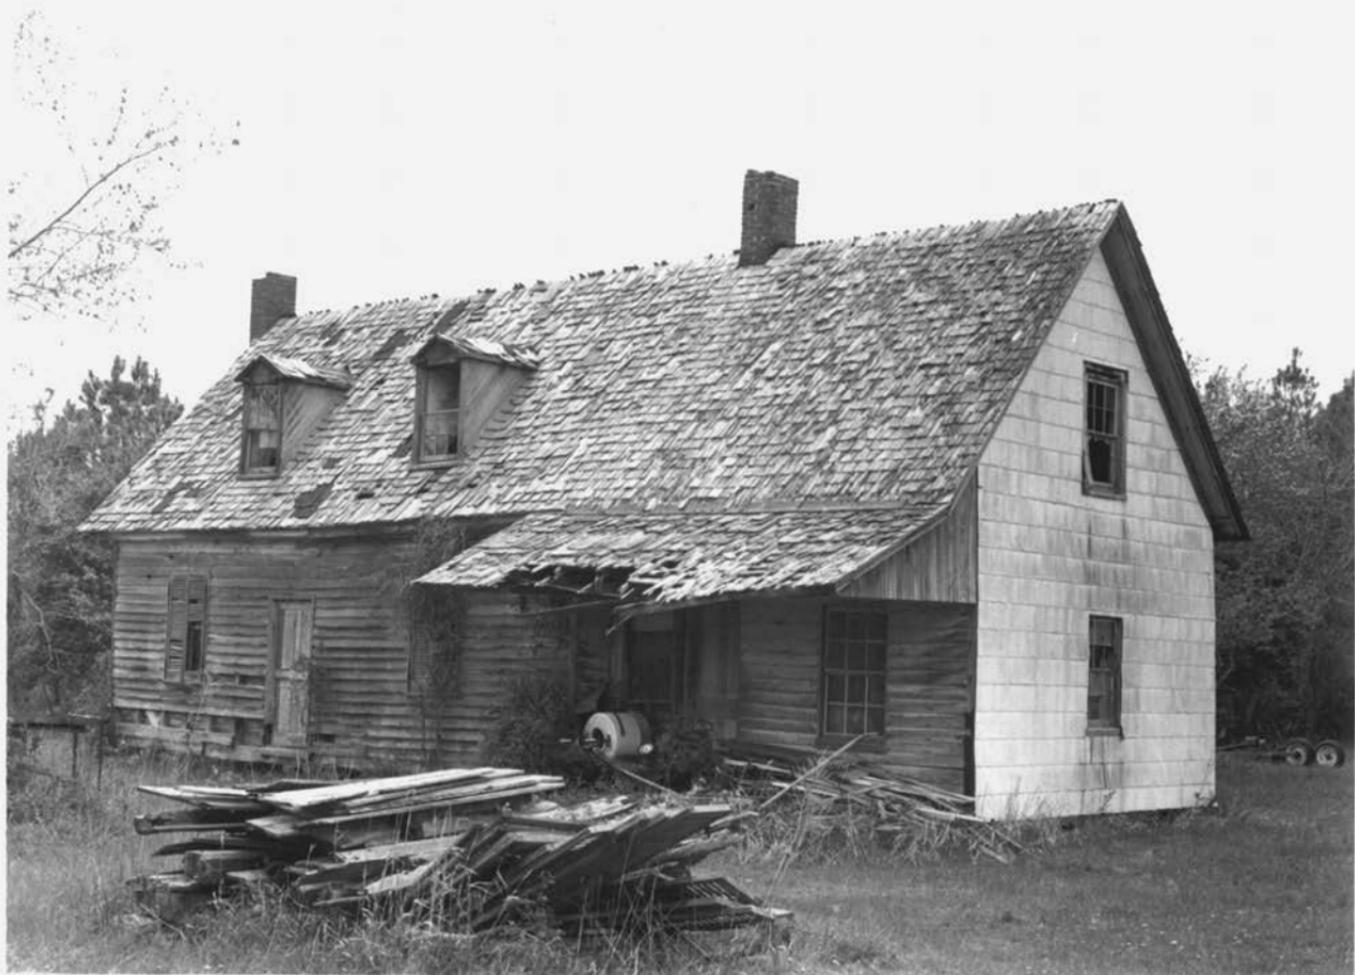
D-645 Pullen's Neglect  
Cambridge vicinity  
Orlando Ridout V Spring 1983  
View from Northeast

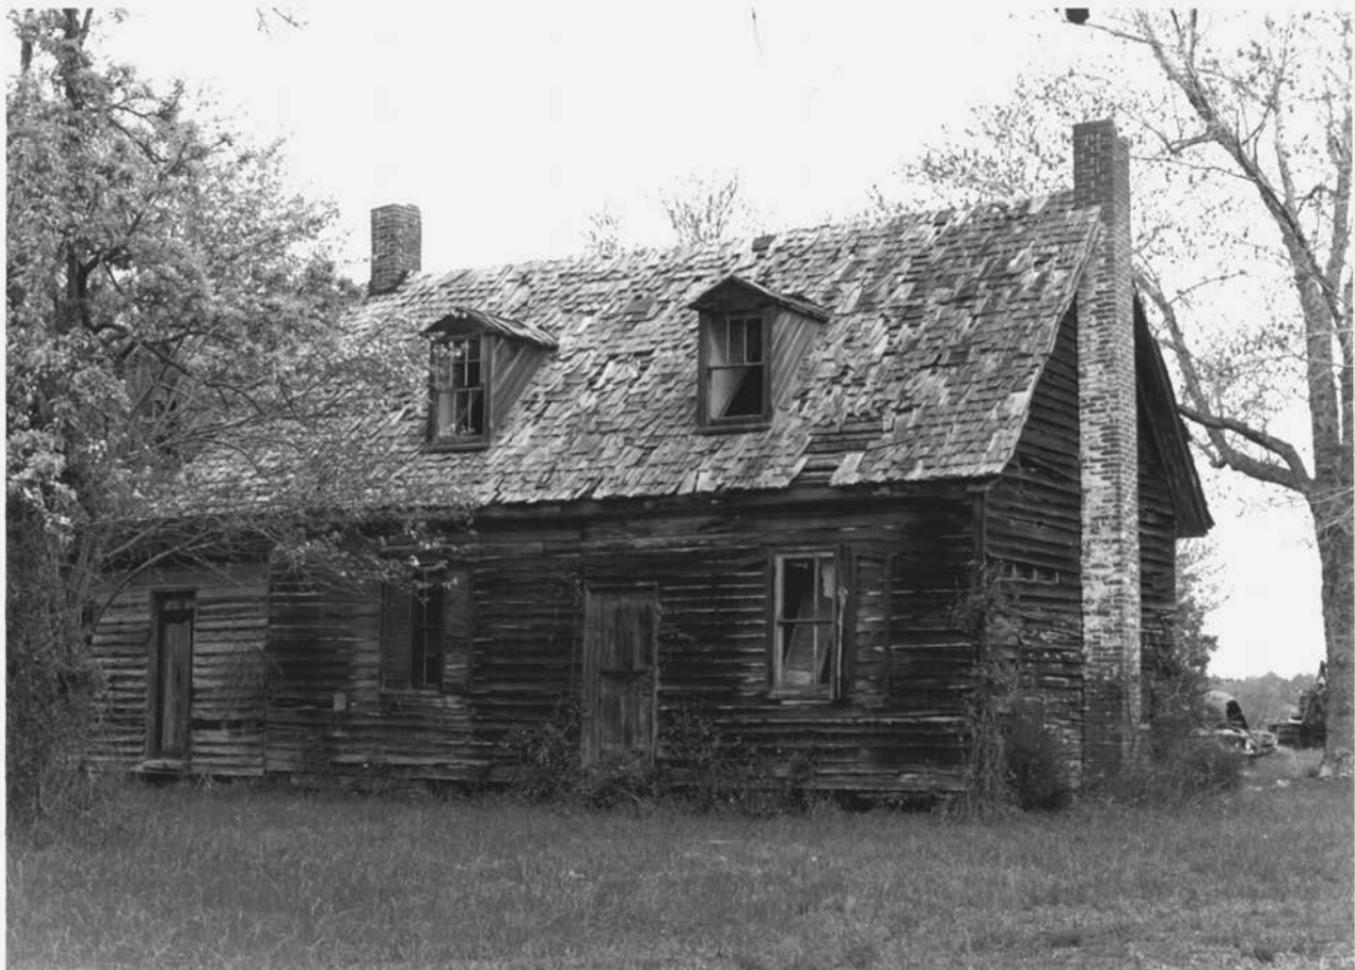
D-645 Pullen's Neglect  
Cambridge vicinity  
Orlando Ridout V Spring 1983  
West facade
