CAPSULE SUMMARY

Survey # F-3-154

Maryland Historical Trust State Historic Sites Inventory Form

historic Willow Brook Farm

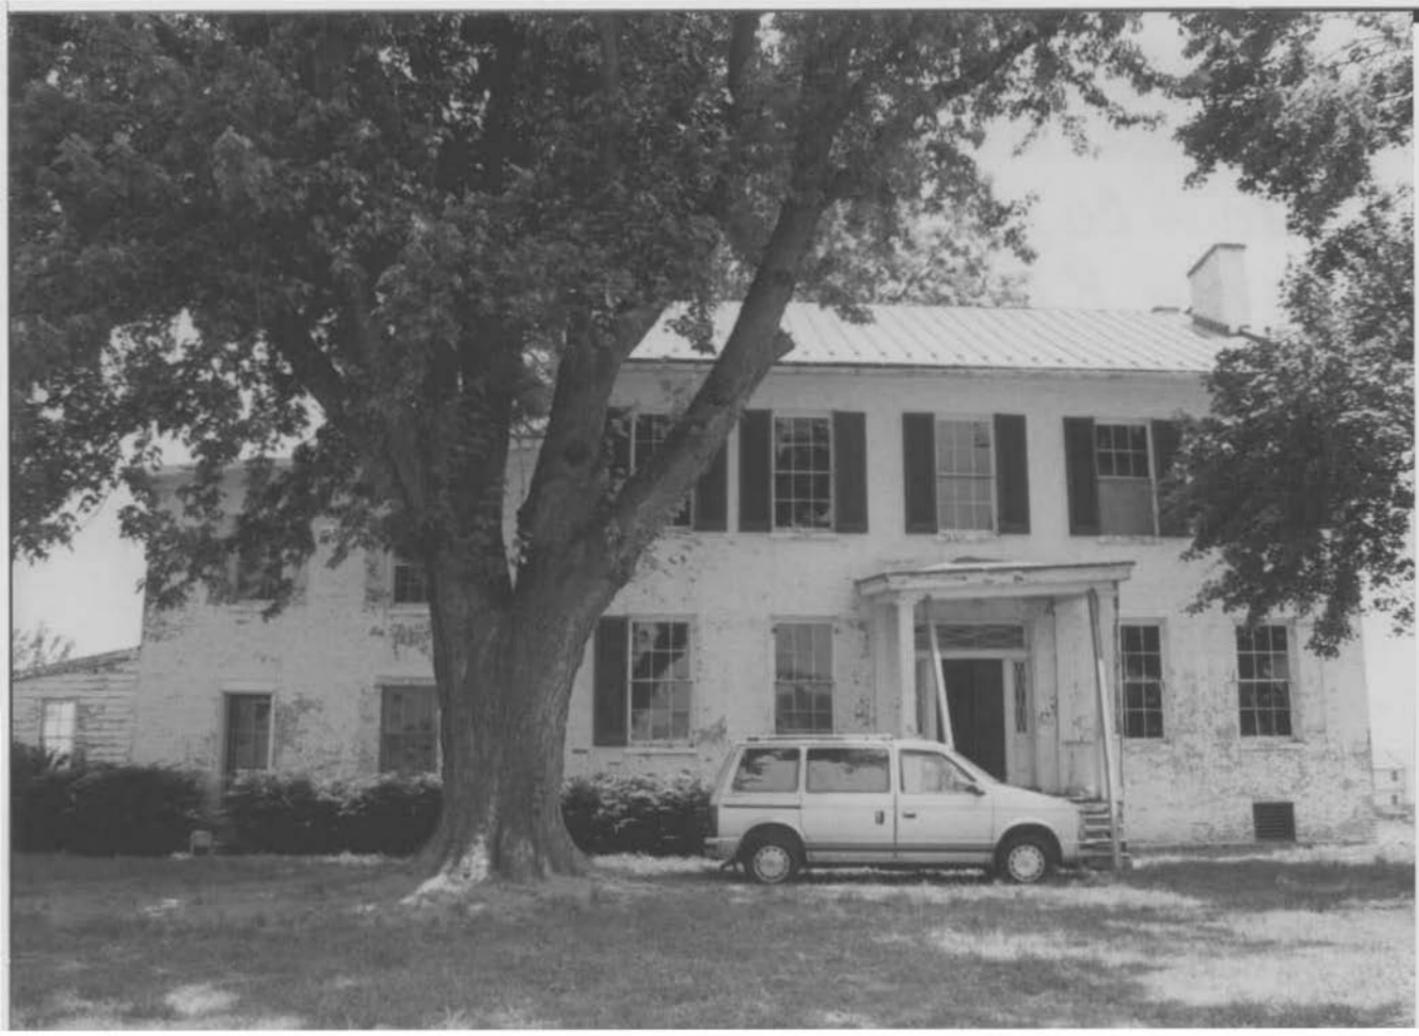
1 of 23

Front, west elevation, E view

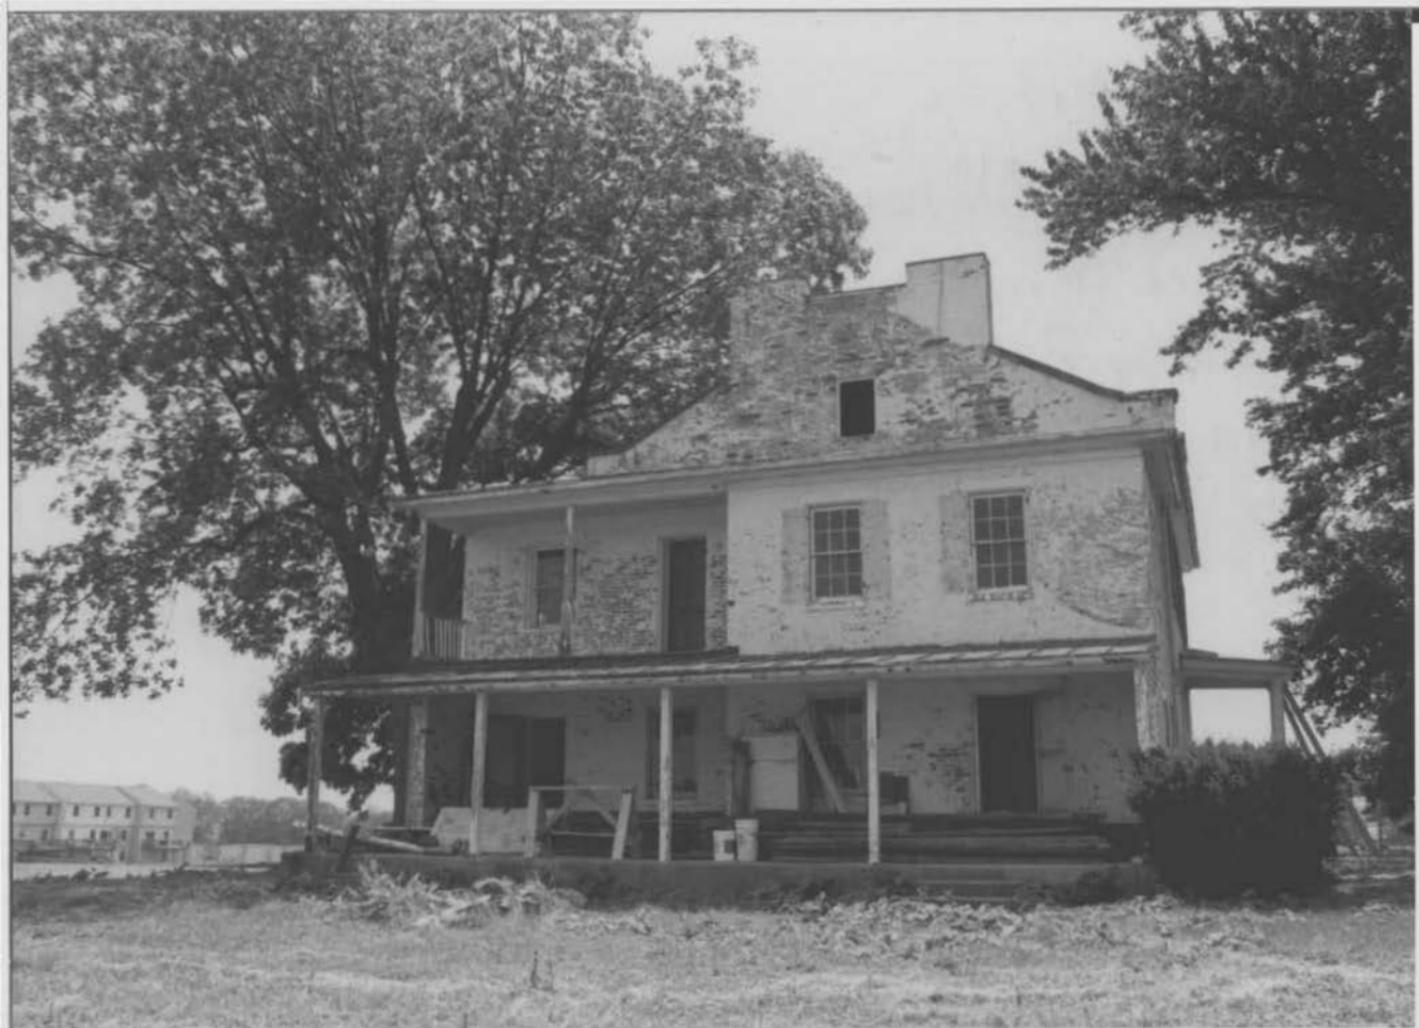
2 of 23

North elevation, SE view

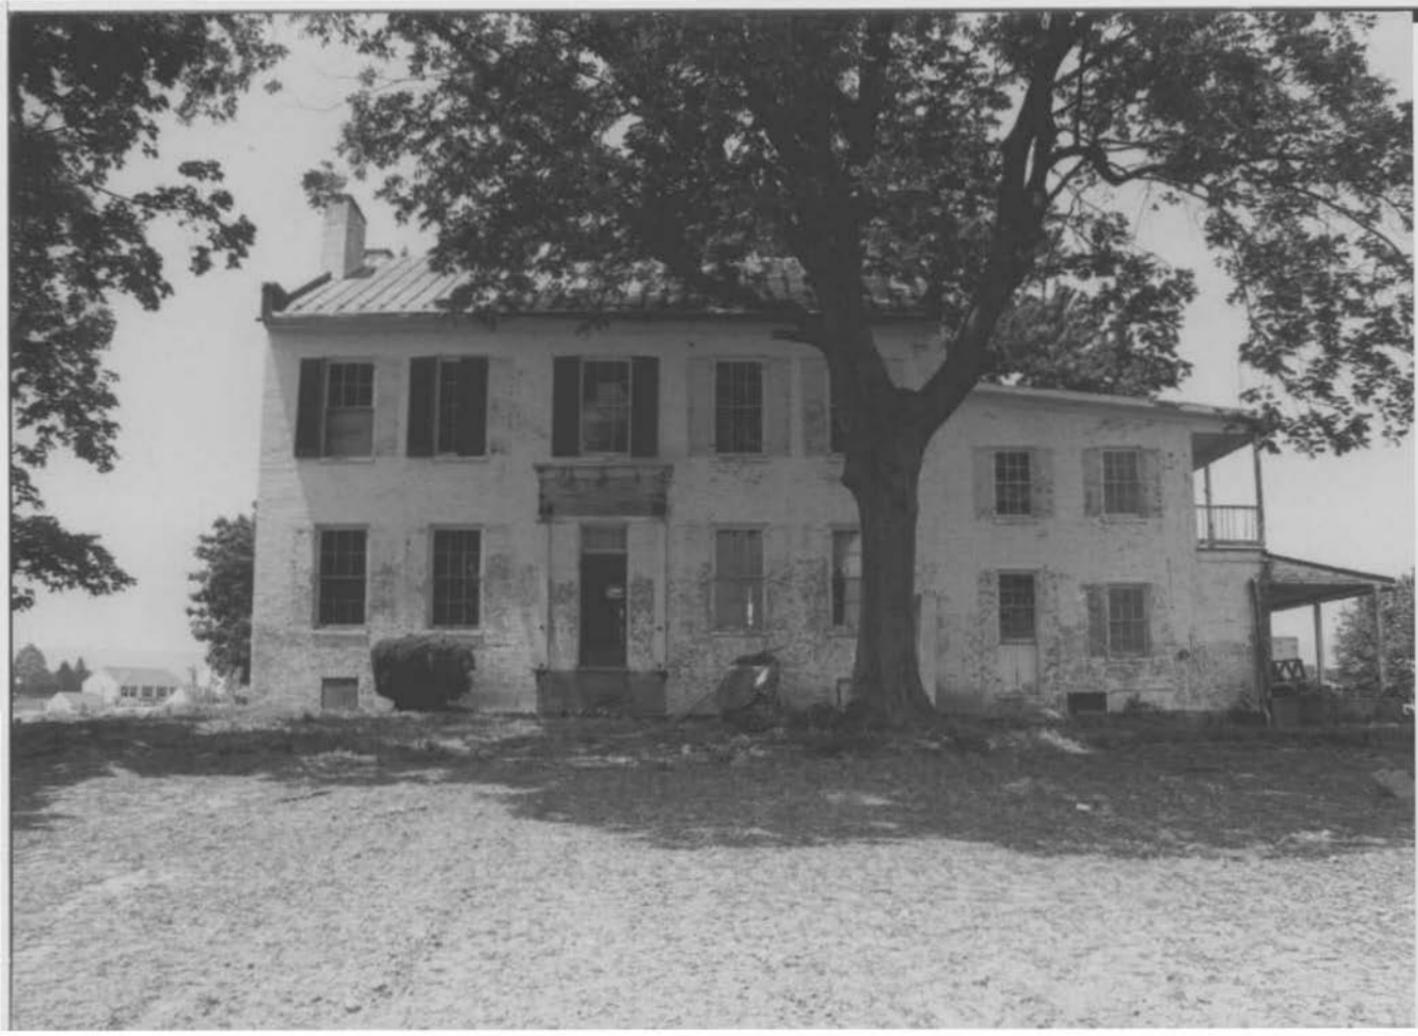
#3 of 23

E. elevation, W view

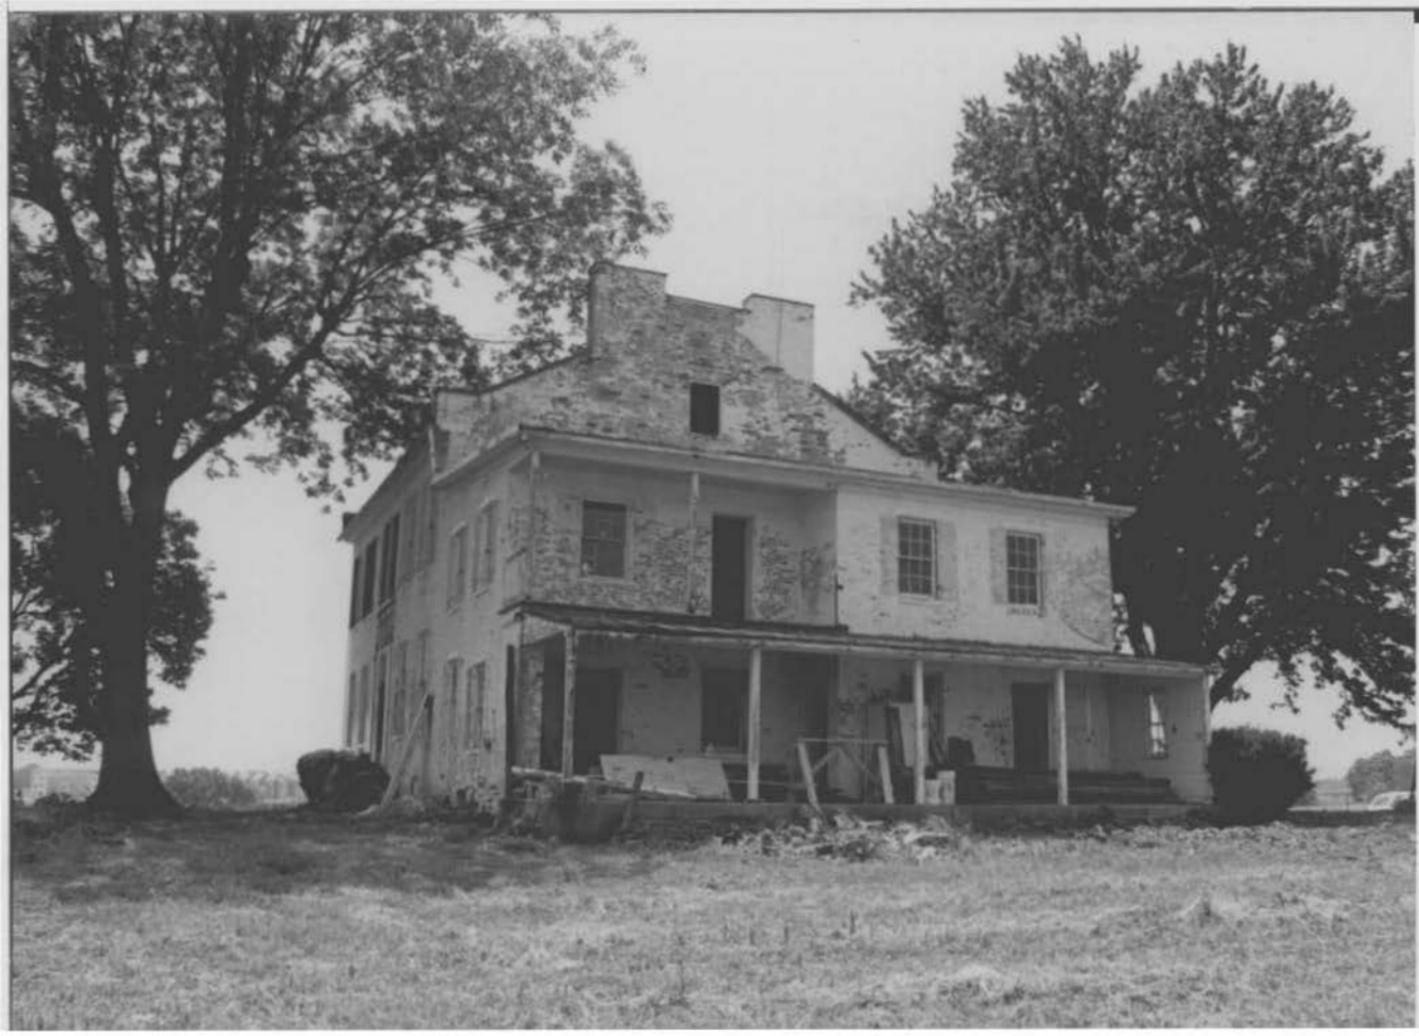
4 of 23

SW view, N+E elevations

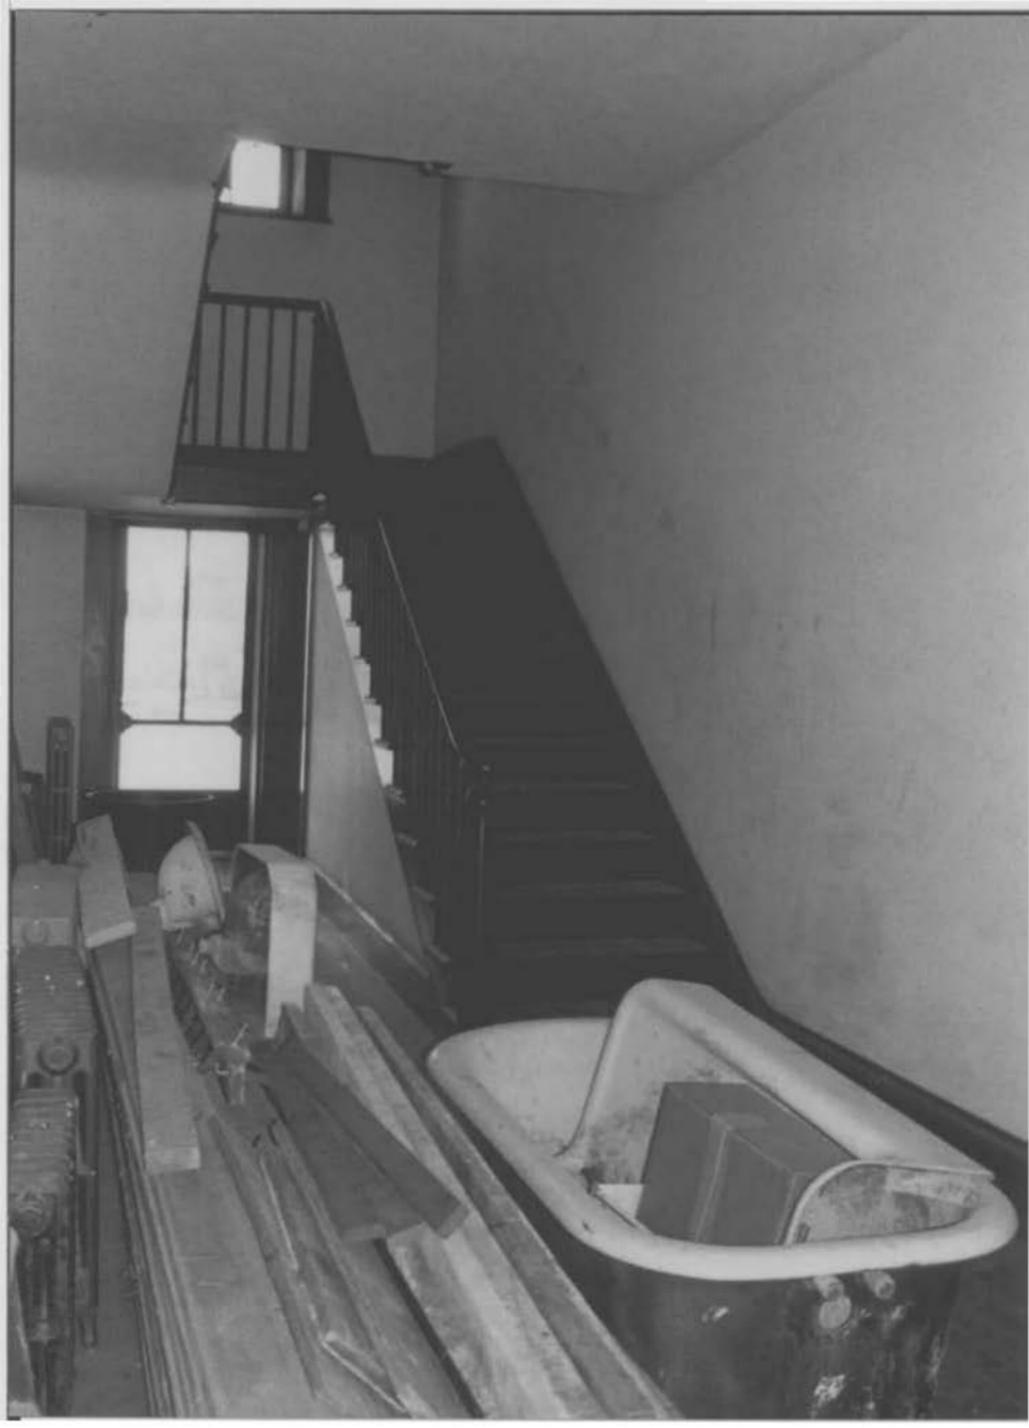
5 of 23

Entrance and Stair hall

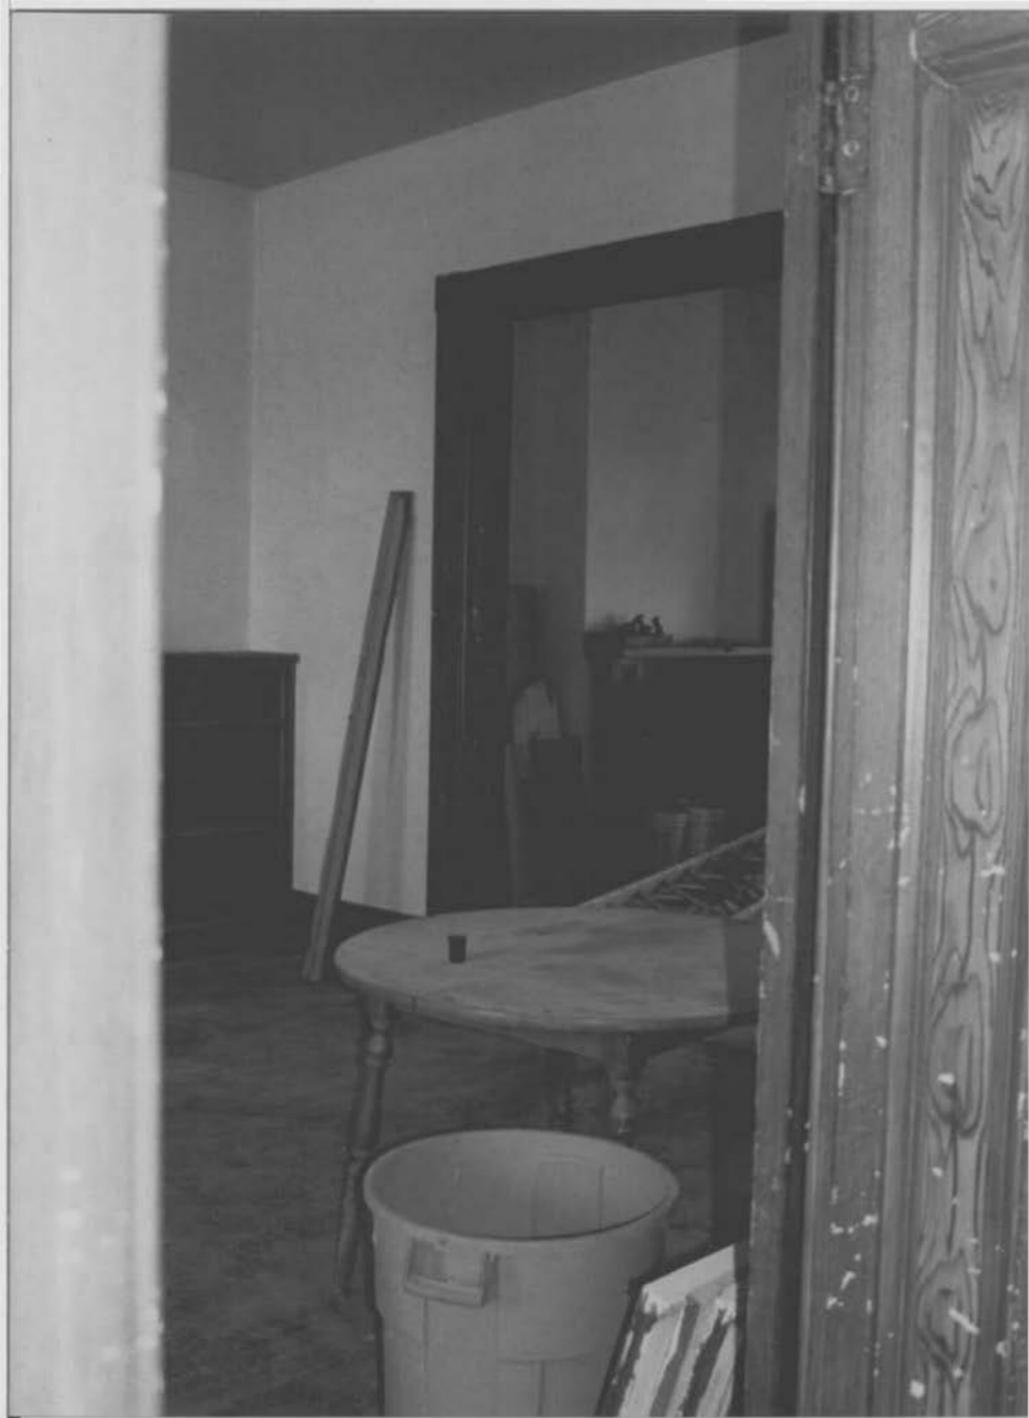
6 of 23

Interior, north-west room, first floor
looking into north-east room

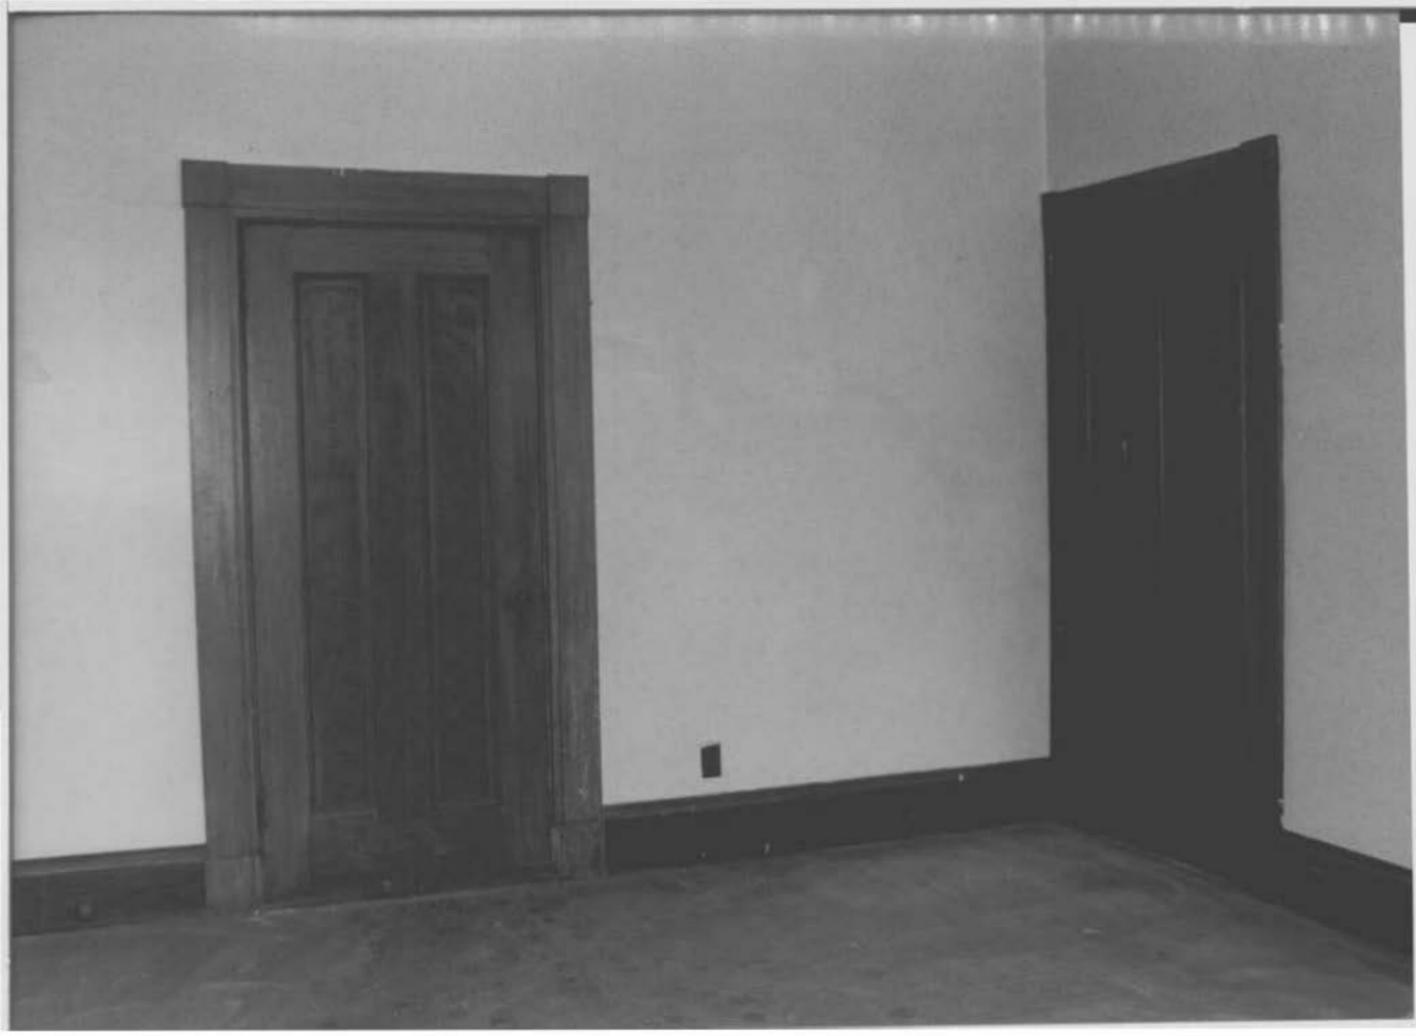
#7 of 23

first floor, SW room, grain painted doors (original)

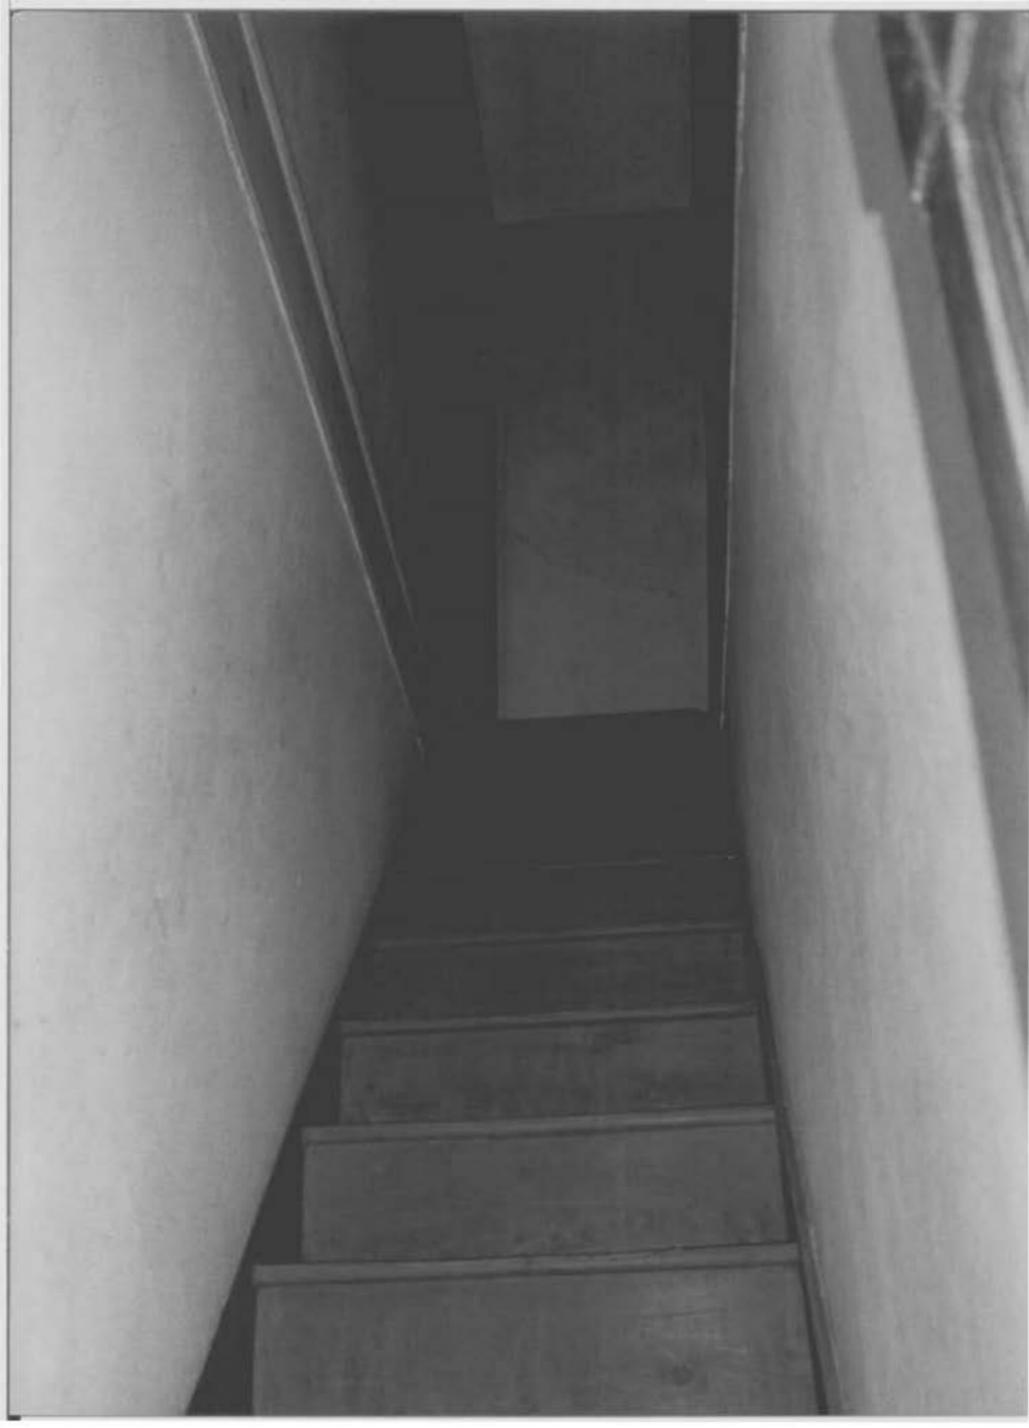
8 of 23

back stairs (servants)

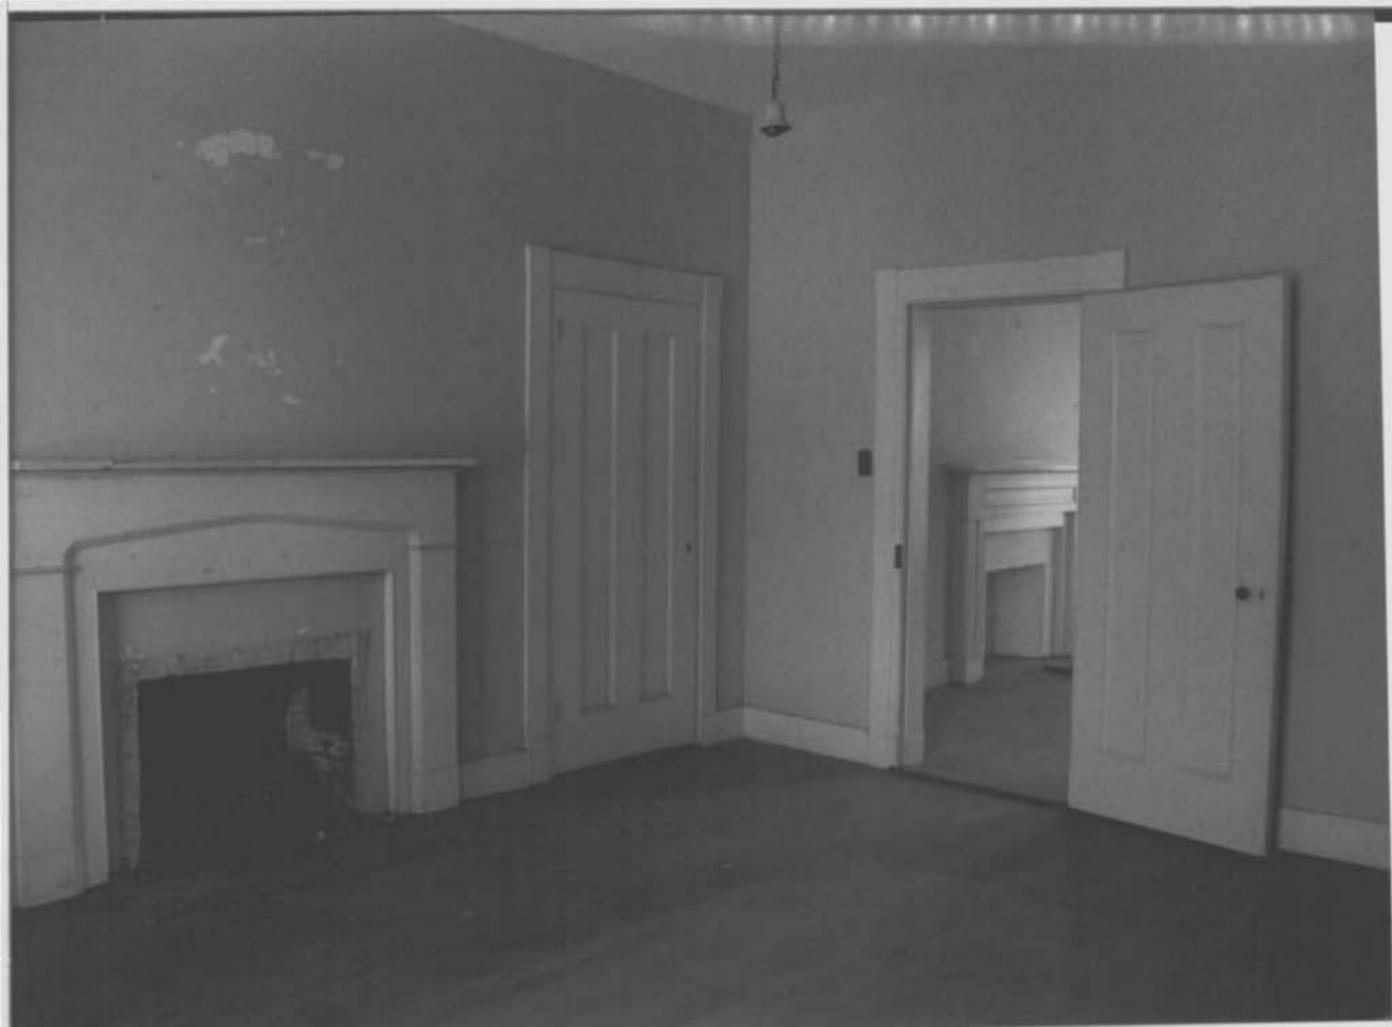
9 of 23

Second floor, northwest room with view into
northeast room

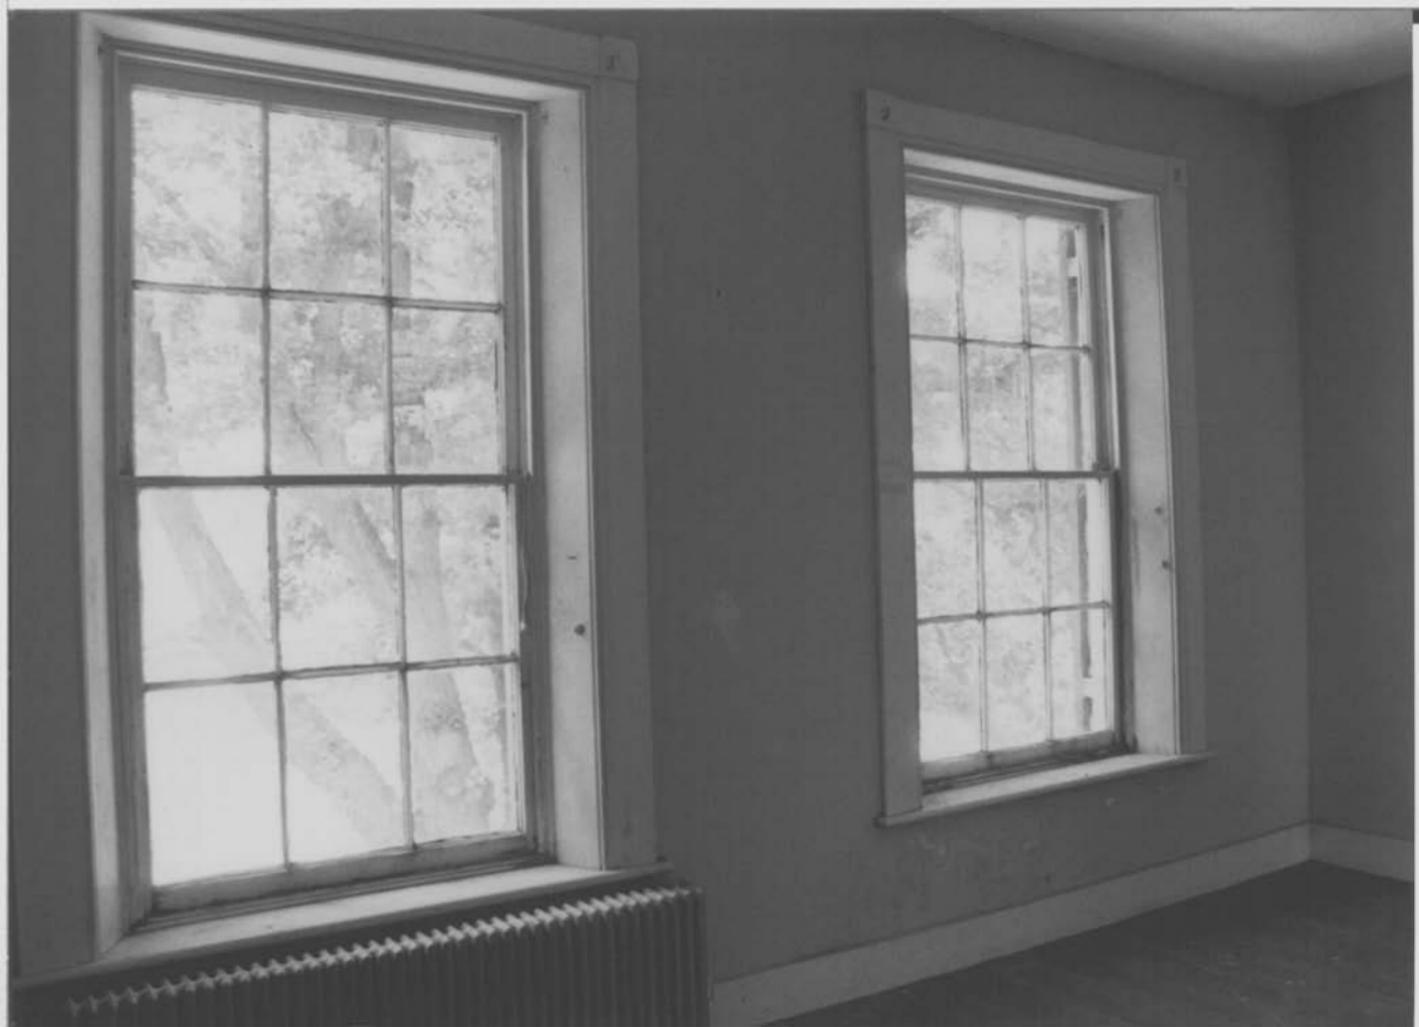
10 of 23

Second floor, Northwest room, with original blind
cord wrap hardware.

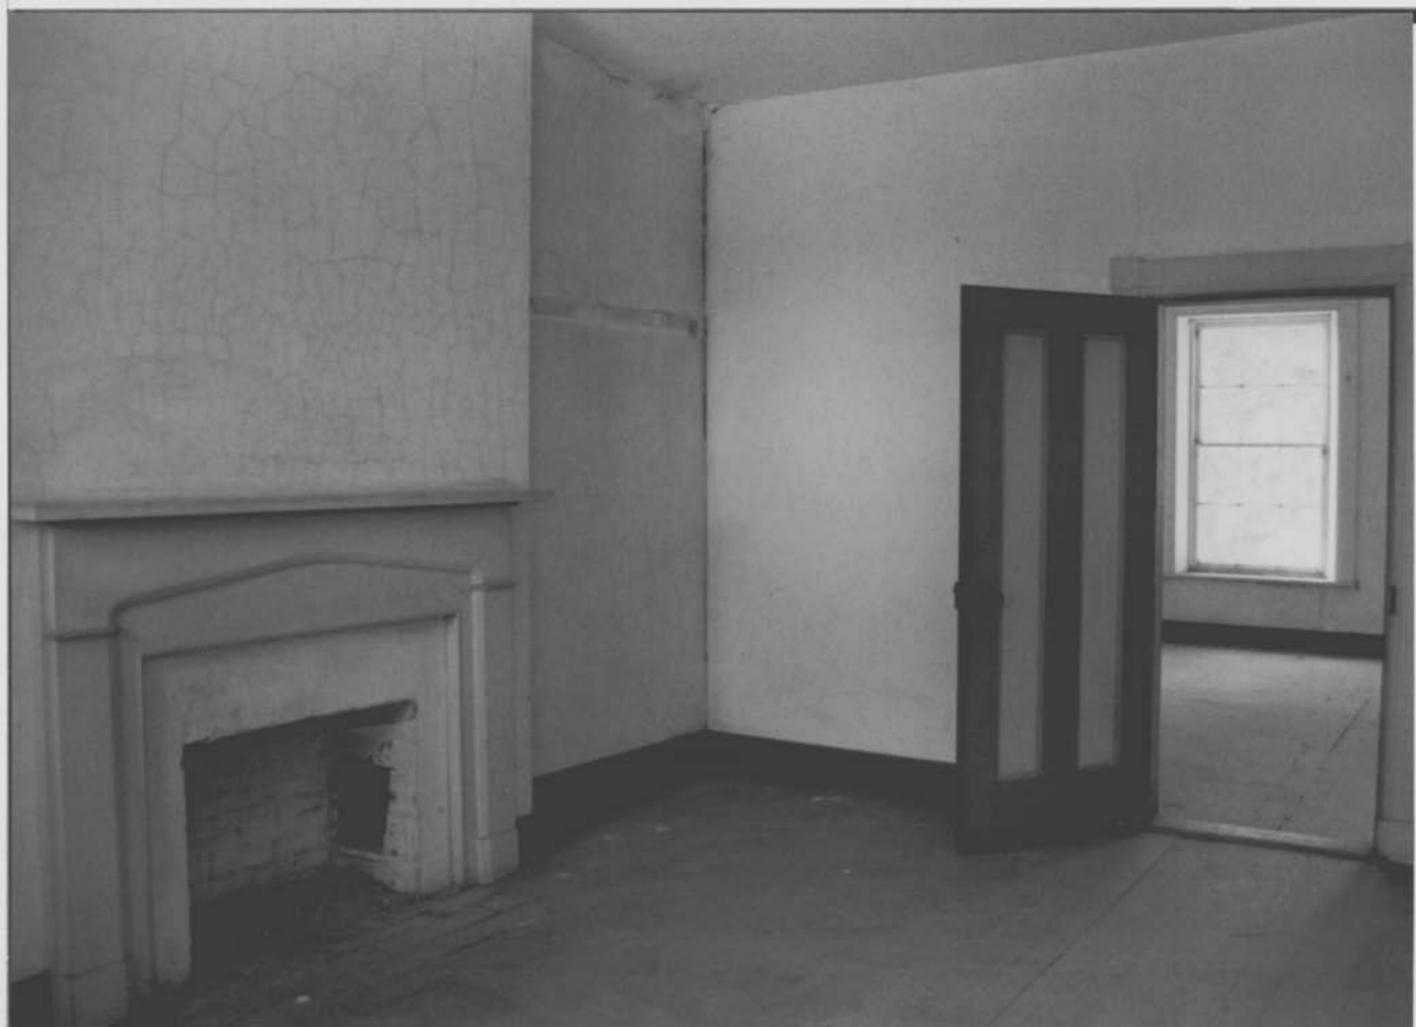
11 of 23

Second floor, southeast with view into southwest room

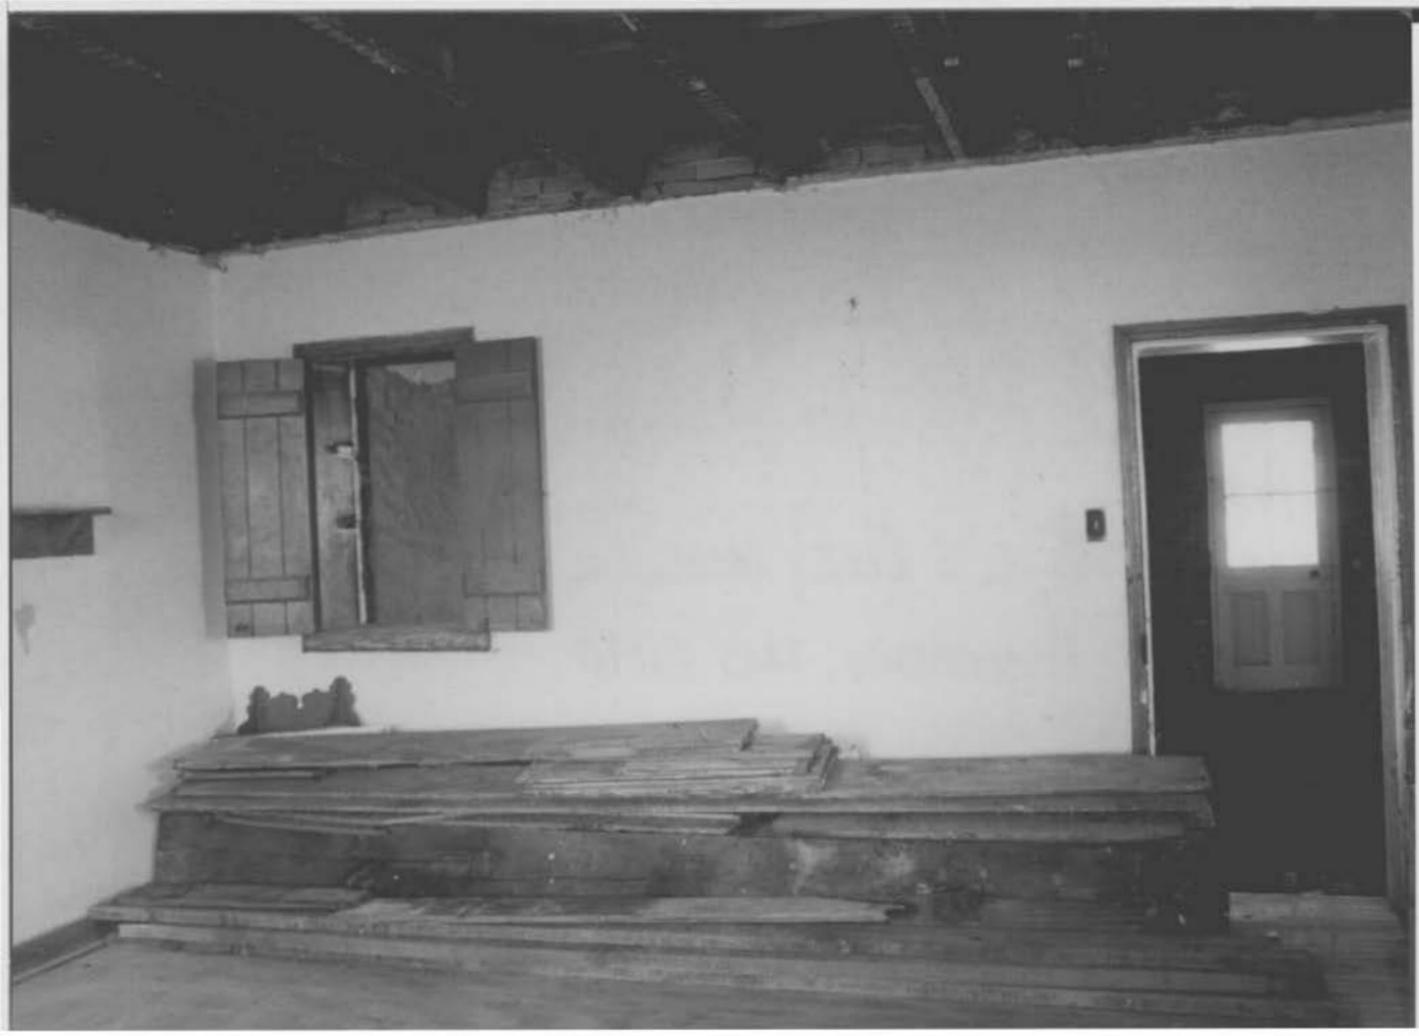
#12 of 23

Interior, east room, first story addition, bolting into
west room

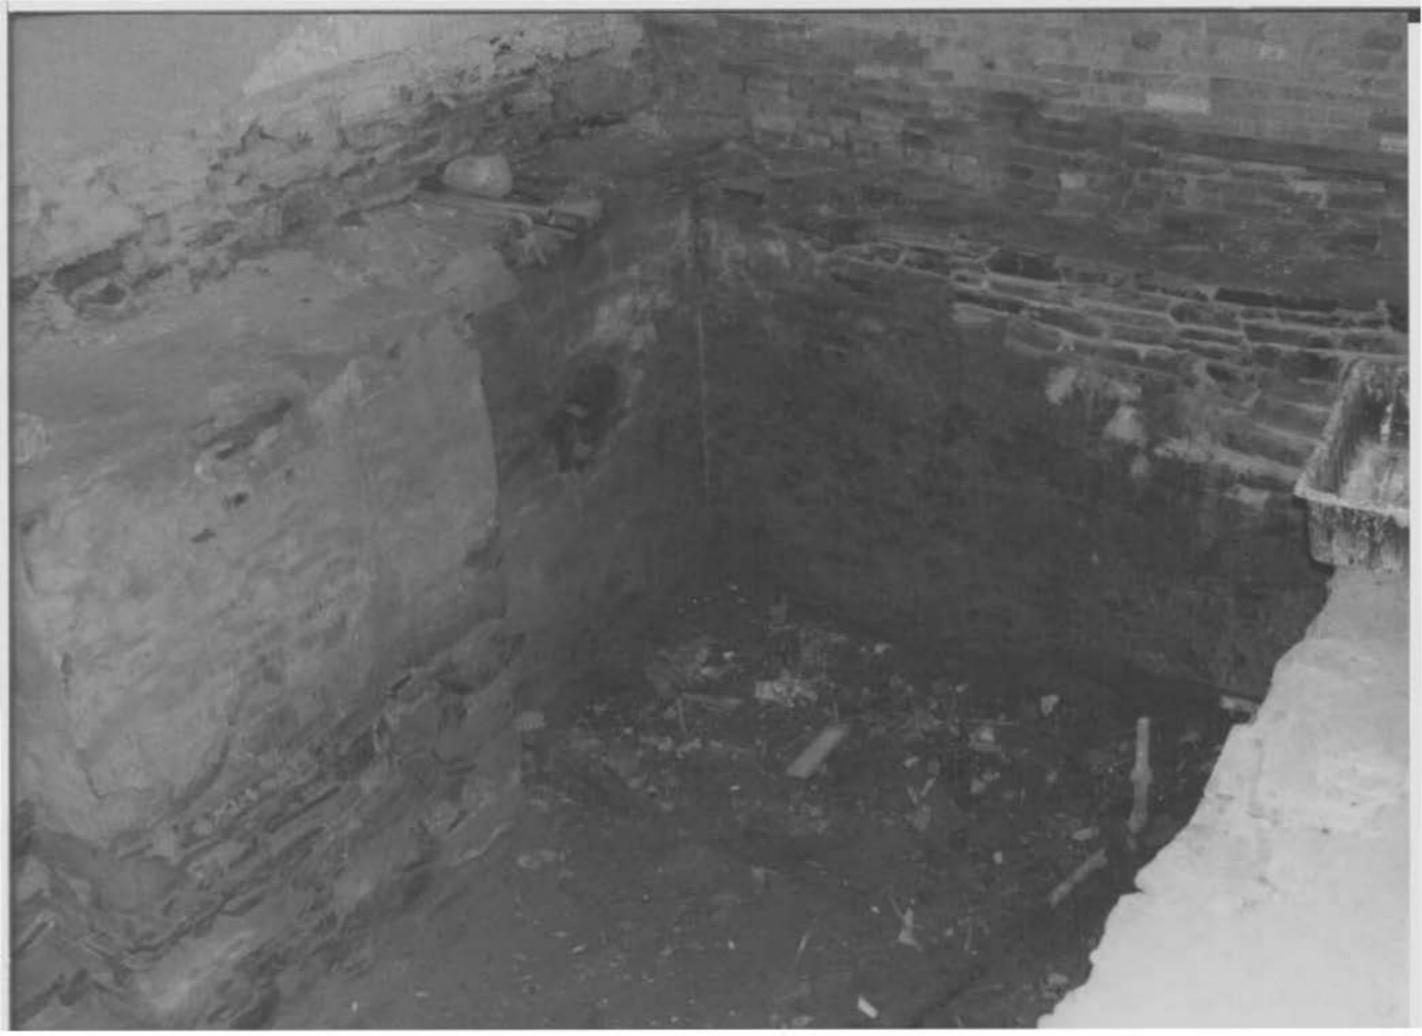
#13 of 23

cellar foundation beneath addition, possibly 18th
century

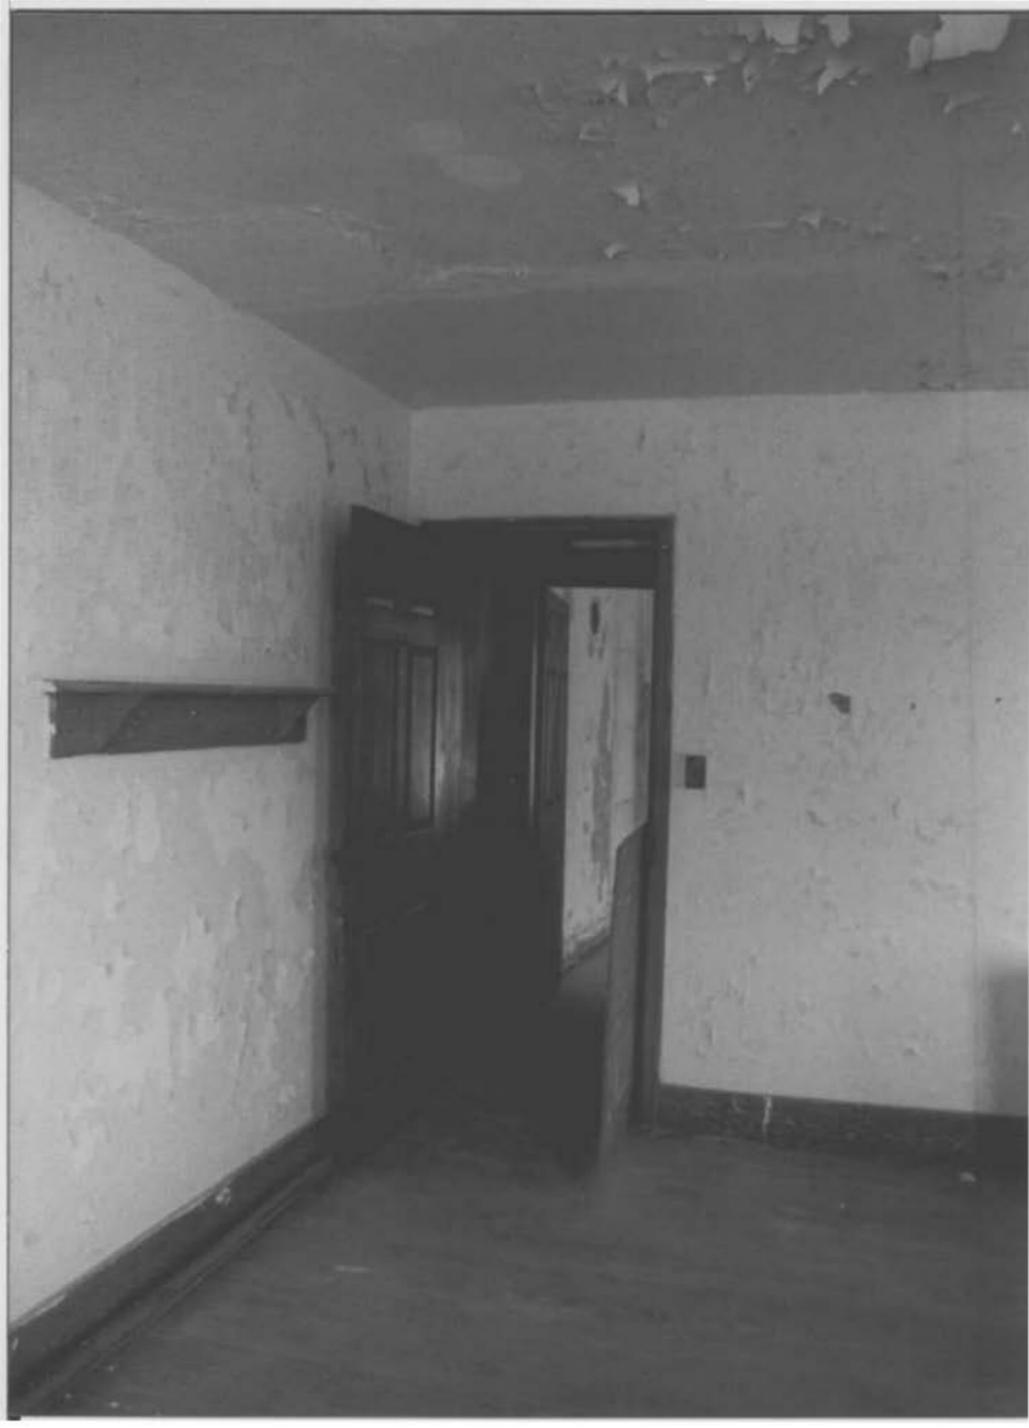
#14 of 23

Second floor, north addition

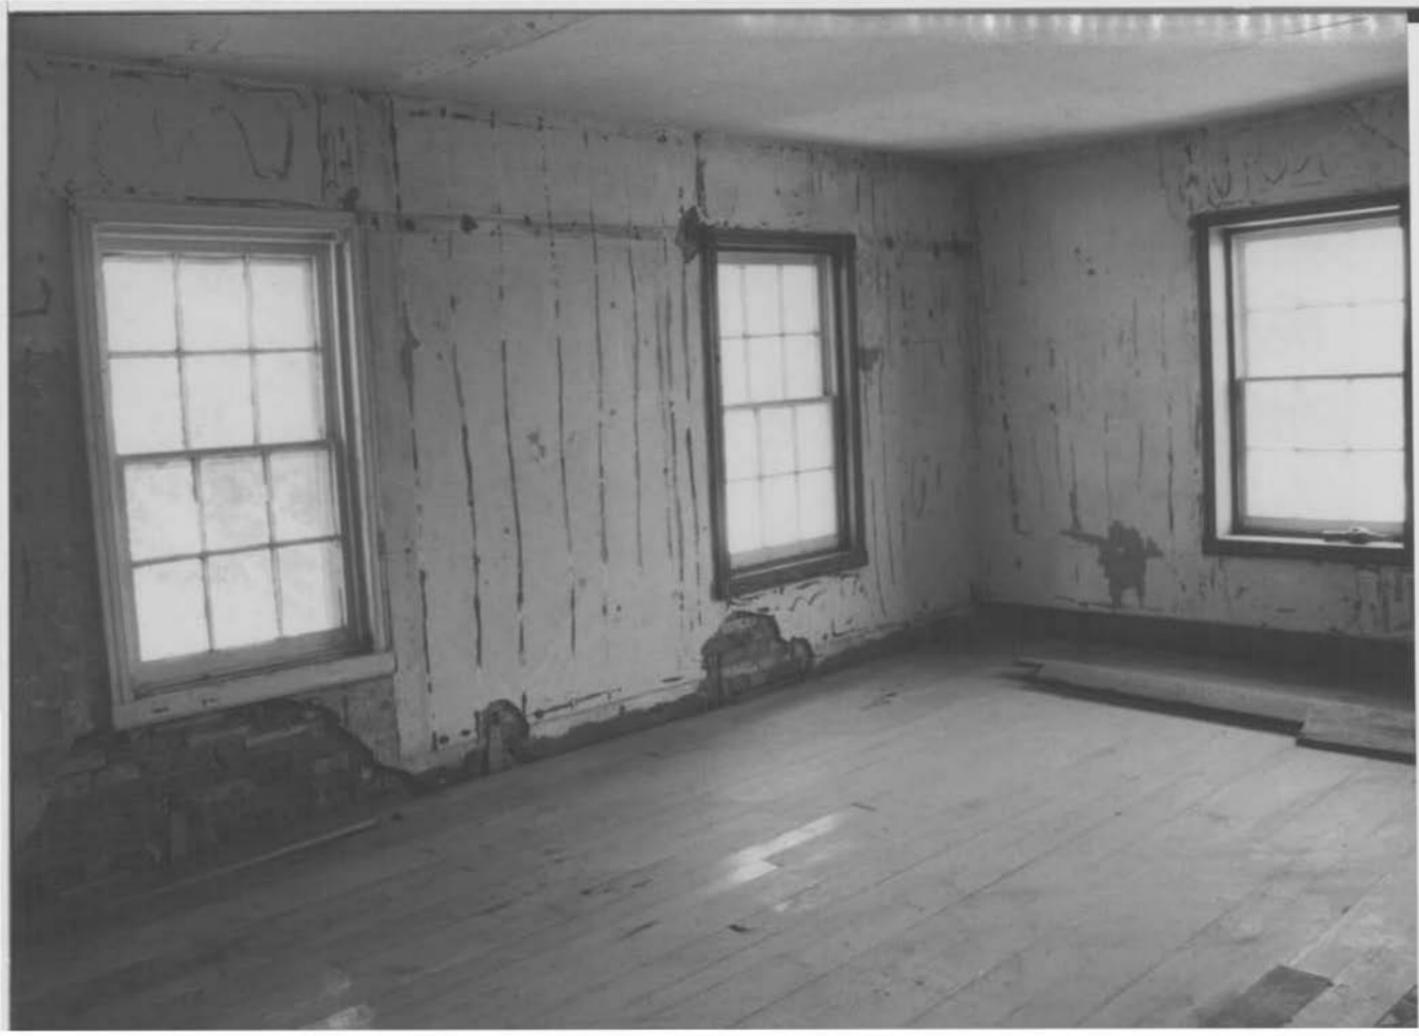
#15 of 23

Second floor, addition
