CAPSULE SUMMARY

Survey # F-3-154

Maryland Historical Trust State Historic Sites Inventory Form

historic Willow Brook Farm

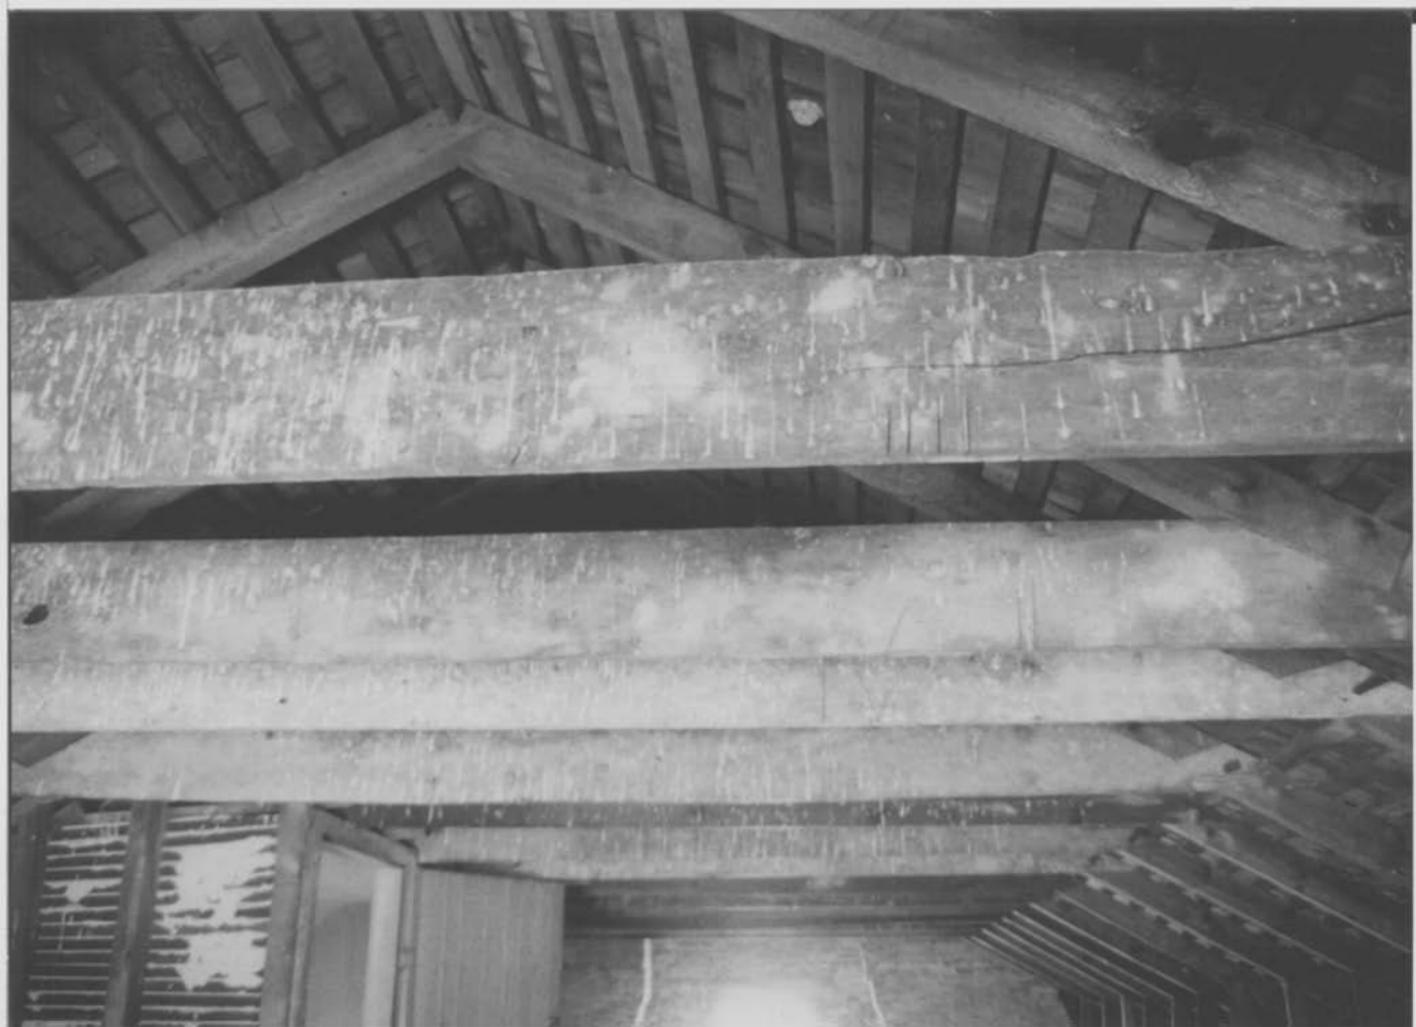
#16 of 23

Attic, roof structure

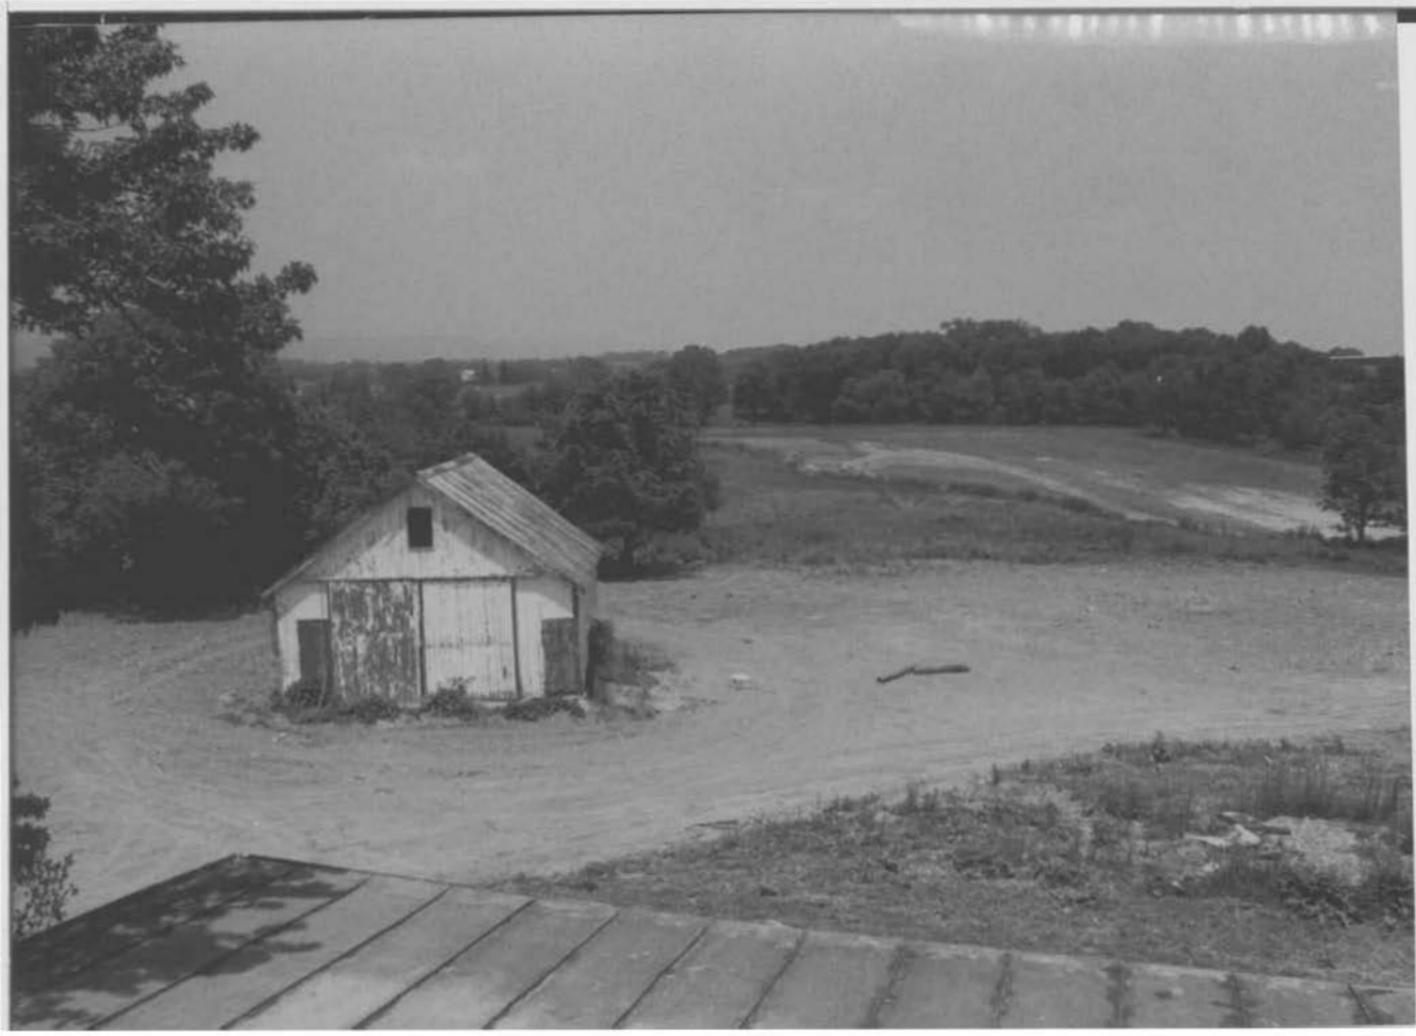
17 of 23

Corn crib and site of farm buildings, N. view
from attic.

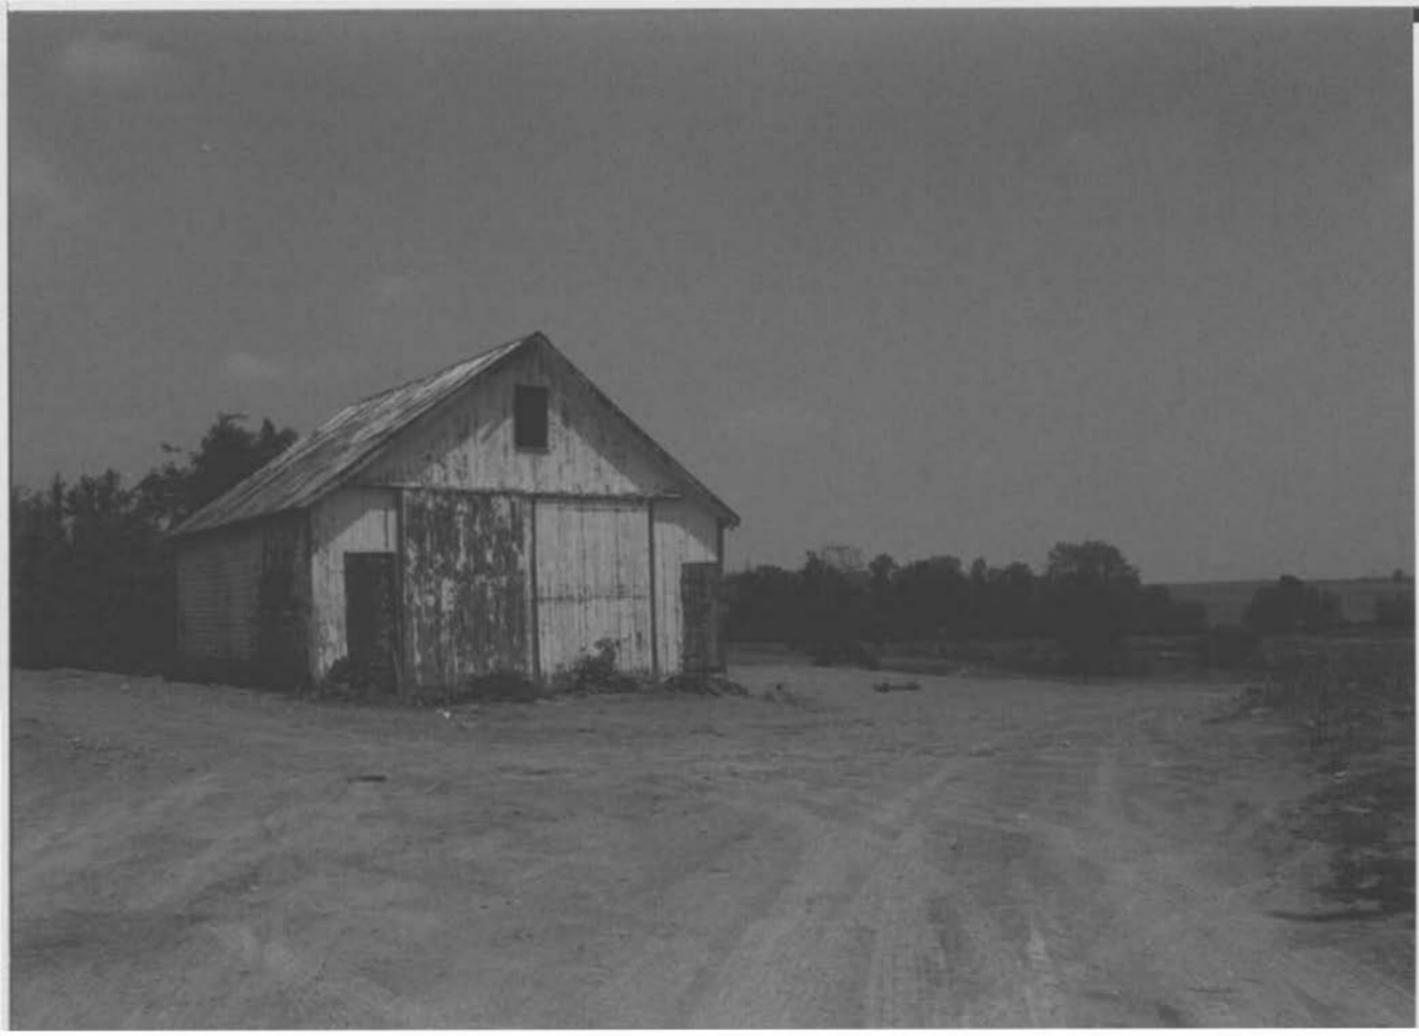
#18 of 23

Corn crib, NE view, and site of farmbuildings

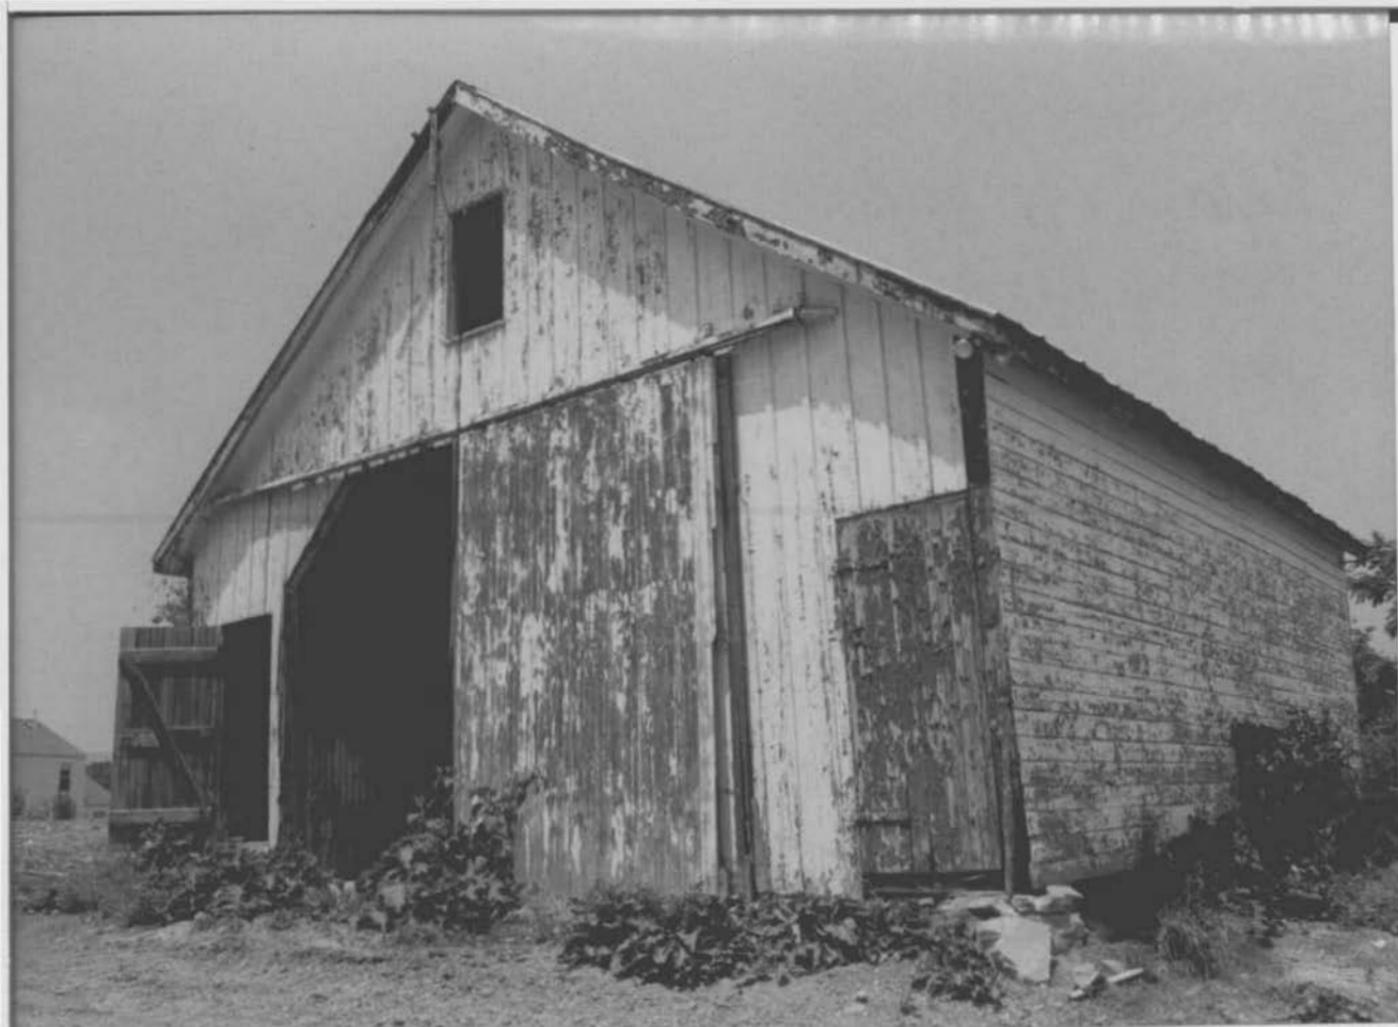
#19 of 23

Corn crib/wagon shed, NW view, S+E elevations

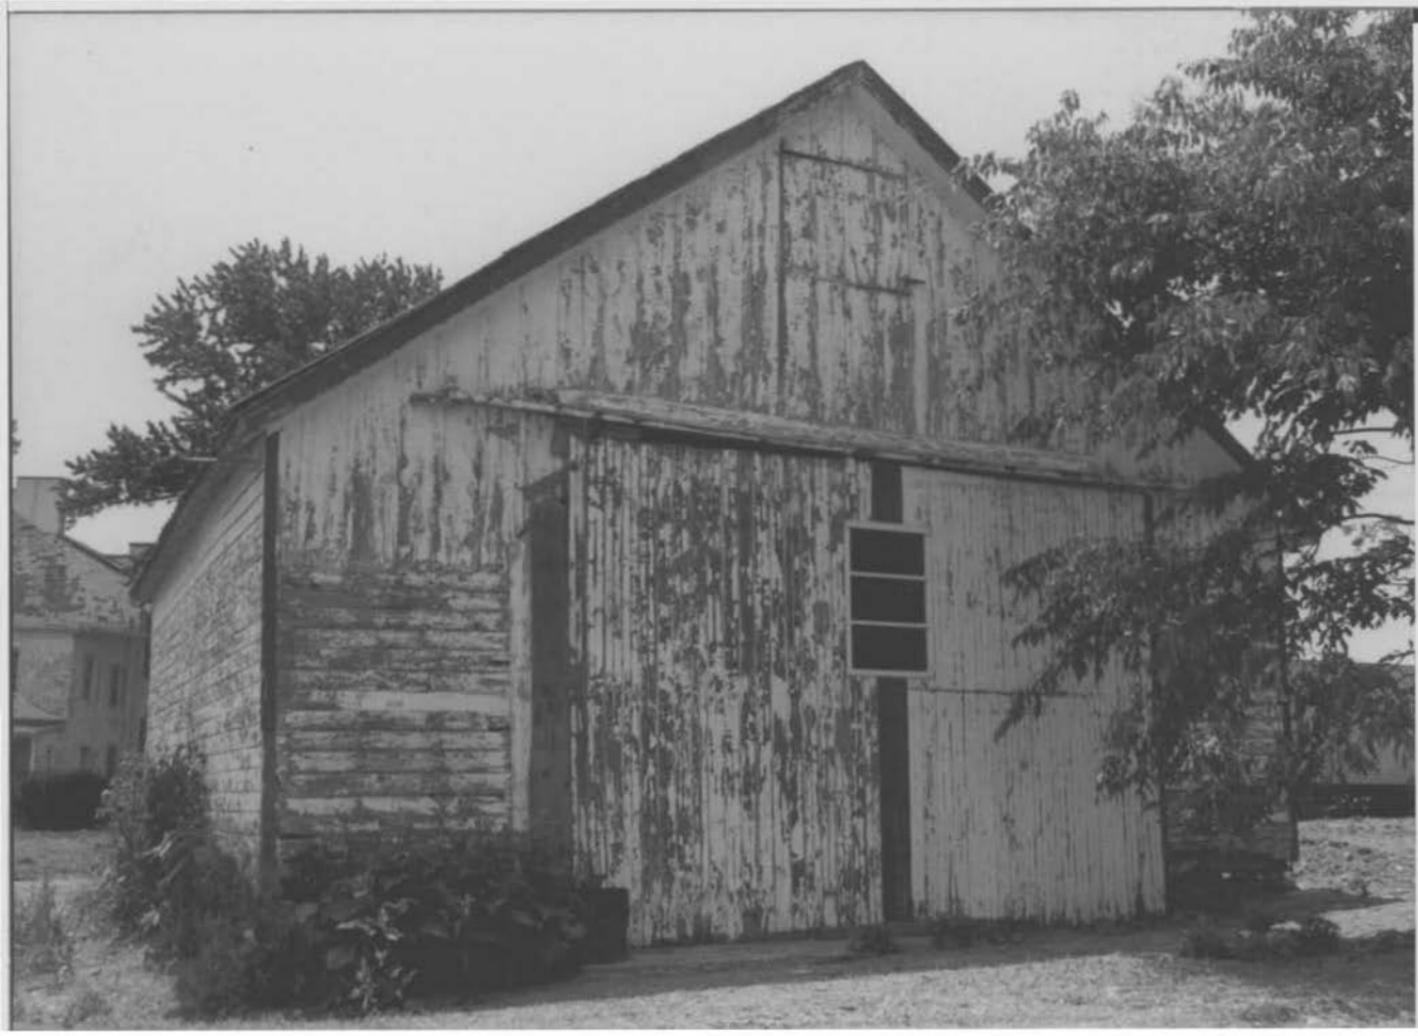
20 of 23

Corn crib, N+E elevations, SW view

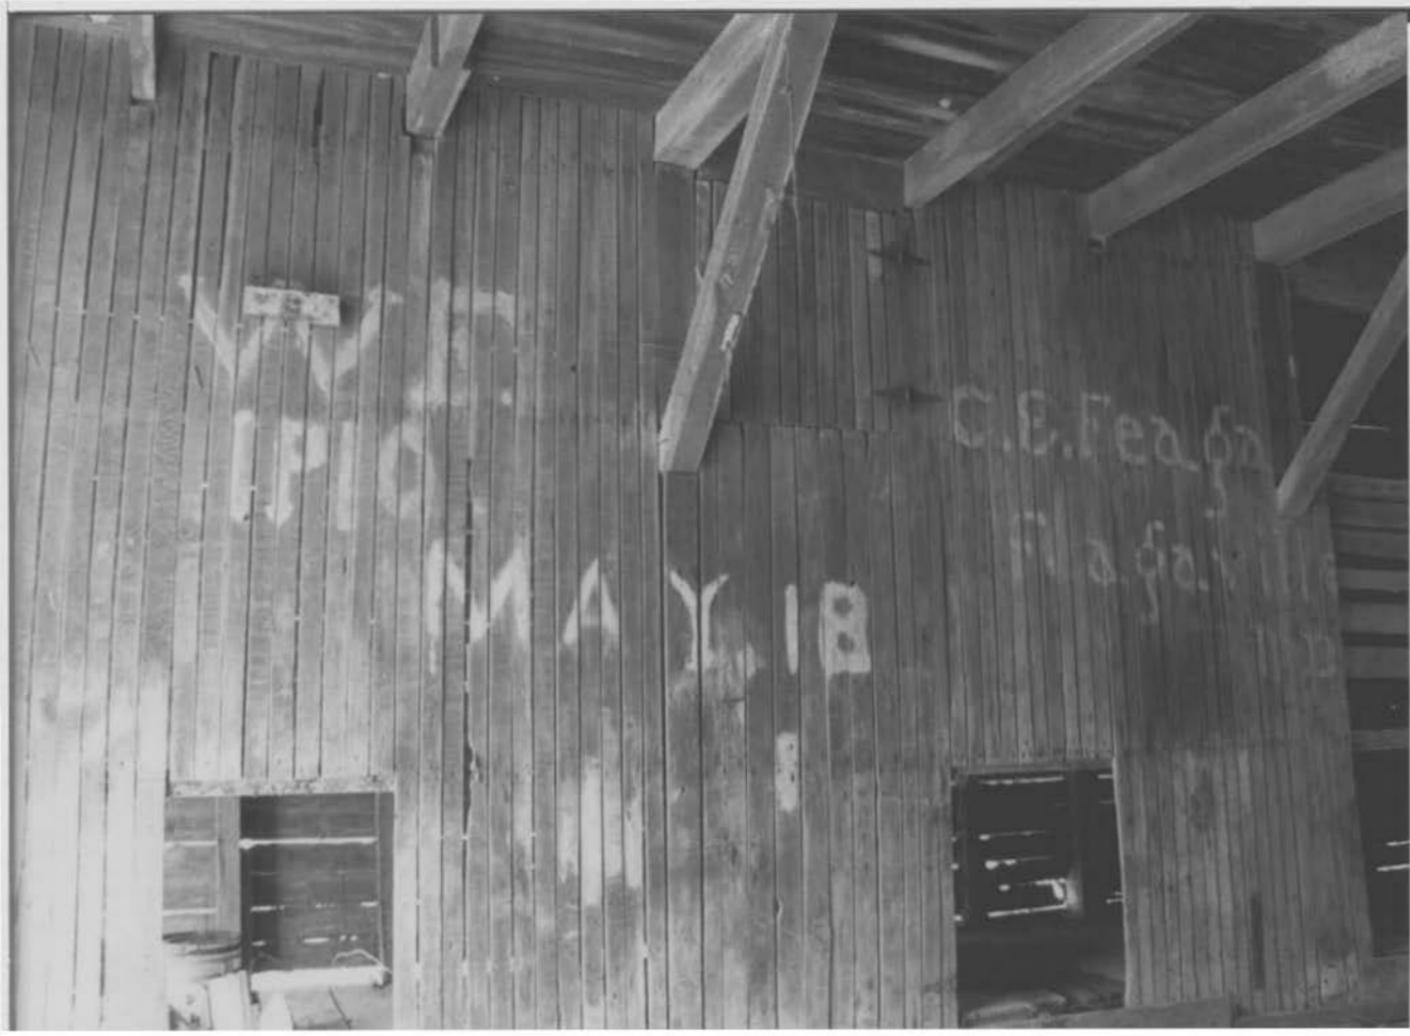
21 of 23

Interior, wagon shed

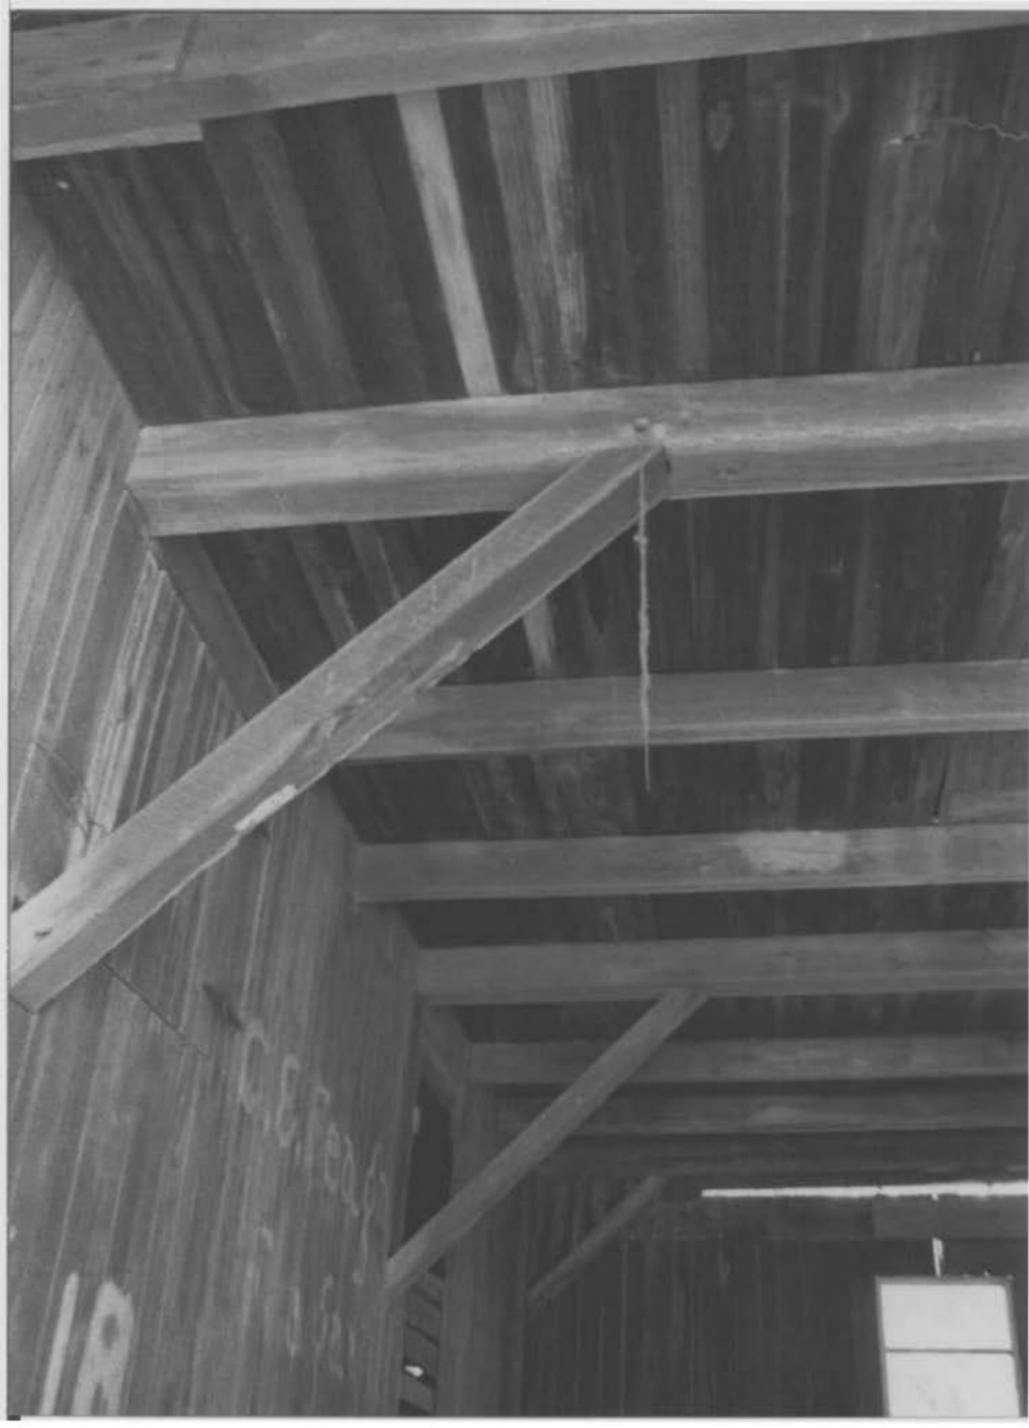
22 of 23

Interior, wagon shed

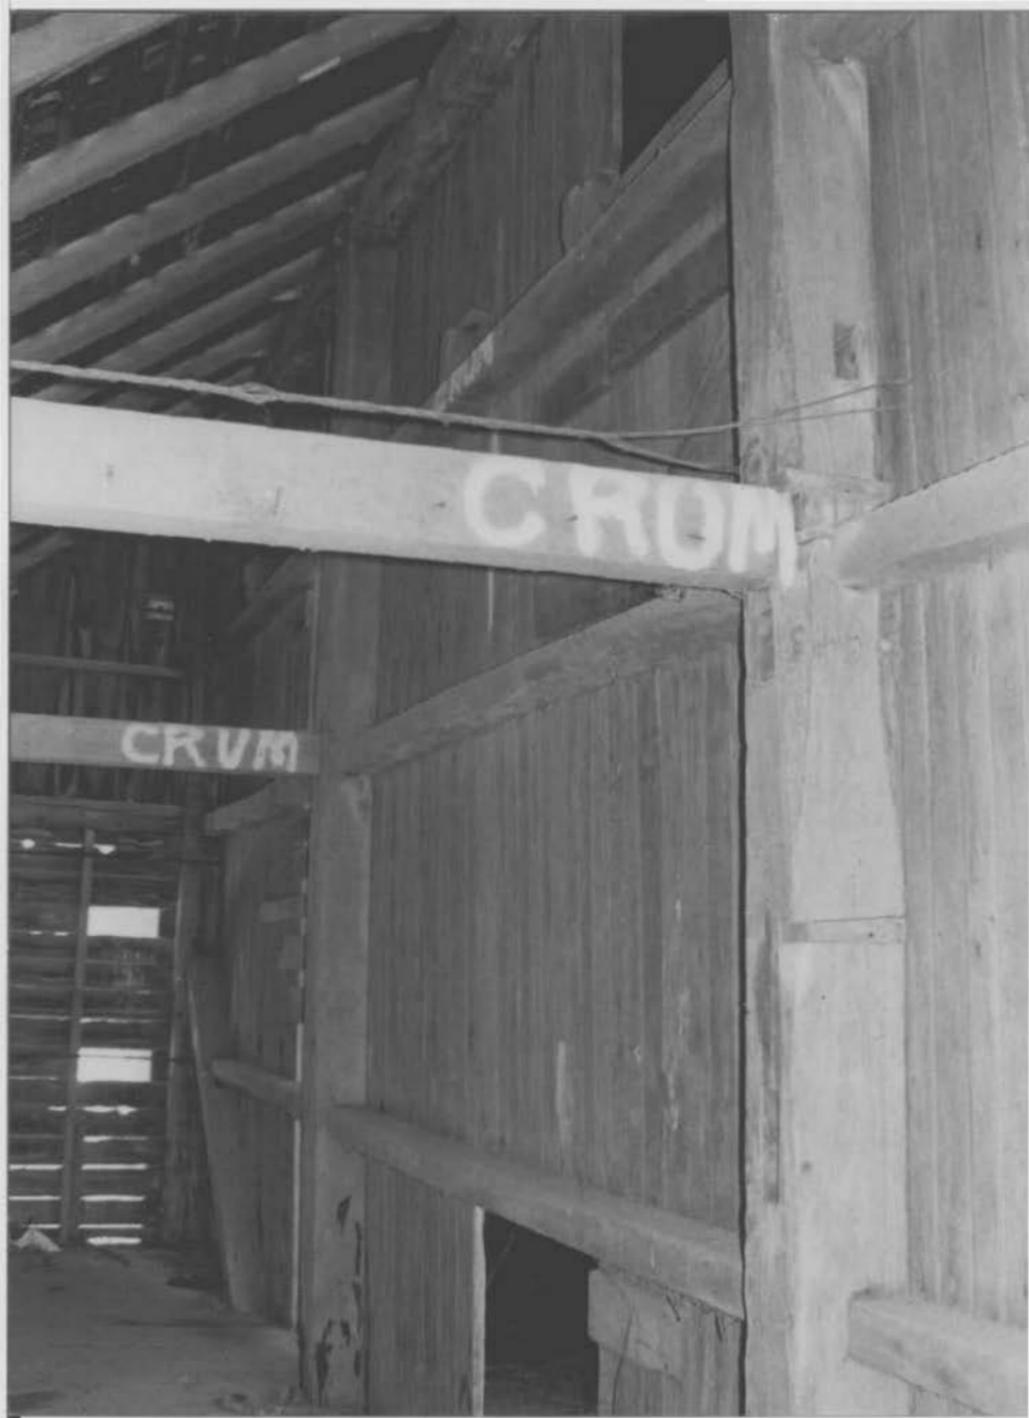
#23 of 23

Interior, corn crib
