MARYLAND INVENTORY OF HISTORIC BRIDGES  
HISTORIC BRIDGE INVENTORY  
MARYLAND STATE HIGHWAY ADMINISTRATION/  
MARYLAND HISTORICAL TRUST

MHT No. F-8-138

SHA Bridge No. F 1904 Bridge name Unionville Road over Branch of Linganore Creek

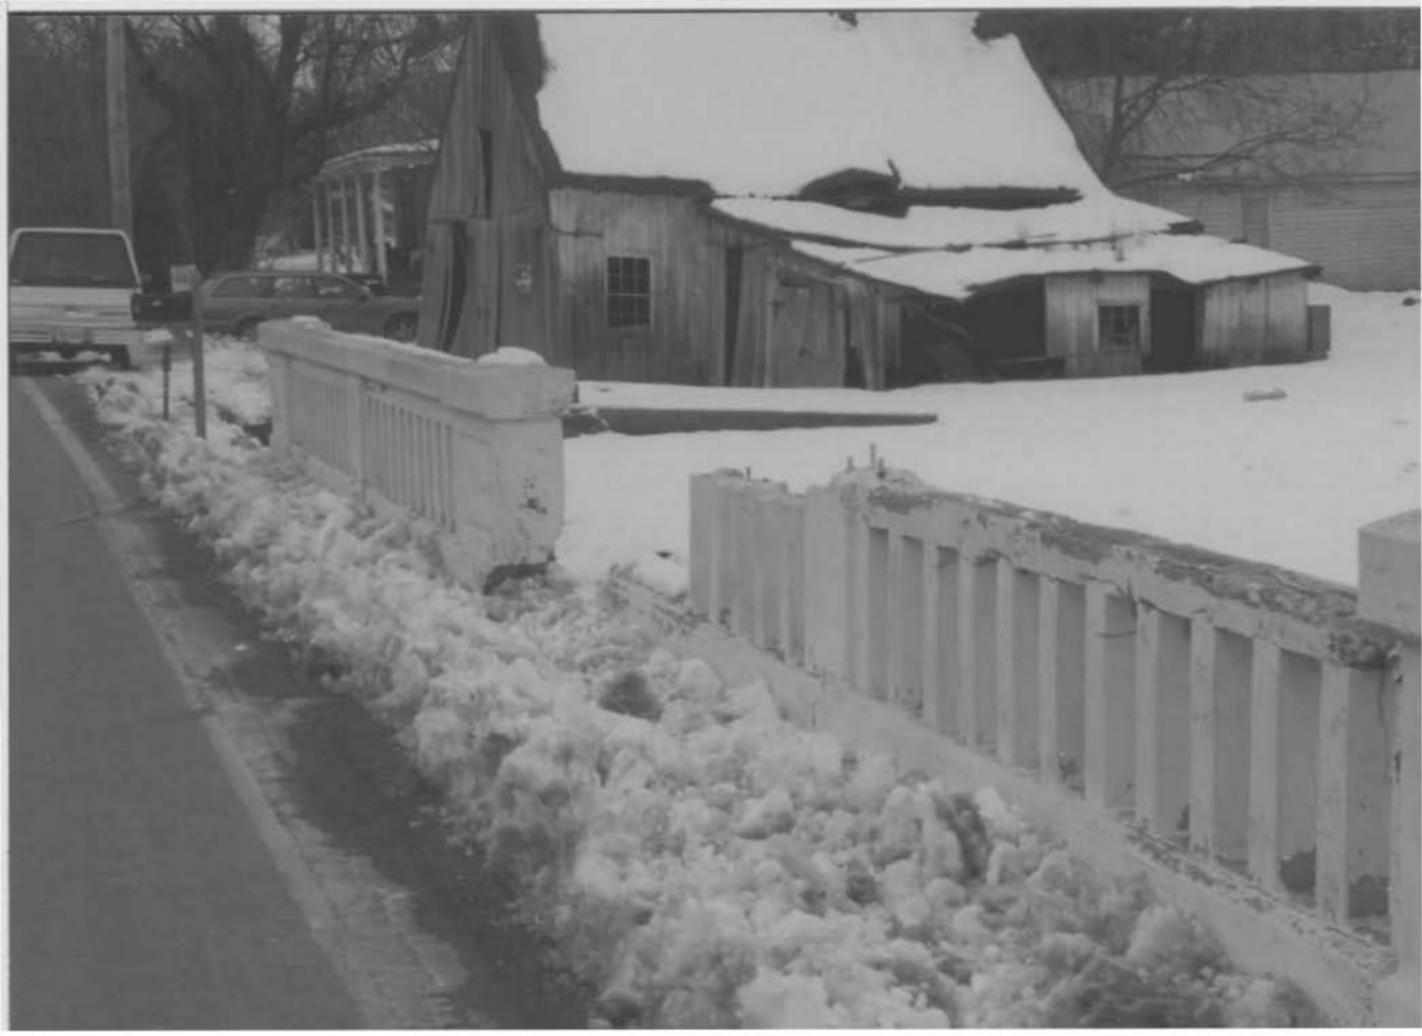
Number 5 of 35 8

No, the concrete parapets have retained integrity of materials, but has been severely damaged due to the concrete slab not being anchored to its supports.

Description DAMAGED PARAPET NORTH

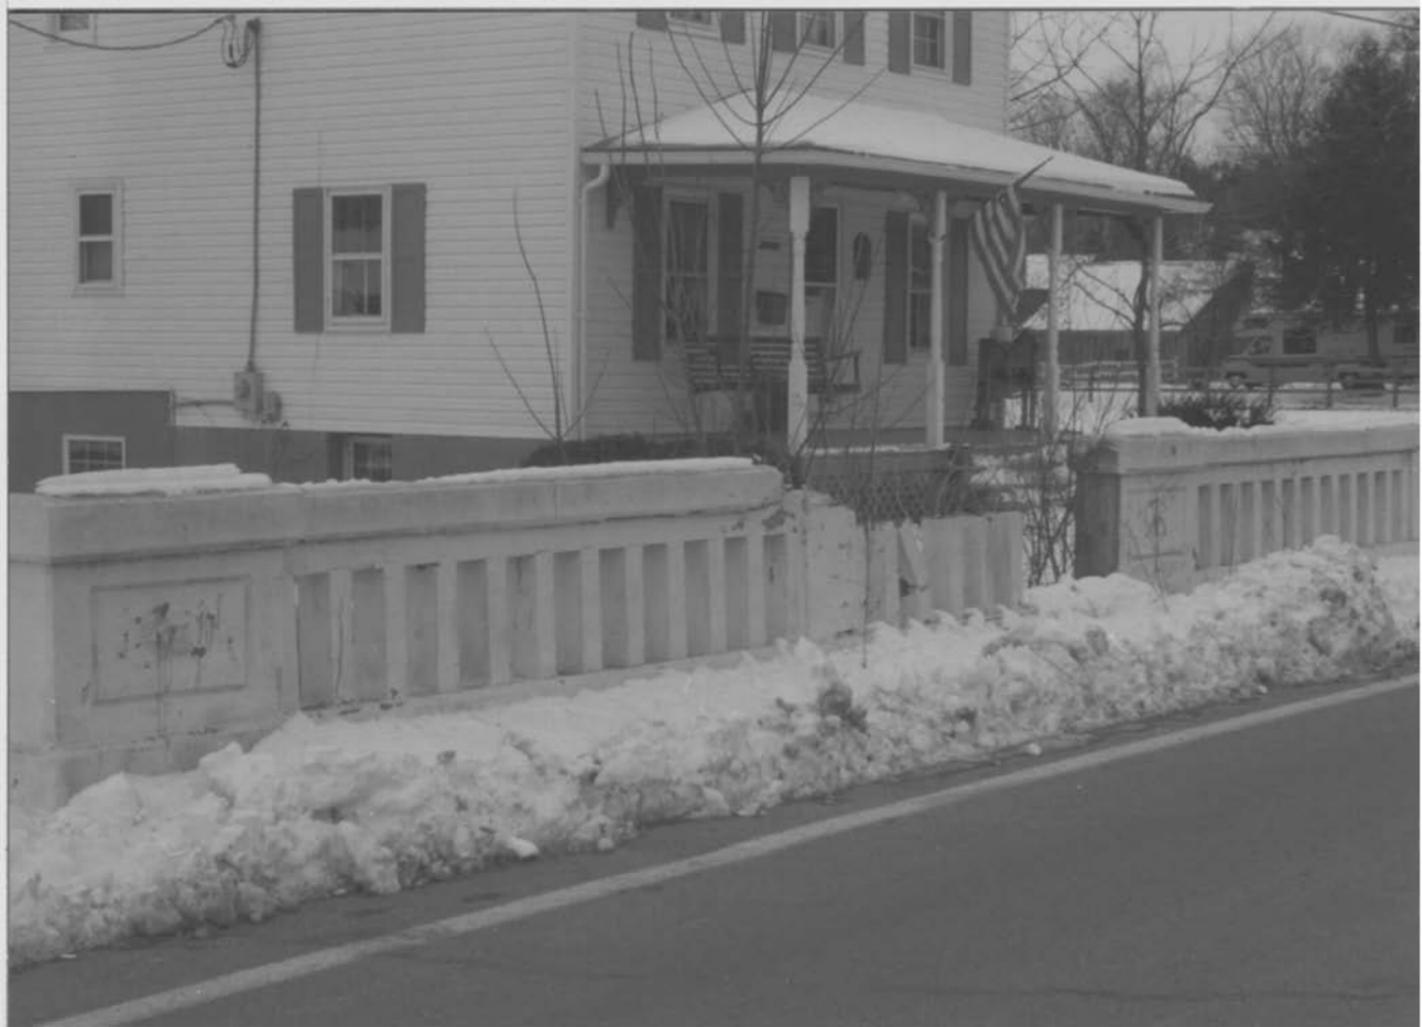
Number 6 of 35 8

Description DAMAGED PARAPET SOUTH

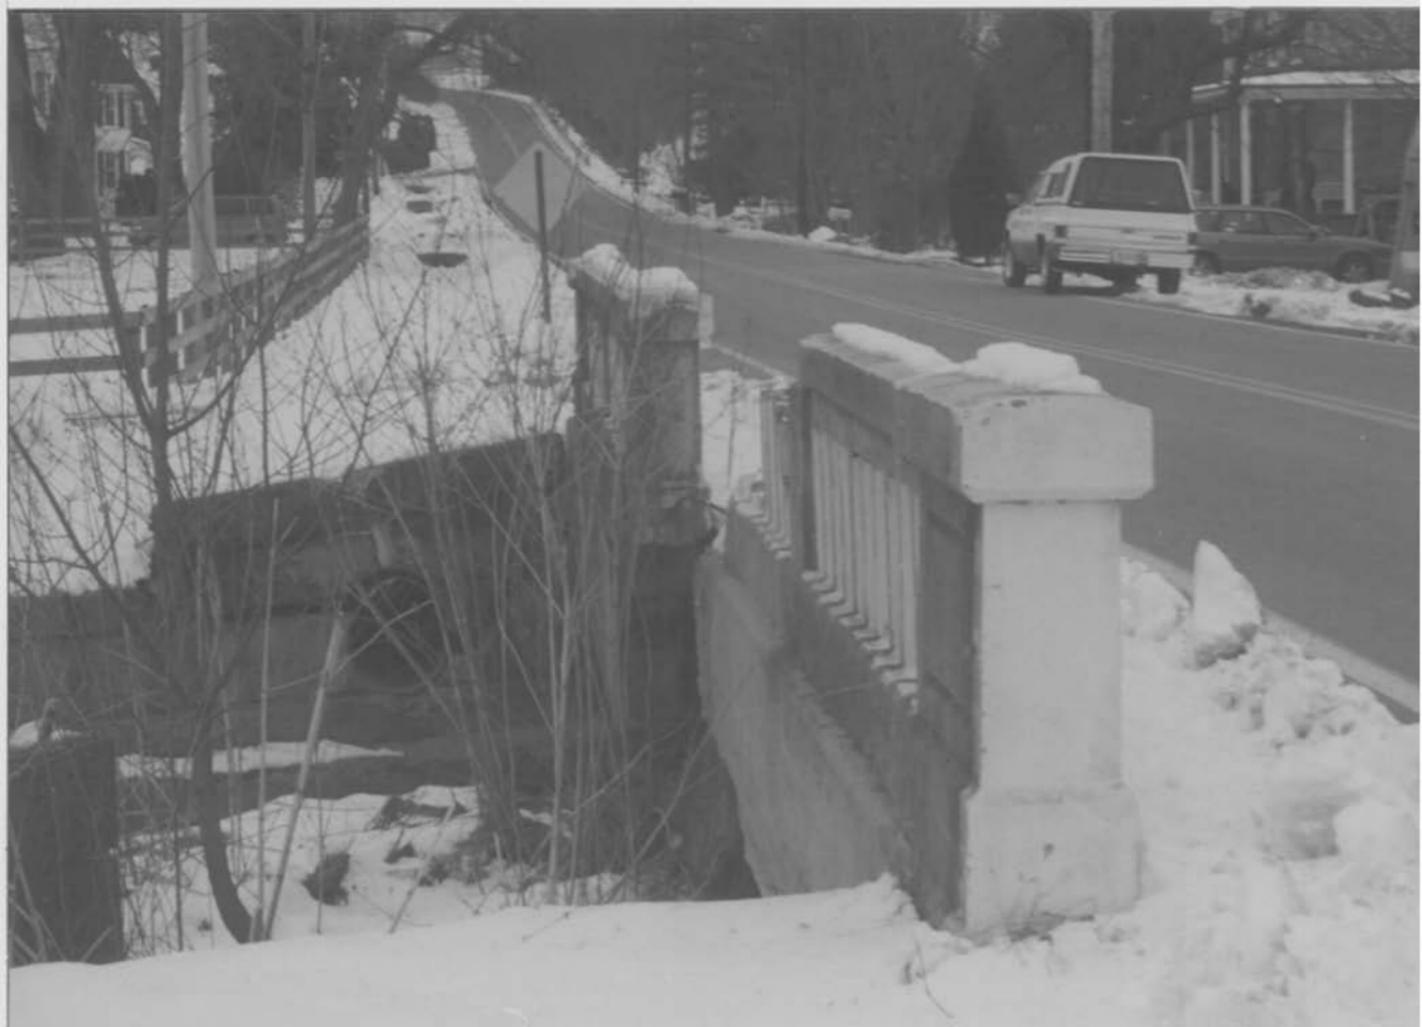
Number <sup>7</sup>33 of 35 <sup>8</sup>

Description DAMAGED PARAPET SOUTH  
AND SHIFTED SLAB

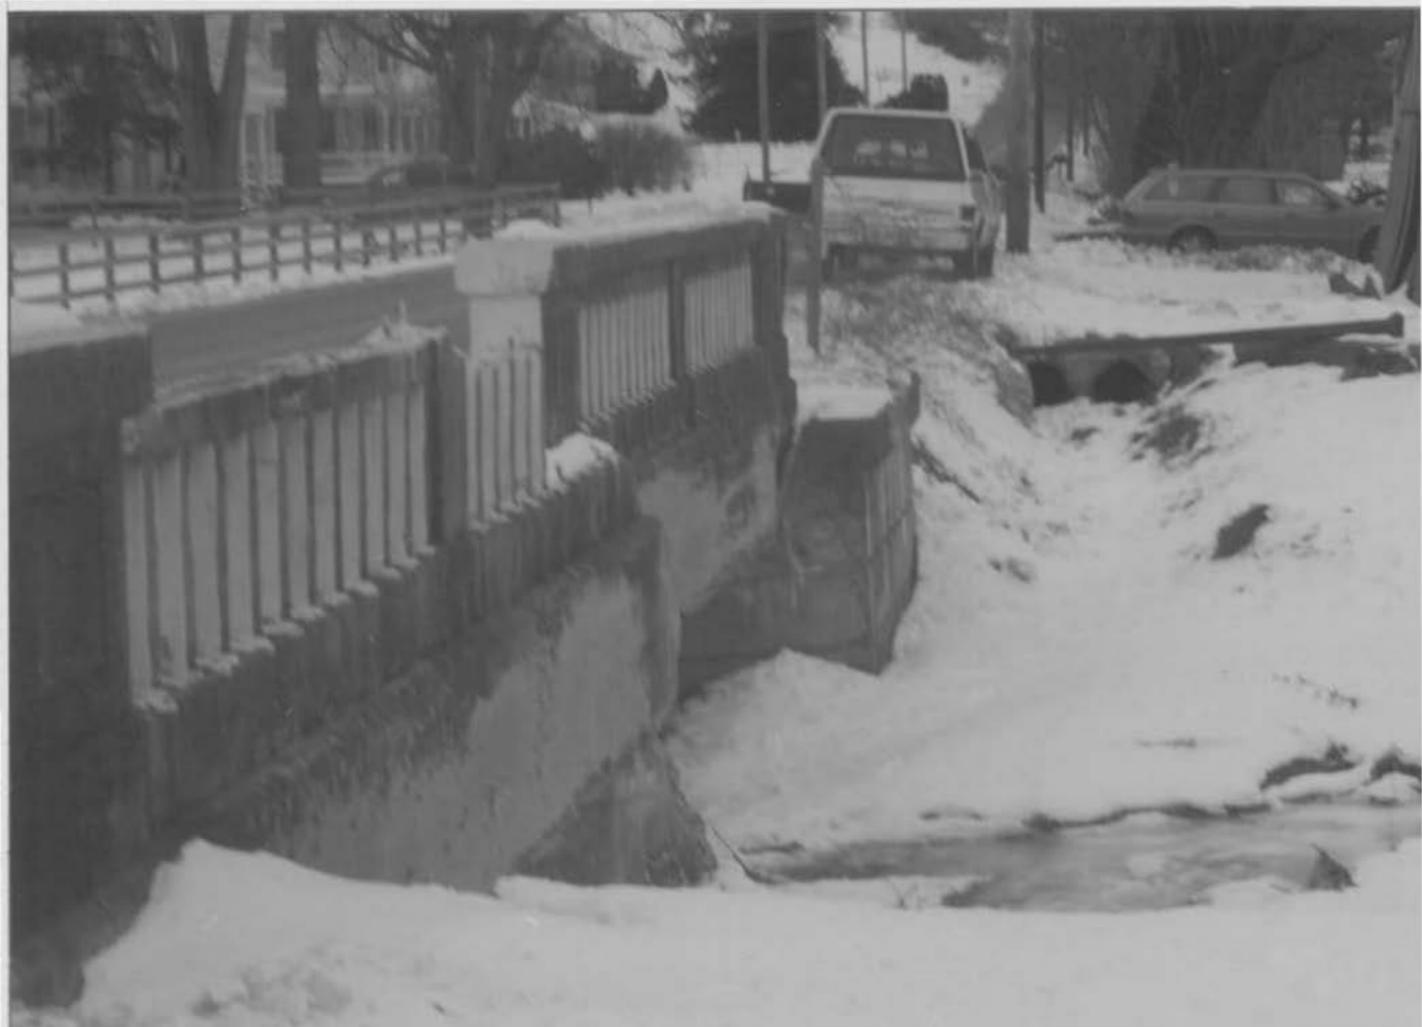
Number 8 34 of 35 8

Description DAMAGED PARAPET NORTH  
AND SHIFTED SLAB
