Maryland Inventory of Historic Properties number: G-U-A-179

Name: US 219 over Yonghiogheny River.

Maryland Inventory of Historic Properties
Historic Bridge Inventory
Maryland State Highway Administration
Maryland Historical Trust

SHA Bridge No. 11024 Name: US 219 over Youghiogheny River

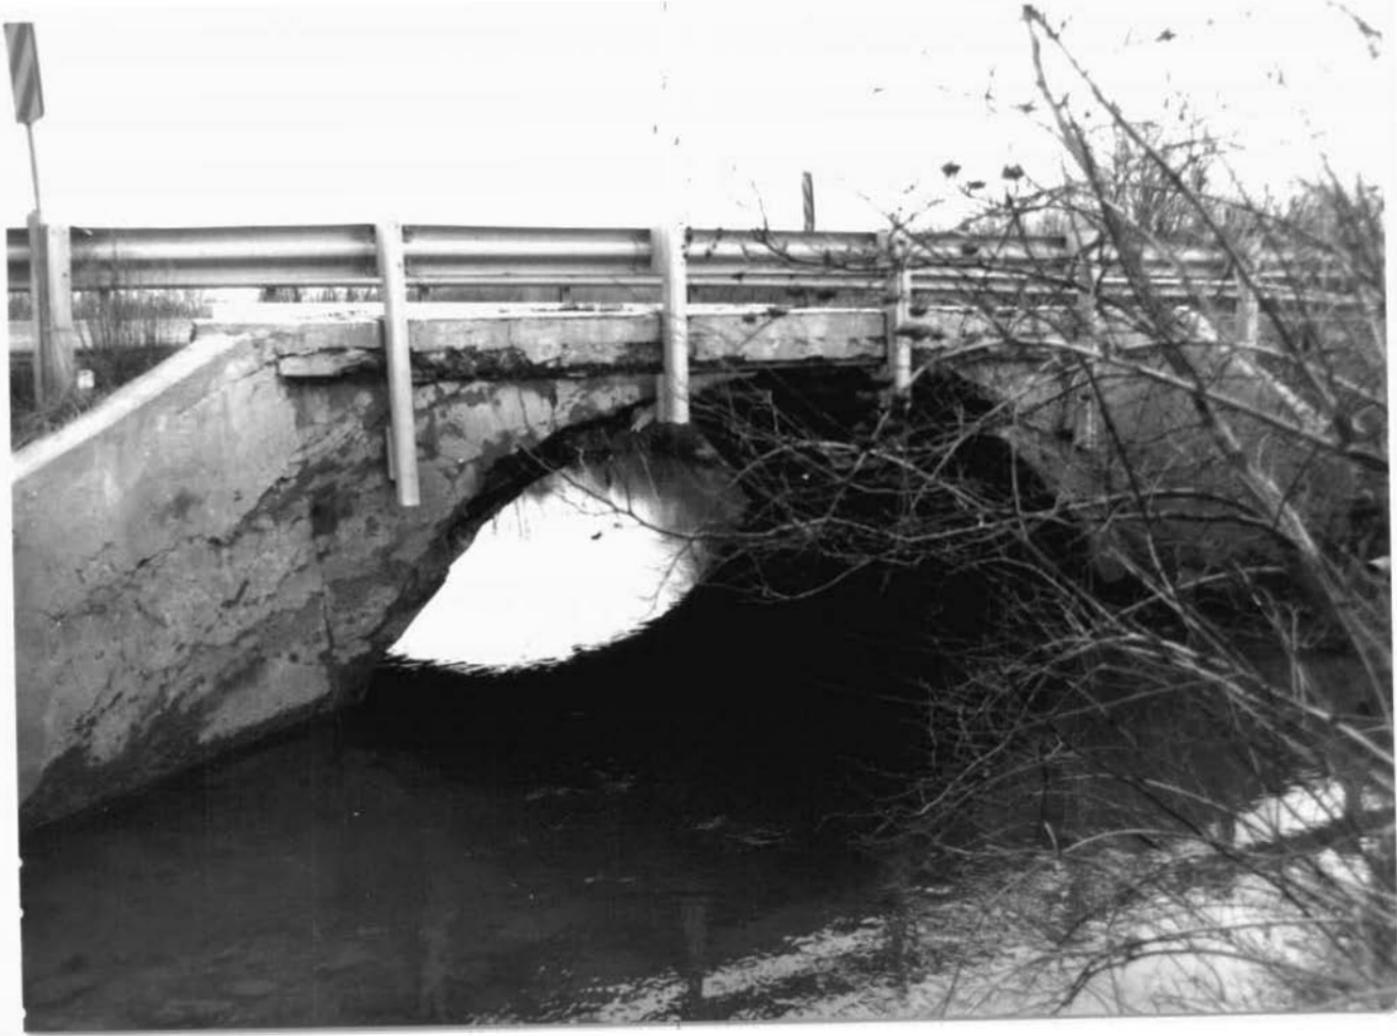
EAST ELEVATION (UPSTREAM)

In 1927 the original bridge was widened. At an unknown date the 1927 parapet walls were removed and replaced with a guardrail system. The upstream spandrel wall has been repaired with gunite.
