Maryland Historical Trust

Maryland Inventory of Historic Properties number: HA-1880

Name: GLENVIEW RD. OVER MILL BROOK

Maryland Inventory of Historic Properties
Historic Bridge Inventory
Maryland State Highway Administration
Maryland Historical Trust

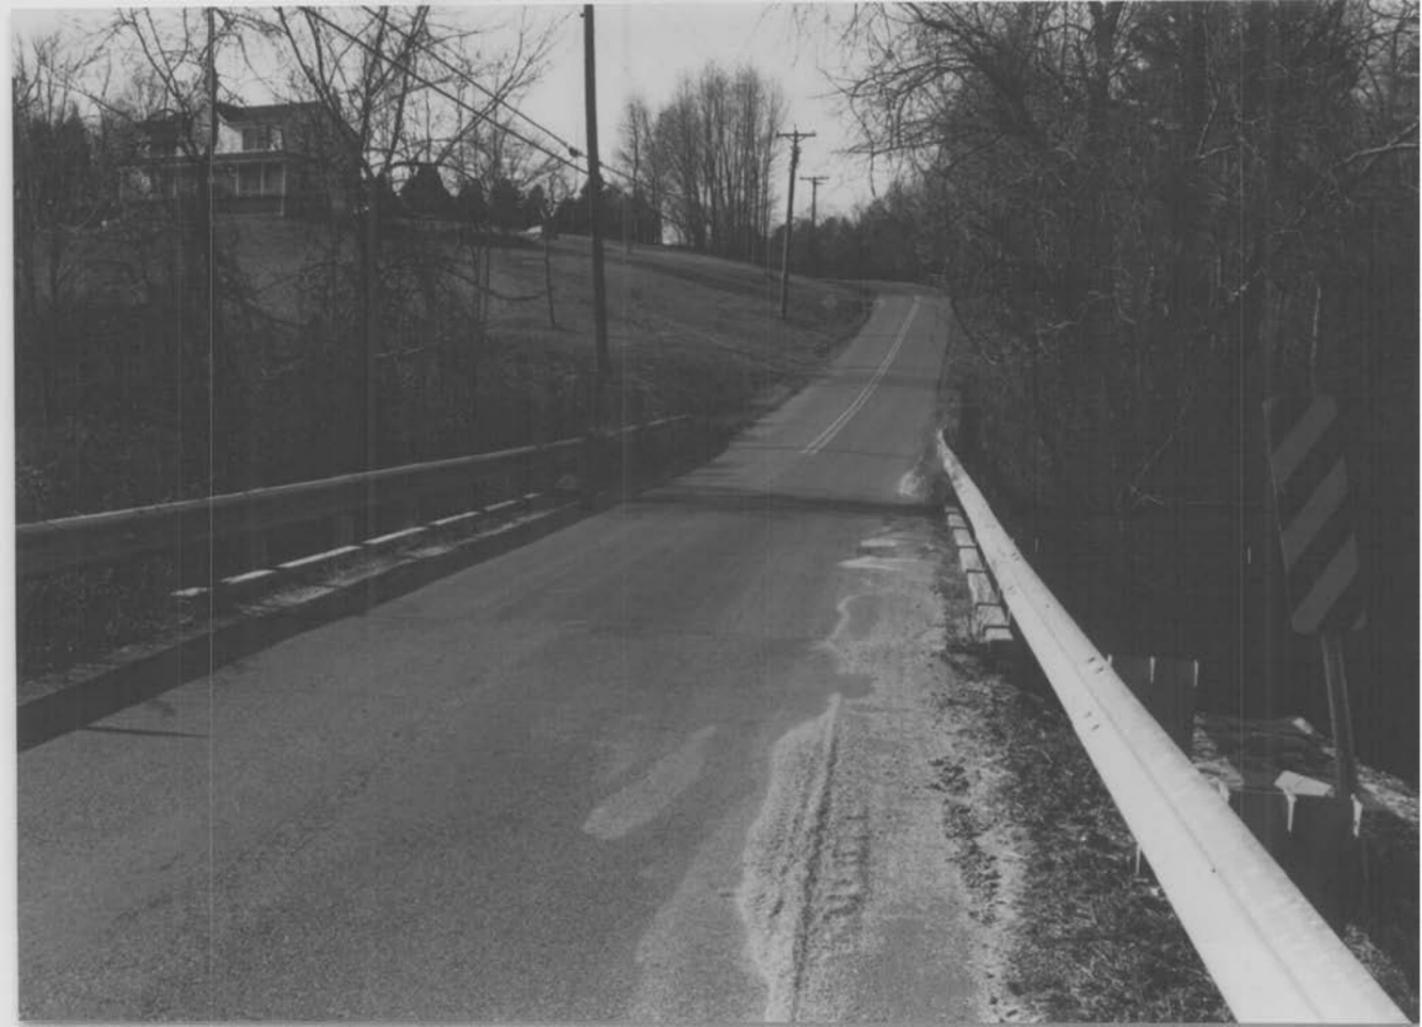
1/4

STATE HIGHWAY BRIDGE H30 OVER MILL
VIEW LOOKING WEST ON BRUK
GLENVILLE ROAD

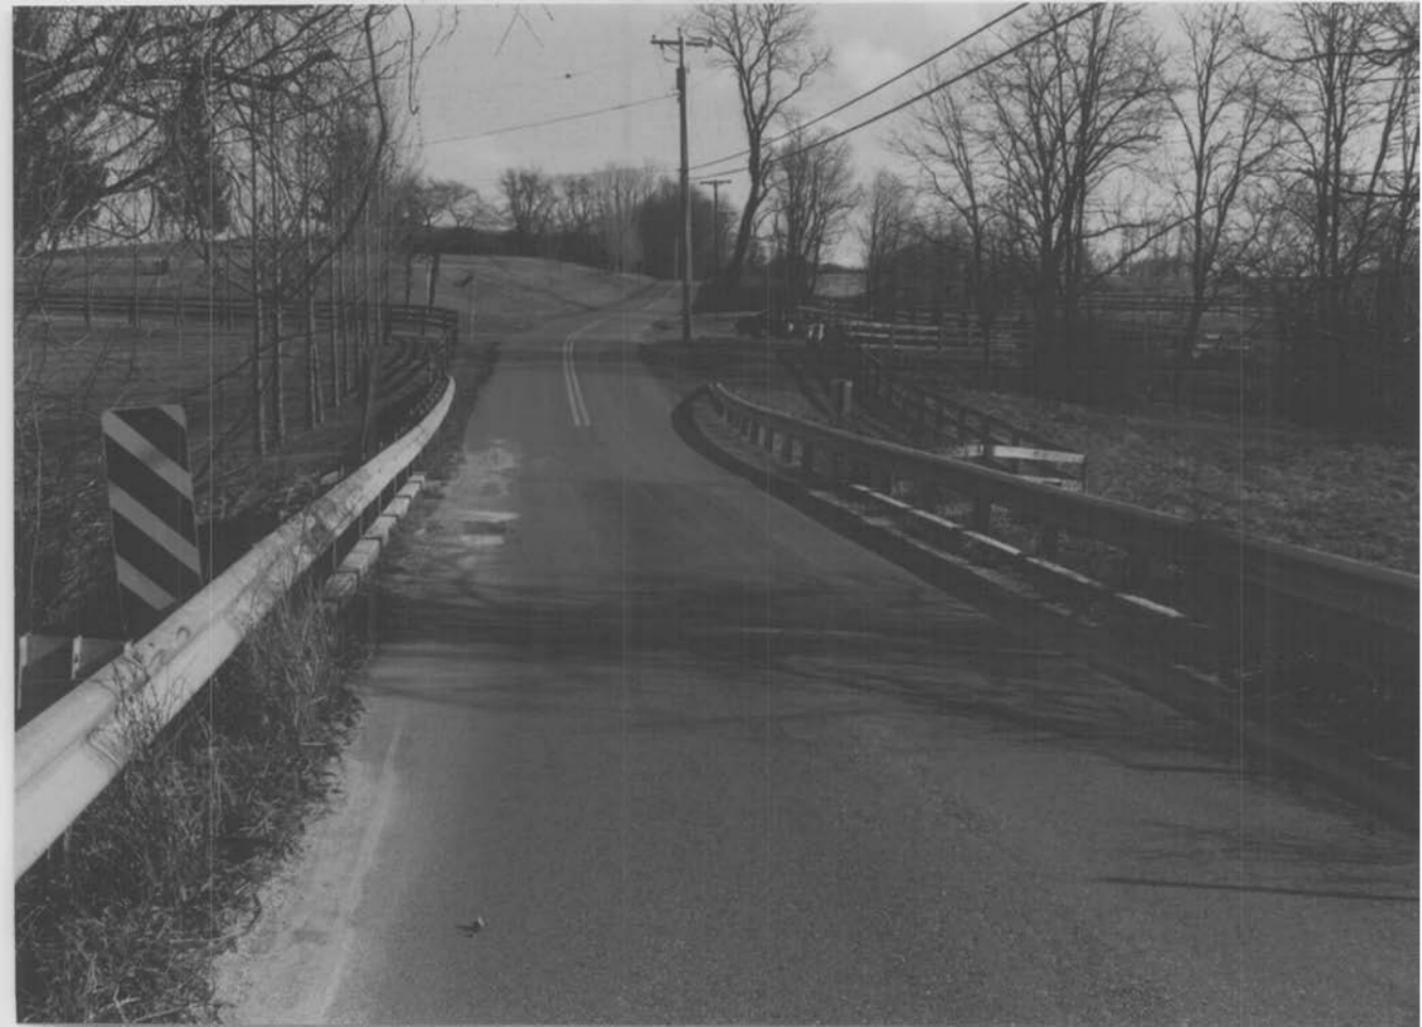
2/4

STATE HIGHWAY BRIDGE H30 OVER
VIEW LOOKING EAST ON MILL BROOK
GLENVILLE ROAD

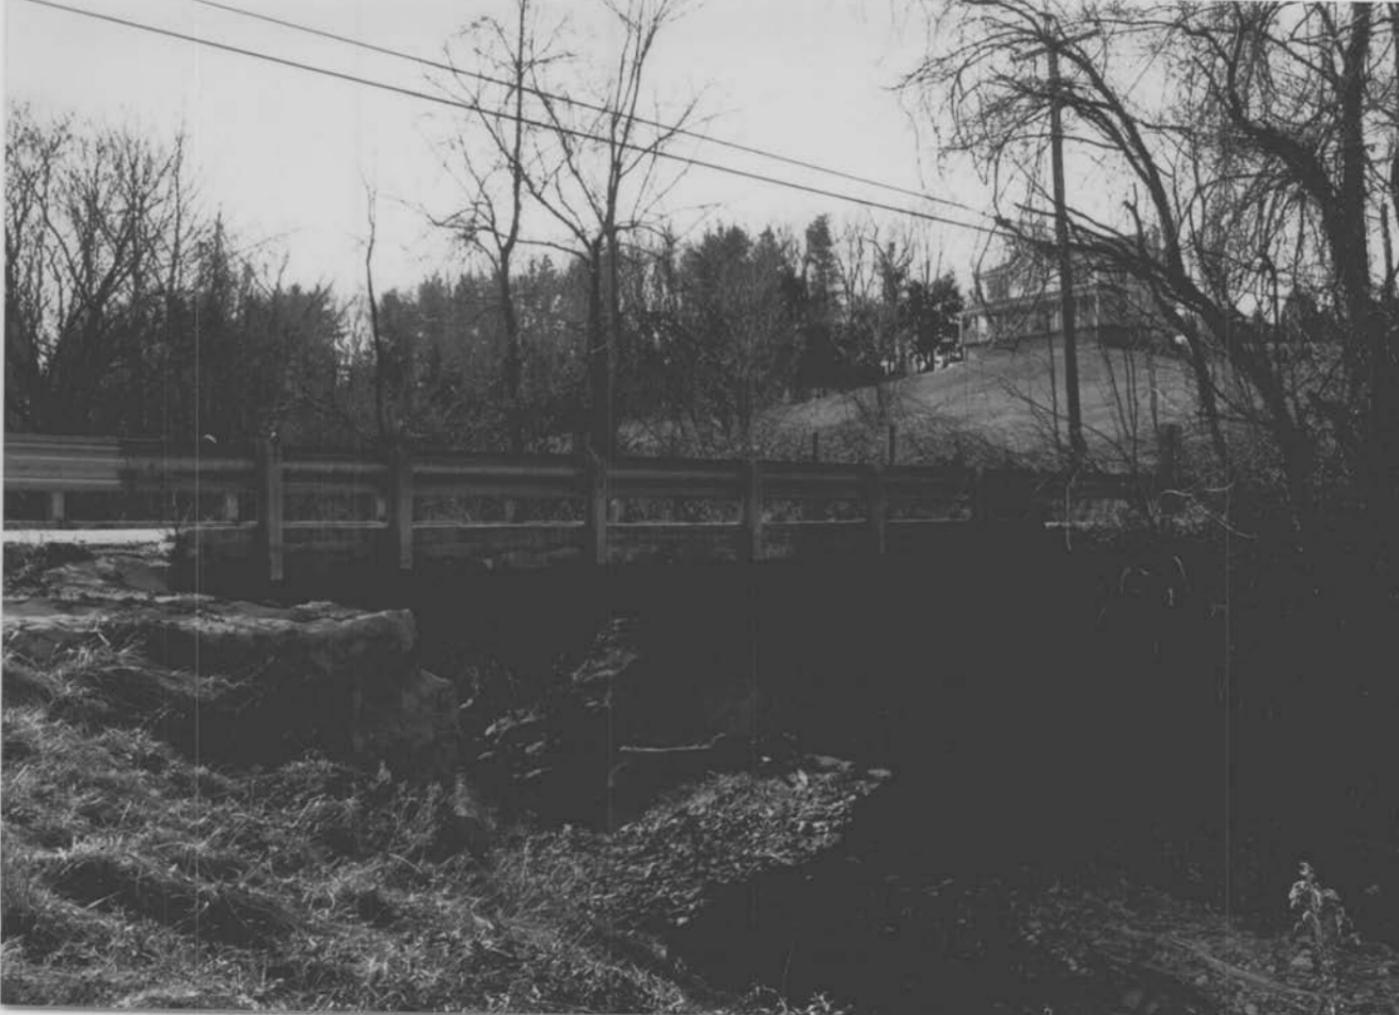
3/4

STATE HIGHWAY BRIDGE H30 OVER
VIEW LOOKING SOUTH MILL BROOK

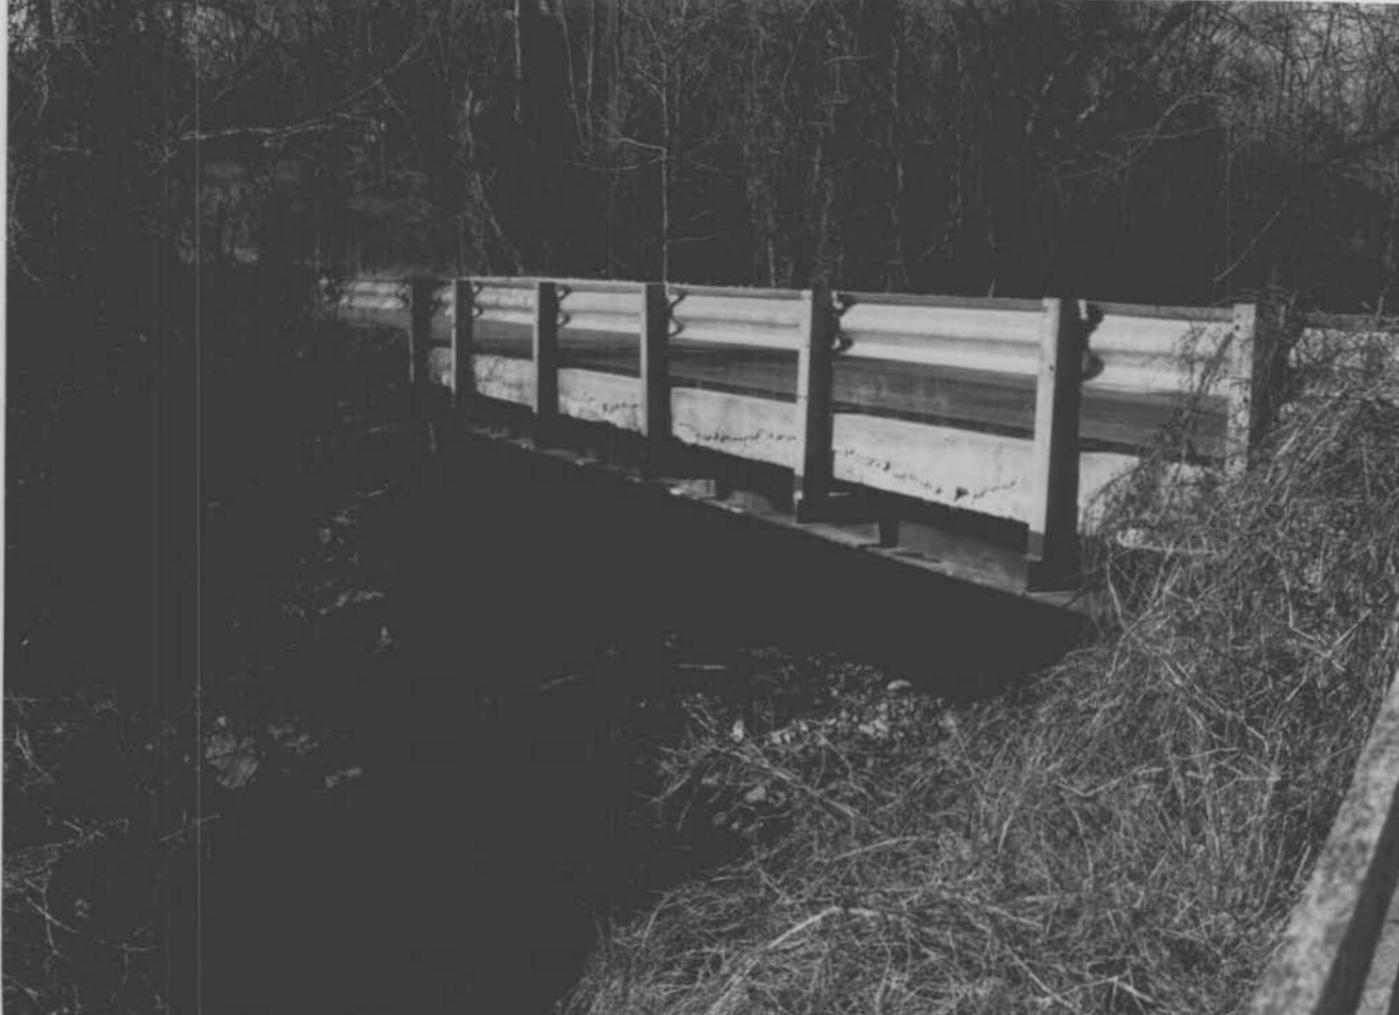
4/4

STATE HIGHWAY BRIDGE H30 OVER
VIEW LOOKING NORTH HILL BROOK
