Maryland Inventory of Historic Properties number: HA-1882

Name: Plumtree Rd. over Plumtree Run.

MHT Number HA-1882

Name and SHA No. H 50 over Plumtree Run

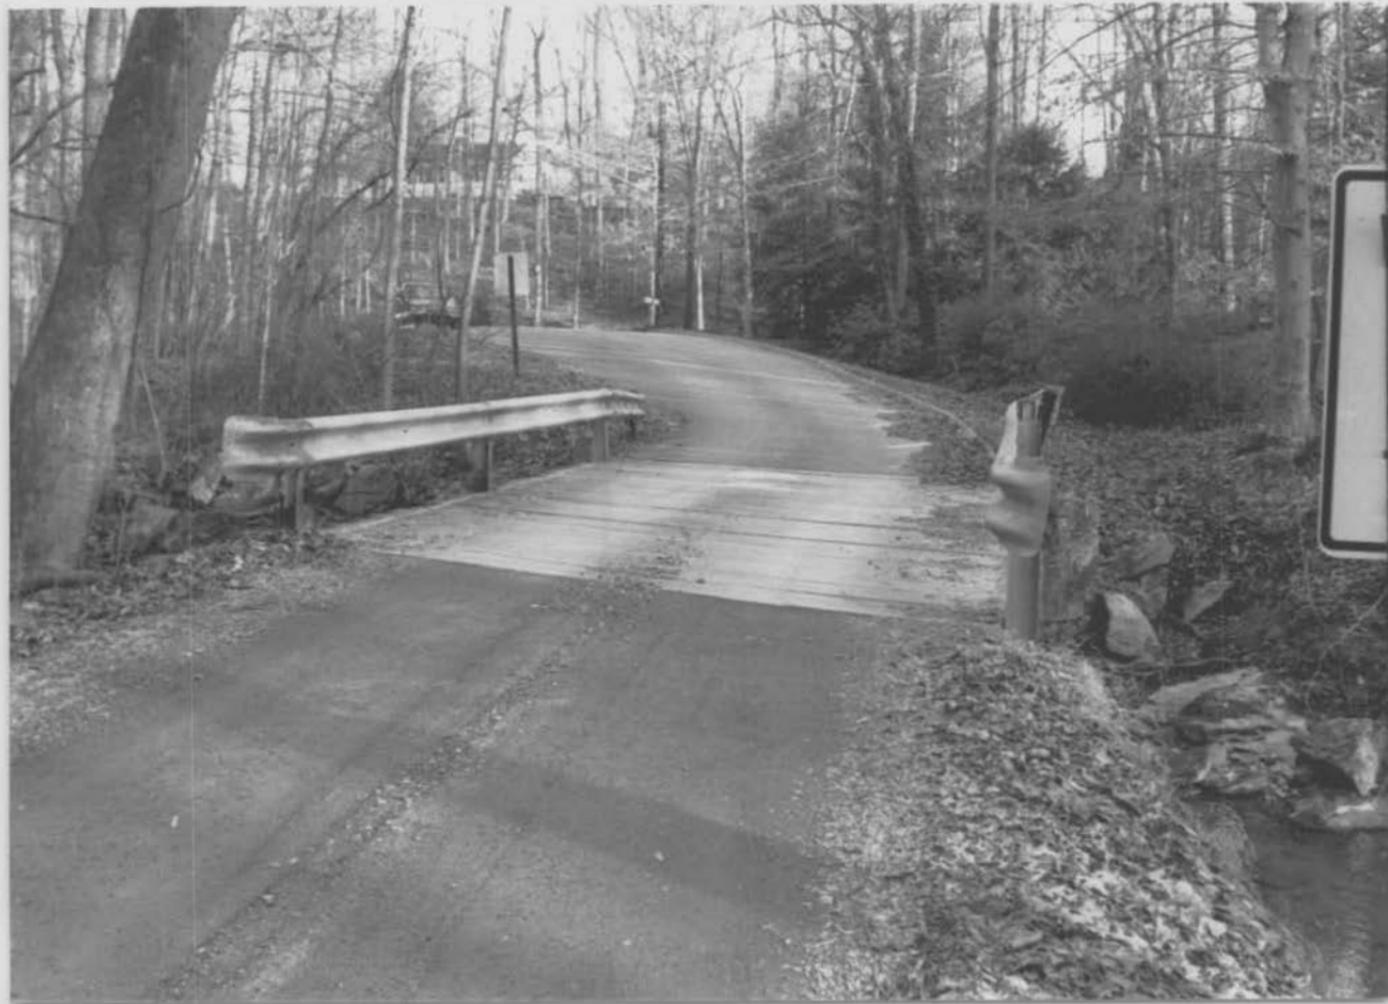
1/4

- BRIDGE NO. HSD OVER PLUM TREE RUN
- VIEW LOOKING EAST ON
PLUM TREE RD

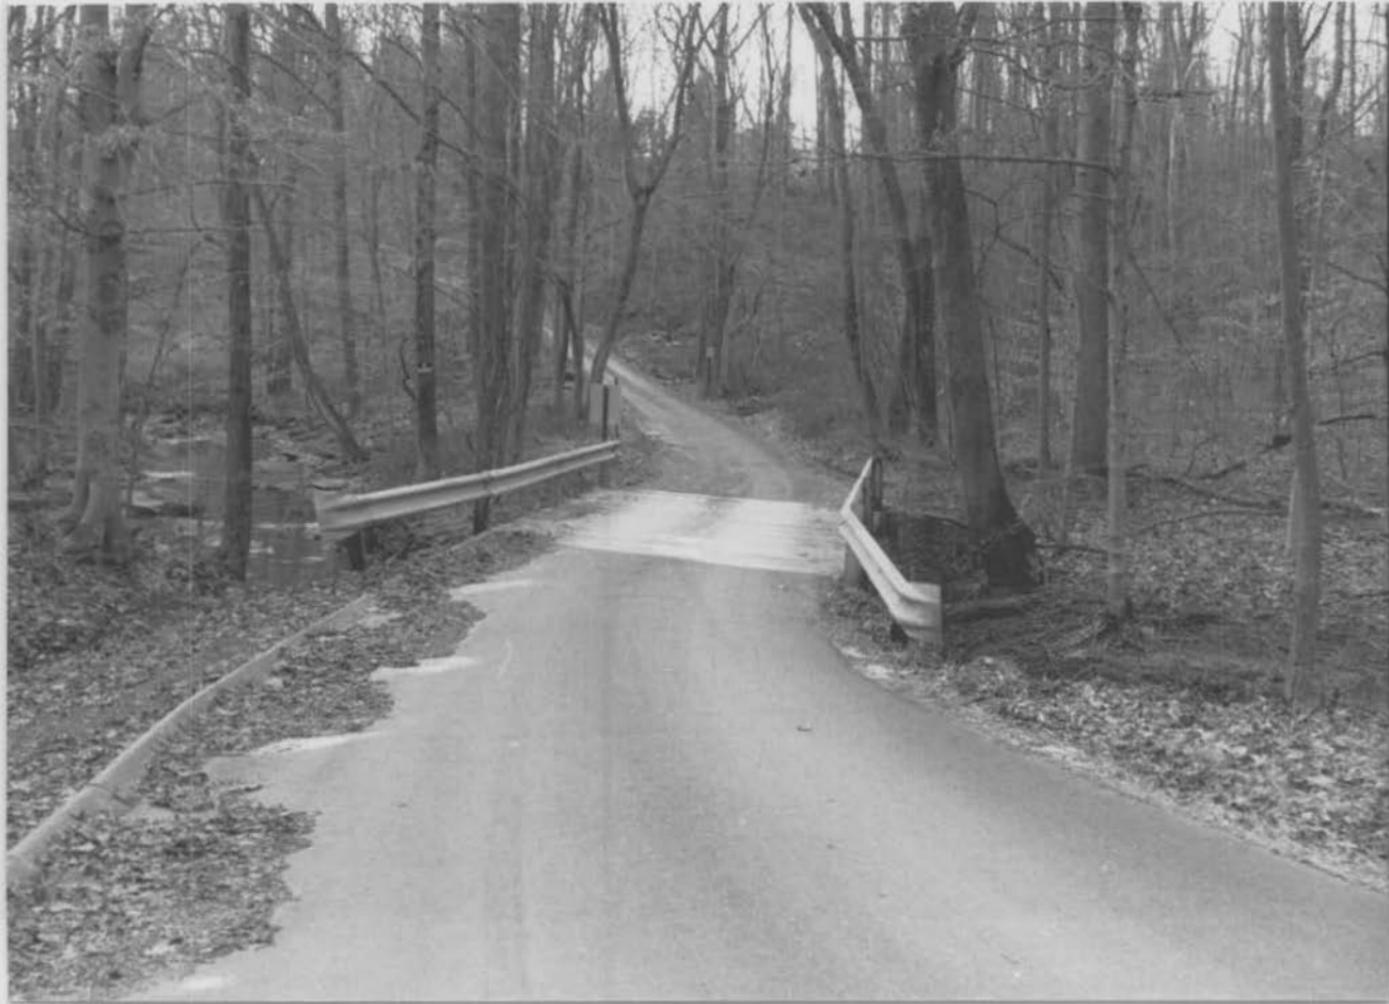
2/4

- BRIDGE NO. ~~H54~~ ^{H50} OVER PLUM TREE RUN
- VIEW LOOKING WEST ON PLUMTREE ROAD

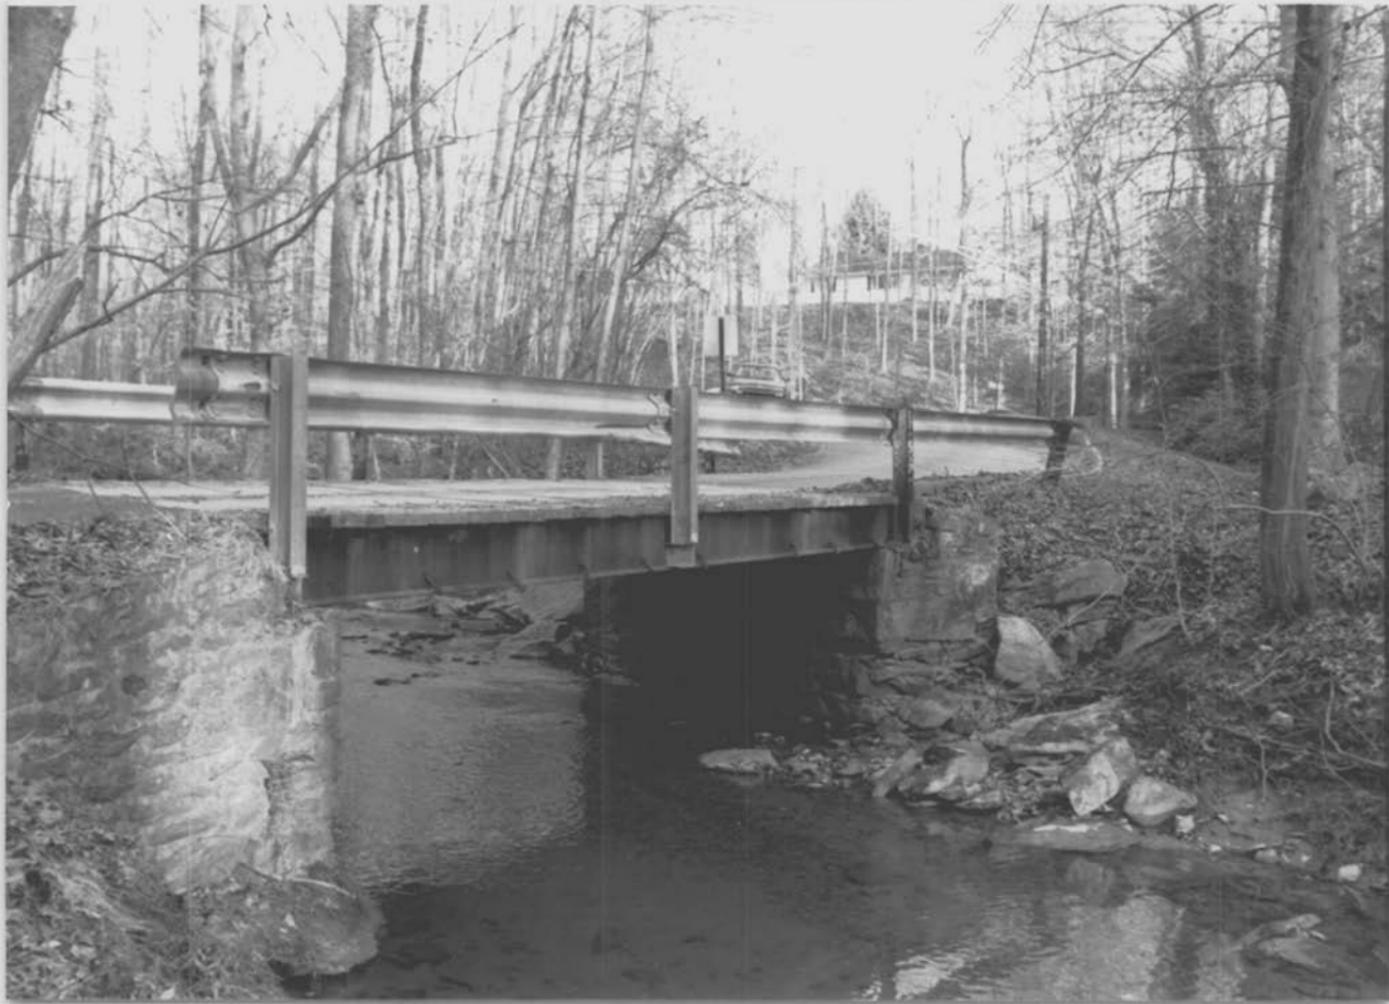
3/4

- BRIDGE NO. ~~150~~ OVER PLUMTREE RUN

- VIEW LOOKING SOUTH

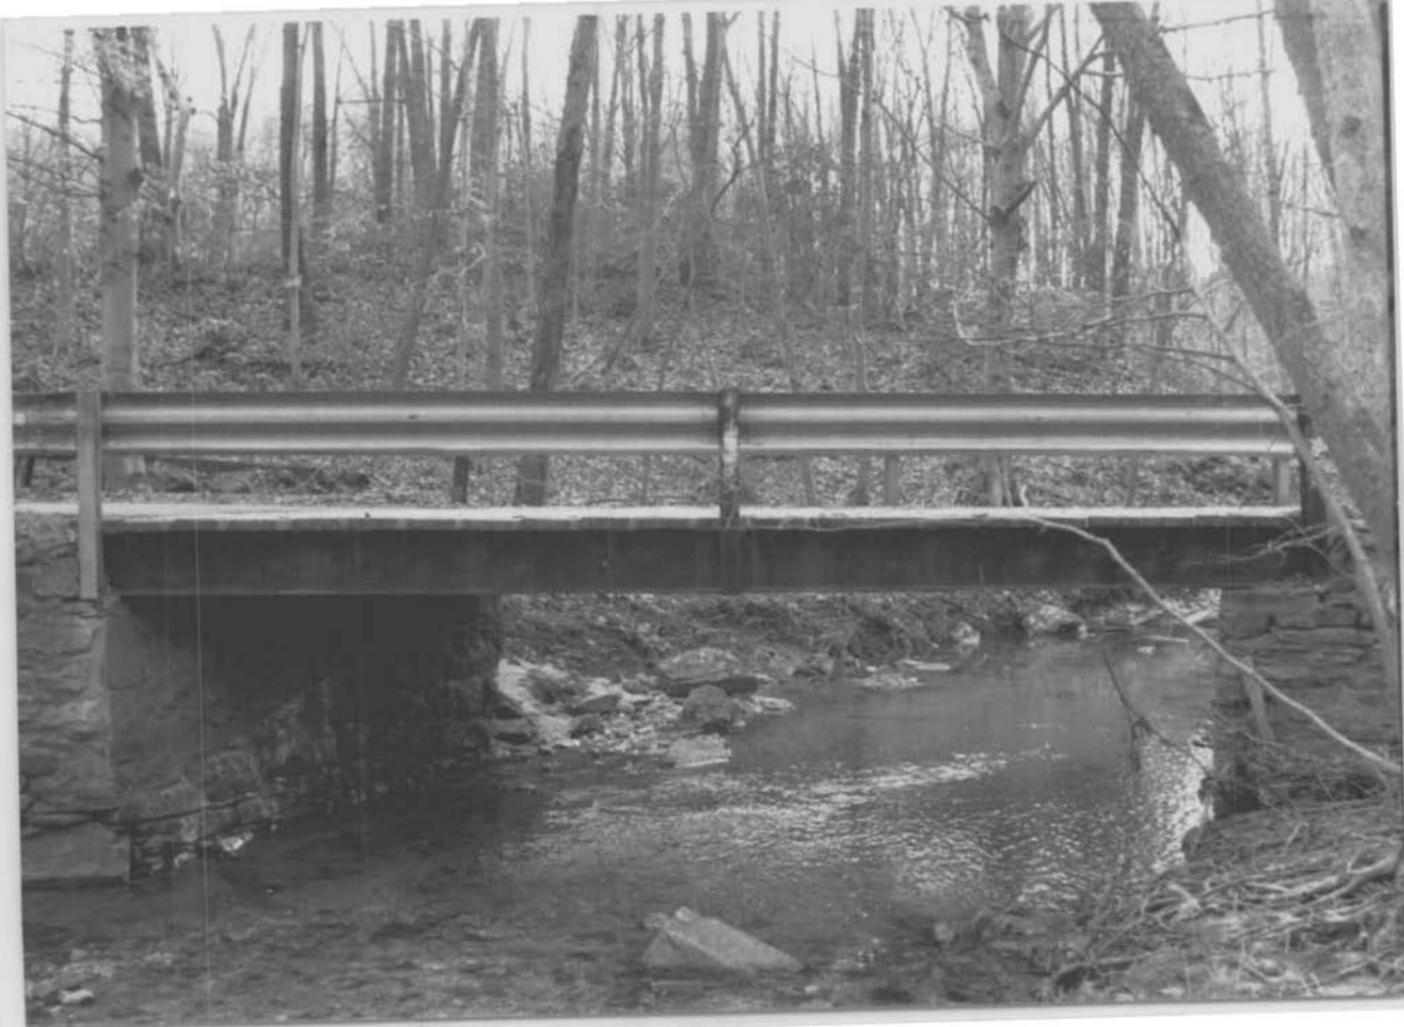
14/24

- BRIDGE NO ~~1882~~ OVER PLUM TREE RUN
- VIEW LOOKING NORTH
