Inventory Number: HA-1989
Hitchcock/Davis Farm
Harford County, Maryland
C. Mazurek
12/28/99

Maryland Inventory of Historic Properties Form

Survey No. HA-1989

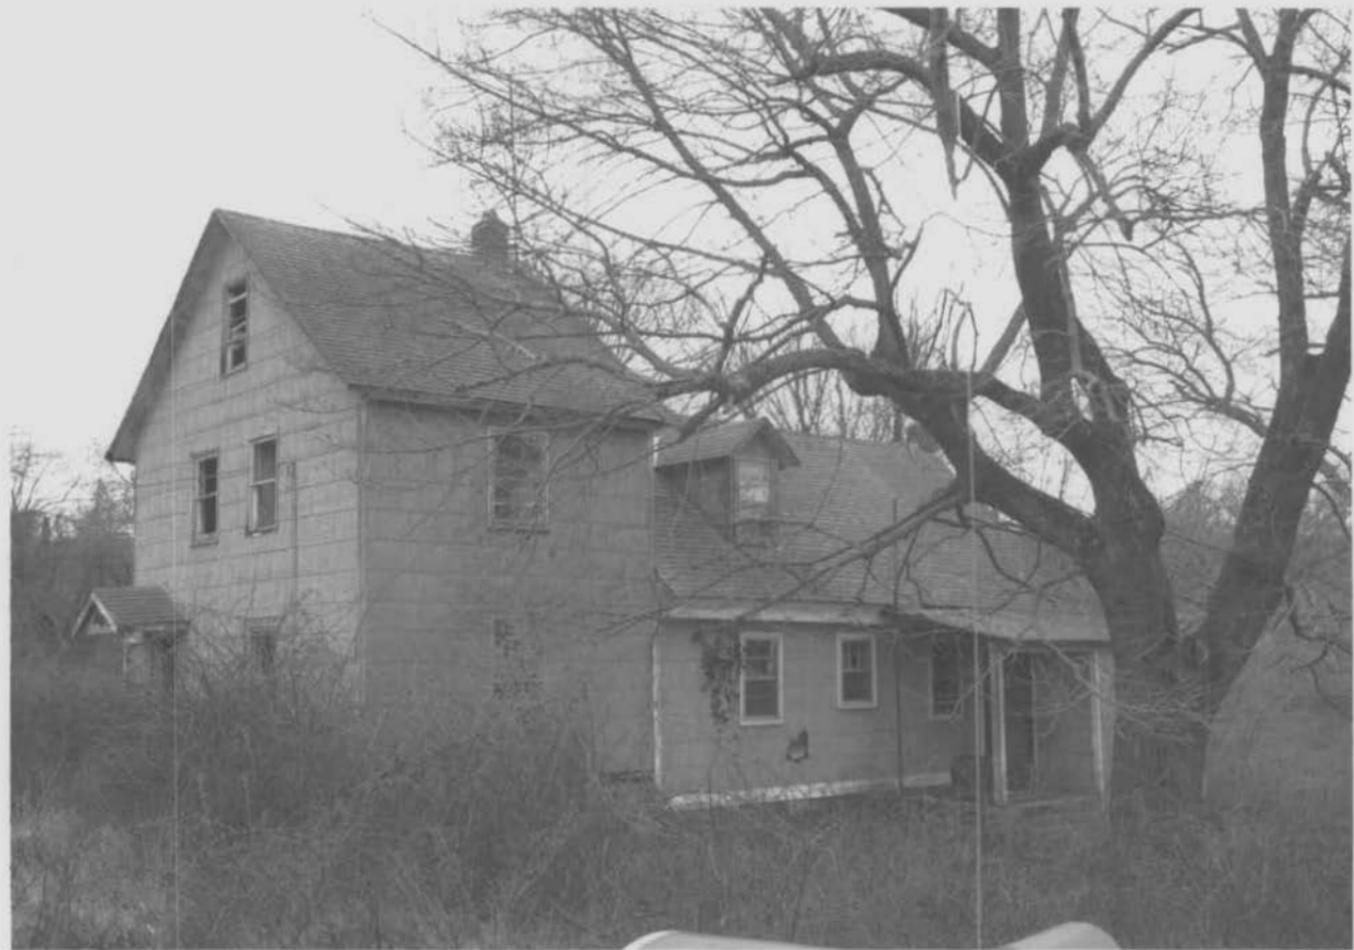
1 OF 2

The newer section is three-stories tall, has frame construction, and has a stone foundation with a thin covering of concrete. Asbestos shingles cover the exterior, while the interior has a covering of plaster and lath. The roof is covered with composition shingles, and has open eaves with exposed rafters. A cinderblock interior chimney is positioned on the ridge of the west side of this addition's roof. Windows are all 1/1 double-hung sash, with wooden sills and lintels, and most of the glass is missing due to vandalism. A simple entrance porch is located on the front (east) facade, that has no pillars or supports. Upon entering the structure from this doorway there is a living room to the right, and a staircase to the left that leads to two upstairs bedrooms and an attic. No basement is located underneath this addition, however major structural elements are still visible because vandals have removed the floorboards in the living room exposing split log floor joists. These joists still have bark on the undersides and appear to be pine. Interior window and door trim is simple, with decoration very sparse.

DEPT. OF NATURAL RESOURCES
FARMHOUSE, N.E. ELEVATIONS

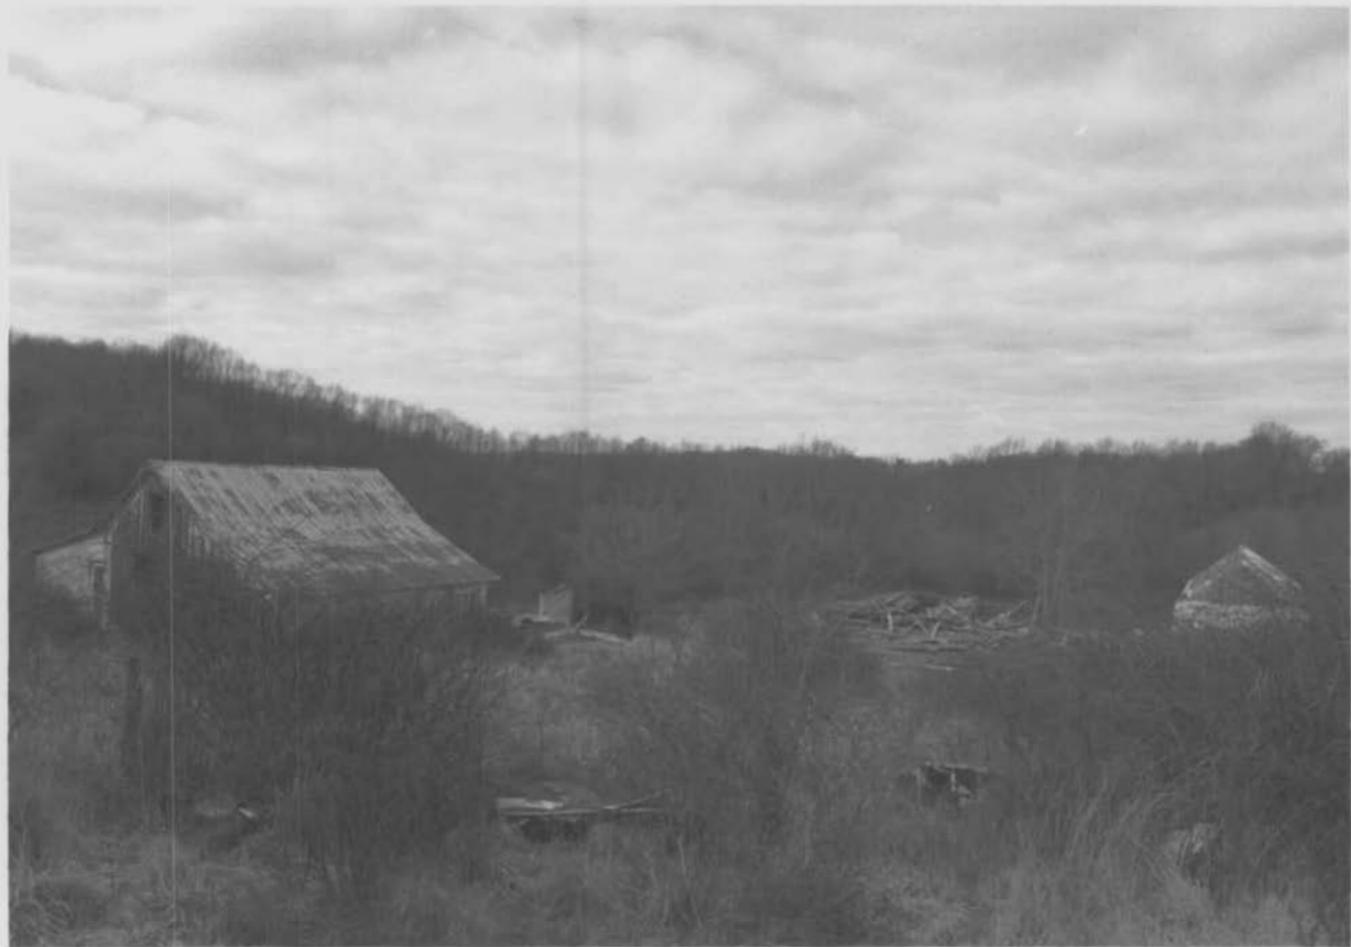
2 OF 2

The bank barn is constructed of wood frame, with a fieldstone foundation, and covered with vertical wood siding and a metal roof. On the west facade is an addition, with particle board siding, and a cinderblock foundation. It appears to be in good condition, and structurally sound.

The dairy barn is constructed of vertical wood siding with a concrete pad foundation. A metal roof is now half removed on the west facade, and most of the side walls are missing. Overall the structure is in very deteriorated condition.

VIEW OF BARNS; FACING NORTH
