HISTORIC PRESERVATION CERTIFICATION APPLICATION
REQUEST FOR CERTIFICATION OF COMPLETED WORK

1. Name of property: Burgess Tenant House (Burgess Estate Complex)(Sam Caplan House)
Address of property: Street 8454 Main Street
City Ellicott City County Howard State Md Zip 21043
Is property a certified historic structure? yes no If yes, date of certification by NPS: 4/29/88
or date of listing in the National Register: _____

2. Data on rehabilitation project:
National Park Service assigned rehabilitation project number: 1023MD
Project starting date: March 1987
Rehabilitation work on this property was completed and the building placed in service on: November 1987
Estimated costs attributed solely to the rehabilitation of the historic structure: \$ \$39,430.00
Estimated costs attributed to new construction associated with the rehabilitation, including additions, site work, parking lots, landscaping: \$ \$ 5,523.10

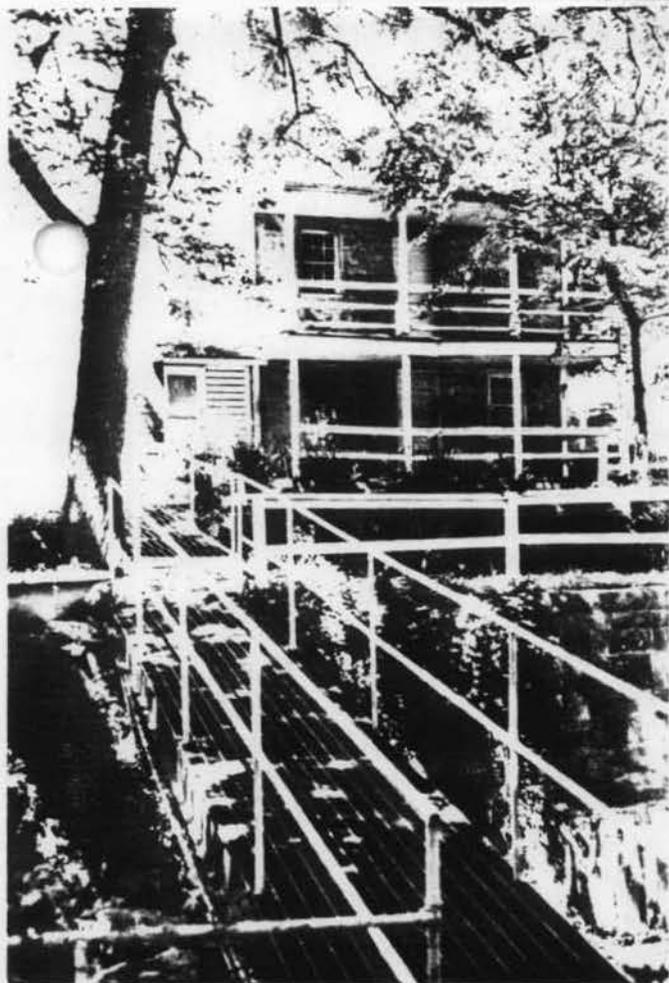
Fig A Early 19th c stone house
with Victorian wood addition to left.
Looking across from millrace (south
elevation)

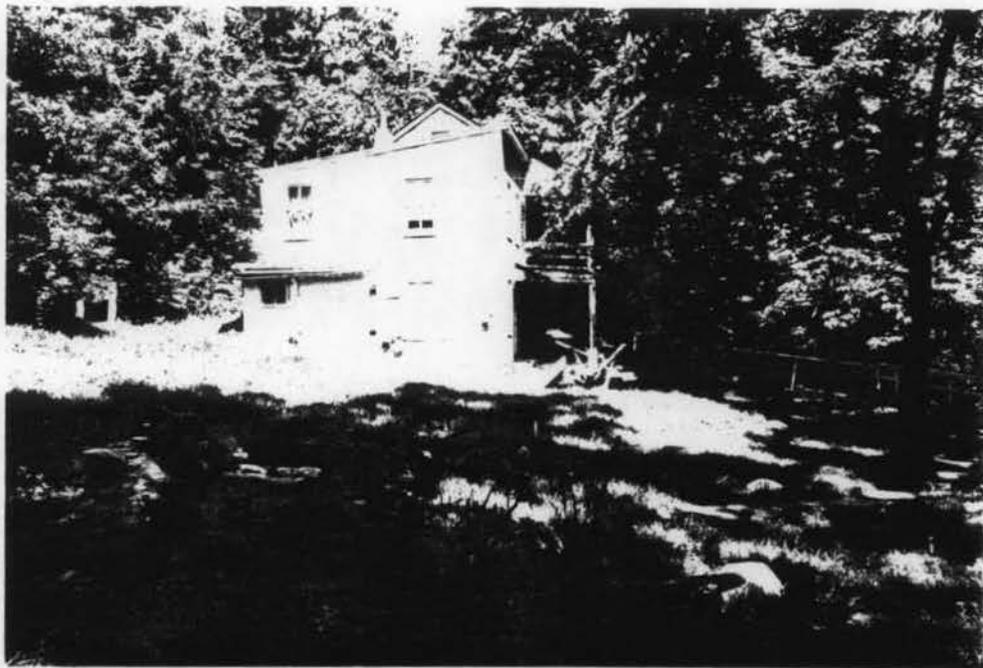
Fig B West elevation showing Victorian
wood addition and recent mud room.
Foundations in foreground are remains
of a small kitchen or storage building

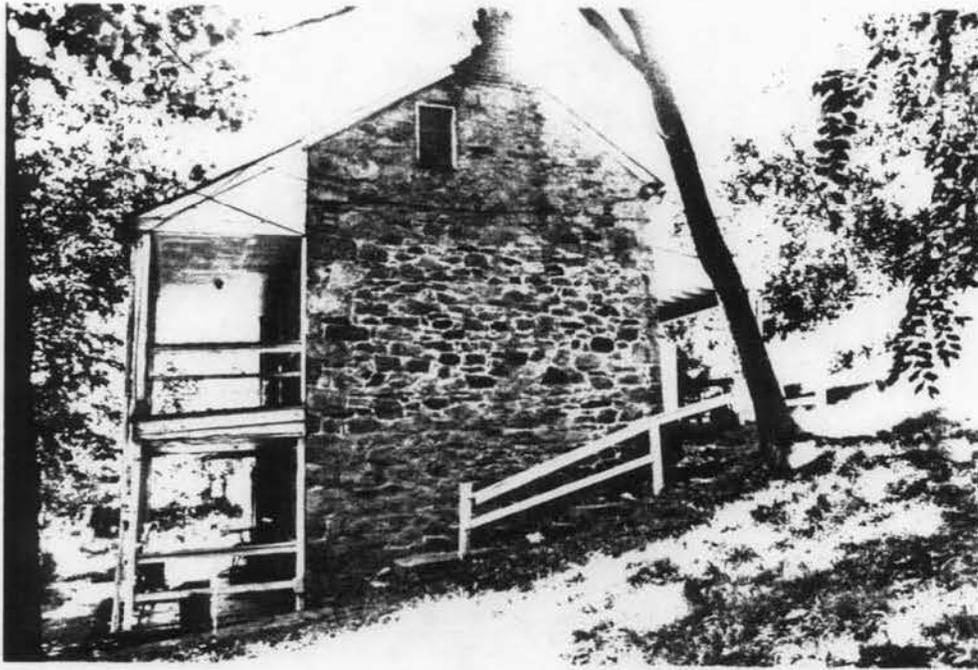
Fig C East elevation showing two-story front porch and one-story rear porch.

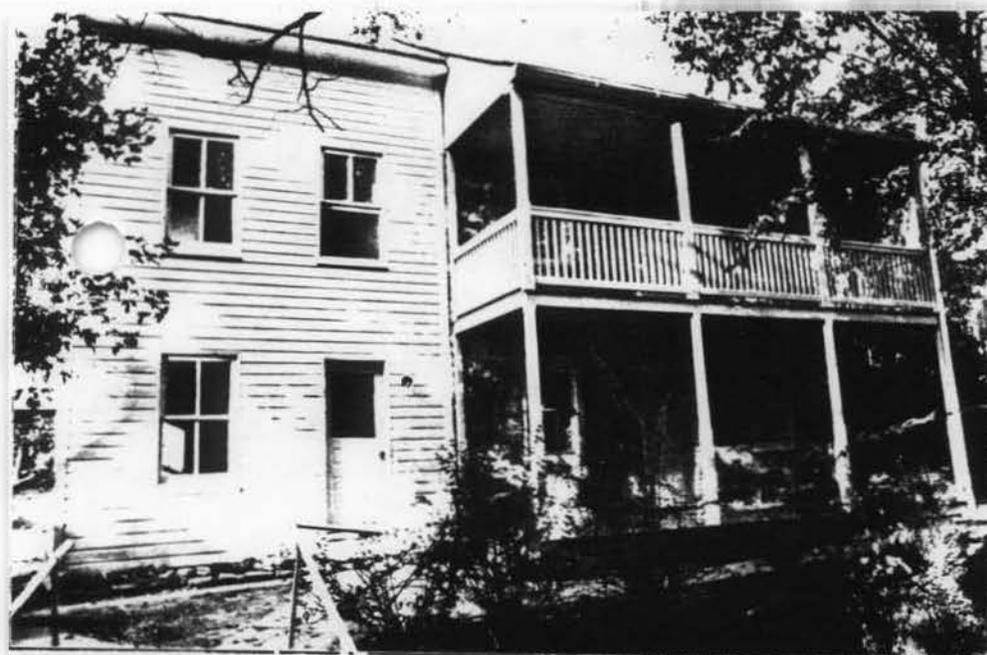
Fig. 1 Front Facade -- porch posts and railings rebuilt based on hist. photo. Doors and windows repaired and along with siding repainted. No site work around the tenant house was done.

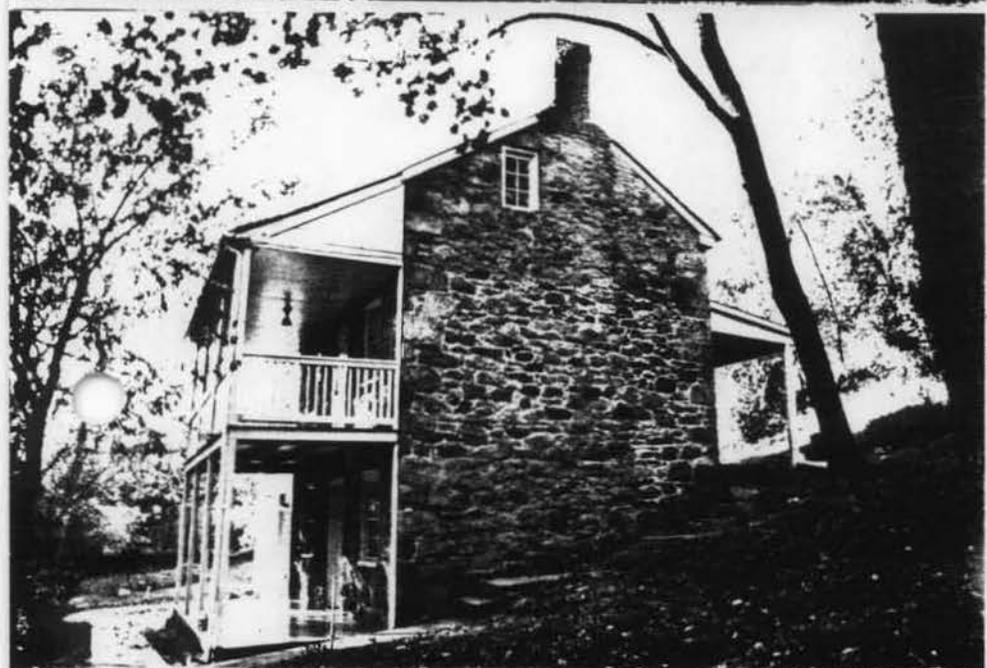
Fig. 2 Window screen and wood rail by side steps removed. Chimney work was not done -- chimney exists as pre-rehab. East side elevation.

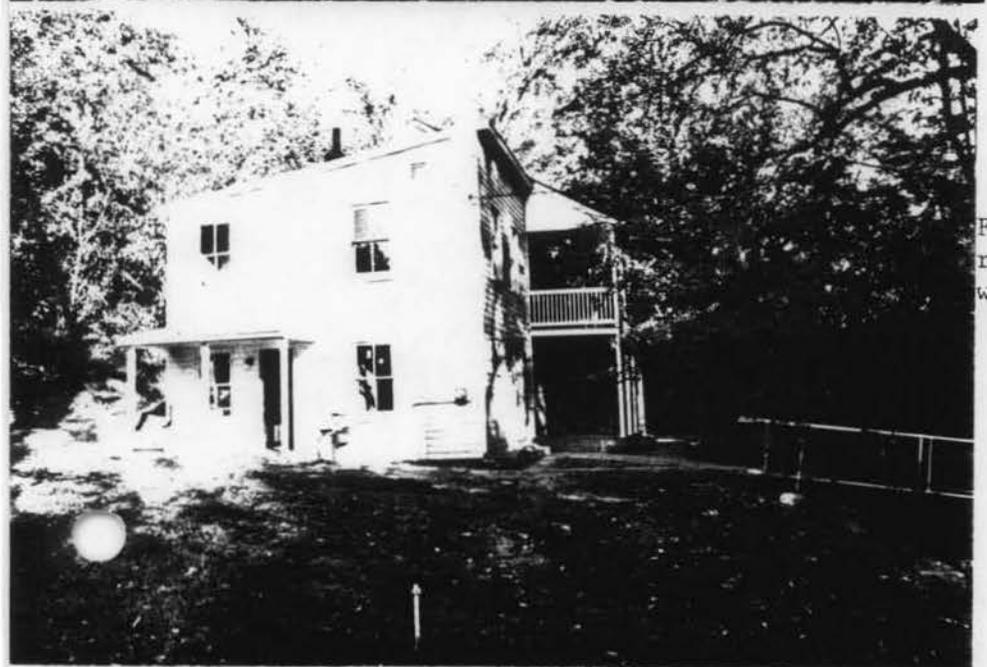
Fig. 3 Mud room porch enclosure of recent vintage was removed. Siding was repainted. West side elevation

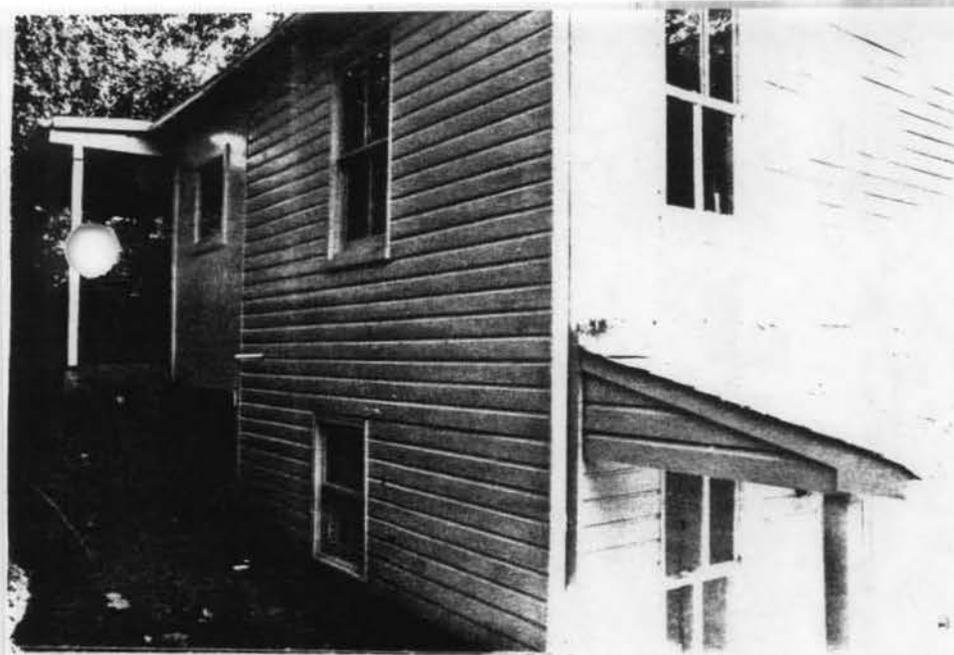
Fig. 4 Rear elevation. Siding was installed where missing and all was painted. Windows repainted.

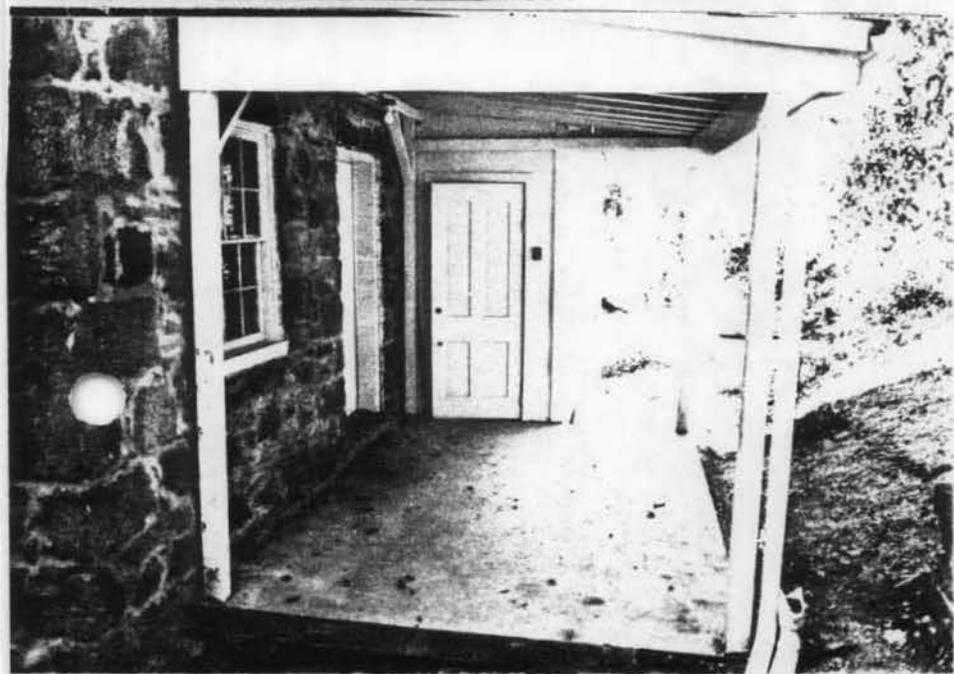
Fig. 5 Rear elevation. Partial 1970s porch enclosure was removed. Missing columns installed. Doors repainted.

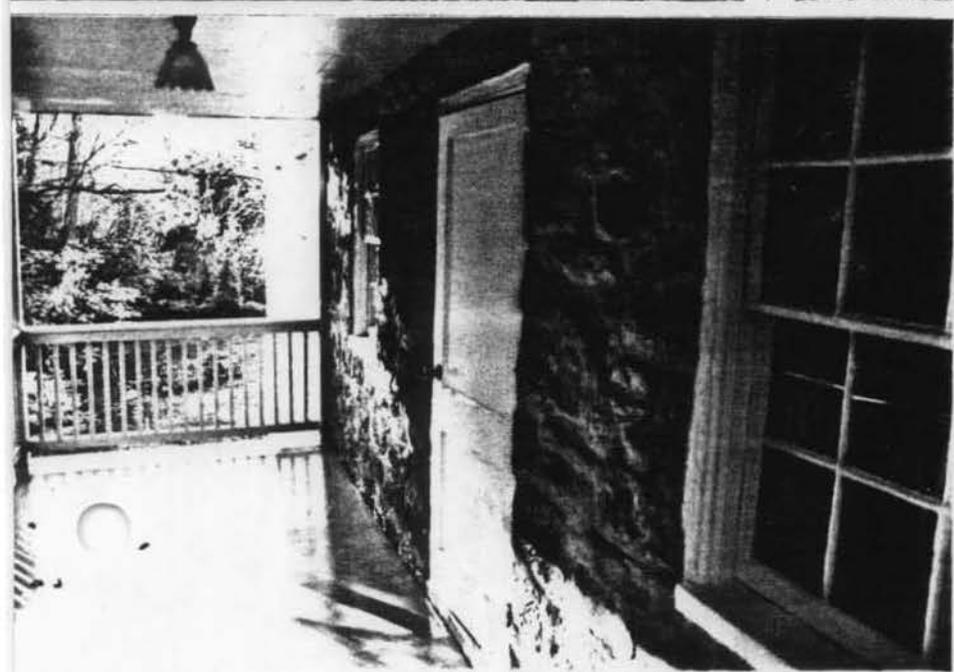
Fig. 6 Front elevation -- second floor. New flooring and wood ceiling to replace deteriorated one-- matches historic. Existing door retained.

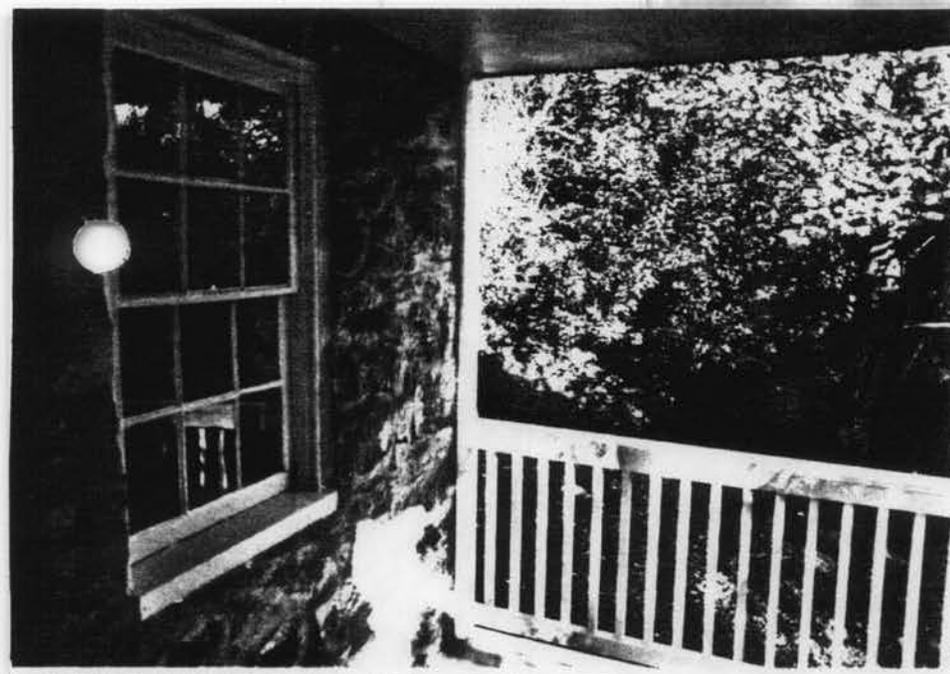
Fig. 7 Front elevation -- second floor. Original windows retained and repaired throughout the bldg.

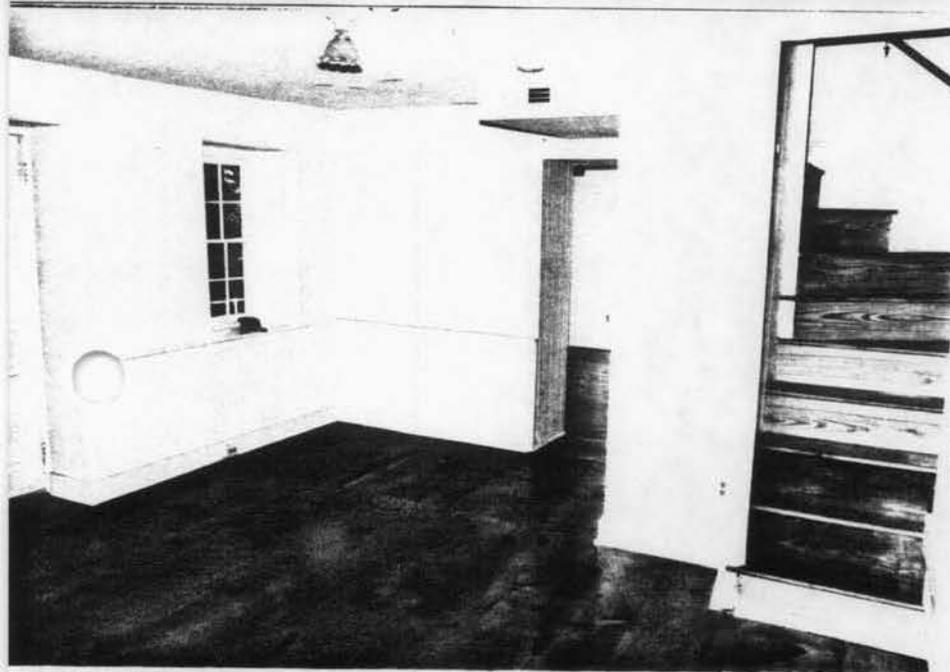
Fig. 8 Living room on first floor. 1950s partitions removed. Floors patched and refinished. Wainscoting retained. Walls are a mix of plaster sections and drywall depending upon pre-rehab condition and new work required. Stairs and doors retained and repainted.

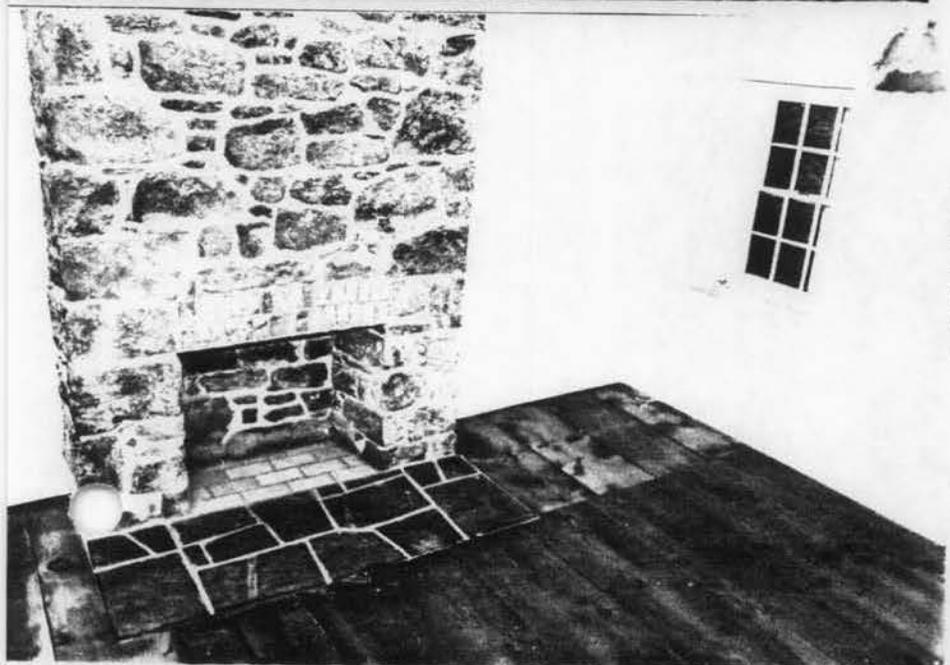
Fig 9. Living room on first floor. 1950s partitions removed along with 1920s alterations. Existing fireplace was restored by removing 1920s enclosure. Stone was repointed using soft mortar as existed.

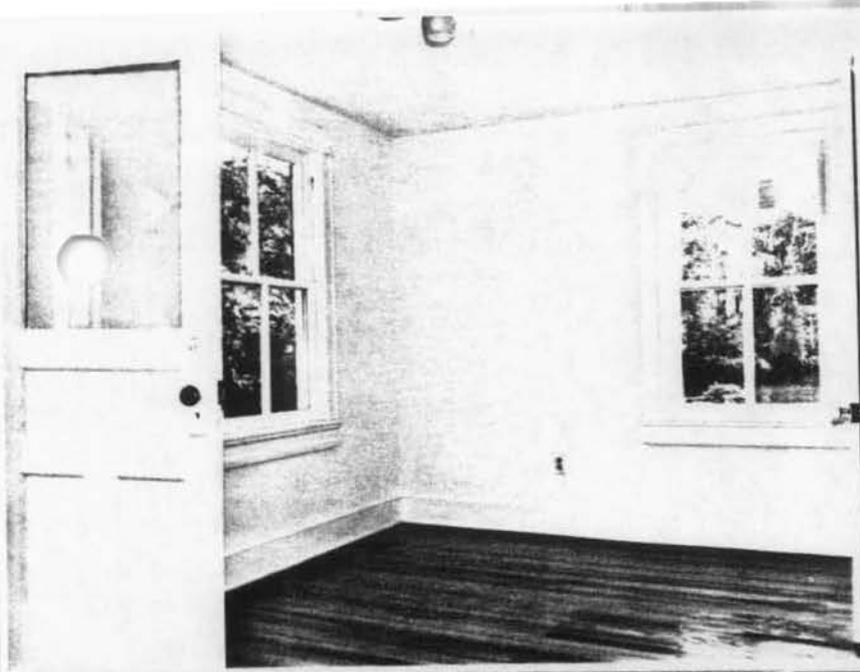
Fig. 10 Victorian wing--first floor
Front door retained; new drywall
replaced patchwork of drywall and
plaster. Floors refinished; window
and door trim saved and repainted.

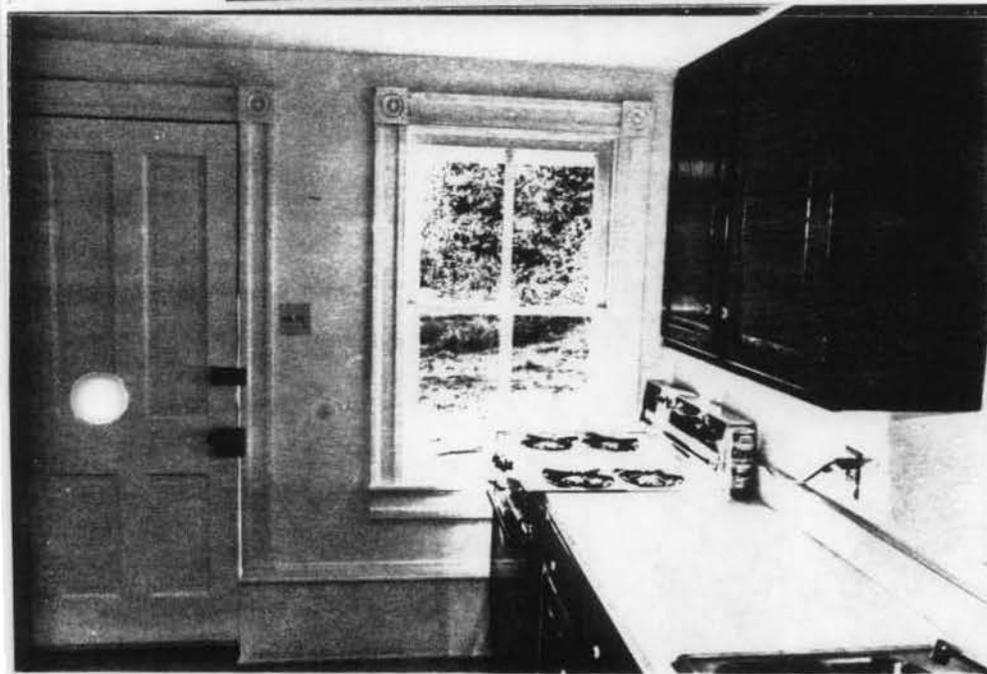
Fig. 11 Victorian wing--first floor
rear portion. New kitchen installed.
Existing door and window onto mudroom
retained and now visible from exterior.

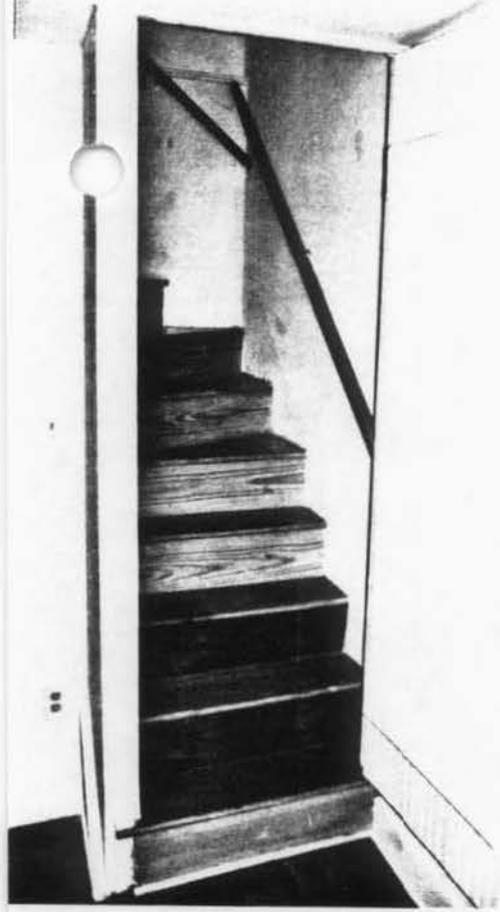
Fig. 12 Stairs from first floor of stone house to second floor retained. A number of the treads were replaced due to damage, wear and rot. Existing door retained.

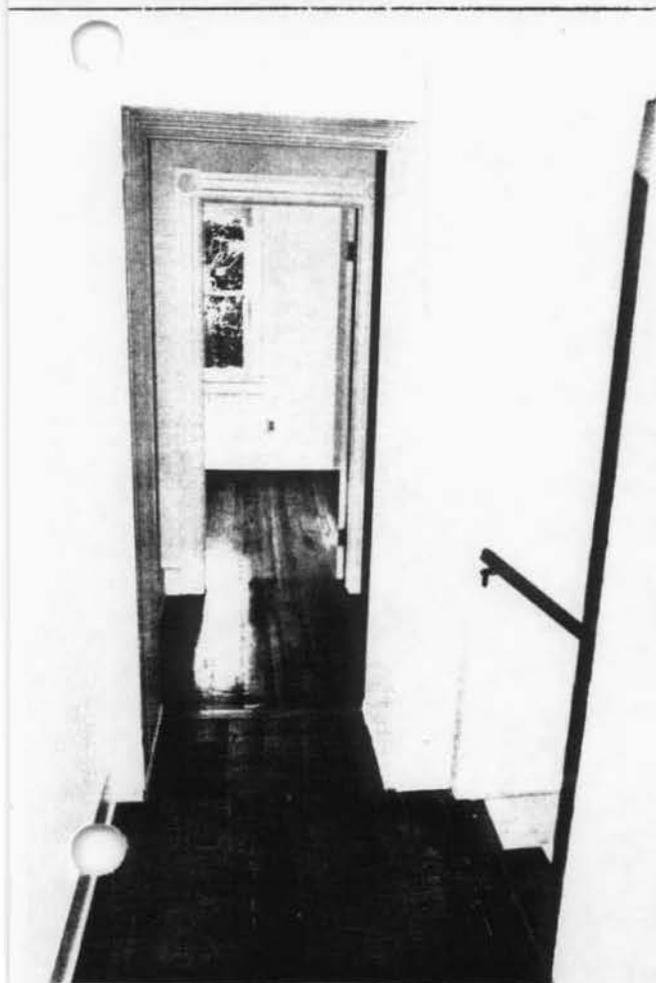
Fig. 13 Stairhall on second floor of stone house. Floor refinished and 1950s alterations removed; walls repaired and reconstructed. Looking from stairs to Victorian wing.

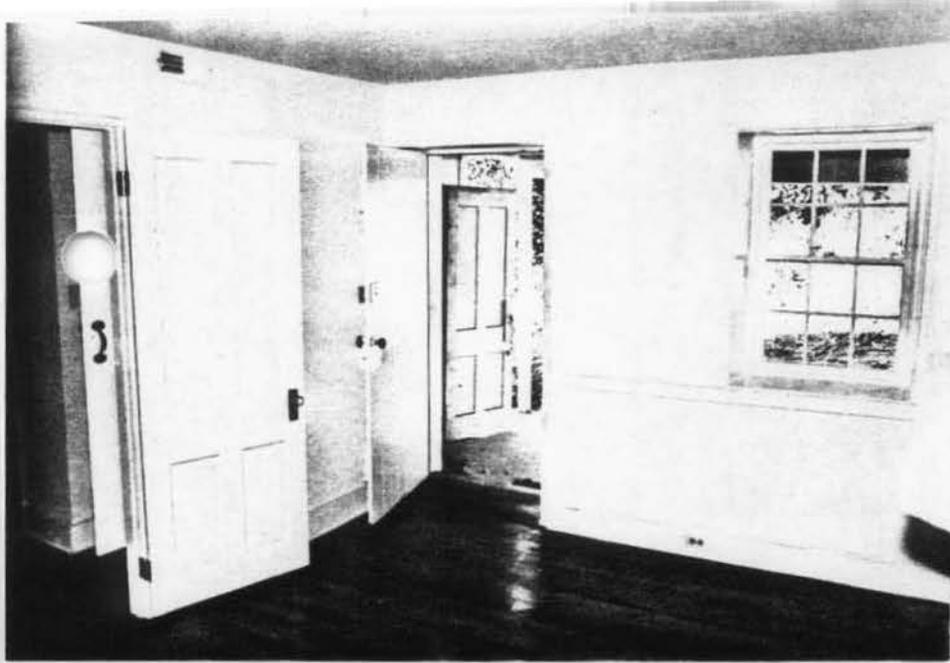
Fig. 14 Second floor of stone hse. Later partitions removed; fireplace, floors, trim and wainscoting repaired and restored. Door onto back is original and was retained along with all historic interior doors. Stairs to attic reoriented to stair hall by turning bottom several steps 90 degrees.

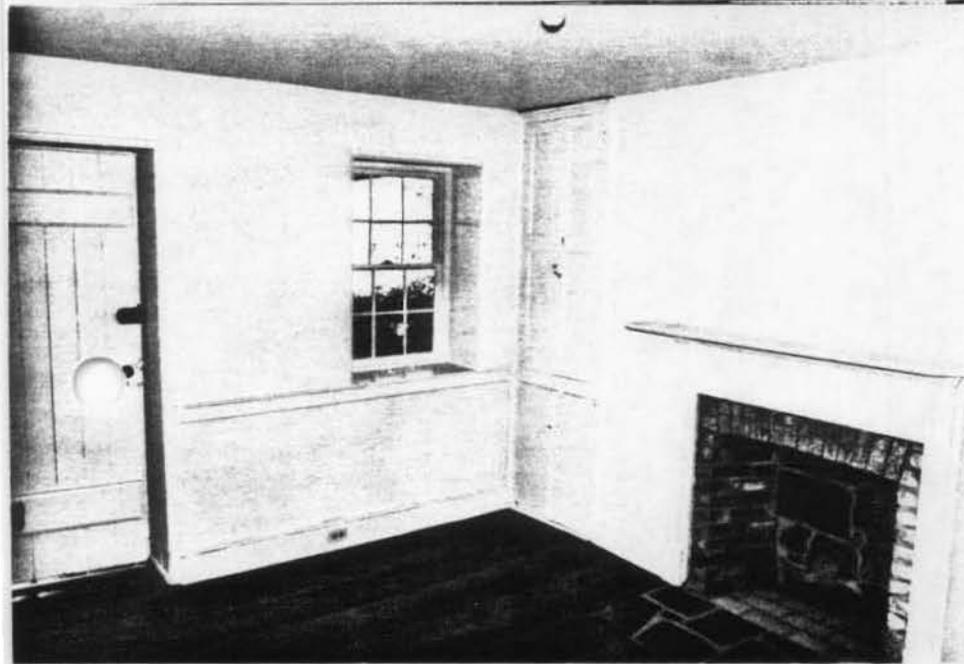
Fig. 15 Second floor of stone hse. Existing fireplace restored.

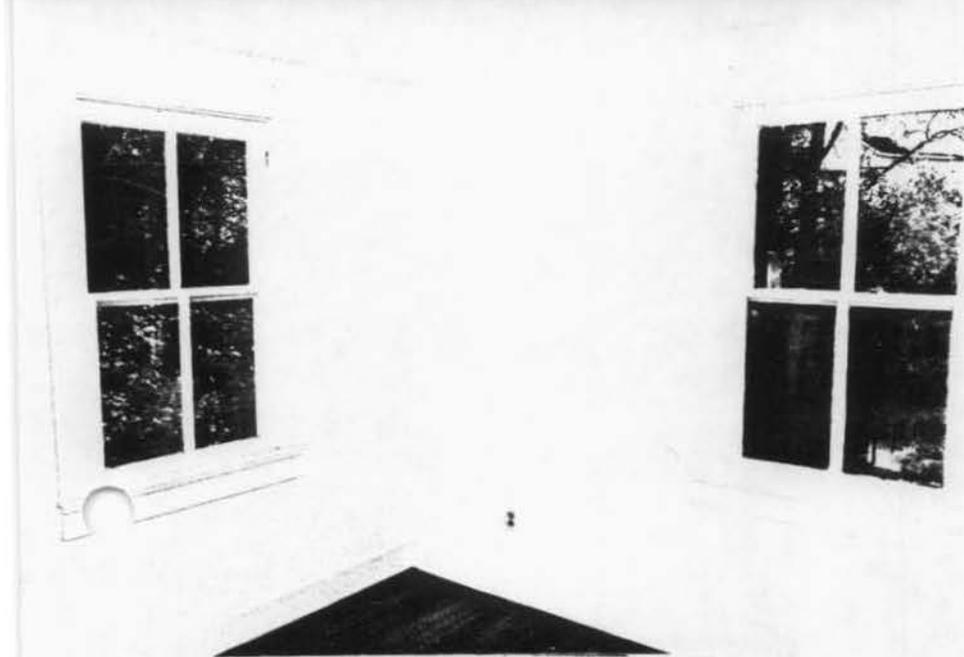
Fig. 16 Second floor of Victorian wing--front room. Existing windows and trim restored; room restored to full size.

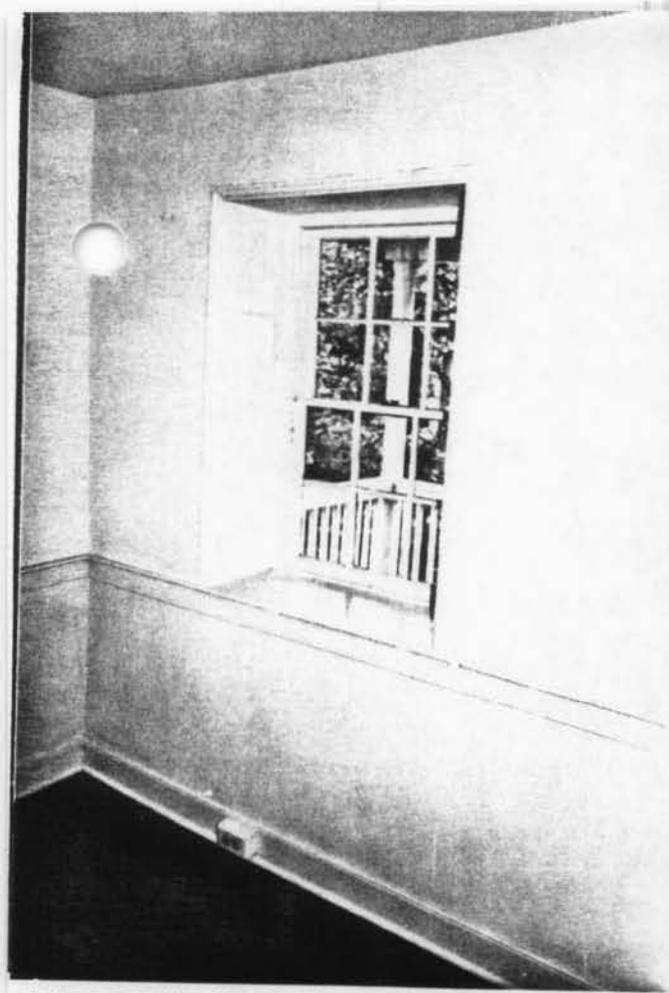
Fig. 17. Second floor of stone house looking to front, showing historic window and trim detail which was retained.

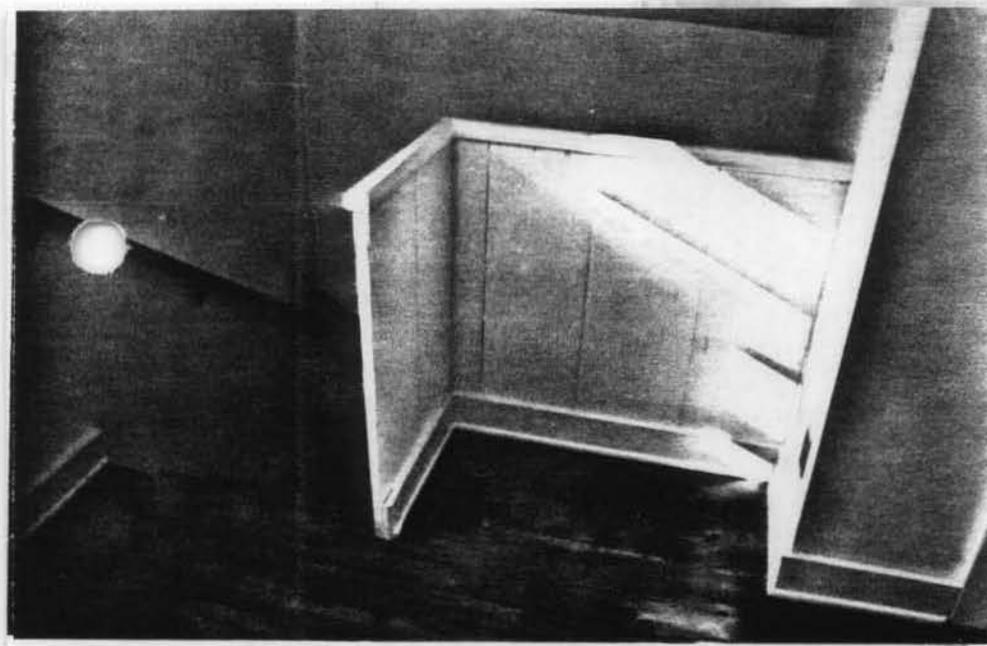
Fig. 20 Top of stairs in attic of stone house showing historic detailing which was retained. Floors were refinished.

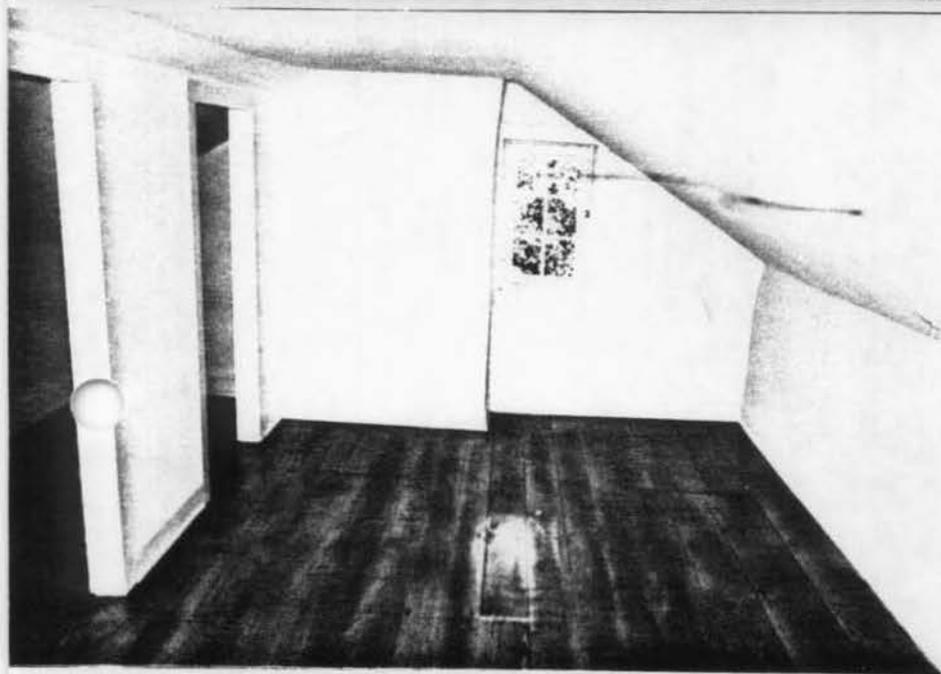
Fig. 21 Attic of stone house
Later center partition was removed
New left side wall was installed for
contemporary closet space. Fire-
place stack shown to left of restored
window. Floors were refinished.
