Maryland Historical Trust

Maryland Inventory of Historic Properties number: HO-657

Name: River Rd over Gockelburn Branch

SUBJECT: River Road over Rockburn Branch (Bridge No. HO-006)
MIHP No.: HO-0657 (HO-657) (406)
W.O. No.: 31760-008

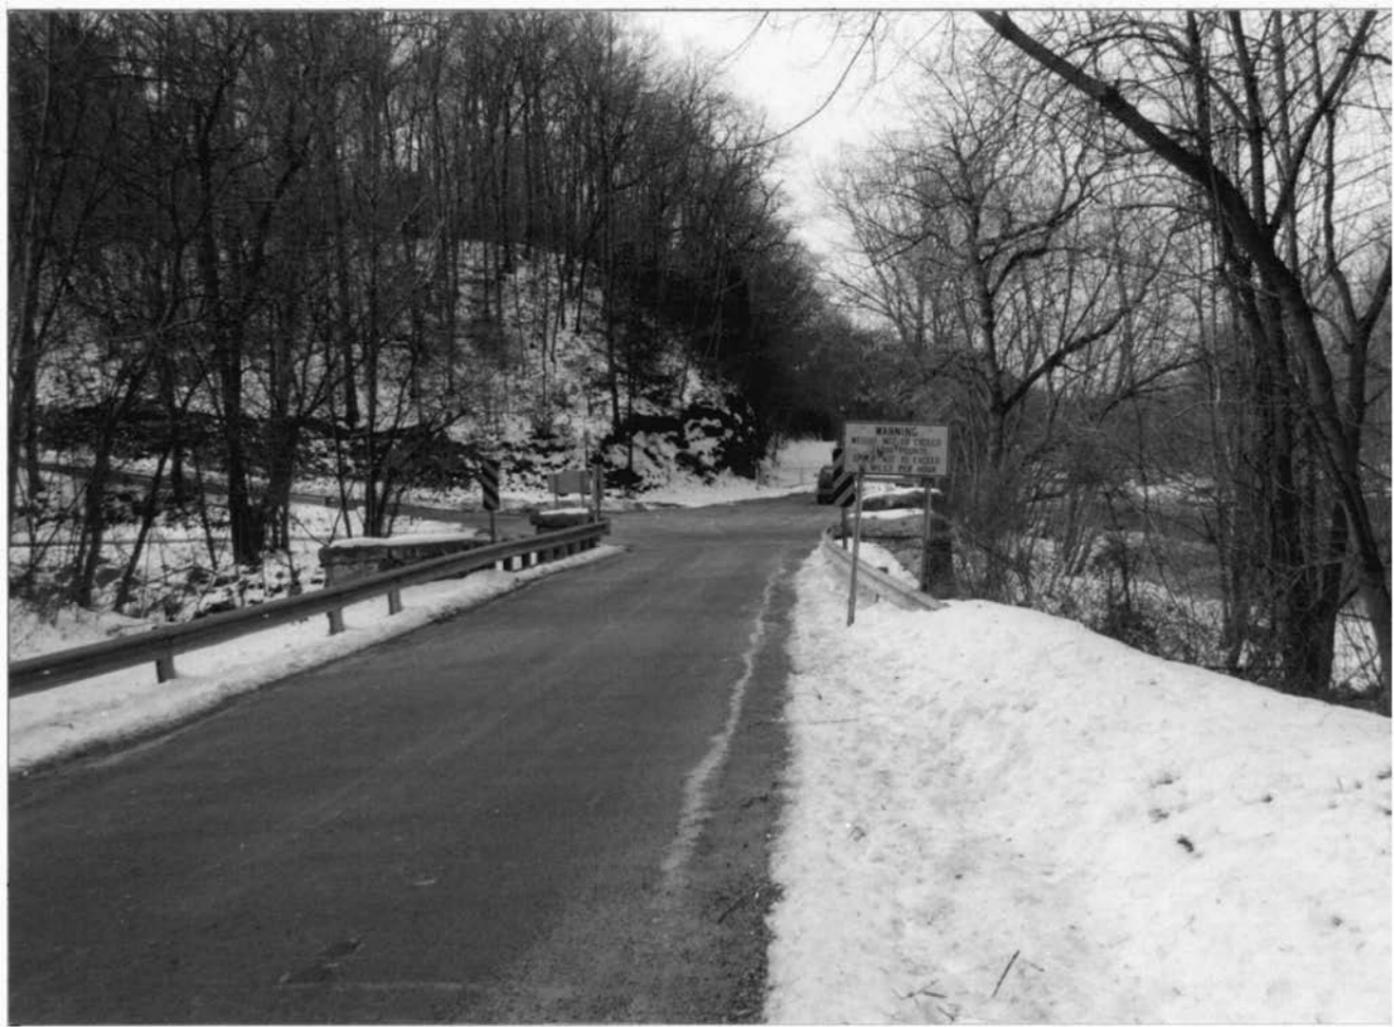
Number ¹33 of ⁴36

Description WEST APPROACH

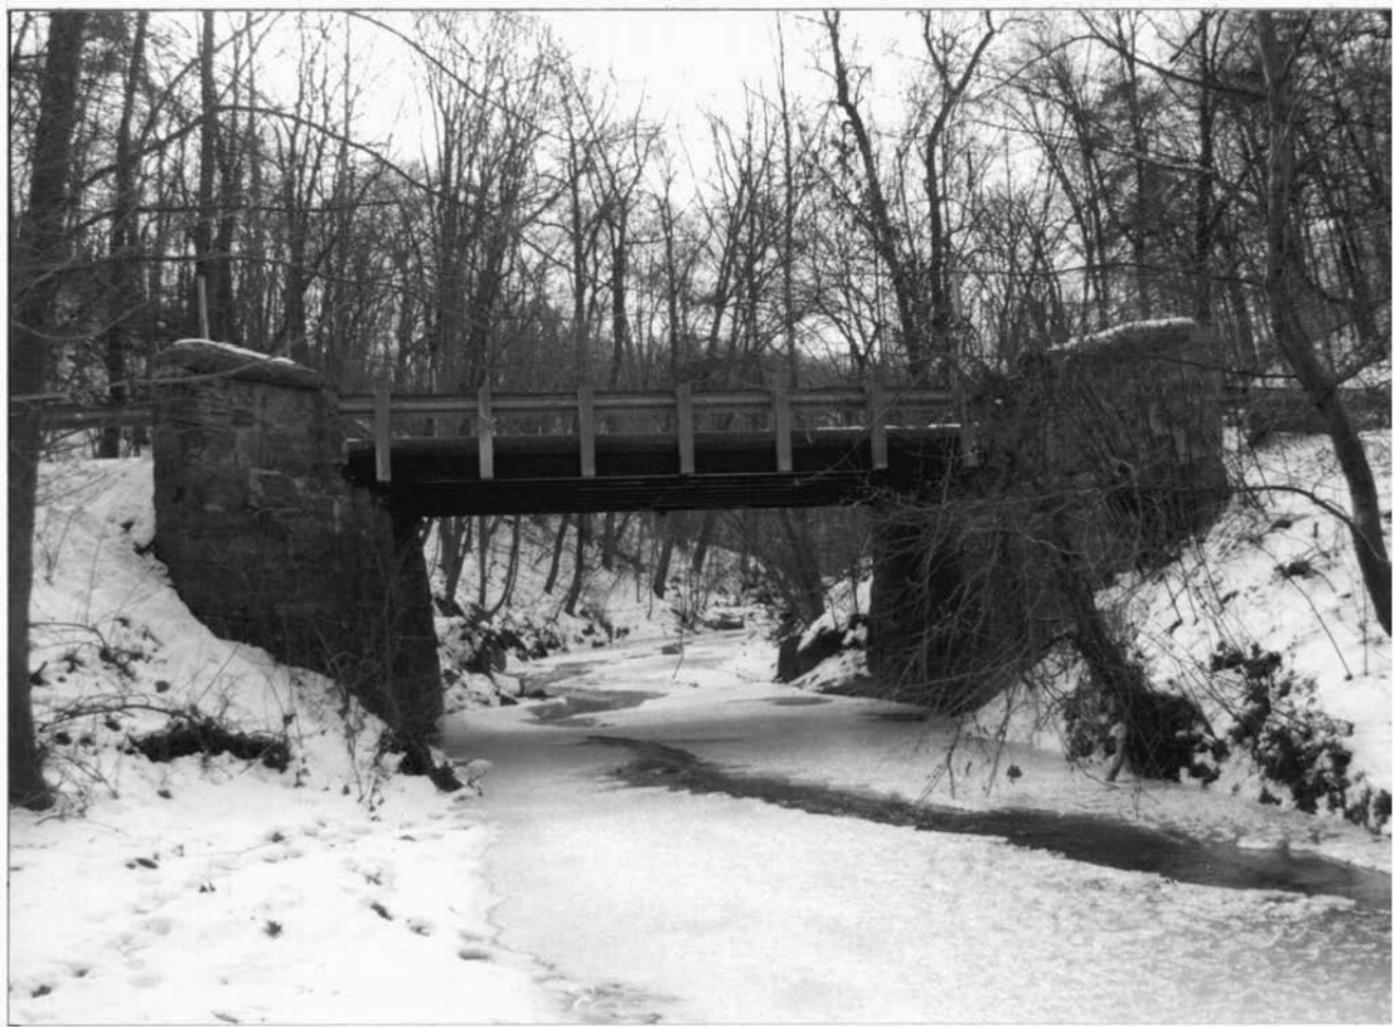
Number 3 of 4
35 of 36

Description NORTH ELEVATION

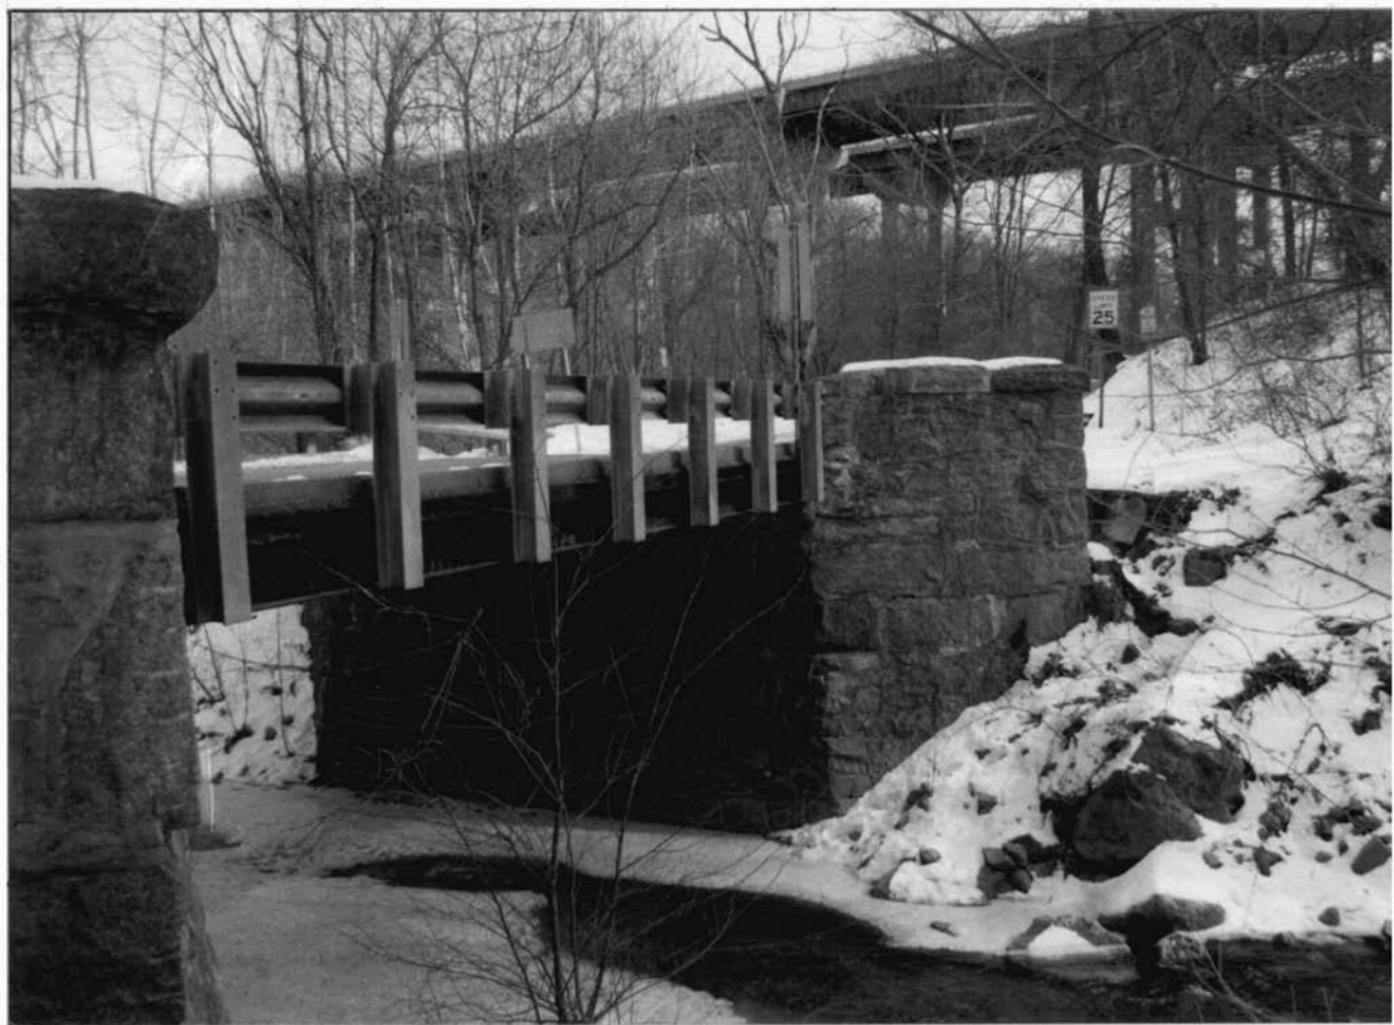
Number 4 of 4
30

Description SOUTH ELEVATION

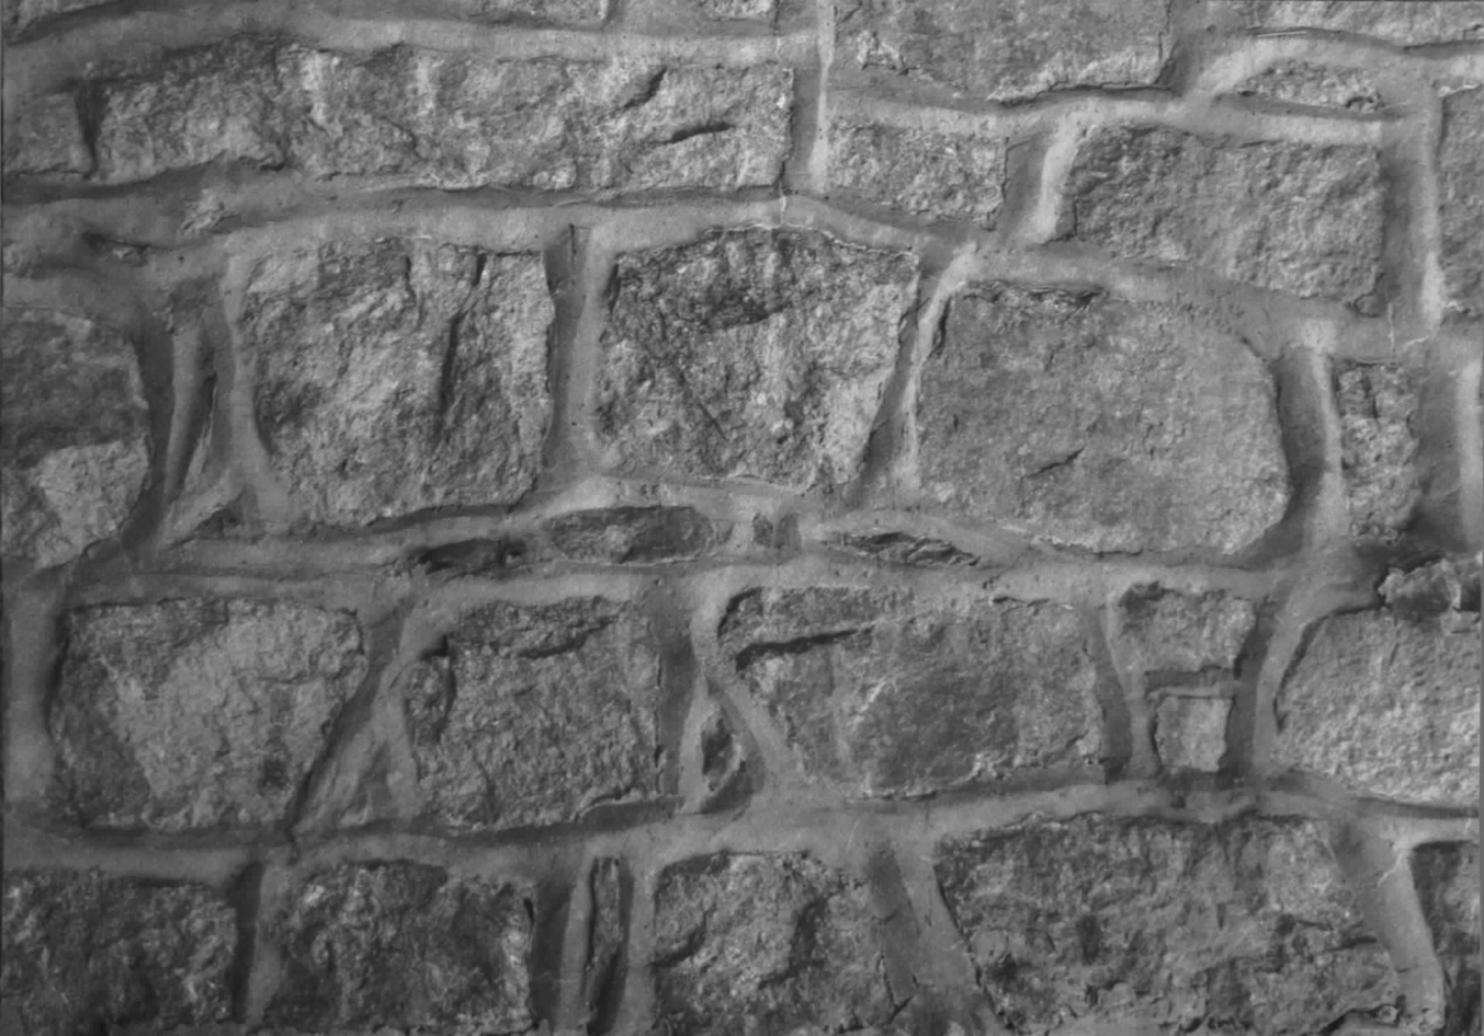
18/45

Typical mortar joint detail (north end of
east abutment shown)

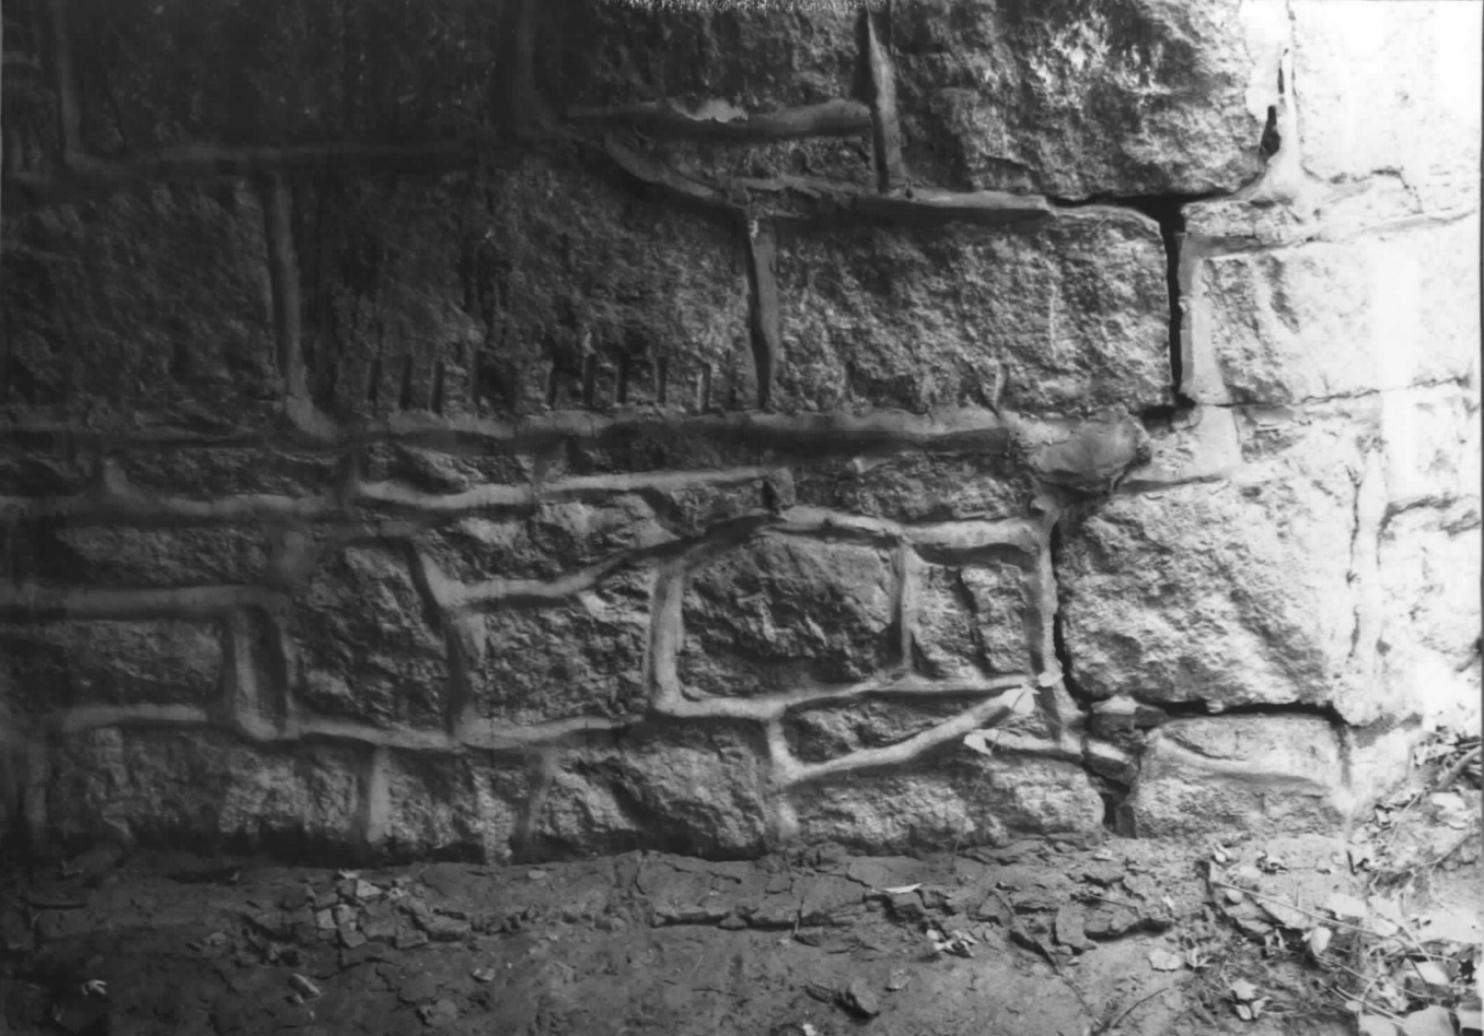
19/45

Typical mortar joint detail (north end of
west abutment shown)

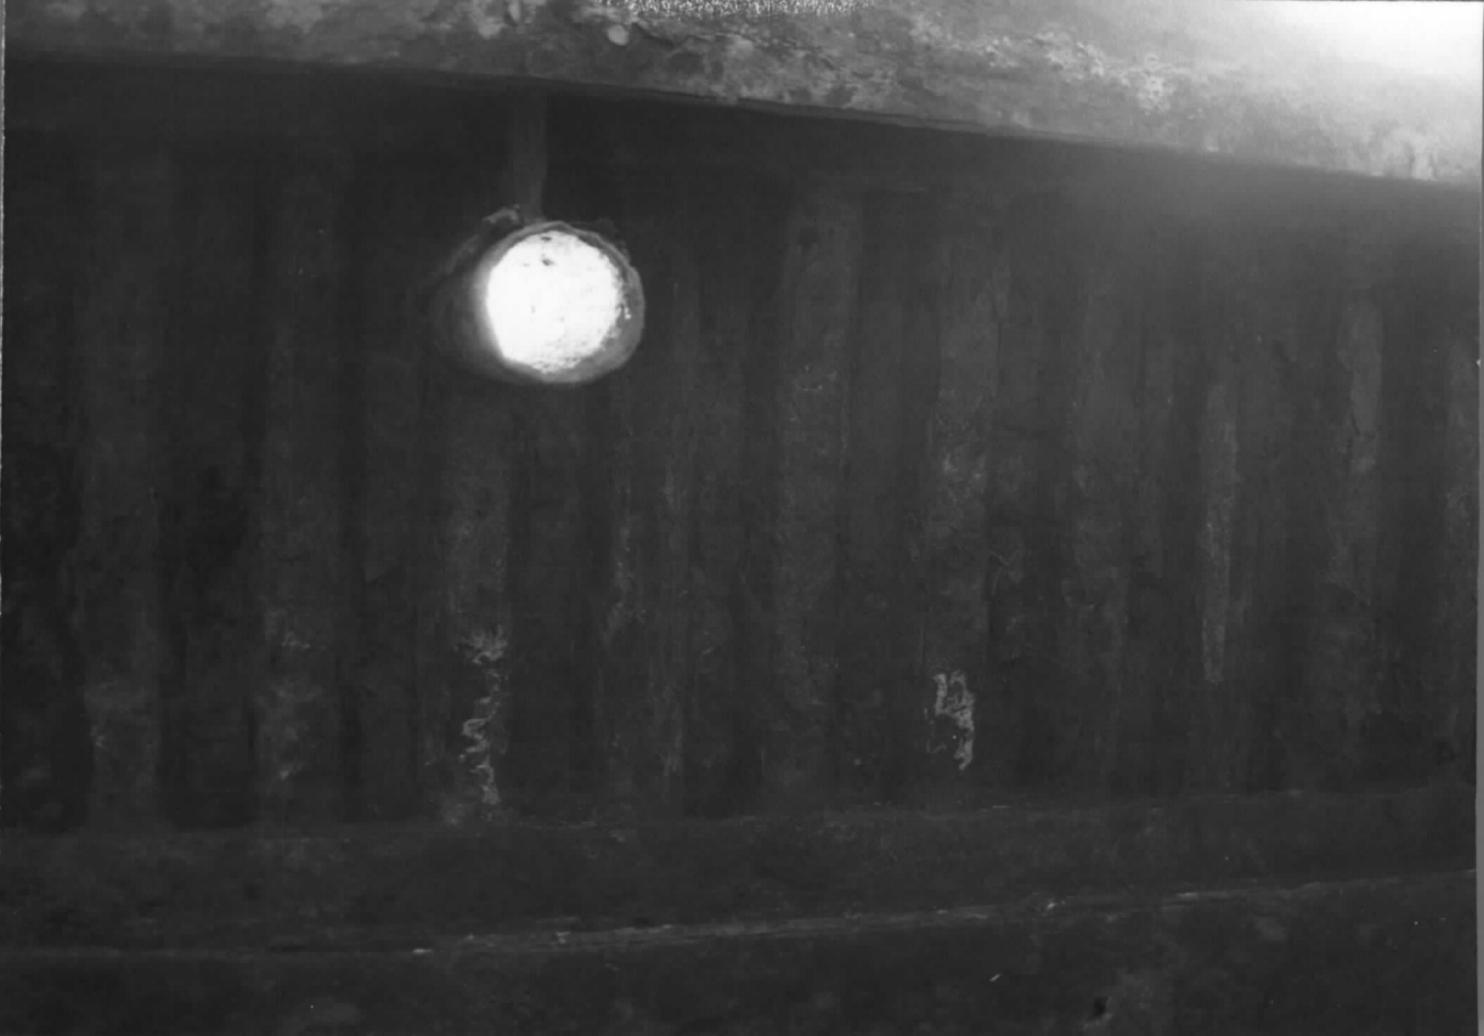
20/45

Deck underside at midspan of Bay No. 1

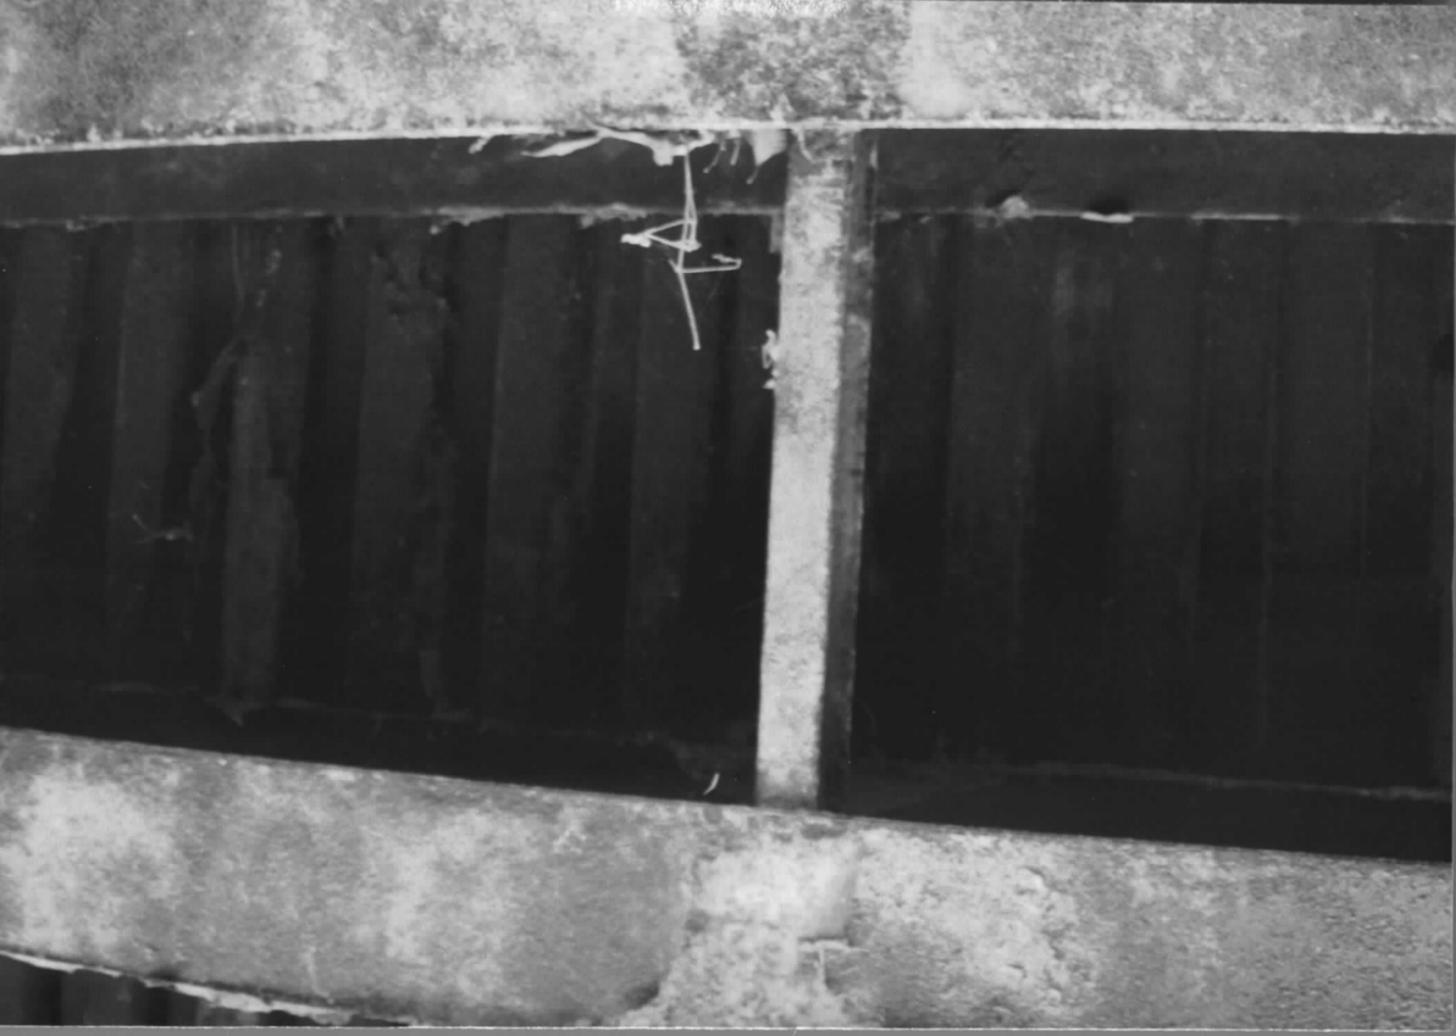
21/45

Deck underside at midspan of Bay No. 3

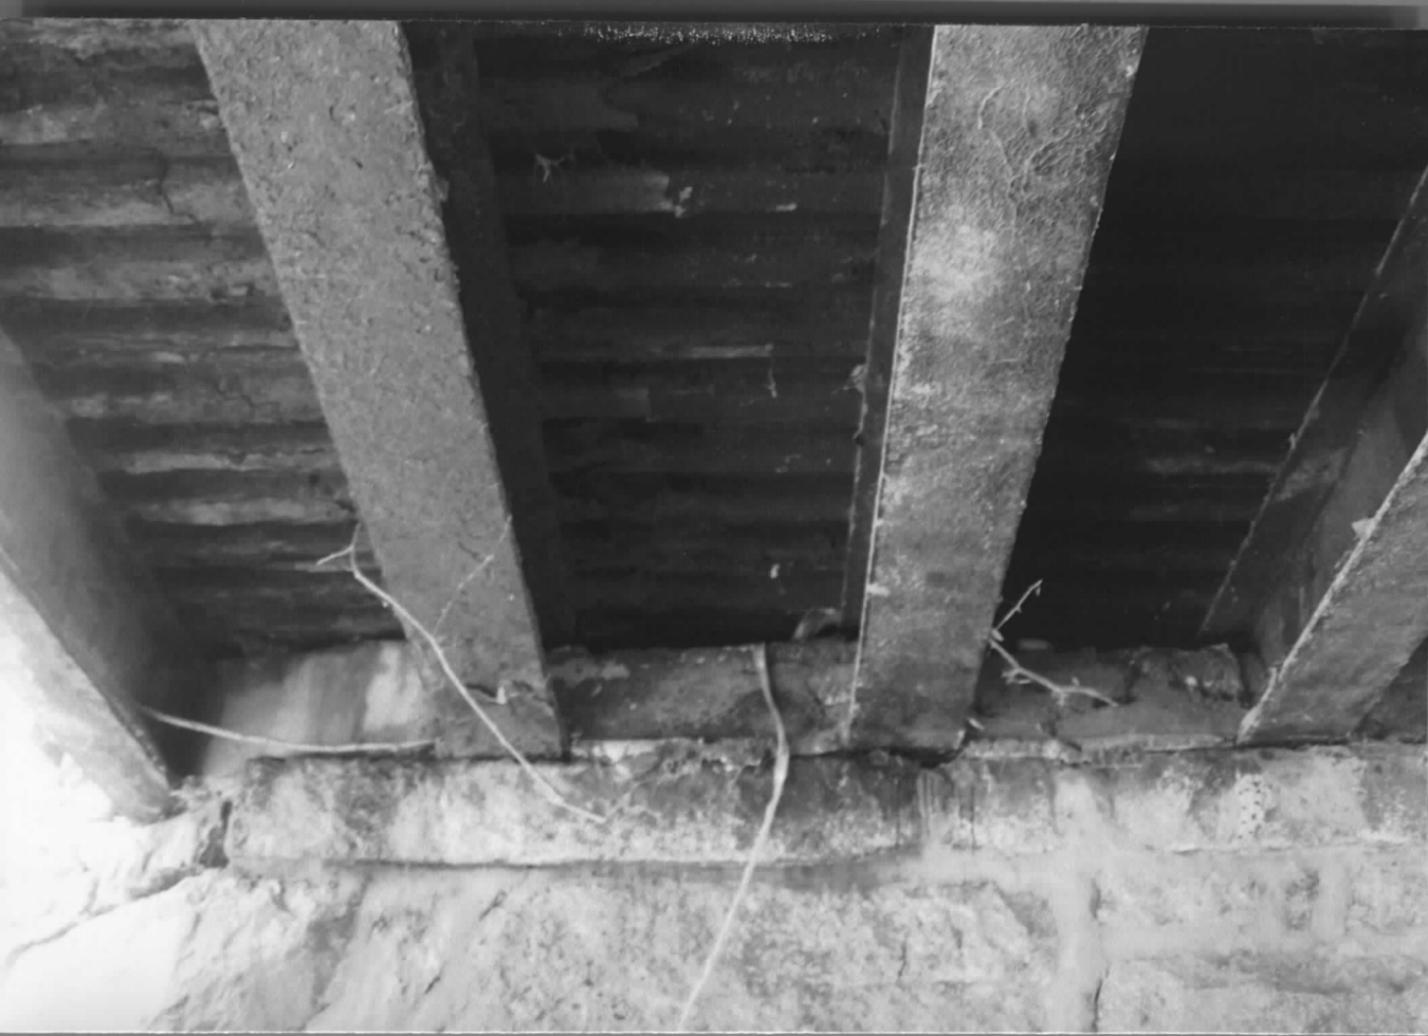
22/45

East abutment beam seat under Bay Nos. 1-3

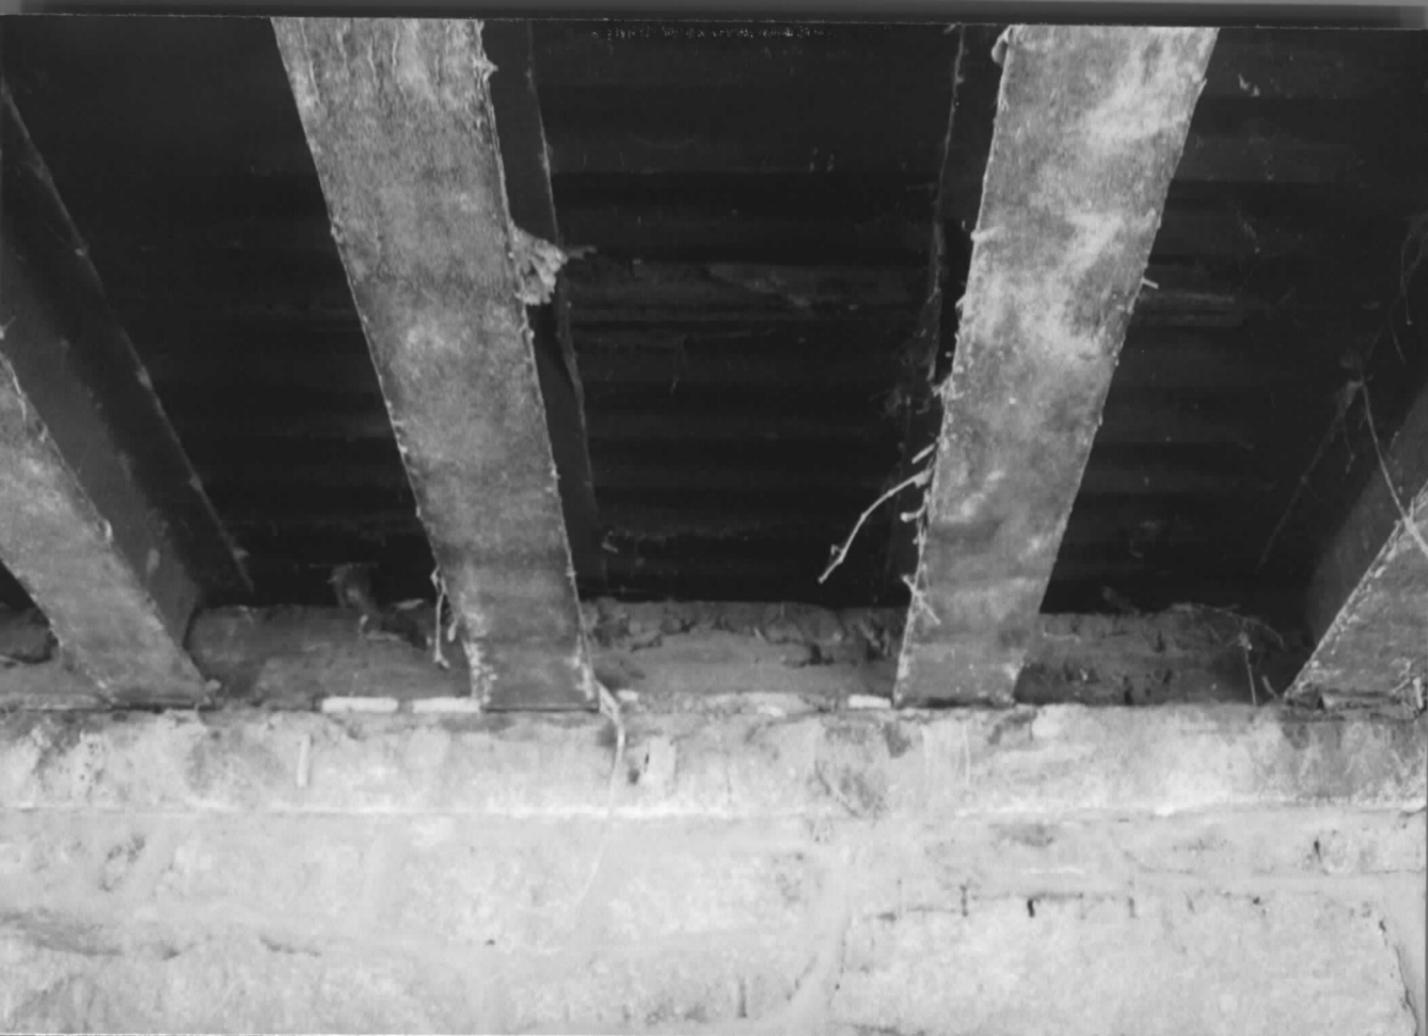
23/45

East abutment beam seat under Bay Nos. 4-6

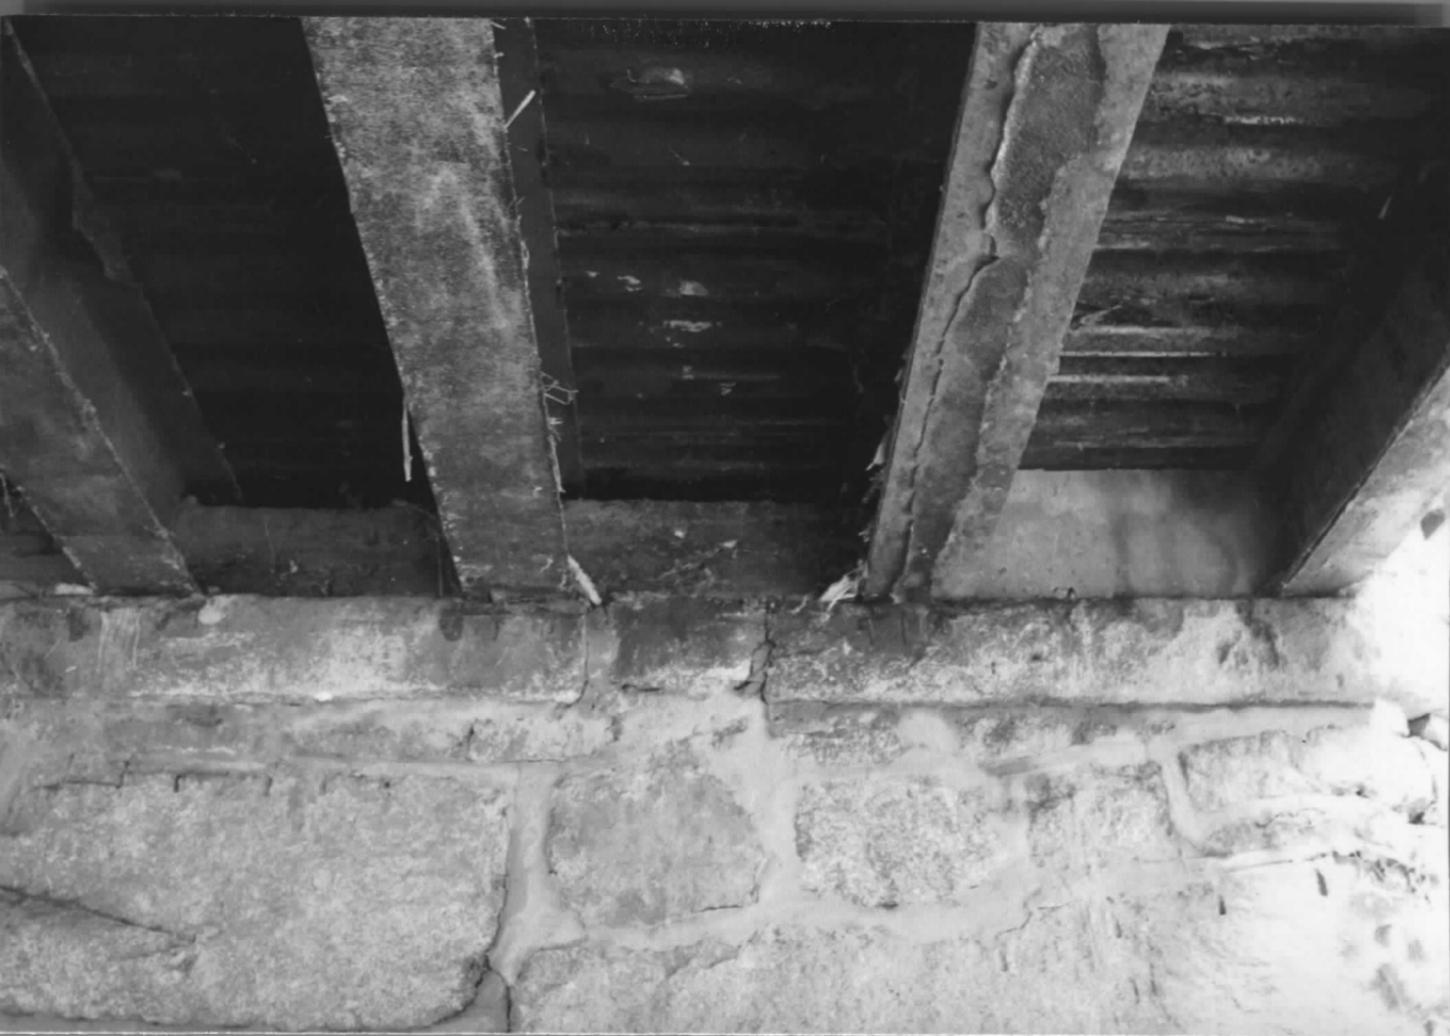
24/45

East abutment beam seat under Bay Nos. 6-8

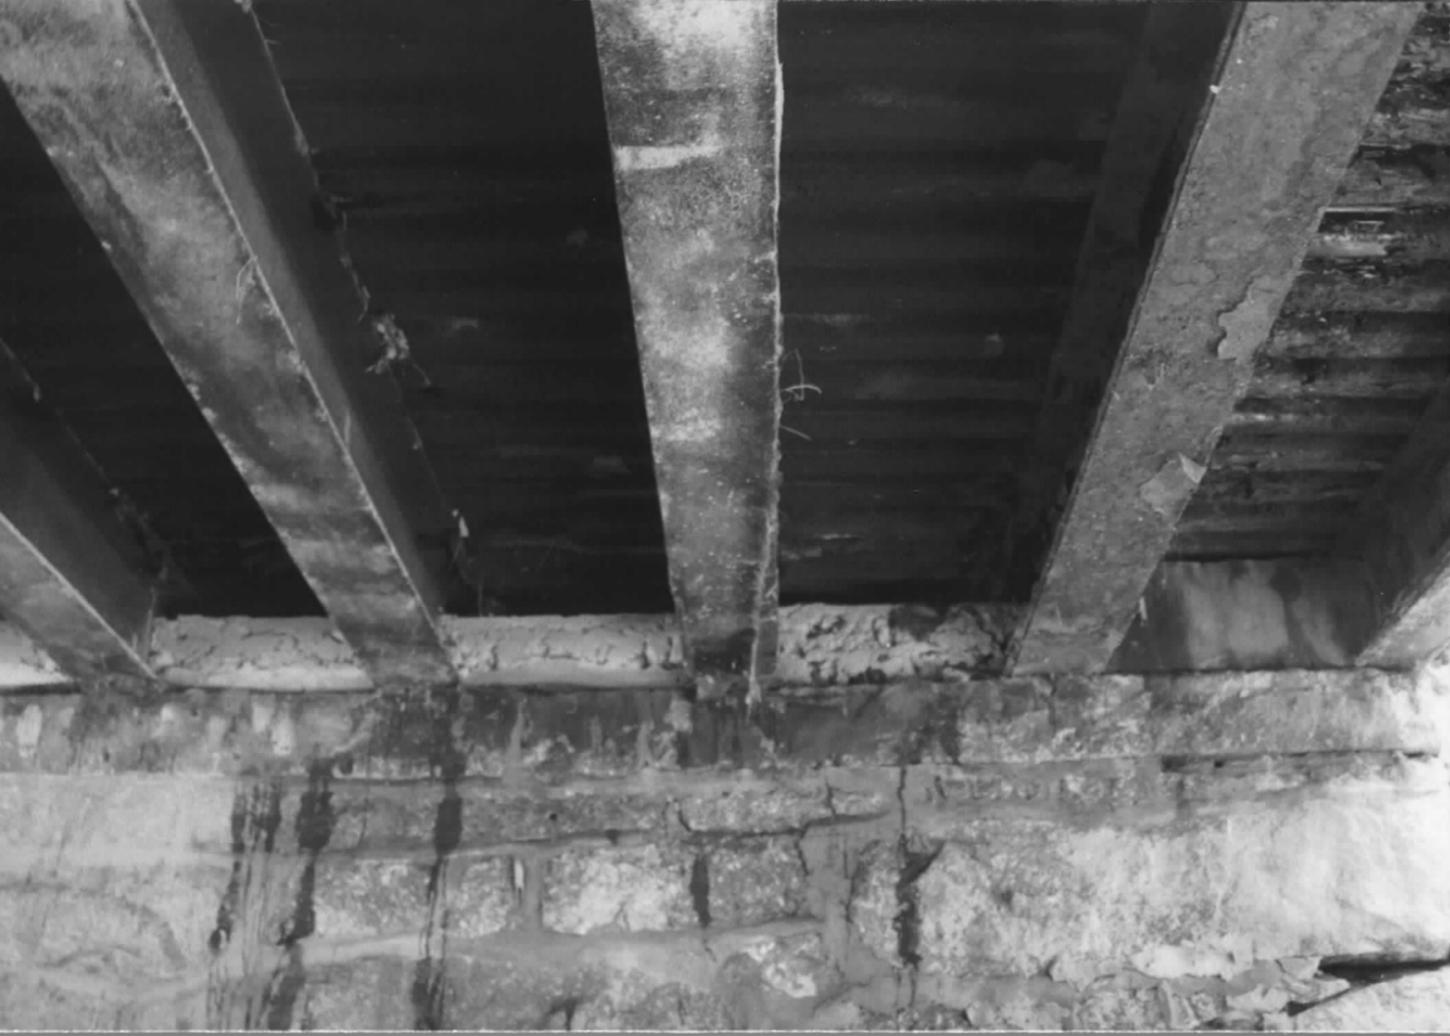
25/45

West abutment beam seat under Bay Nos. 1-4

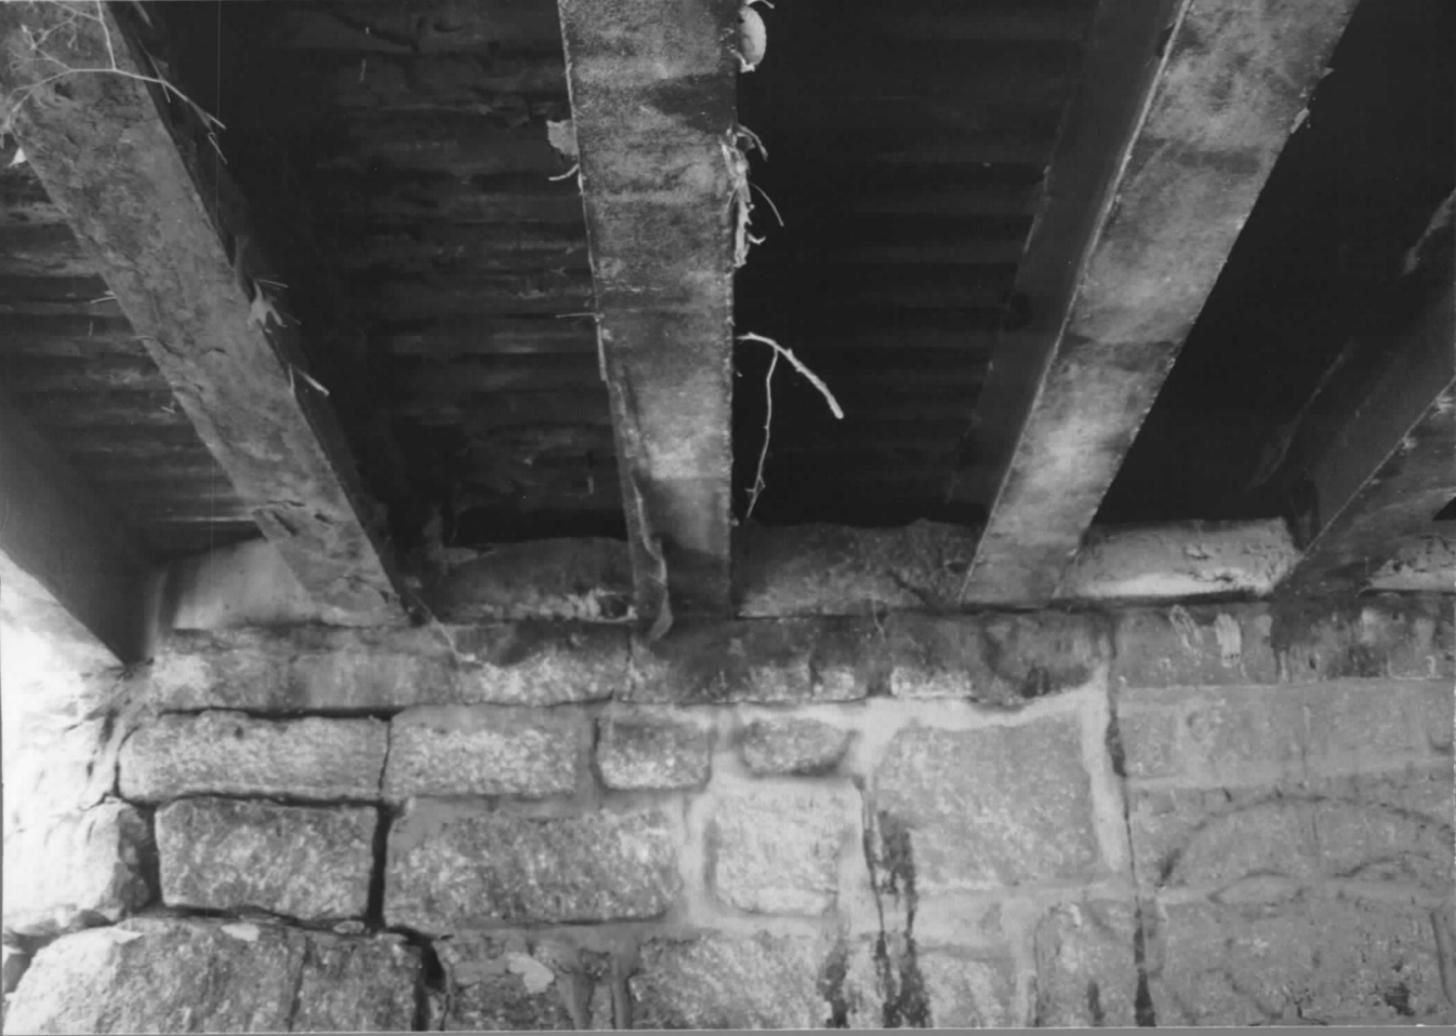
26/45

West abutment beam seat under Bay Nos. 5-8

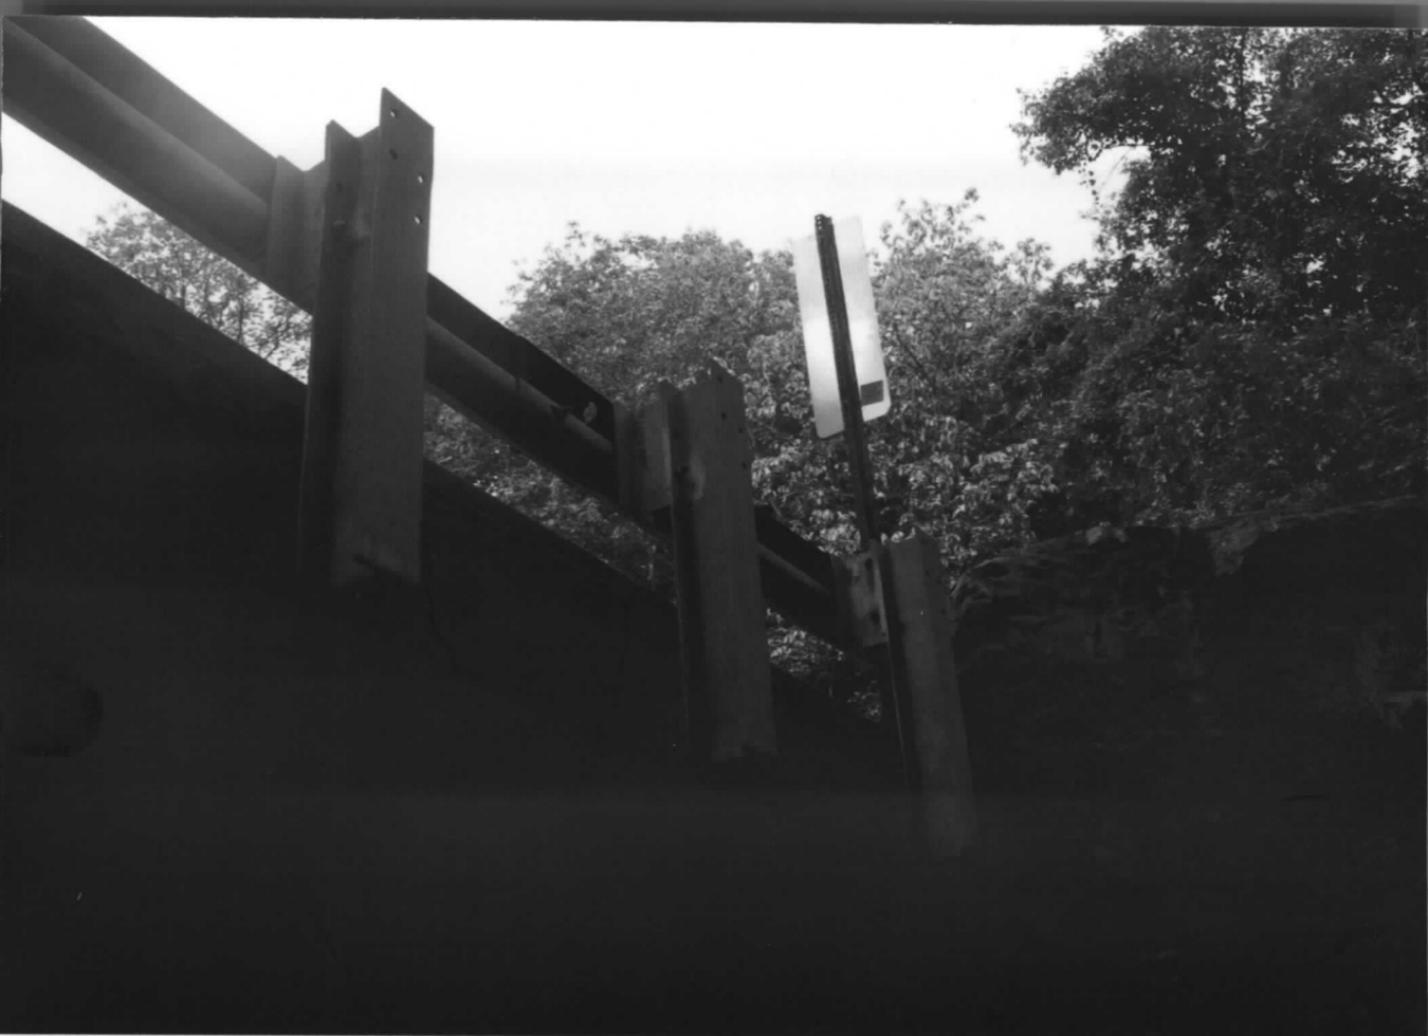
27/45

North bridge rail at west end

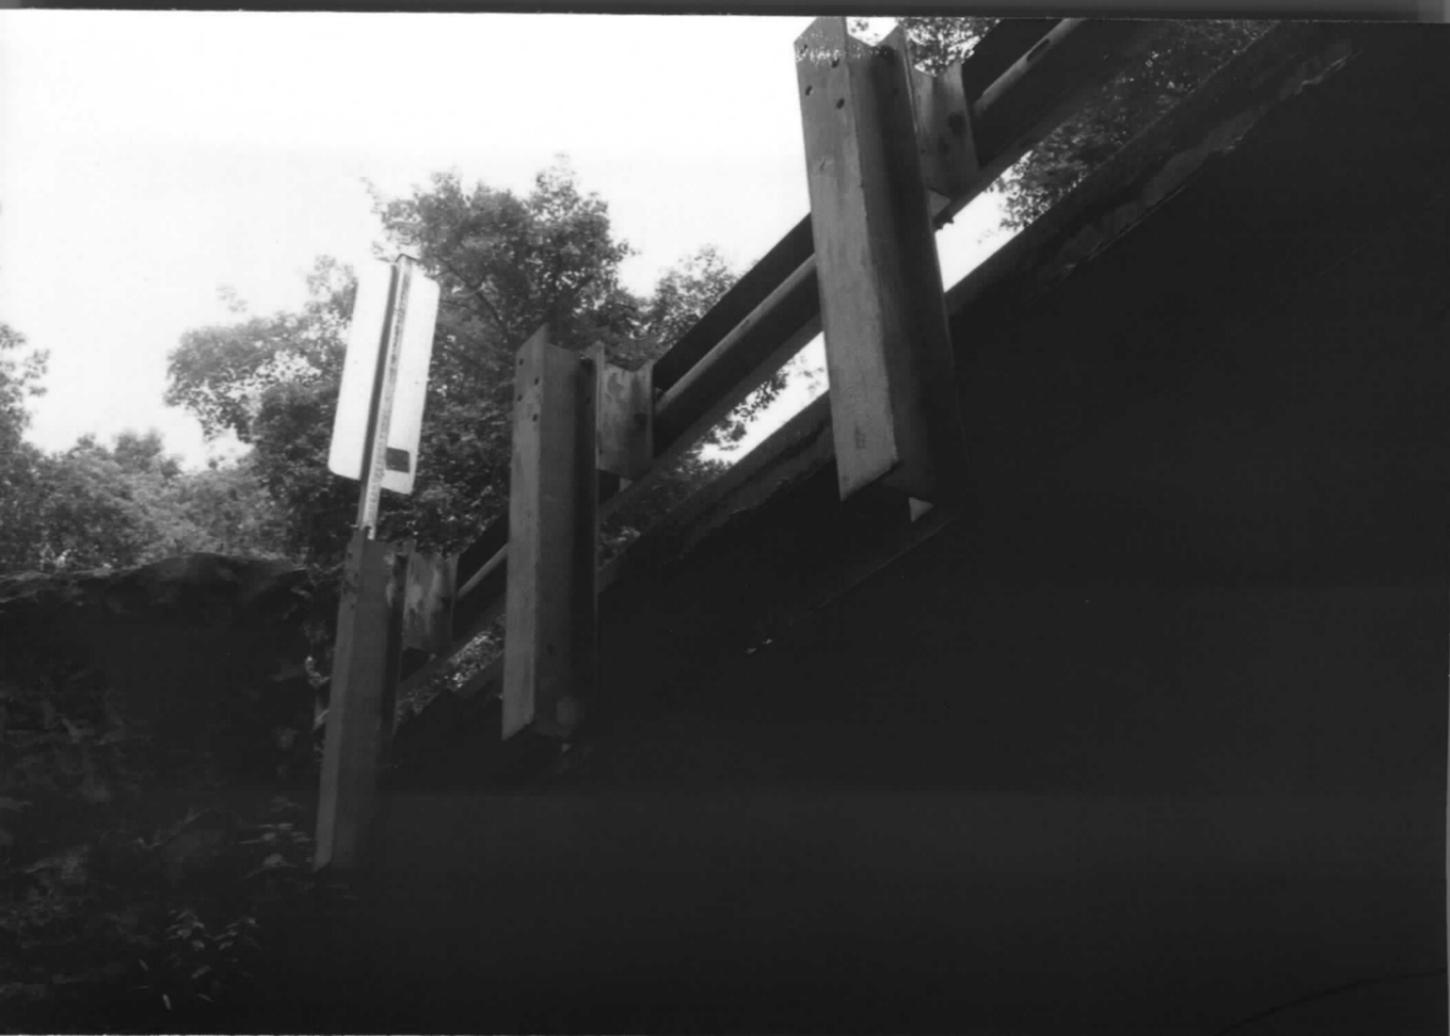
28/45

South bridge rail at west end

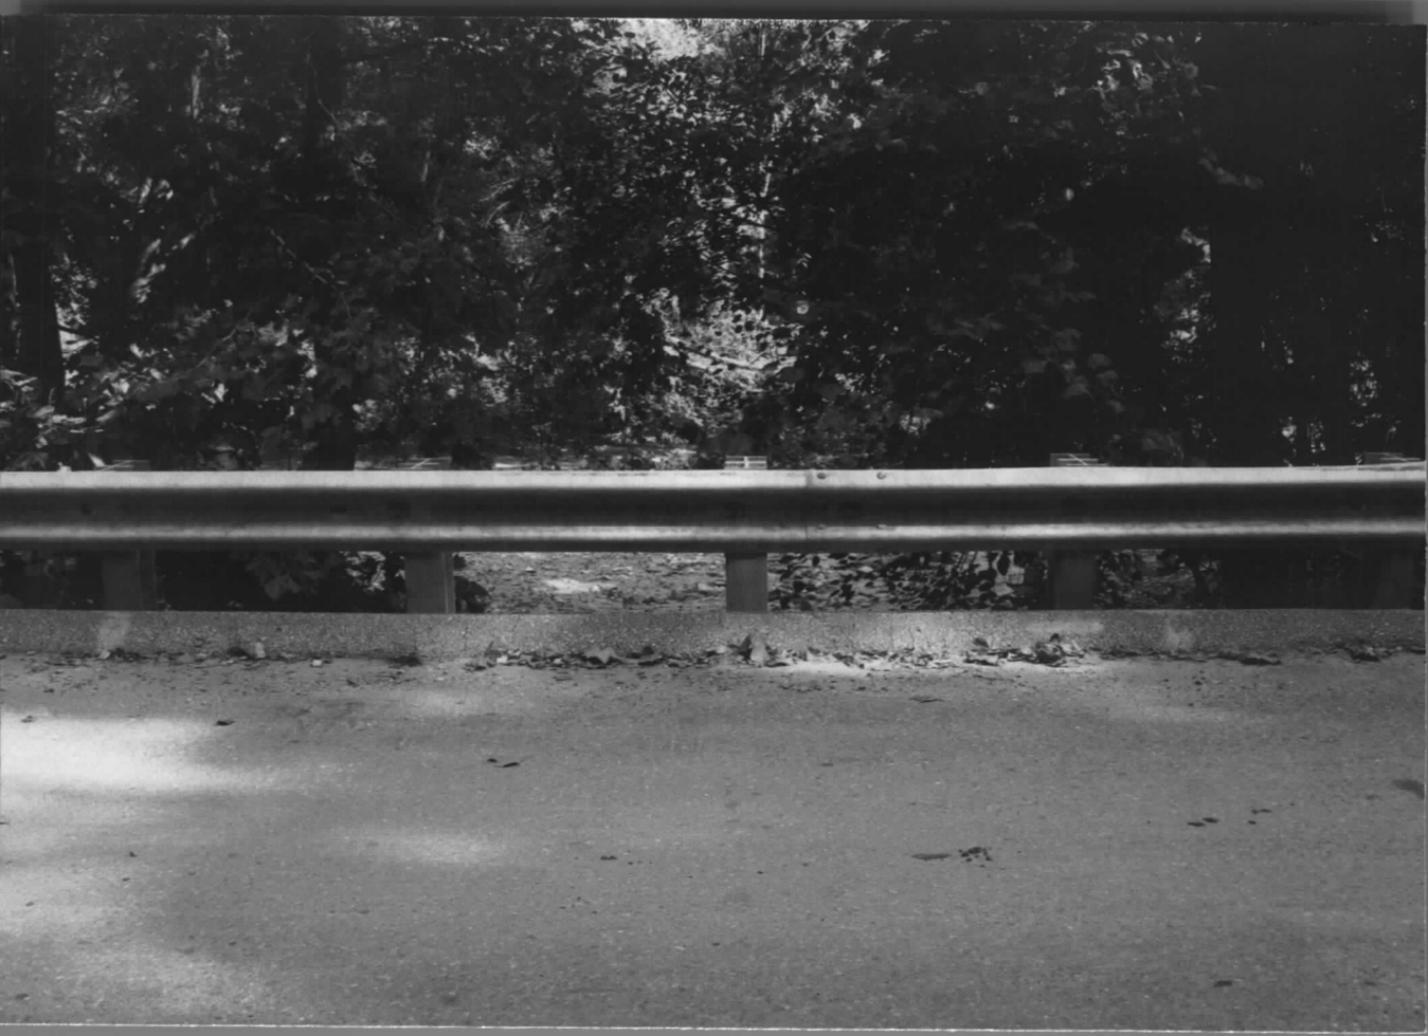
41/45

The stone masonry parapet would be considered an ornamental feature. Applied ornamentation is an important character defining element. This parapet was removed in order to install a modern W-beam guard rail for safety reasons. The parapet was designed to match the stone abutments and did not serve a major structural purpose, but rather was a decorative feature.

North bridge rail
