Maryland Historical Trust

Maryland Inventory of Historic Properties number: HO-657

Name: River Rd over Gockelburn Branch

SUBJECT: River Road over Rockburn Branch (Bridge No. HO-006)
MIHP No.: HO-0657 (HO-657) (406)
W.O. No.: 31760-008

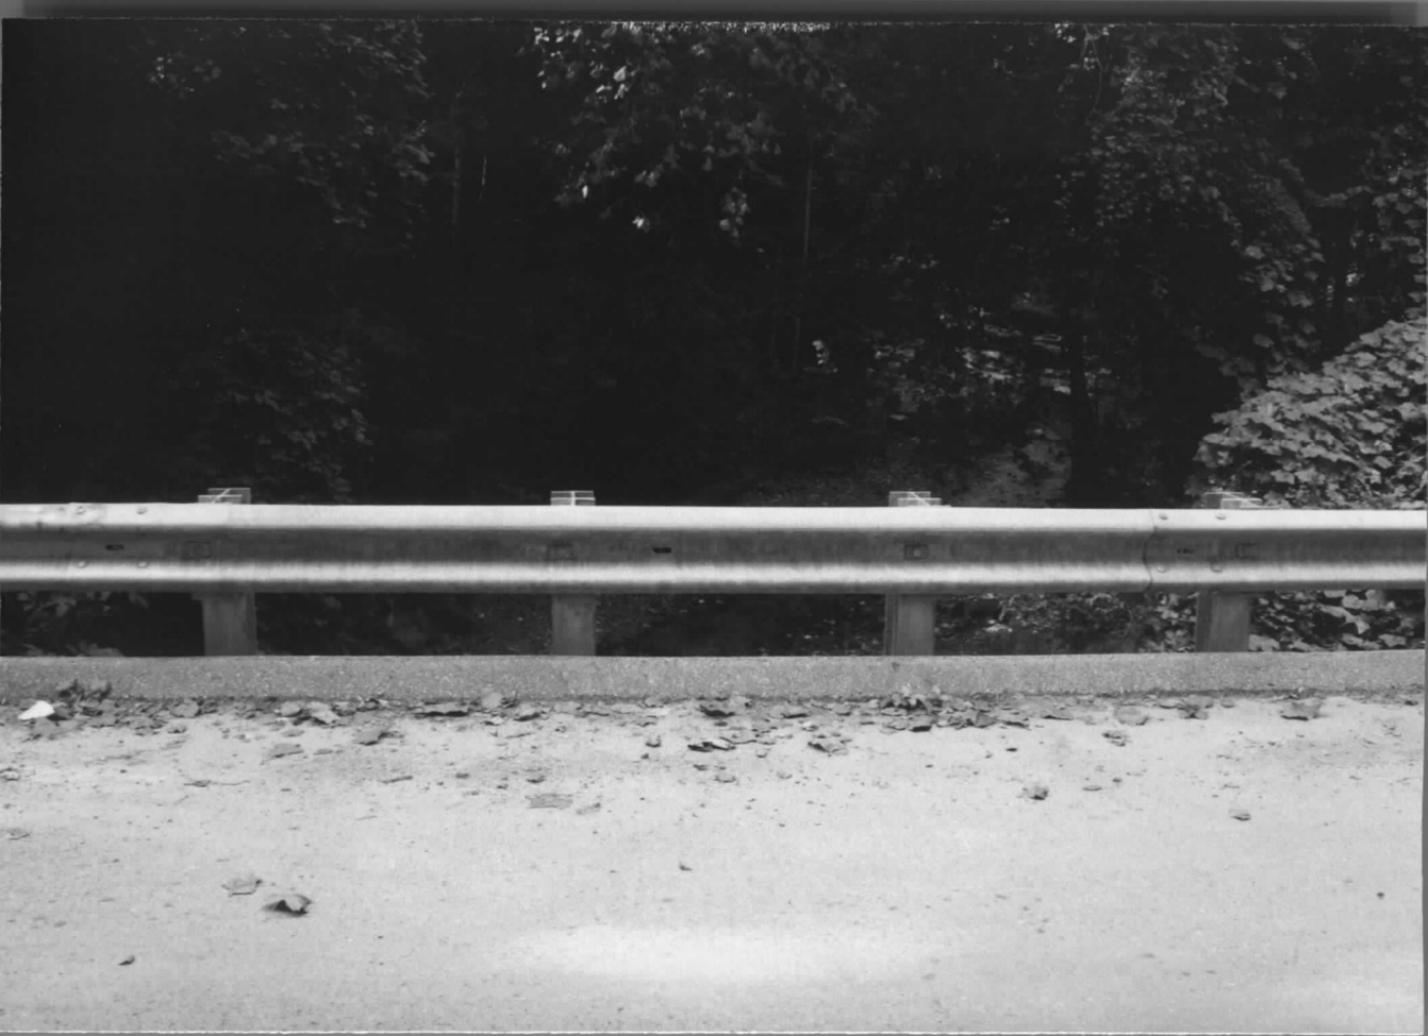
42/45

South bridge rail

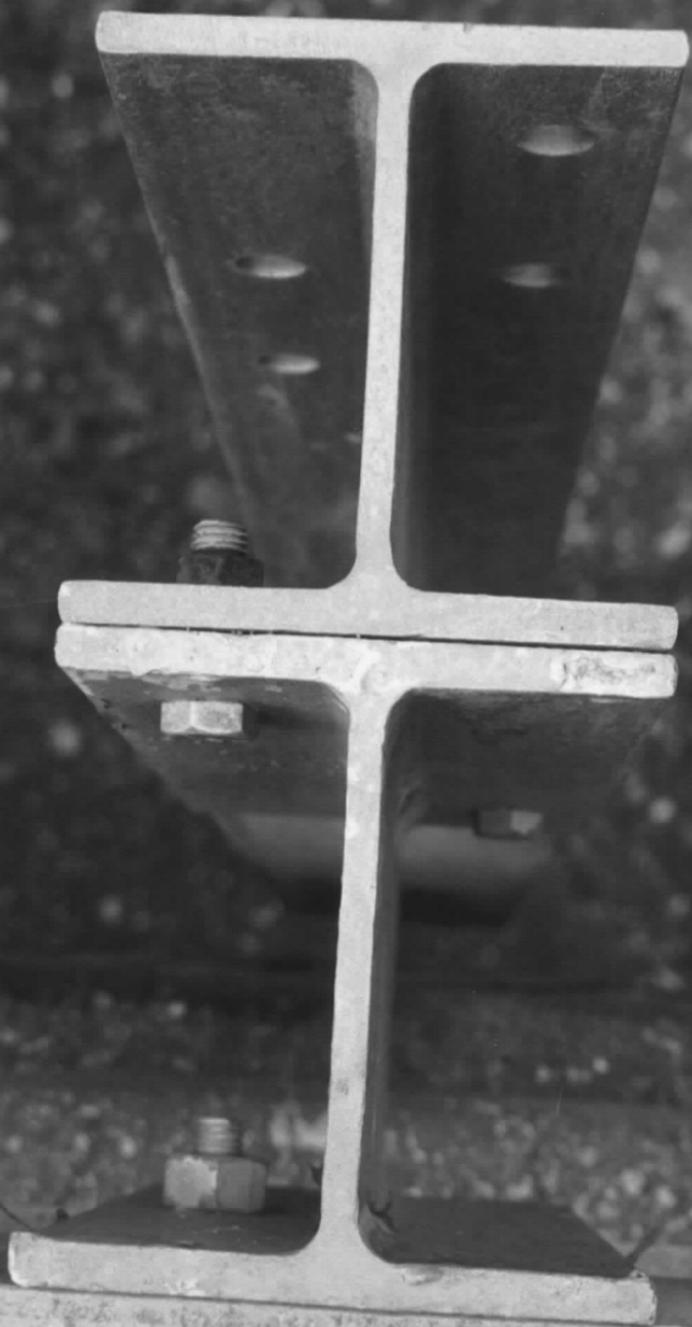
43/45

South bridge rail Post No. 4 (looking
down at midspan)
