Maryland Inventory of Historic Properties number: ~~HO-35~~ HO-662

Name and SHA No. Hipsley Mill Road over Cabin Branch/HO35

MARYLAND INVENTORY OF HISTORIC BRIDGES  
HISTORIC BRIDGE INVENTORY  
MARYLAND STATE HIGHWAY ADMINISTRATION/  
MARYLAND HISTORICAL TRUST

SHA Bridge No. HO 035 Bridge name Hipsley Mill Road Bridge over Cabin Branch

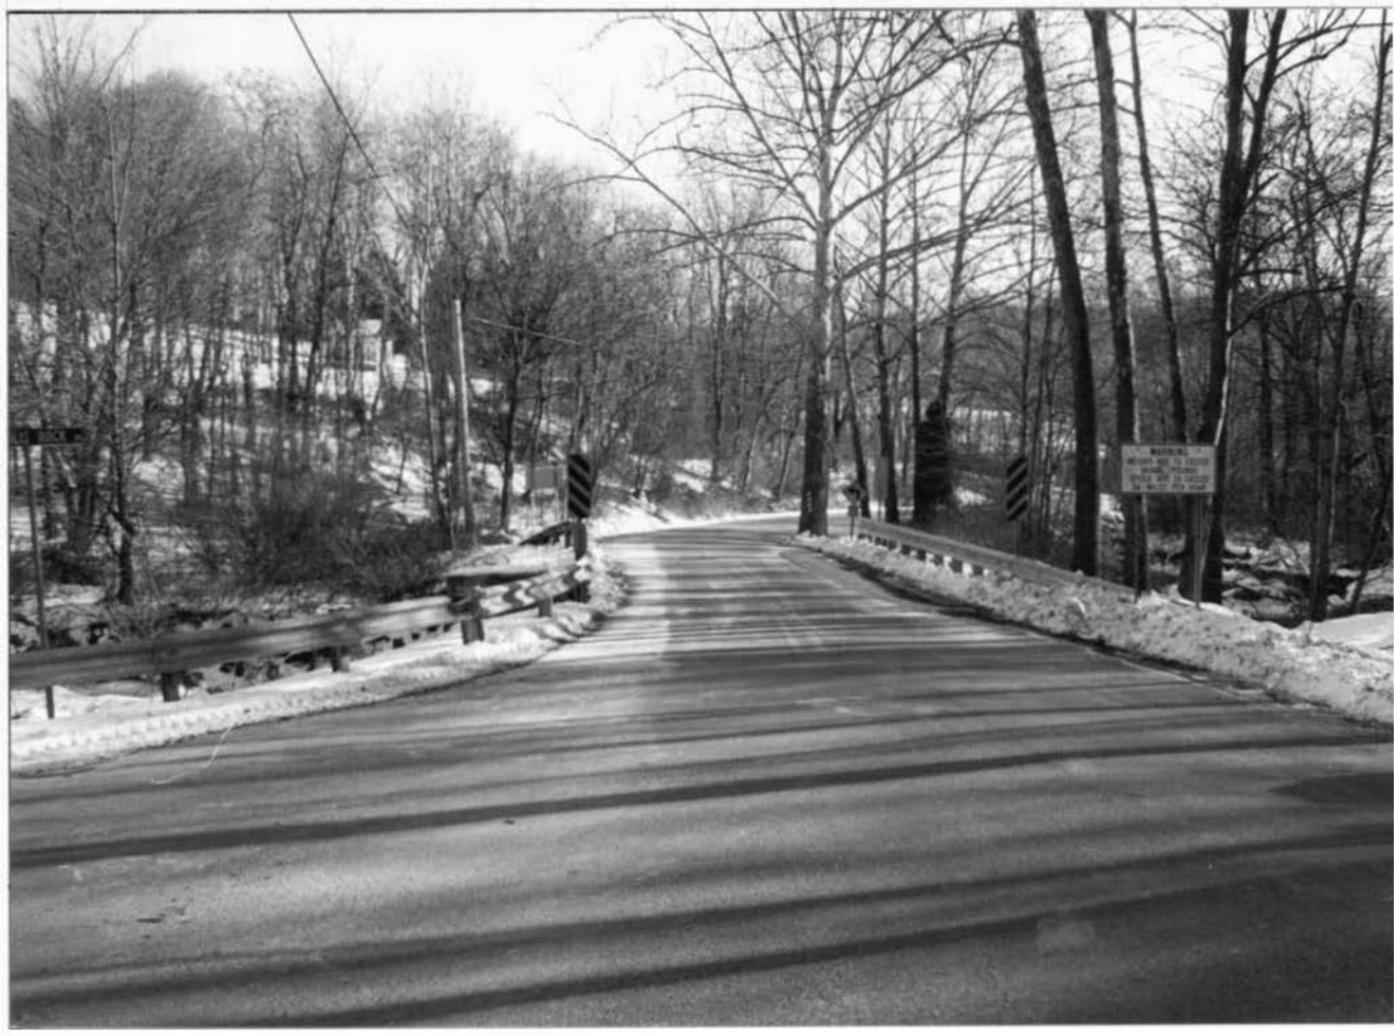
Number 1 4  
13 of 31

Description SOUTH APPROACH LOOKING  
NORTHEAST

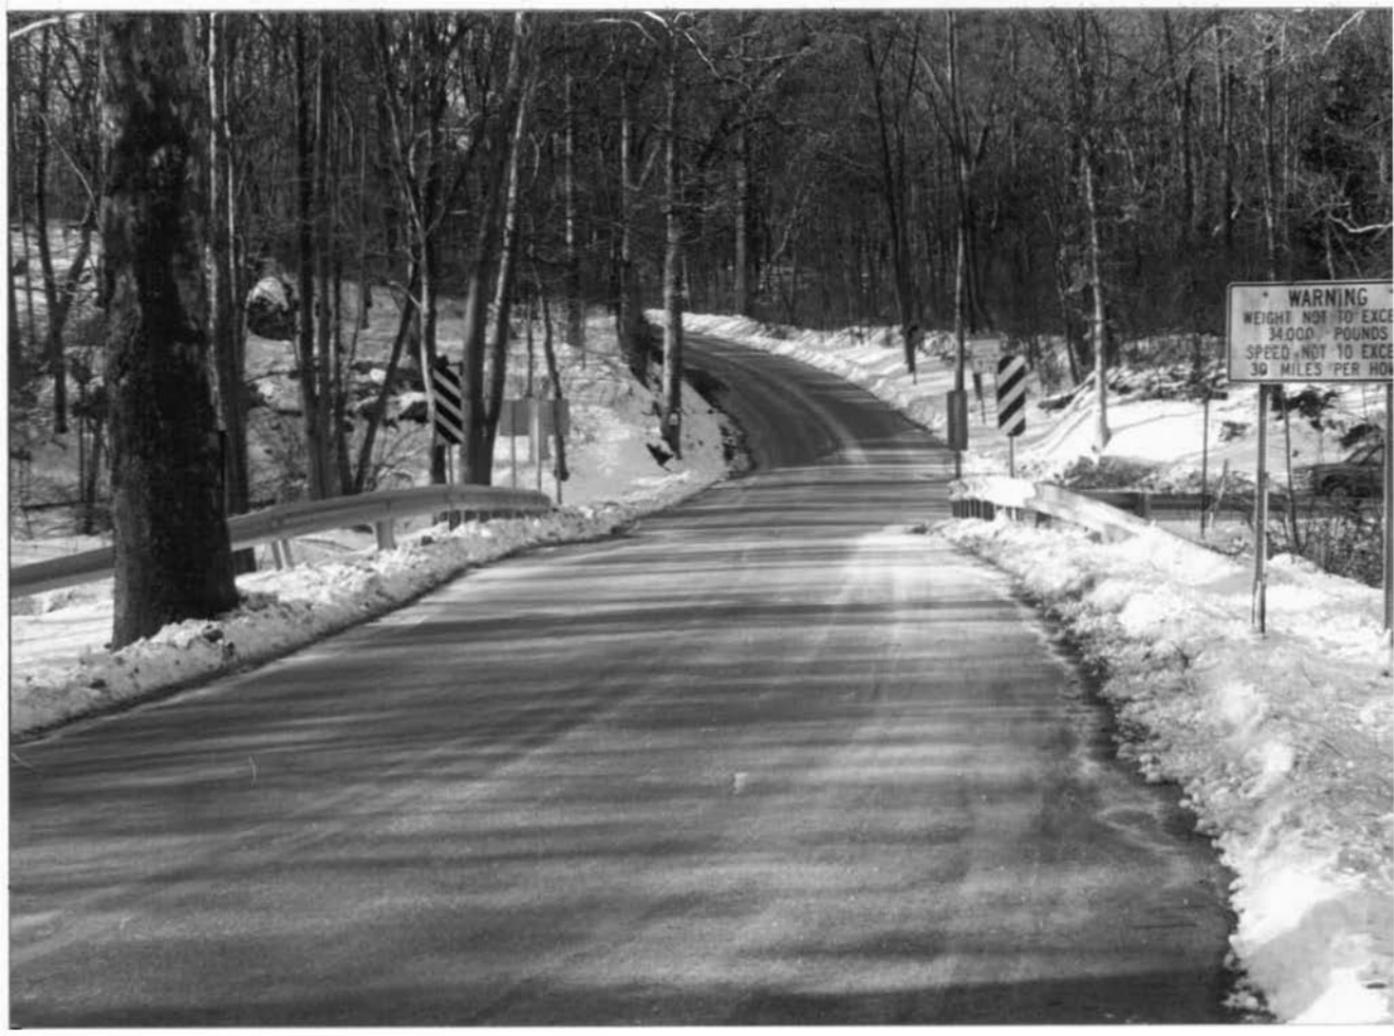
Number <sup>2</sup>~~14~~ of <sup>4</sup>~~31~~

Description NORTH APPROACH LOOKING  
SOUTHWEST

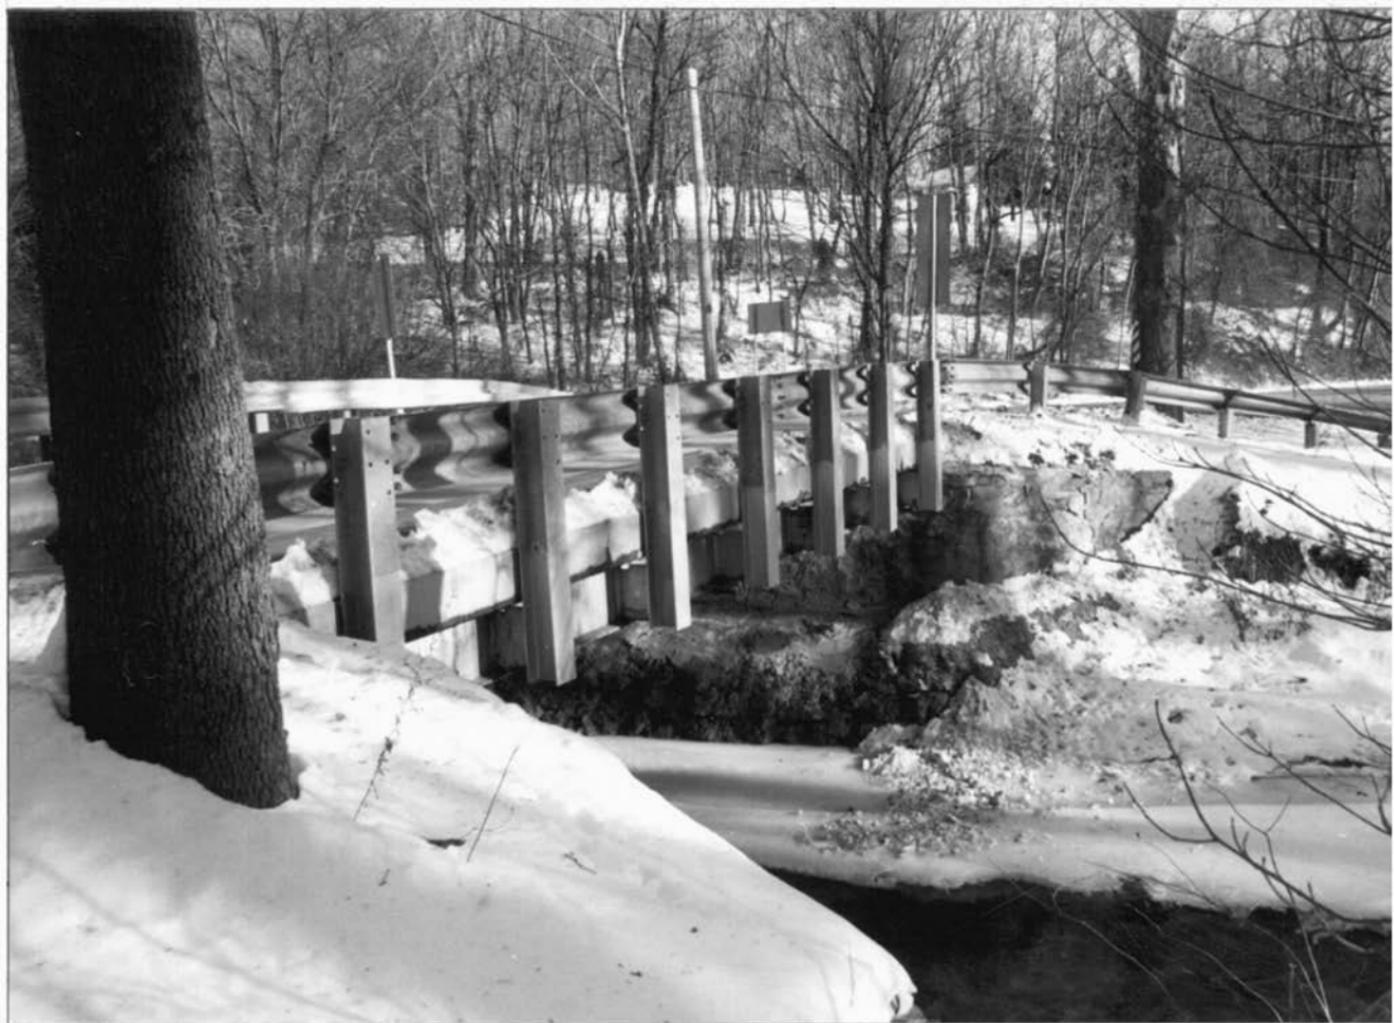
Number 15 of 21

Description EAST ELEVATION LOOKING

~~WEST~~ NORTH

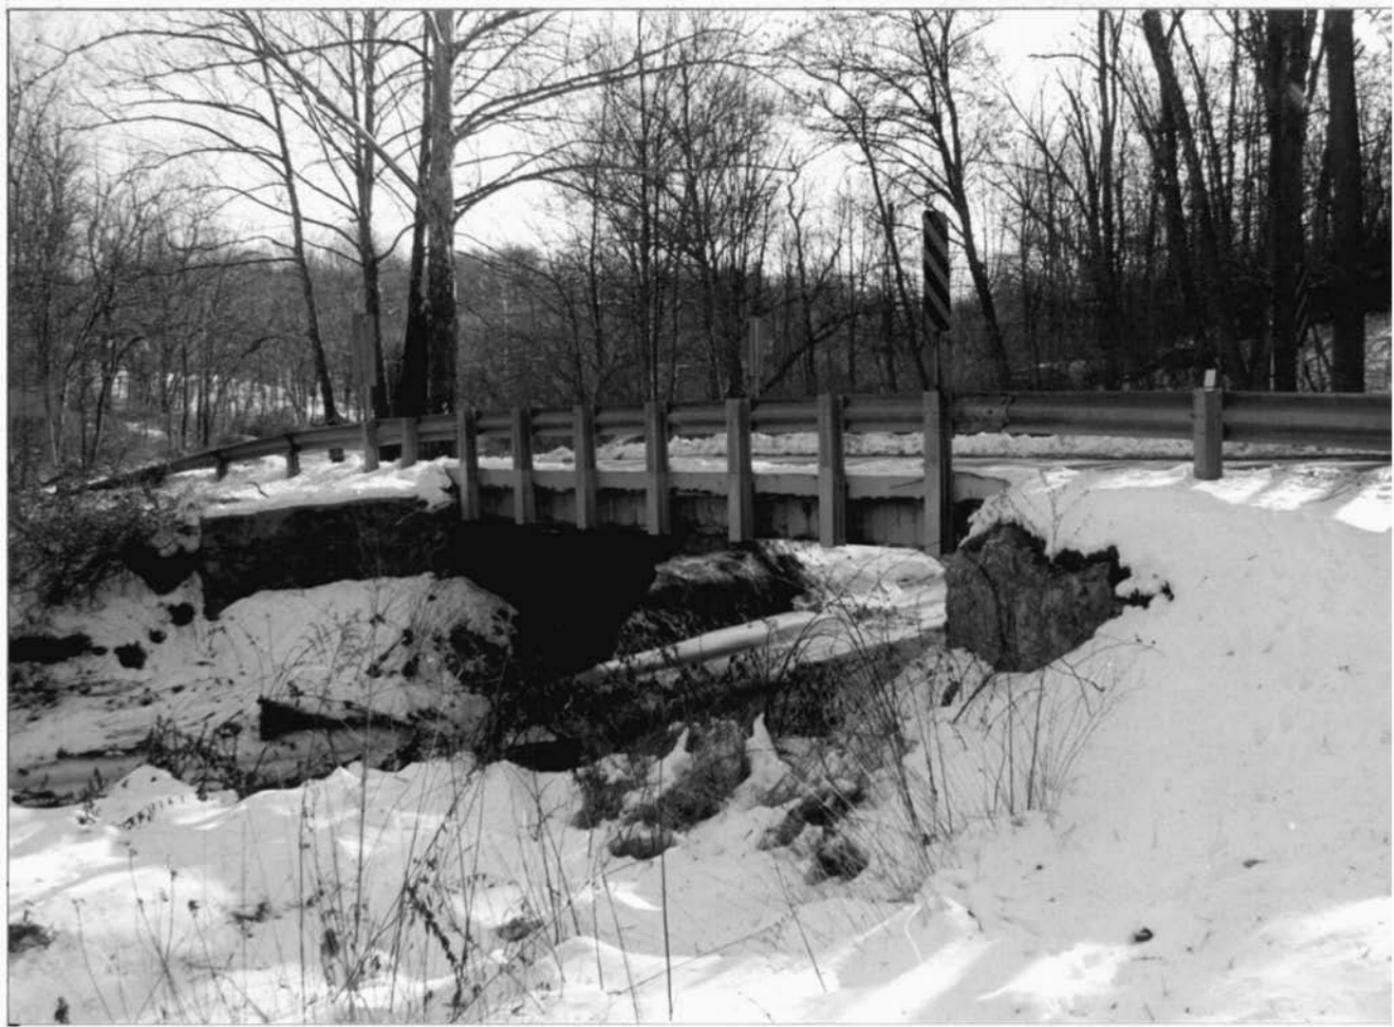
Number 4 of 4  
~~6~~ of 31

Description WEST ELEVATION LOOKING  
EAST
