Maryland Inventory of Historic Properties number: HO-663

Name: Daisey Polover Little Cattail Crk. (HO-38)

Name and SHA No. Daisy Road over Little Cattail Creek/HO38

MARYLAND HISTORICAL TRUST ADDENDUM SHEET
 DAISY ROAD BRIDGE PROJECT

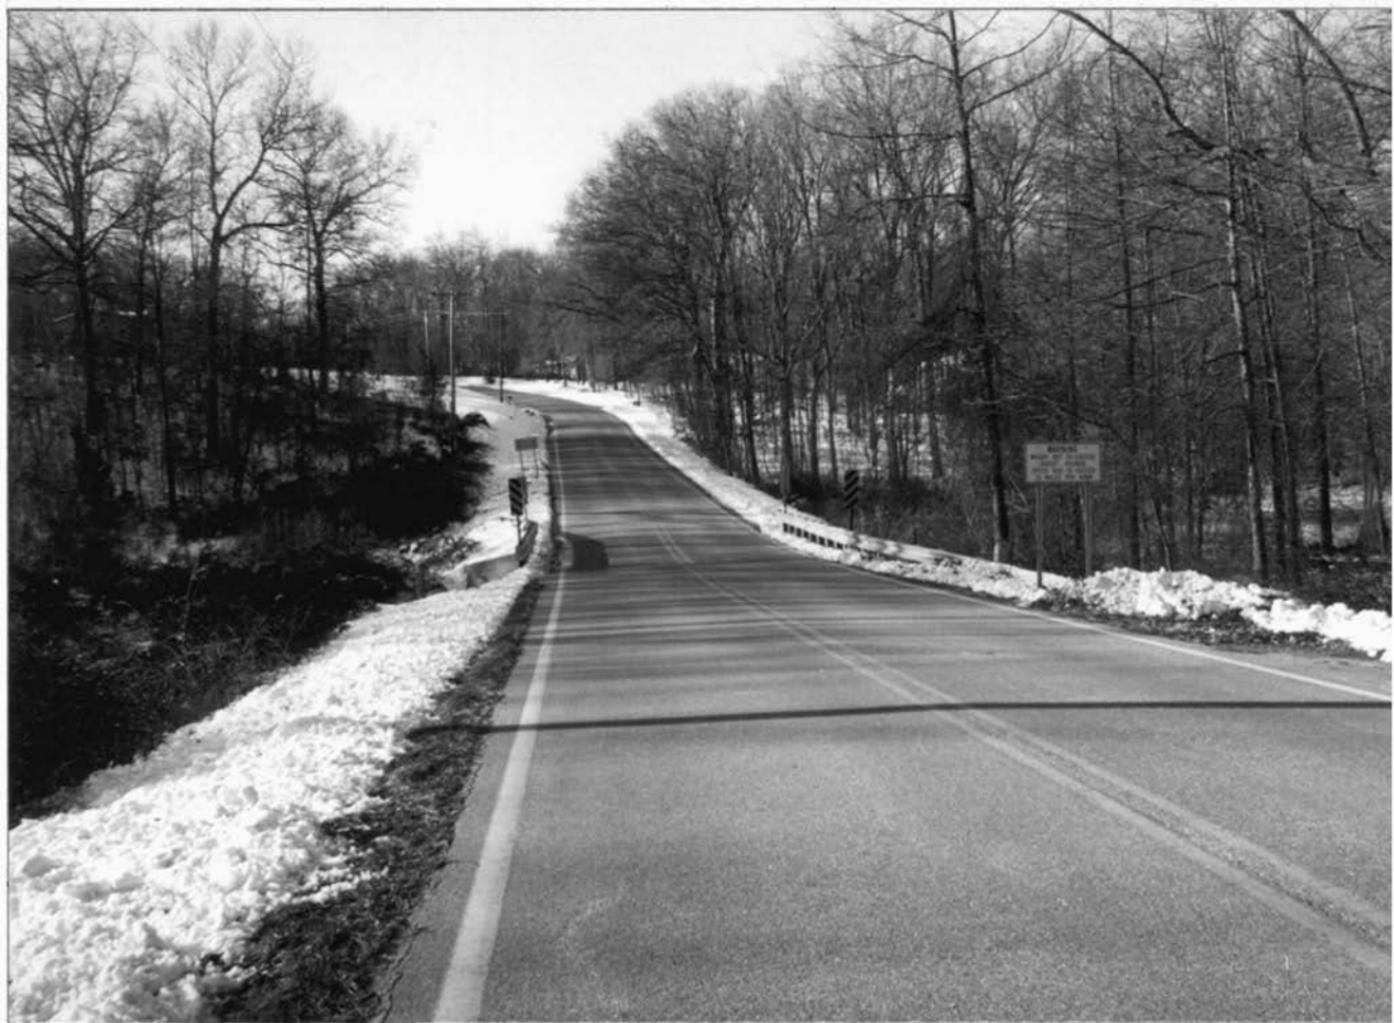
Number [↓]~~1~~ of ~~2~~⁴

Description NORTH APPROACH LOOKING SOUTH

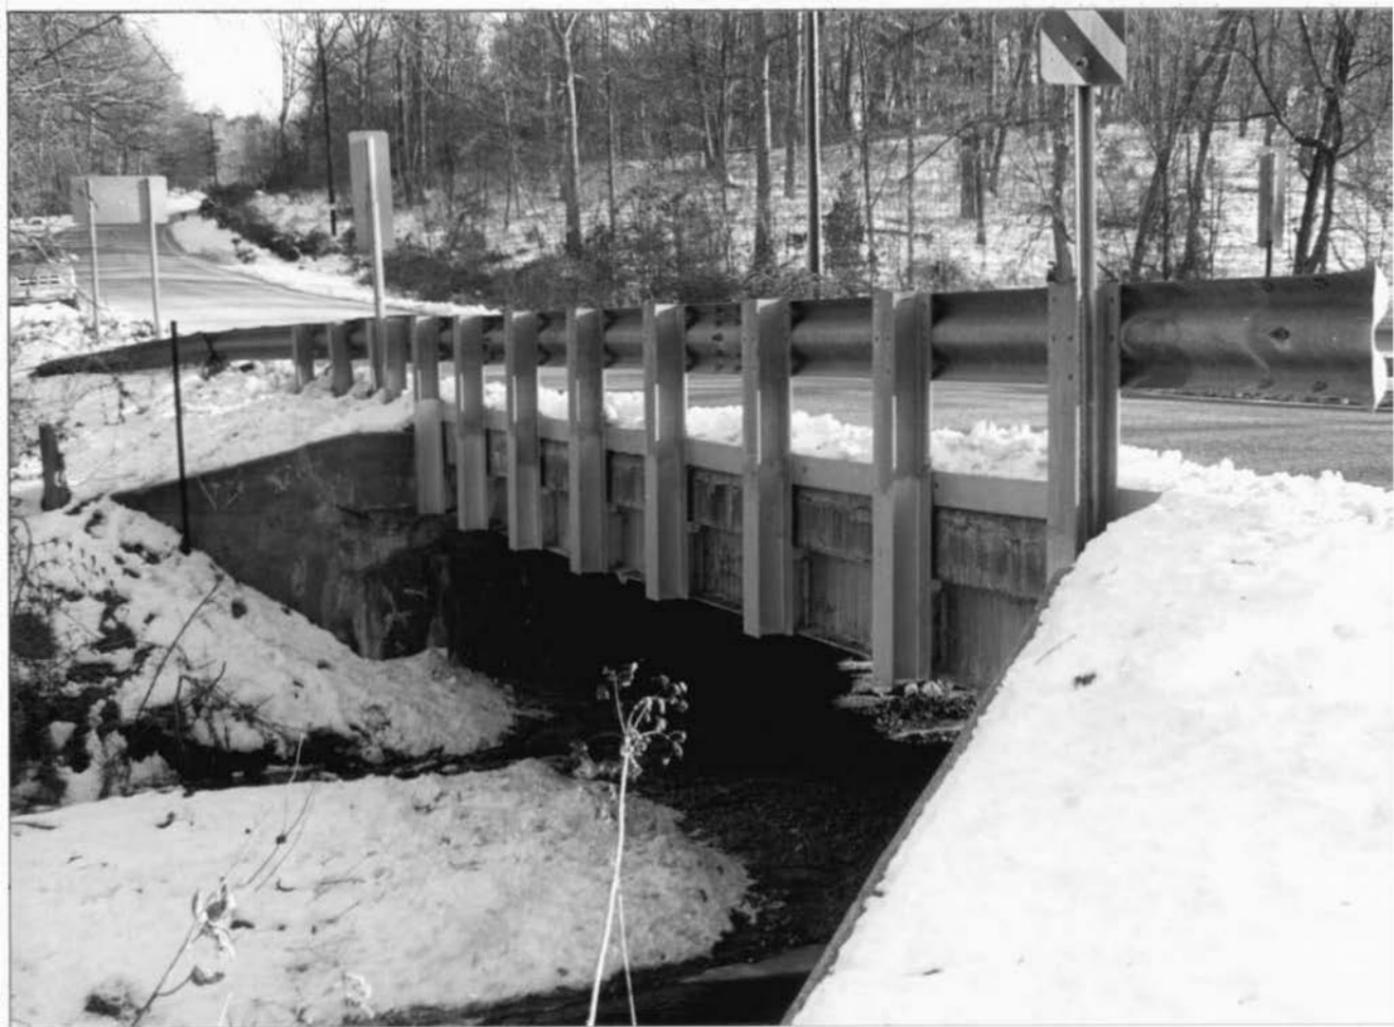
Number 3 of 4
10 of 21

Description WEST ELEVATION LOOKING

NORTHEAST

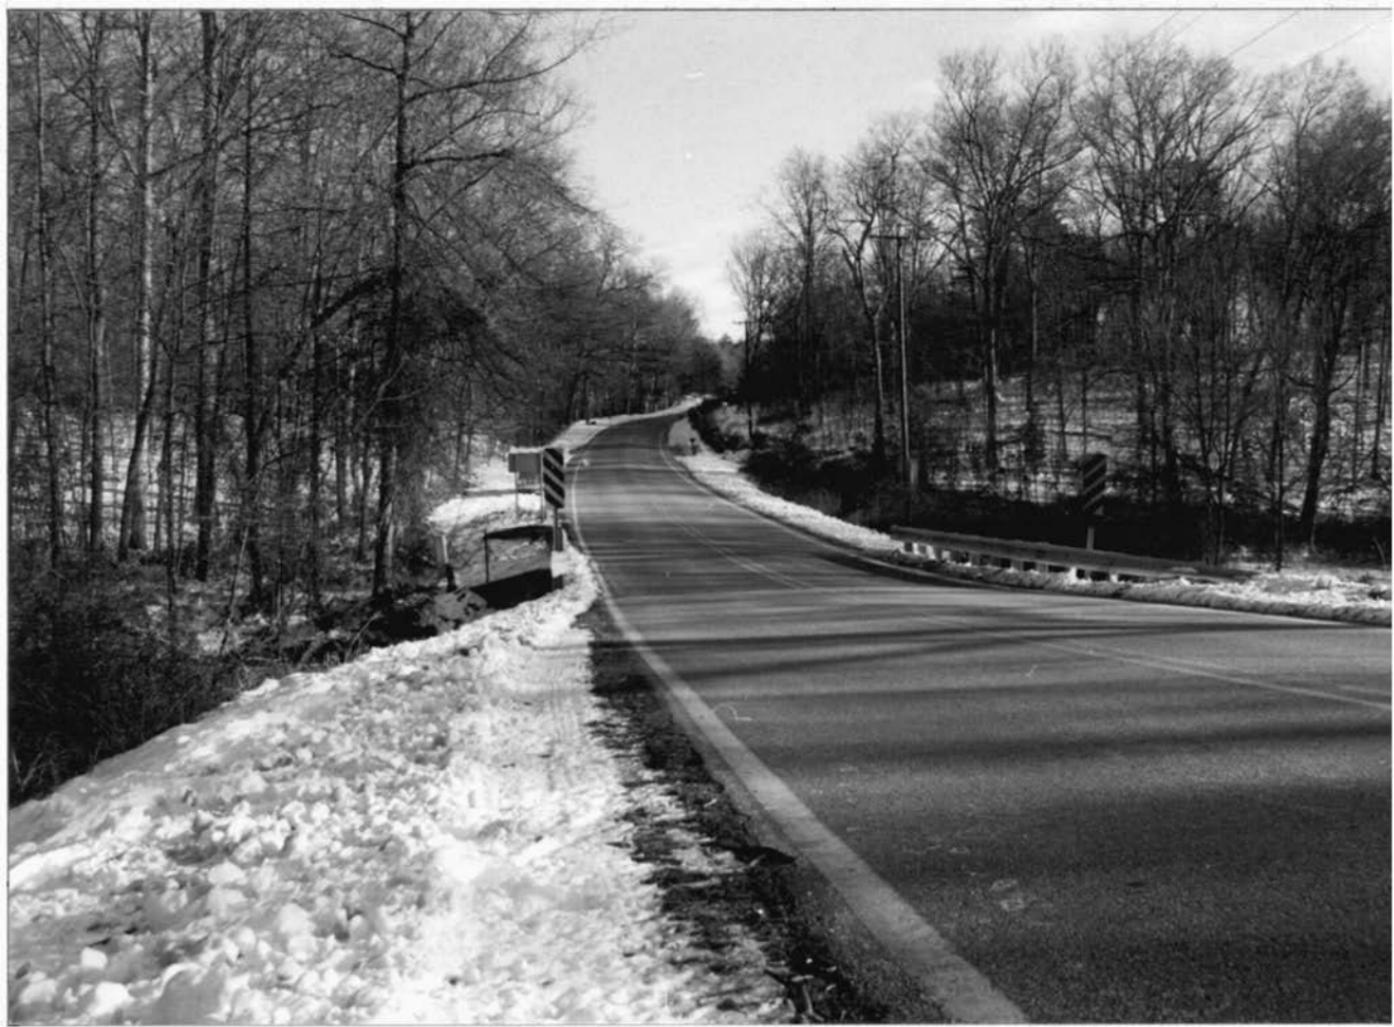
Number X of 31

Description SOUTH APPROACH LOOKING
NORTH

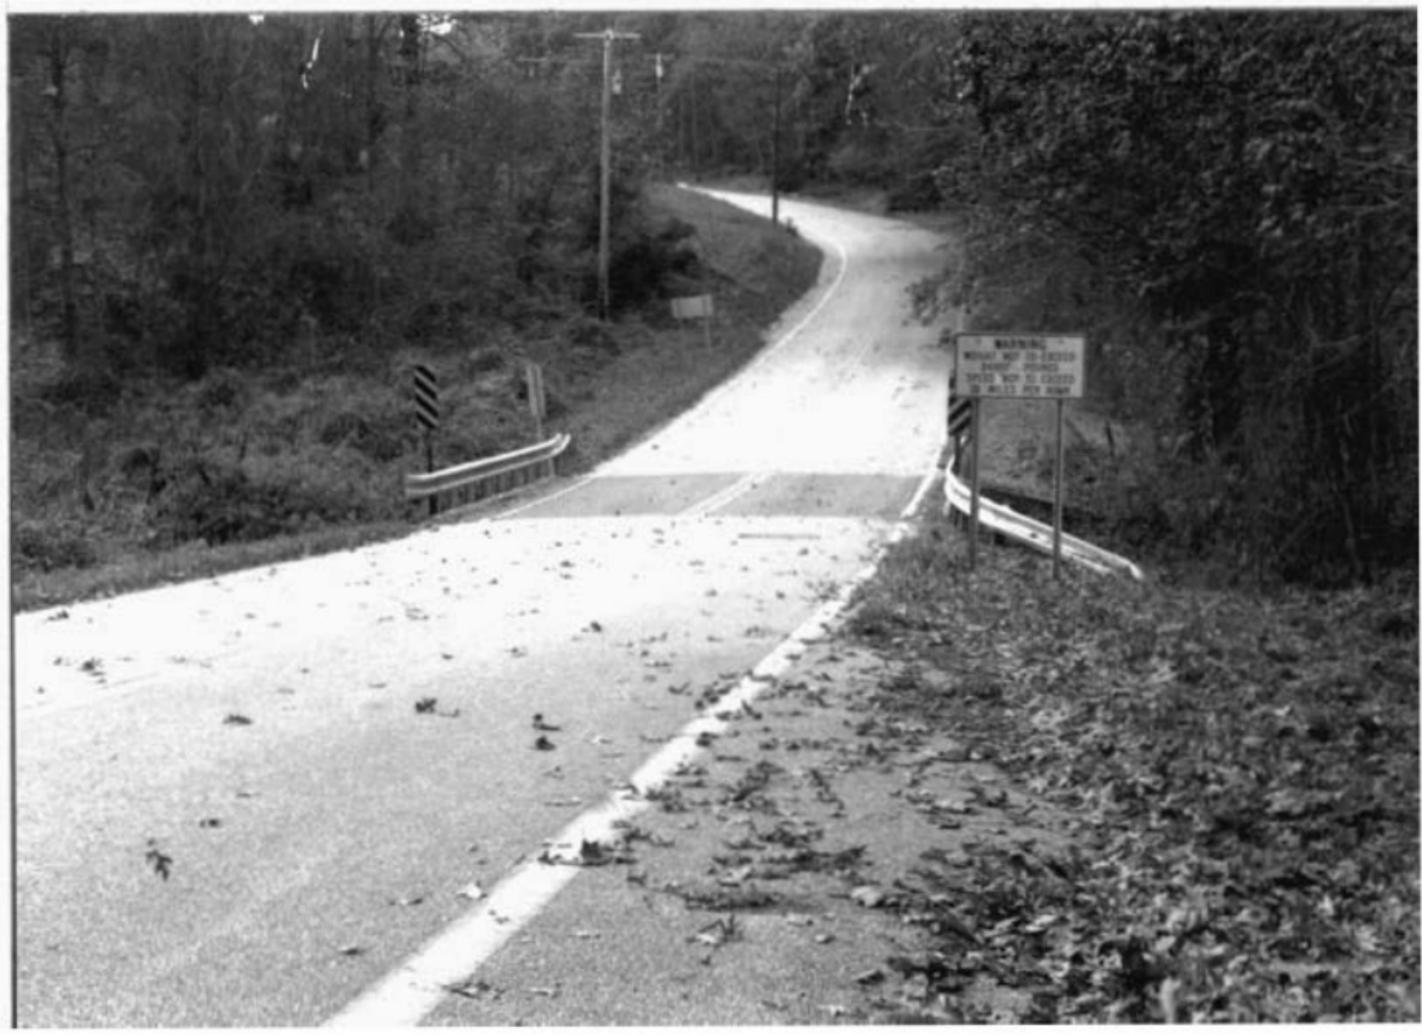
1. HO-663
2. BRIDGE HO-38, EAST OF OUR LITTLE CAMEL CREEK
3. HOWARD CO, MD
4. STEAK-HOLDER
5. NOVEMBER 1997
6. MD SHED
7. NORTH ROADWAY APPROACH, LOOKING SOUTH
8. 1 OF 6

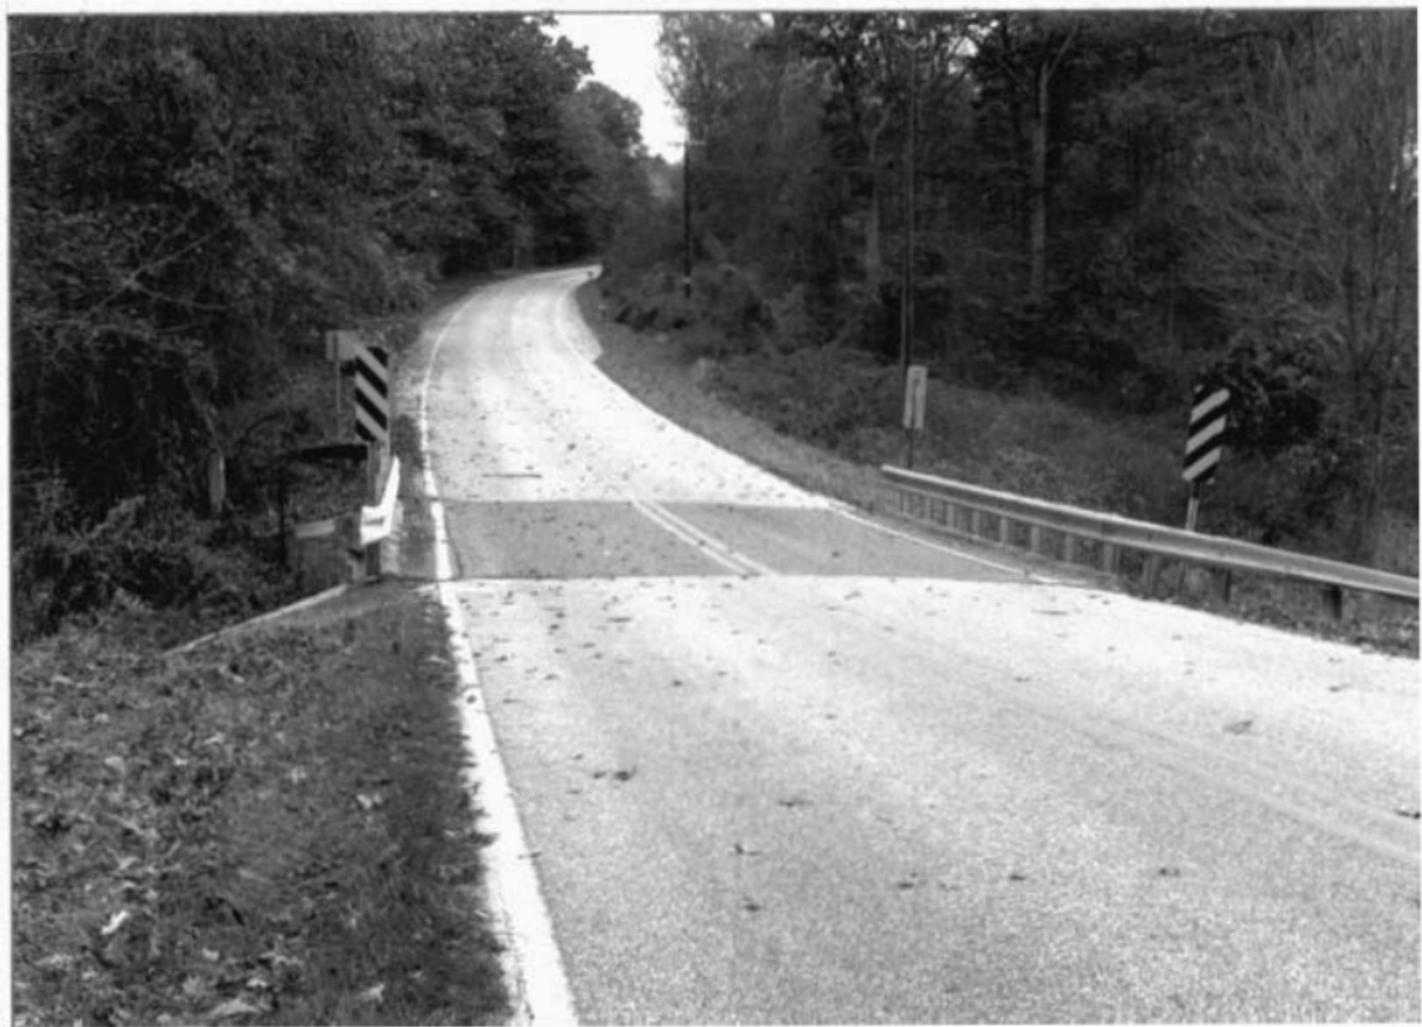
1. HO-663
2. BRIDGE HO-38, DAISY RD OVER LITTLE CATTAIL CREEK
3. HOWARD Co, MD
4. SUSAN TAYLOR
5. NOVEMBER 1997
6. M^s. SUDO
7. SOUTH - CALVERT APPROACH - LOOKING NORTHERLY
8. 2 OF 6.

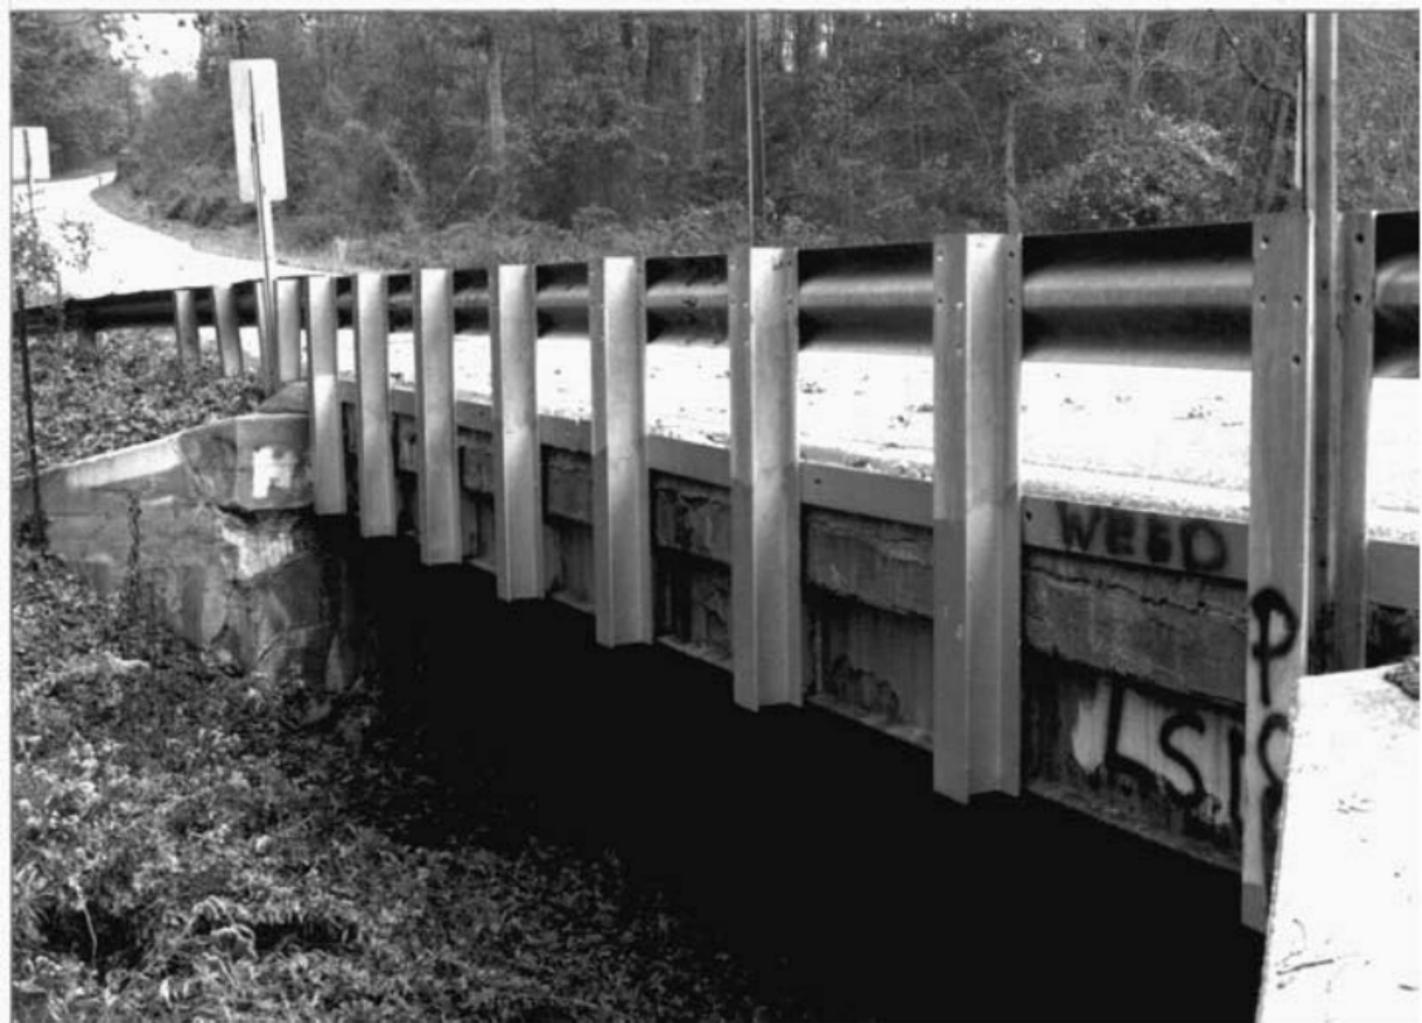
8. 3 of 6

7. W.S. ELEVATION

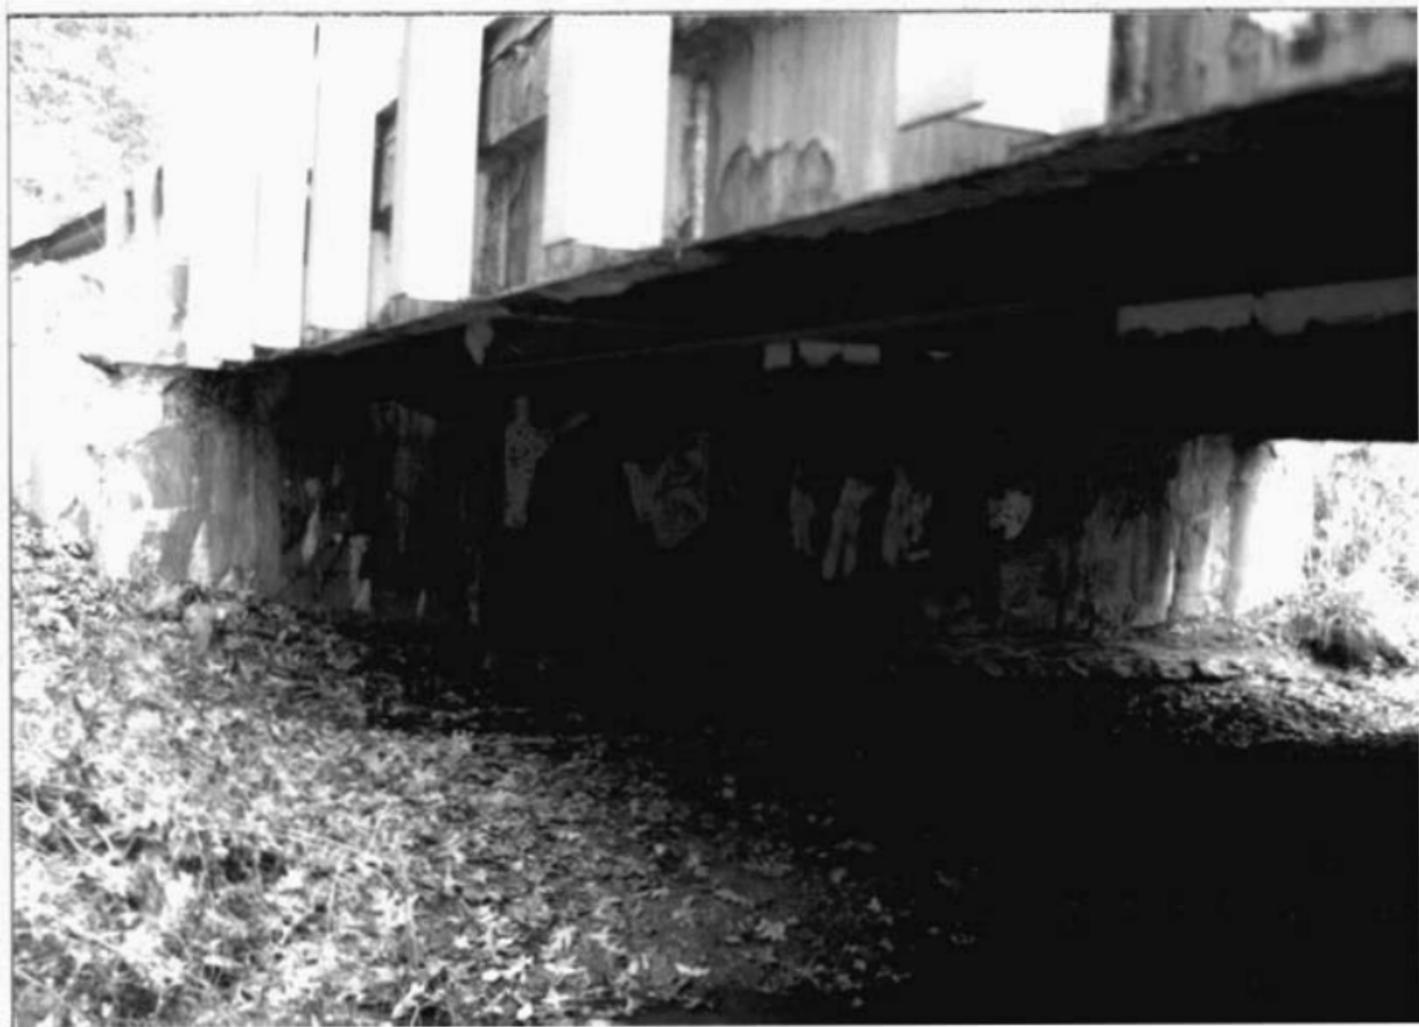
8. 5 OF 6

According to the 1997 inspection report, the superstructure is in poor condition and the substructure is in fair condition. The asphalt wearing surface is settling and cracking at the approaches. Both edges of the concrete deck exhibit large spalls. The interior girders exhibit minor loss of web and flange thickness at the supports. The exterior and first interior girders on the upstream and downstream sides of the bridge display severe corrosion with significant section loss along the bottom flanges at both abutments. The concrete on the abutments is cracked and spalling, and both abutments have been heavily patched.

7. NORTH APPOINTMENT
