Maryland Historical Trust

Maryland Inventory of Historic Properties number: HO-664

Name: Daisy Rd over Cattail Crk. (Bridge HO-41)

Maryland Inventory of Historic Properties  
Historic Bridge Inventory  
Maryland State Highway Administration  
Maryland Historical Trust

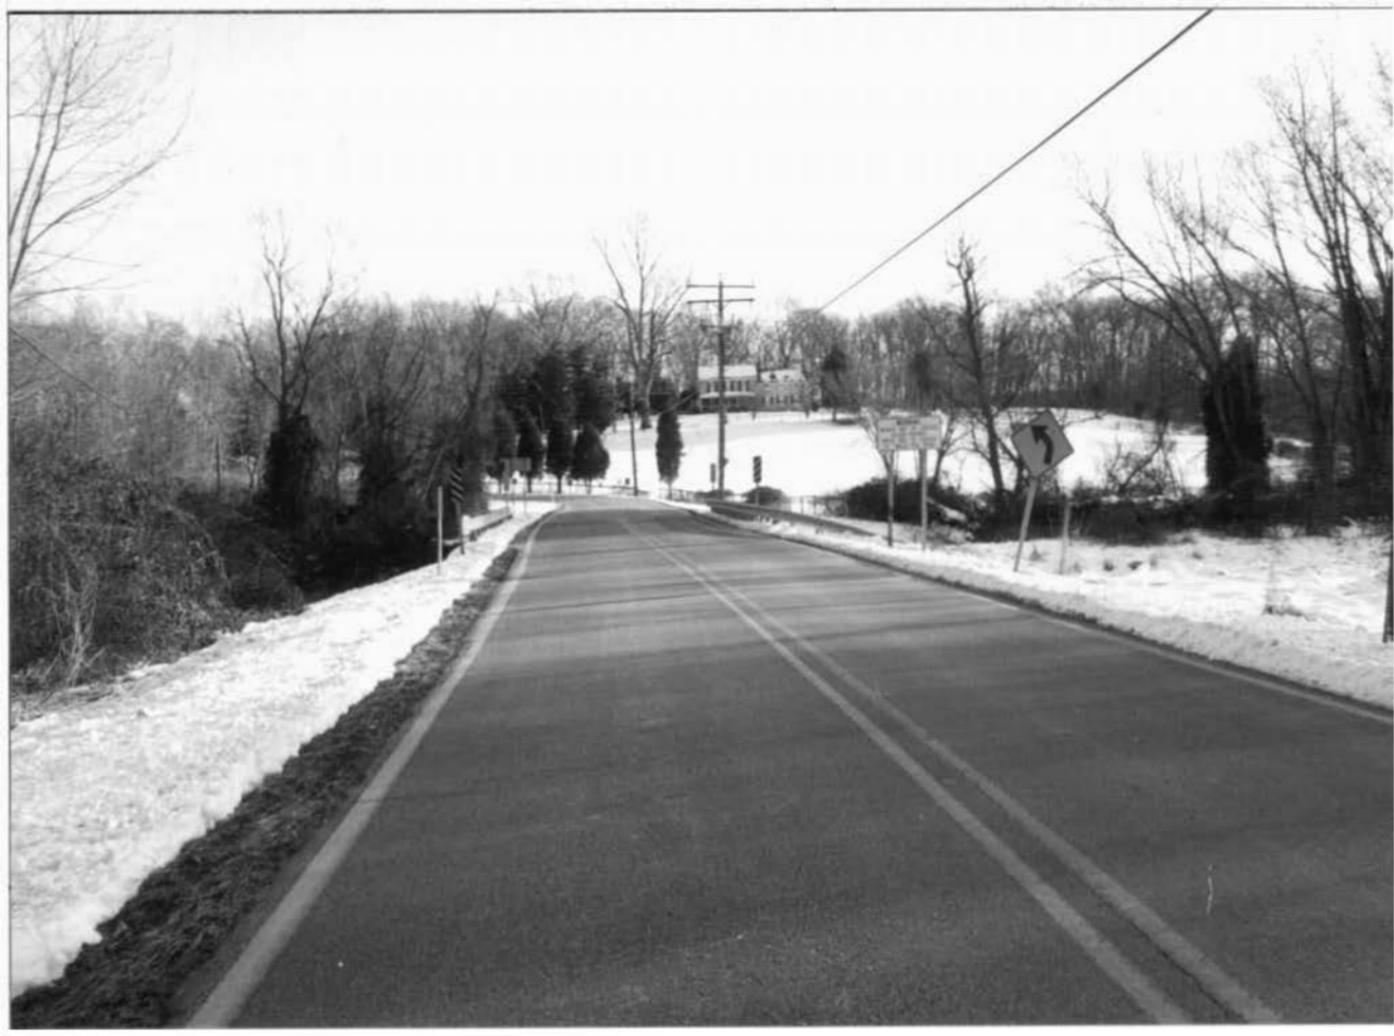
Number <sup>1</sup>~~3~~ of <sup>4</sup>~~21~~

Description West Approach Looking EAST

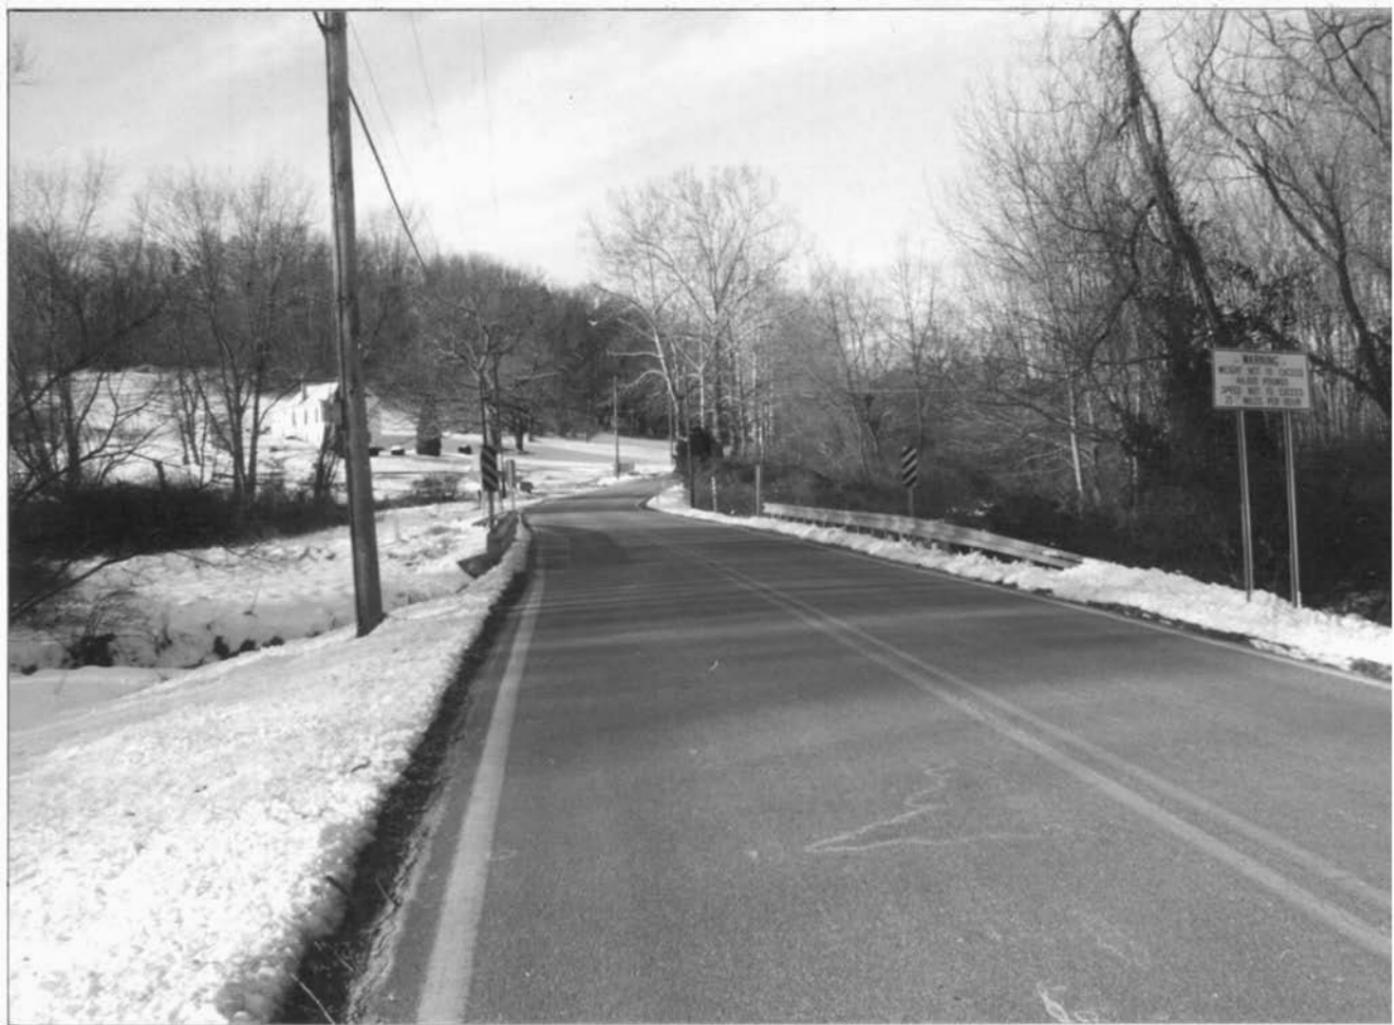
Number 2 of 4

Description EAST APPROACH LOOKING WEST

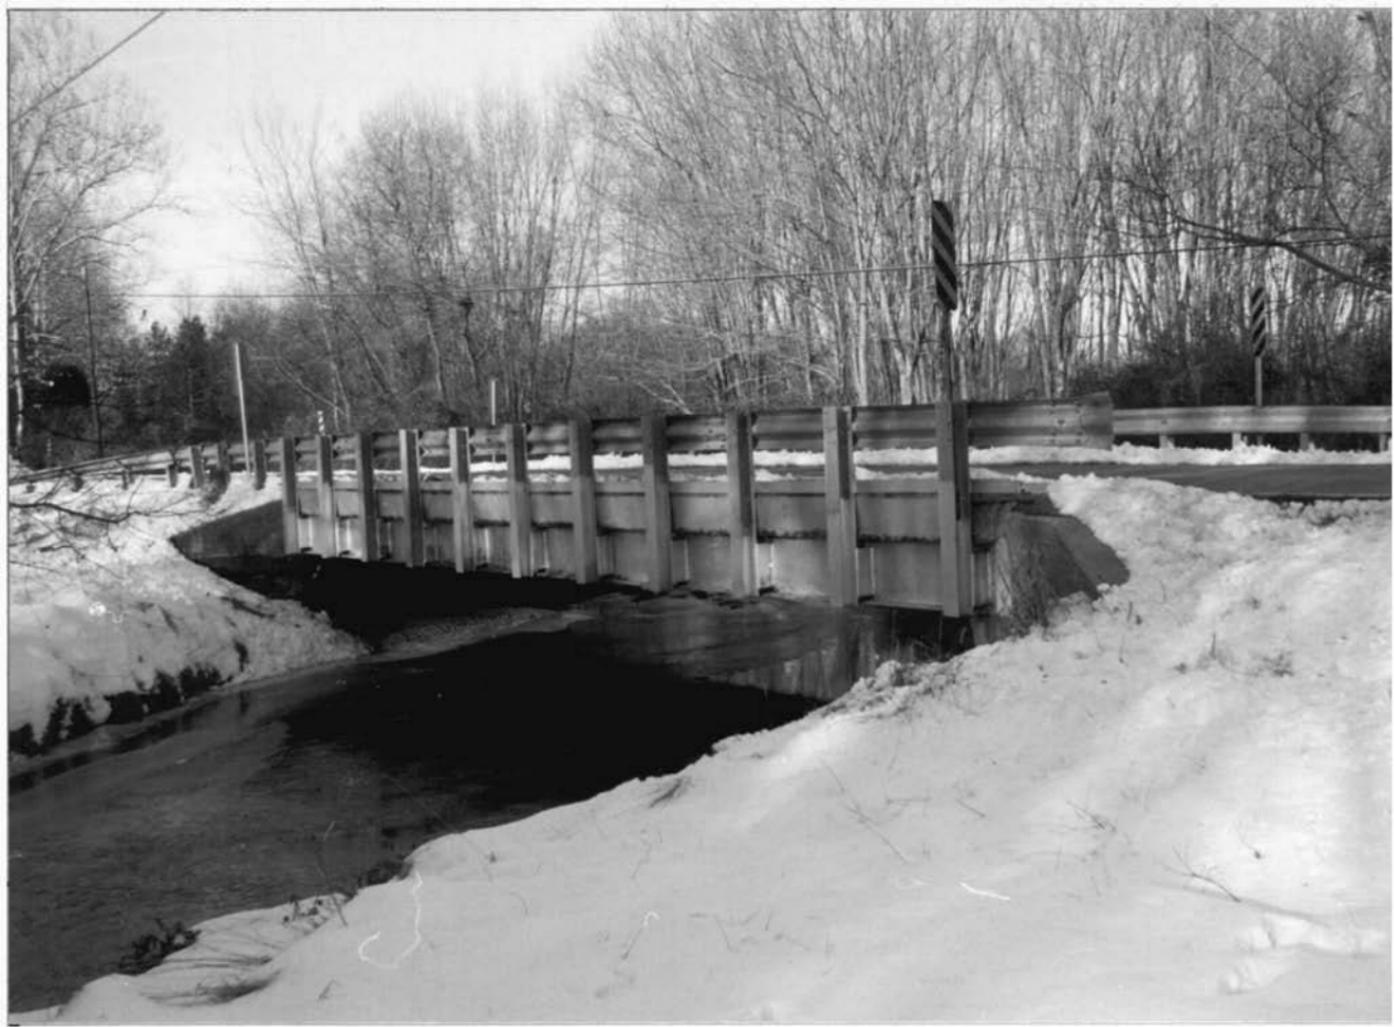
Number 3 of 4

Description SOUTH ELEVATION LOOKING

NORTH

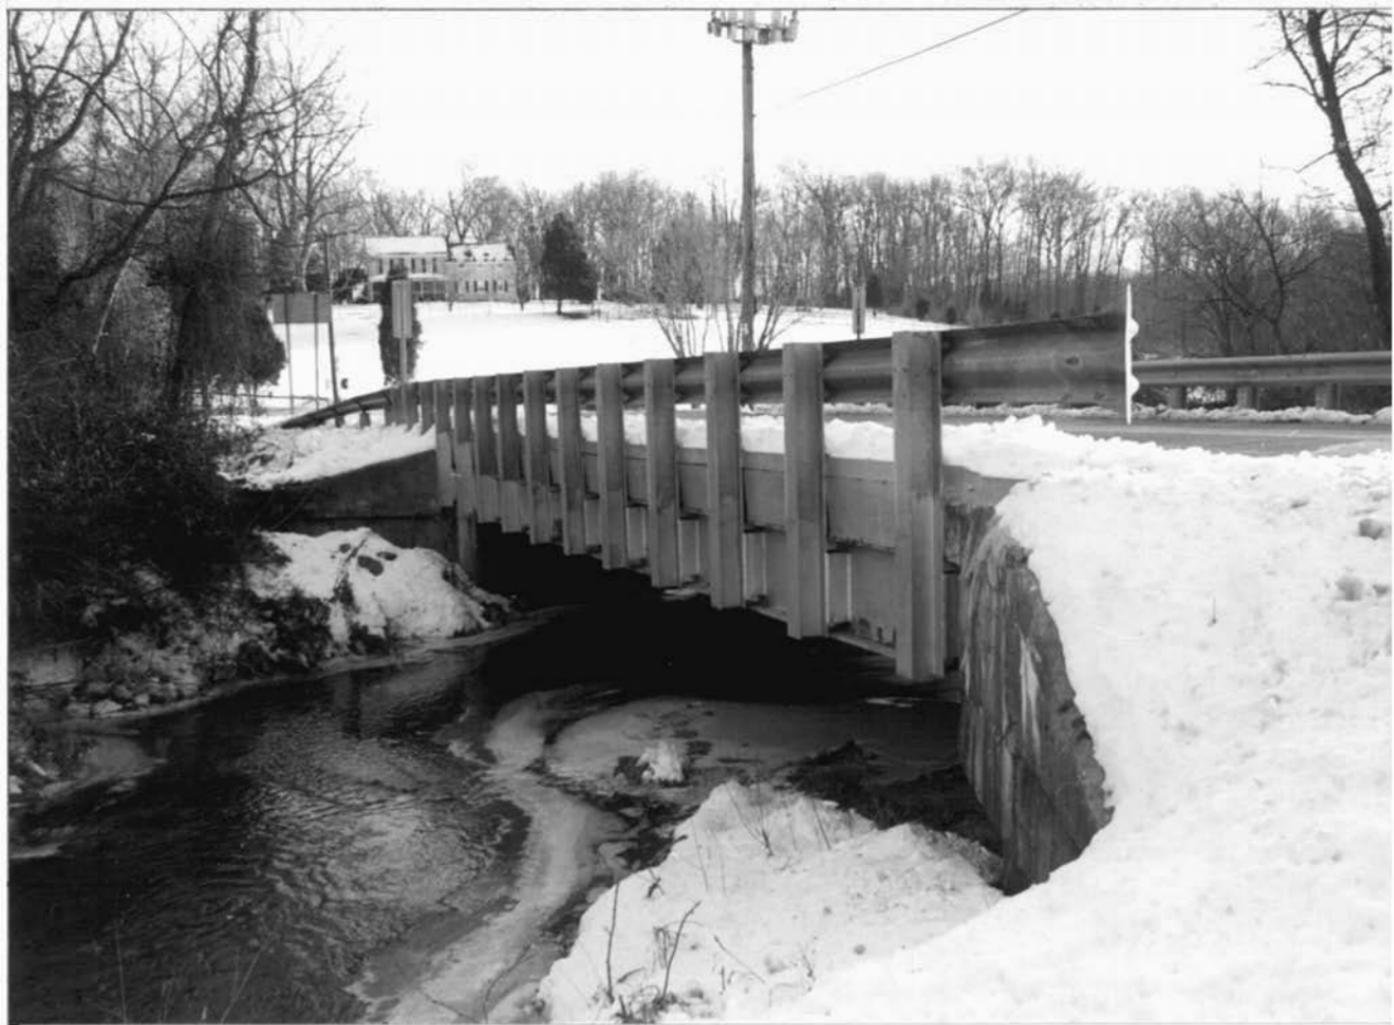
Number 4 of 4

Description NORTH ELEVATION LOOKING

SOUTH

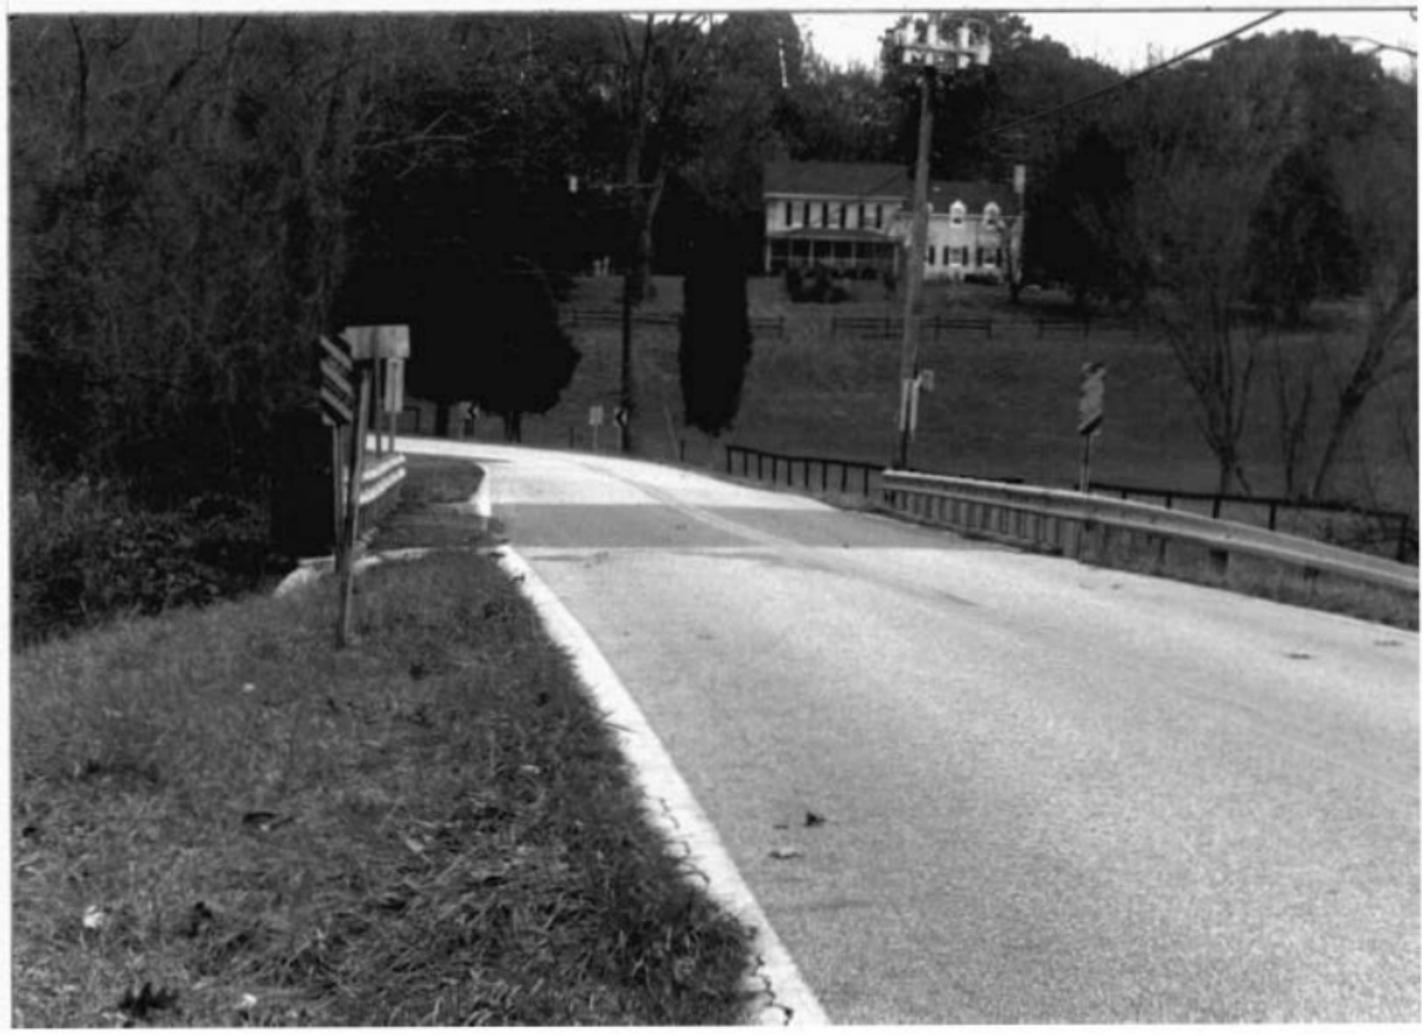
1. 43-502
2. BRIDGE 110-41 DAISY ROAD OVER CATTAIL CREEK
3. HOWARD CO. MD
4. SUSAN TAYLOR
5. NOVEMBER 1997
6. MD SHPO
7. SOUTH ROADWAY APPROACH, LOOKING NORTH
8. 1 OF 6

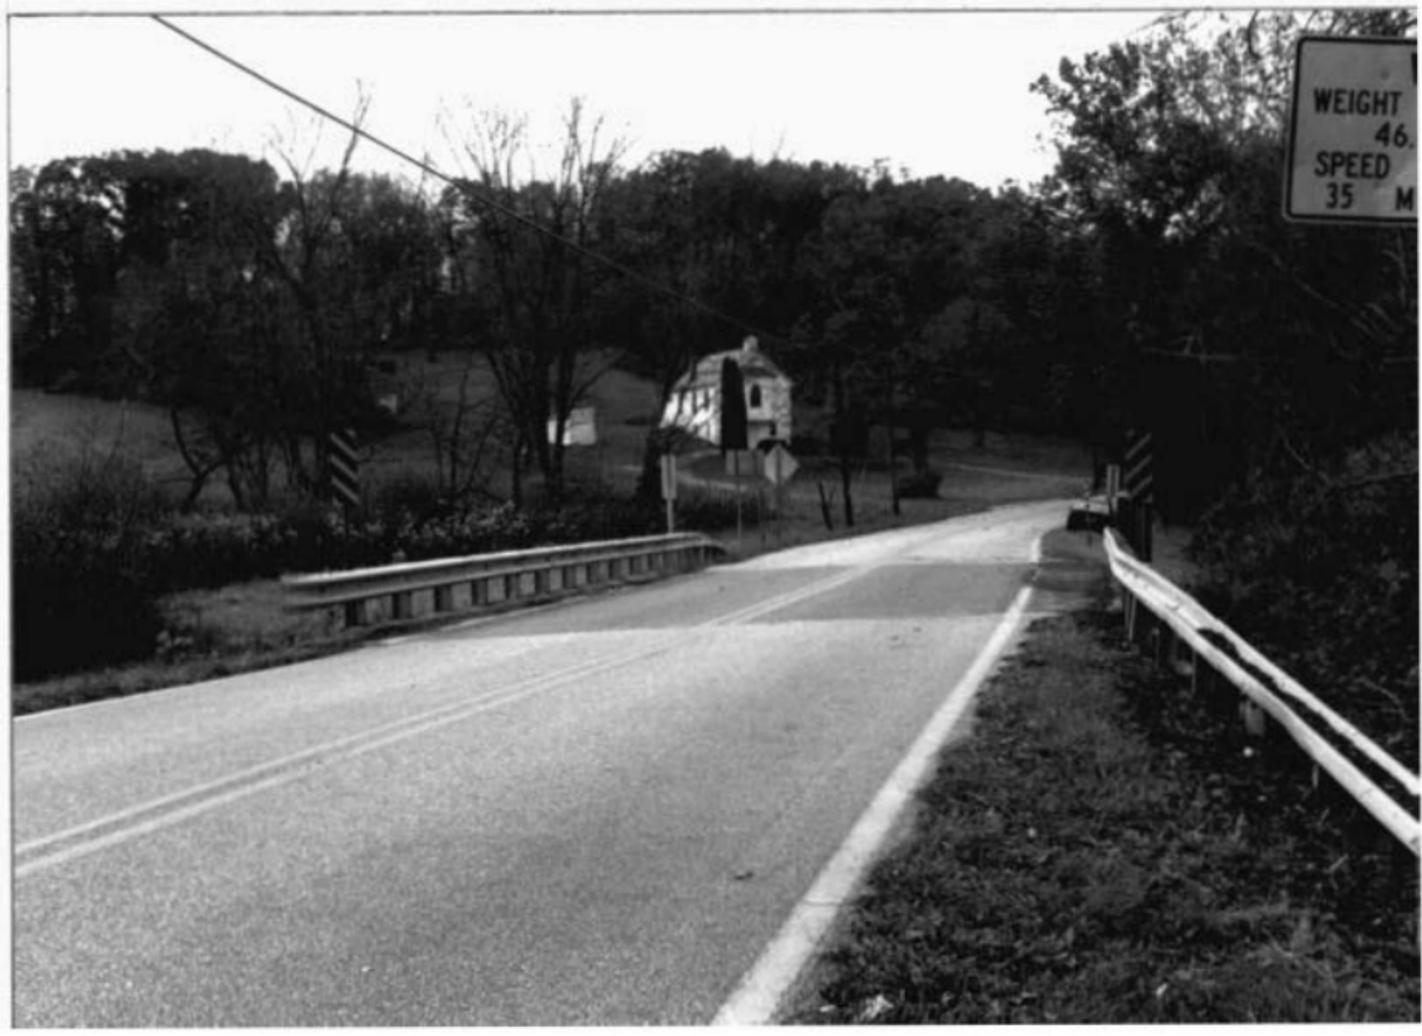
1. HO-664
  2. BRIDGE HO-41 DAISY ROAD OVER CATARAUGUS CREEK
  3. HOWARD CO., MD
  4. SUSAN TAYLOR
  5. NOVEMBER 1997
  6. MD SIDC
  7. NORTH FORWARD APPROACH, LOOKING SOUTH
- P. 2 OF 6

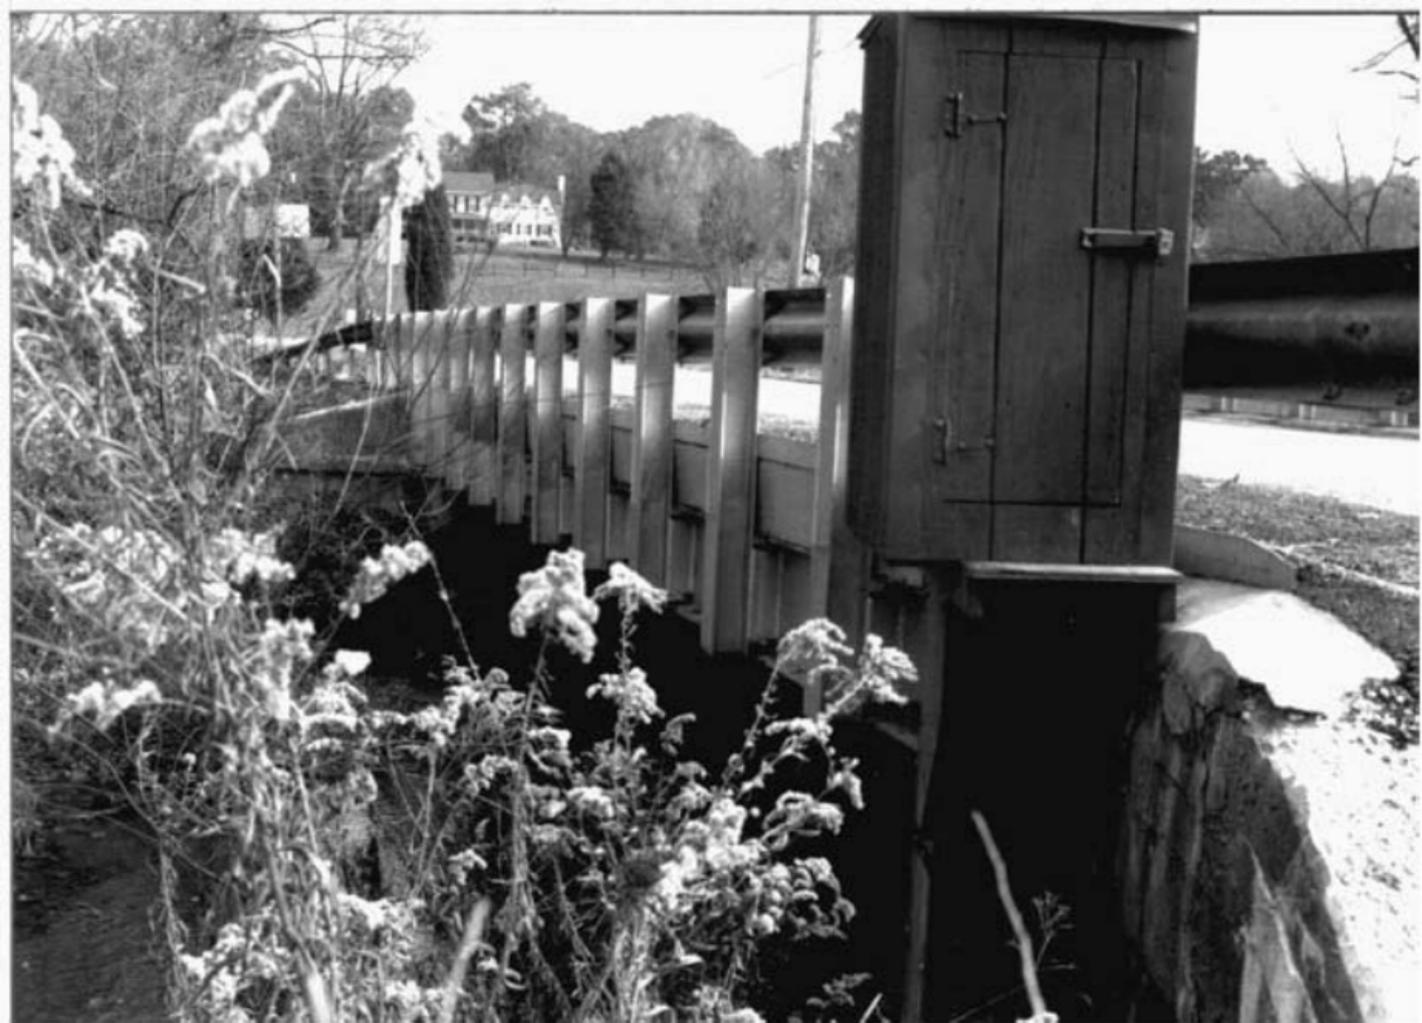
8. 4 OF 6

7. WEST ELEVATION

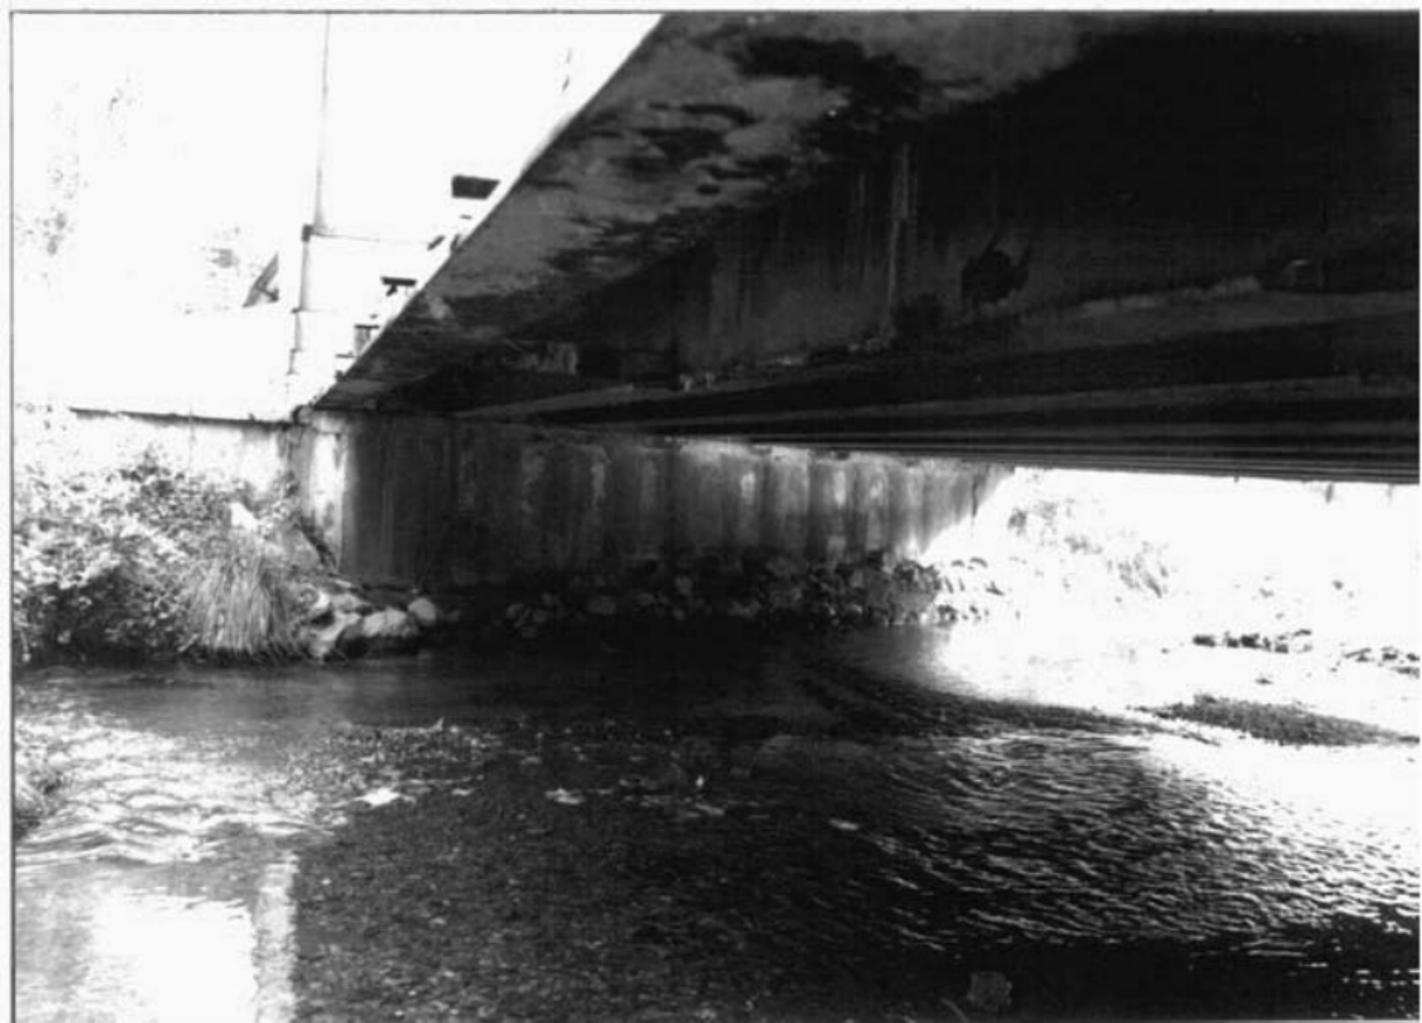
8. 6 of 6

Concrete abutments are considered primary character defining elements. There is nothing in the county inspection records to indicate that any repair work has been done to the abutments in the past. The most recent inspection report lists the substructure as being in fair condition and recommends repairing cracks and spalling in the masonry.

7 SOUTH ABUTMENT / GIRDERS

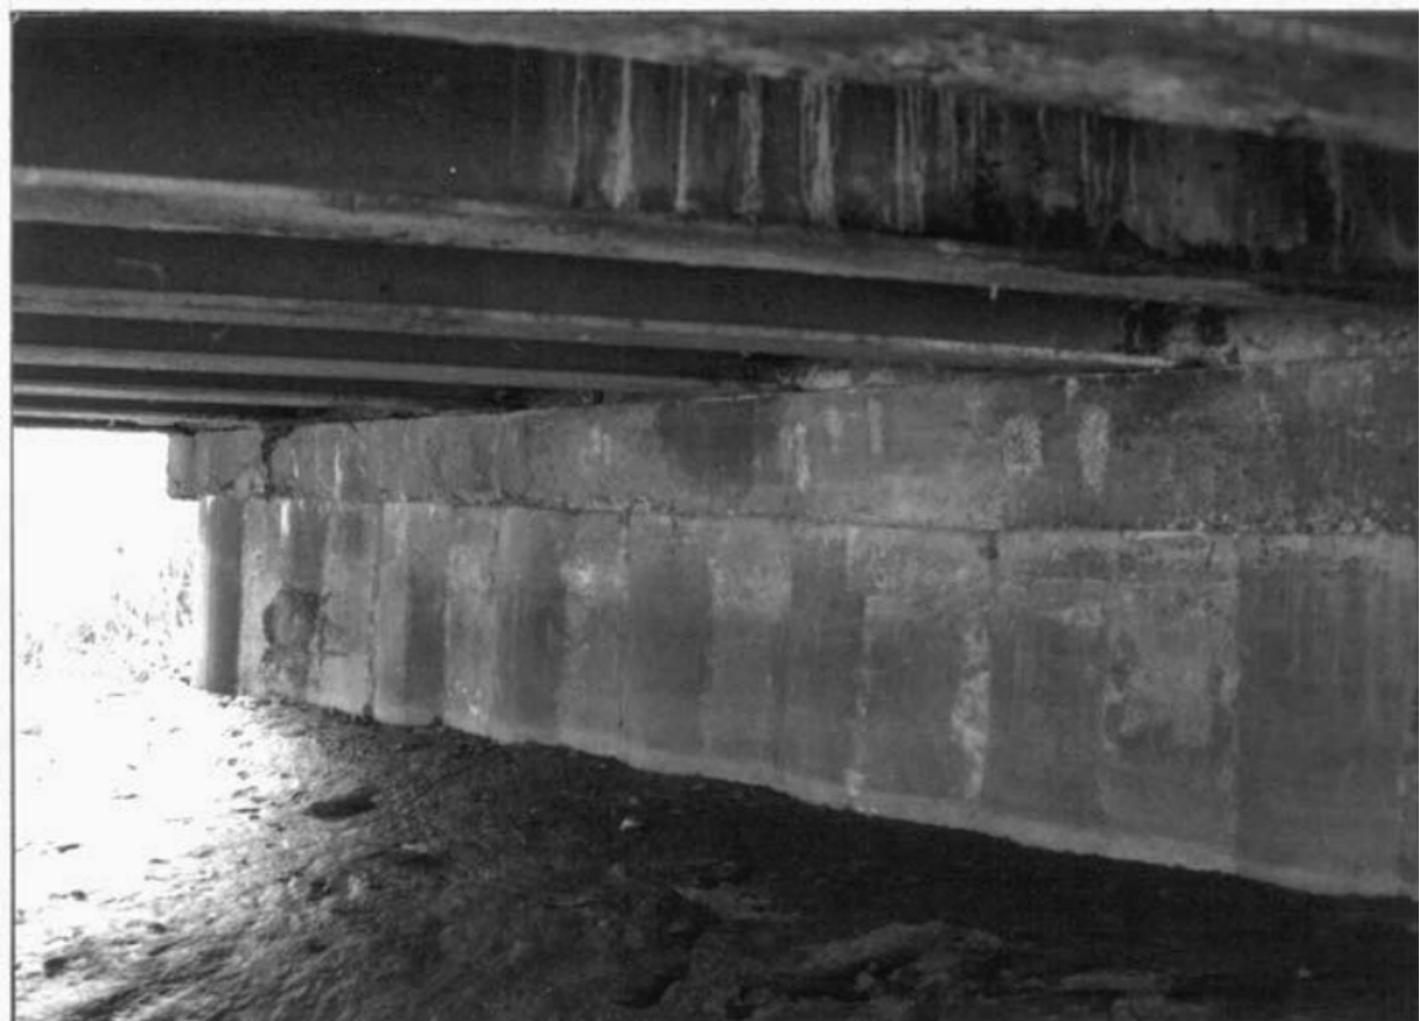
8. 5 OF 6

7. NORTH ABUTMENT & GIRDERS
