**MARYLAND HISTORICAL TRUST
NR-ELIGIBILITY REVIEW FORM**

Property Name: Small Structure No. 13166XO Inventory Number: HO-753

Address: MD 983 over Tributary of Patuxent River City: Laurel, MD Zip Code: N/A

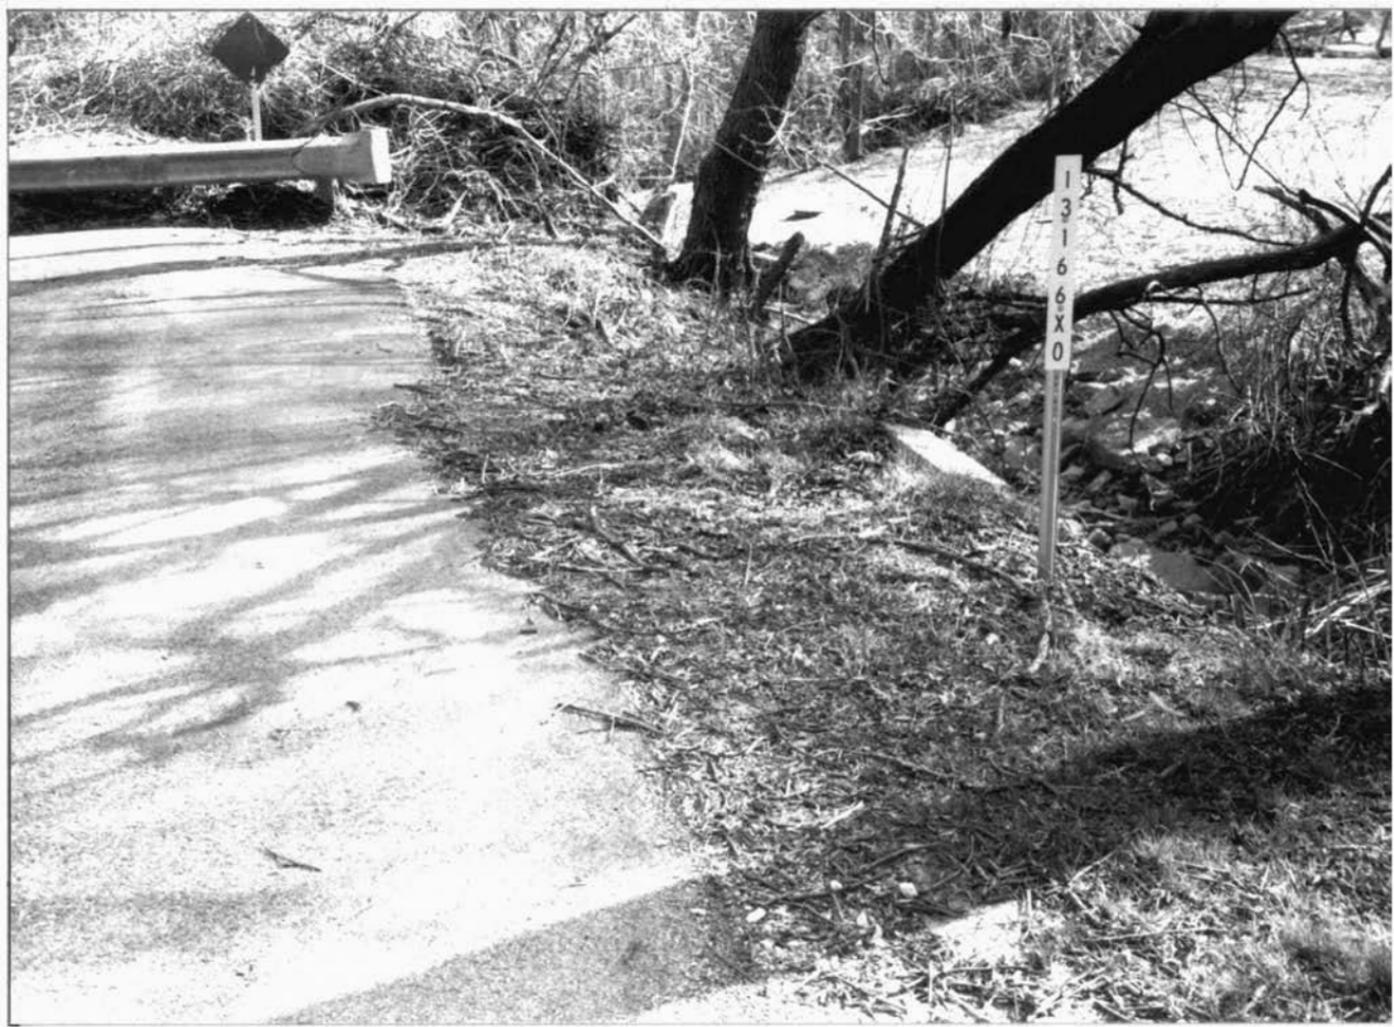
View of Inlet Road (west) at
road sign for
