Maryland Historical Trust State Historic Sites Inventory Form

Survey No. K-104

historic Bungay Hill Farm, Bungay, Bungy

NAME/ADDRESS: Bungay Hill Farm, Rock Hall, MD 21661

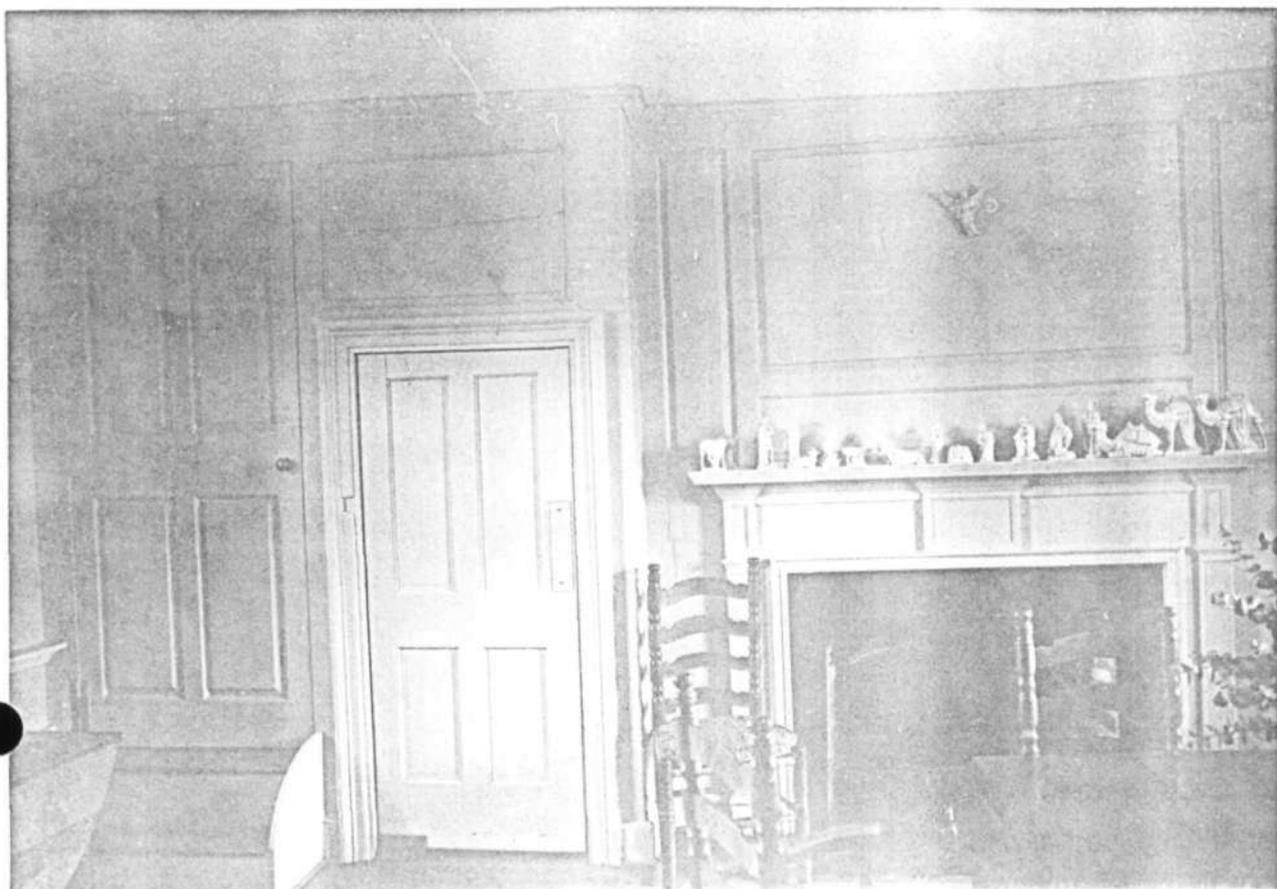
DINING ROOM, MAIN SECTION, BUNGARY HILL FARM
(K-104)

Present dining room (see photo) - Painted raised and beveled paneling, bevel similar in size to that of living room. Overmantle: one large panel above smaller one. Mantle appears later than date on house gable end, toward end of third quarter of 18th century or early 4th quarter. Pilasters have fairly bold reeding. Frieze has center and side raised, then recessed panels with a gouge-work strip between sections. Shelf is straight with composite edge, including a cyma. Alterations around the mantle in addition to the style of the mantle may indicate the mantle is a later addition to the room. Some Federal elements.
