Samuel Massey House

# Maryland Historical Trust State Historic Sites Inventory Form

and/or common Samuel Massey Farm

Survey No. K-157

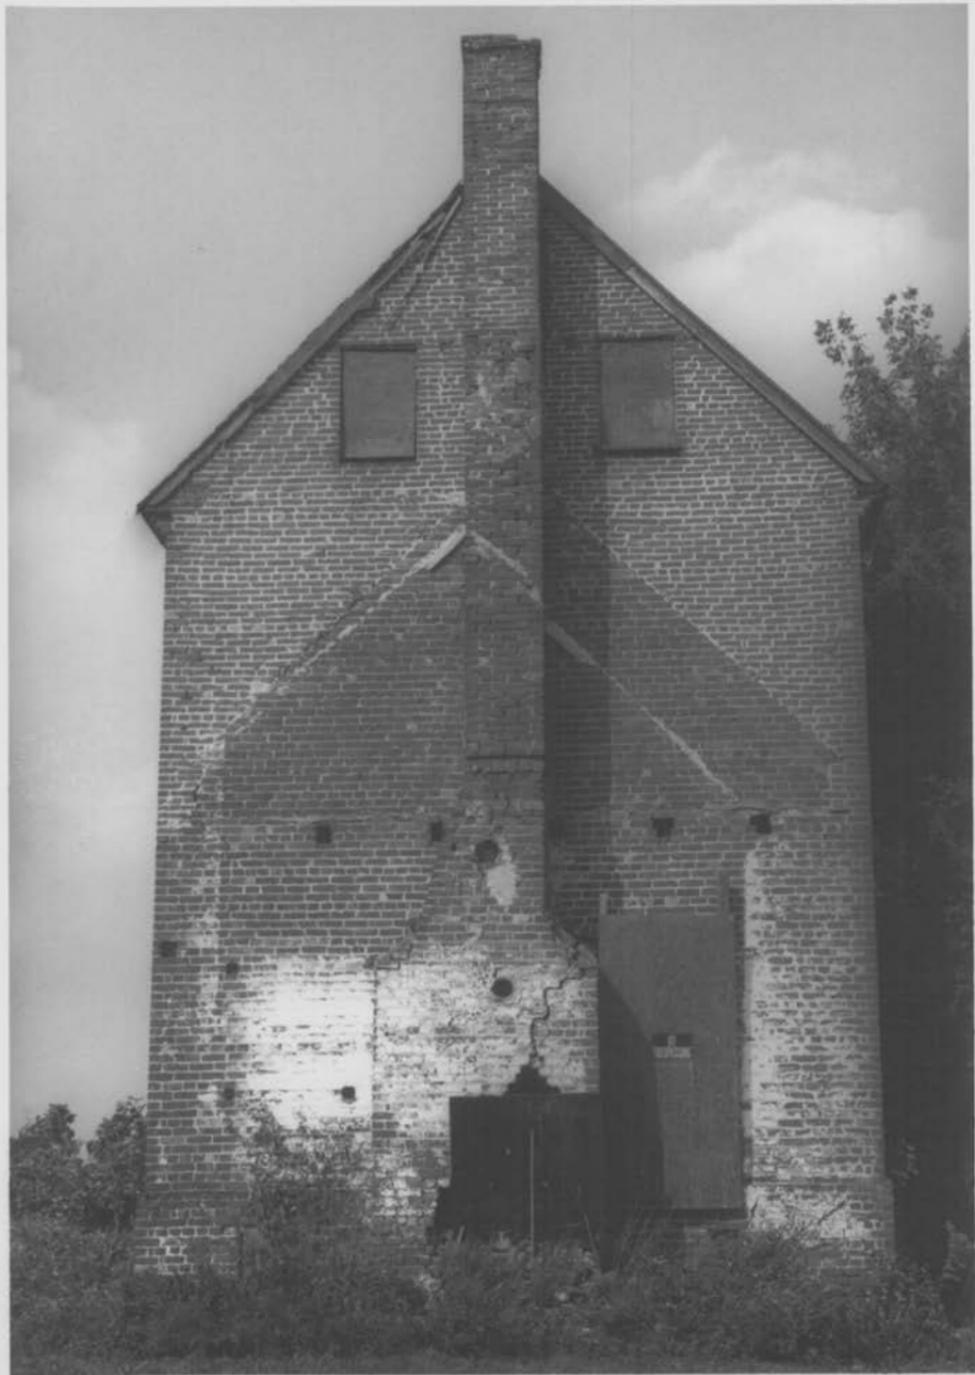
Samuel Massey Farm  
Rt. 299, near Sassafras  
M. Q. Fallaw - 7/30/86  
View to north

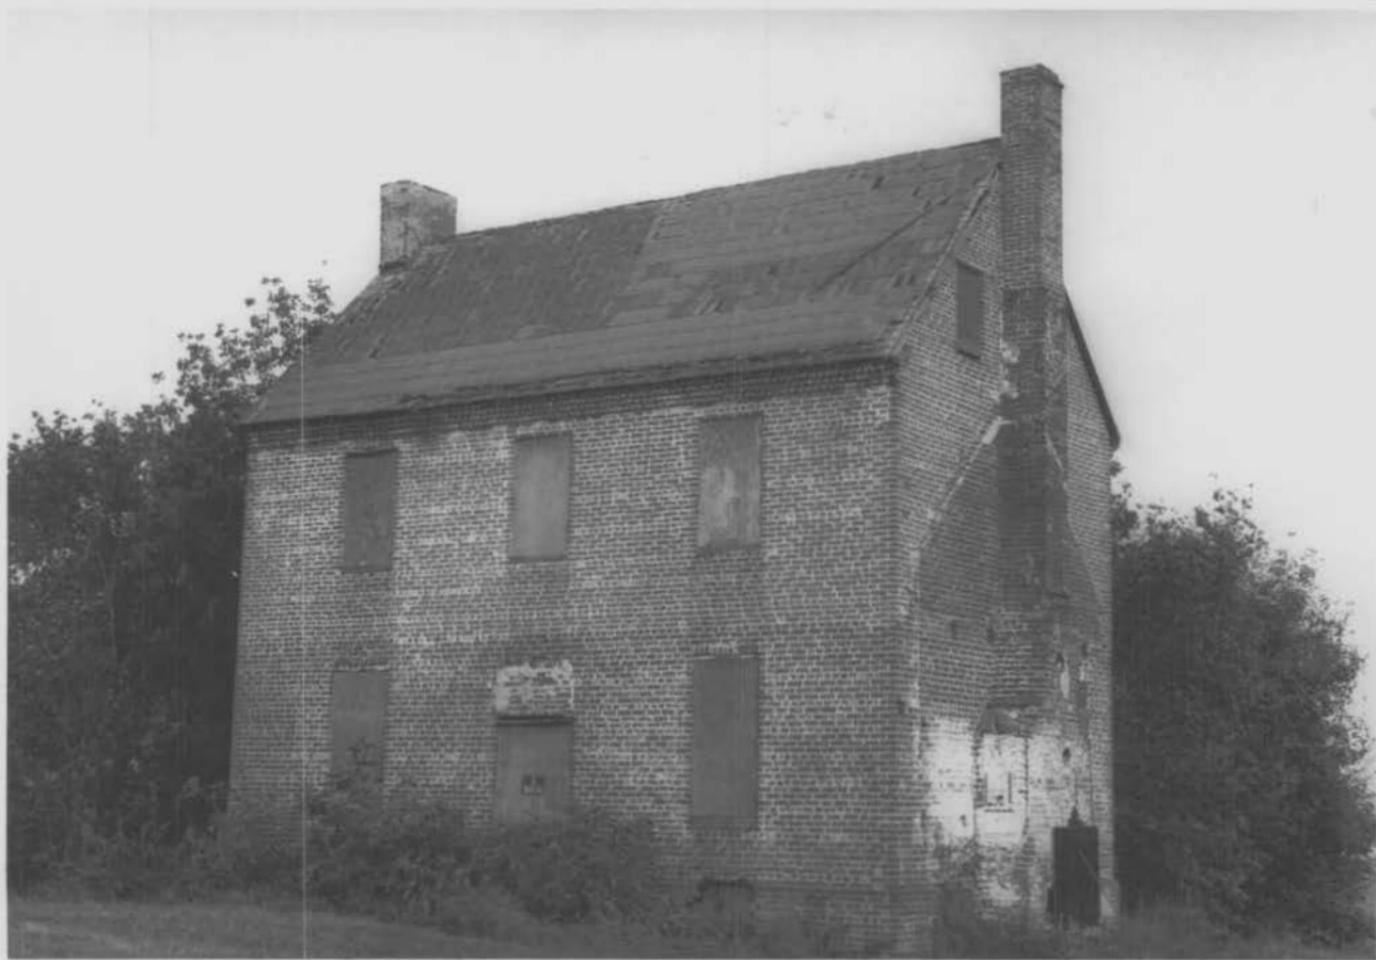
114-27  
K-157  
Samuel Massey Farm  
Rt. 299, near Sassafras  
M. Q. Fallaw - 7/30/86  
View to northeast
