Maryland Historical Trust

Maryland Inventory of Historic Properties number: ~~PG 85B-11~~
Name: Cedarville Balover Mattawoman
Crk

Maryland Historic Highway Bridges
 Bridge Type Metal Girder
 Map H-11 Mattawoman
 County Prince George's
 Bridge # and name P 407/Cedarville Rd. over Mattawoman Creek

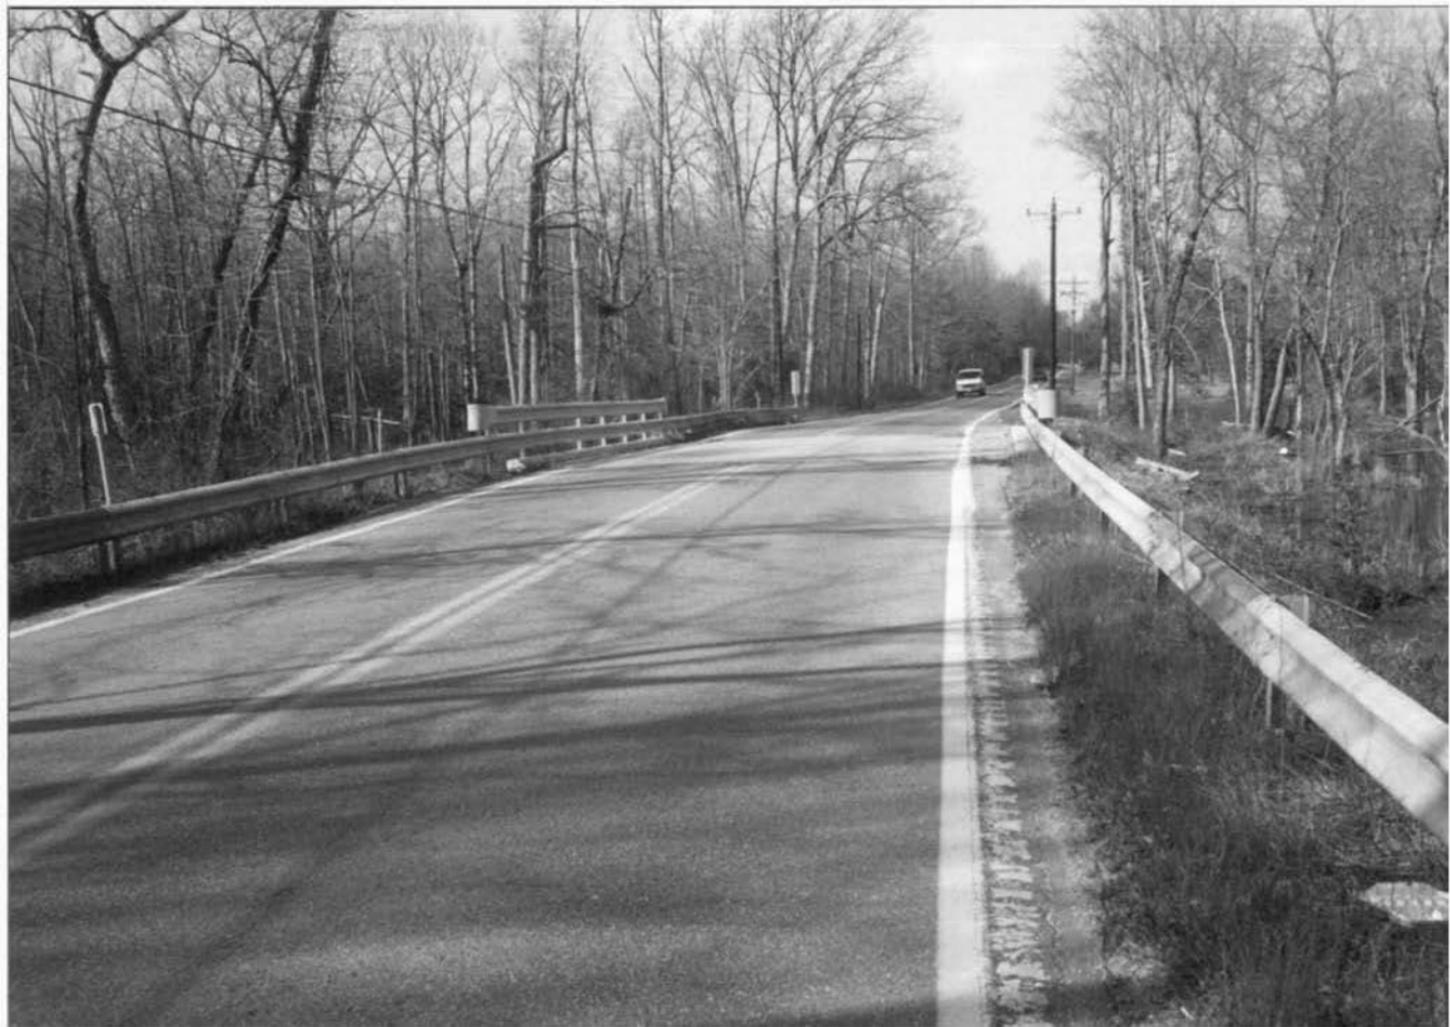
Number 1⁴
~~23~~ of ~~24~~

Description EAST APPROACH LOOKING WEST

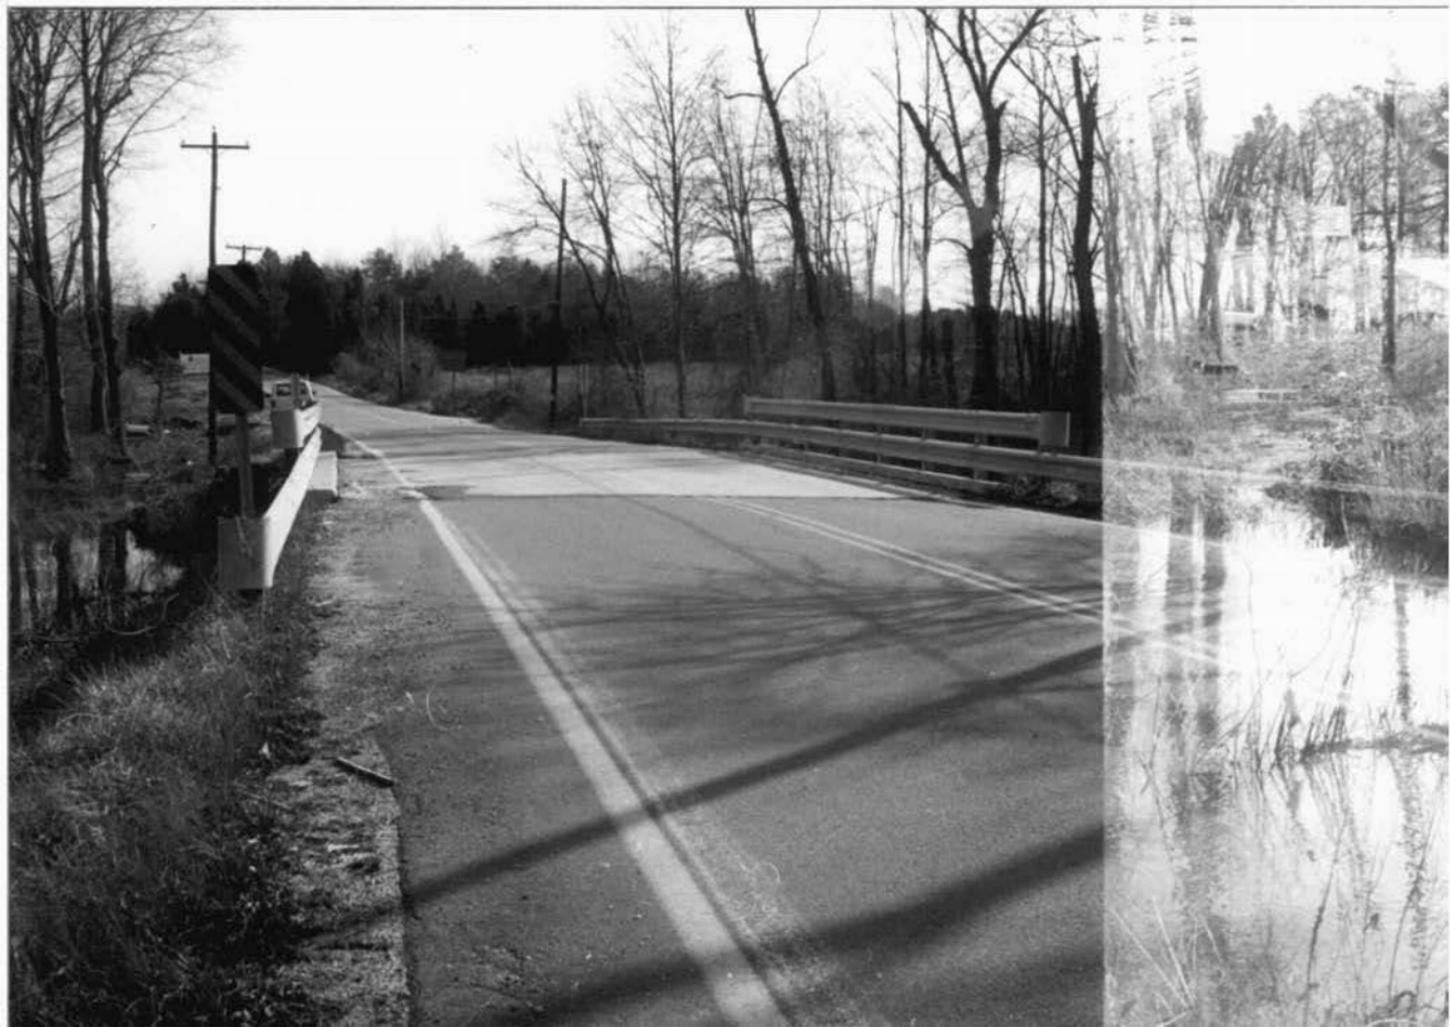
Number 2 of 4

Description WEST APPROACH LOOKING EAST

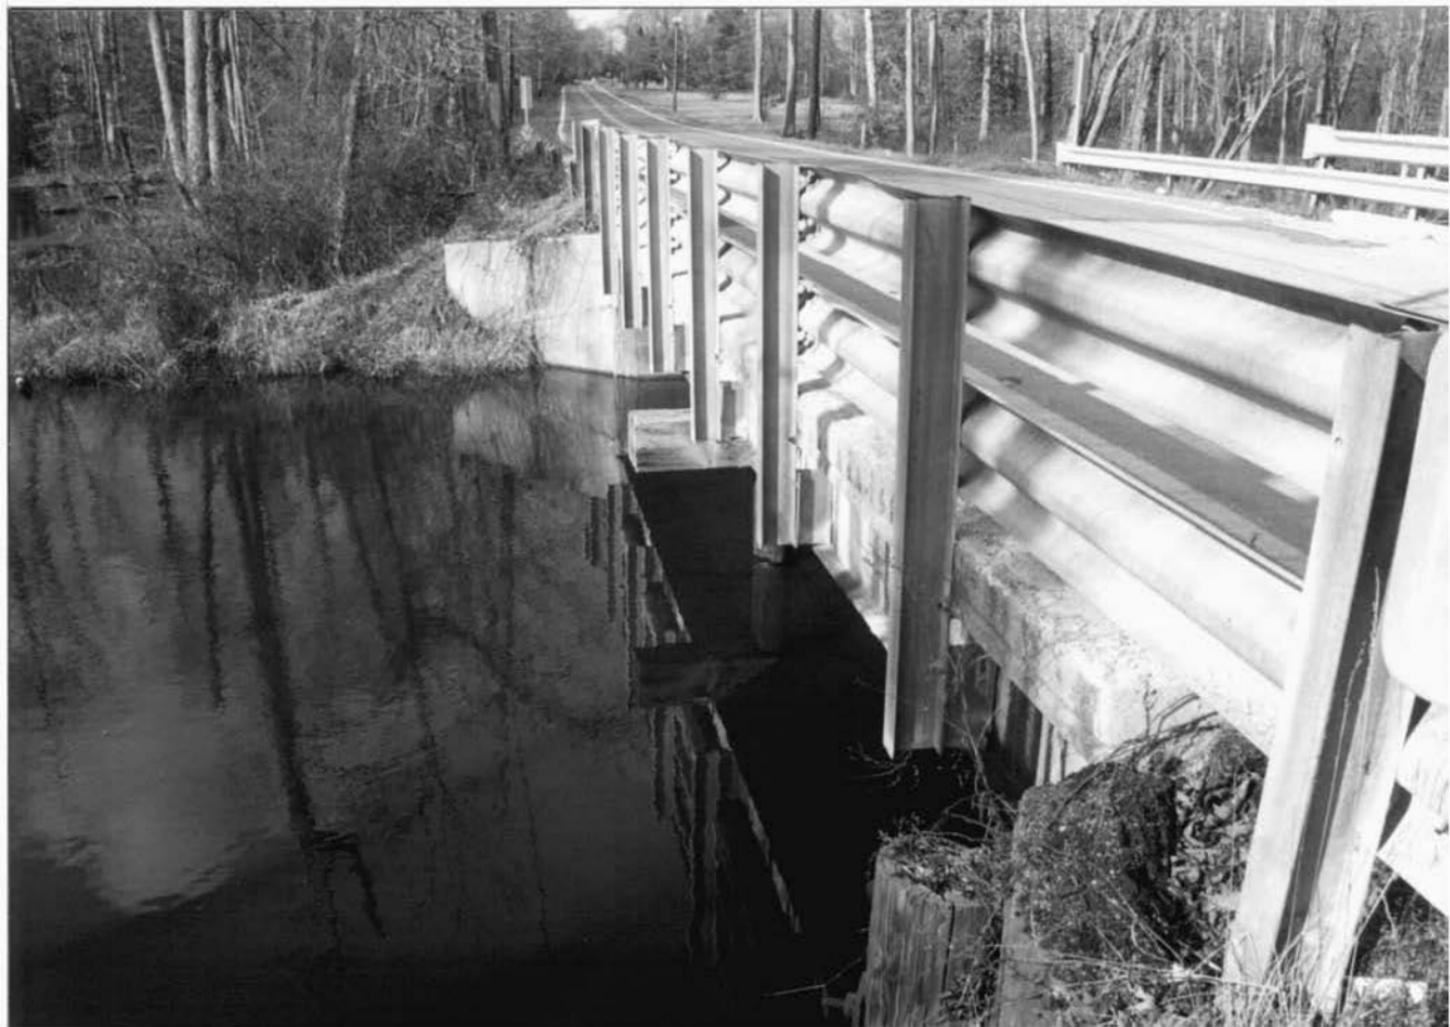
Number 48 of 4

Description SOUTH ELEVATION
