INVENTORY FORM FOR STATE HISTORIC SITES SURVEY

Hermitage Slave Quarter

QA-113A

Orlando Ridout V, Historic Sites Surveyor

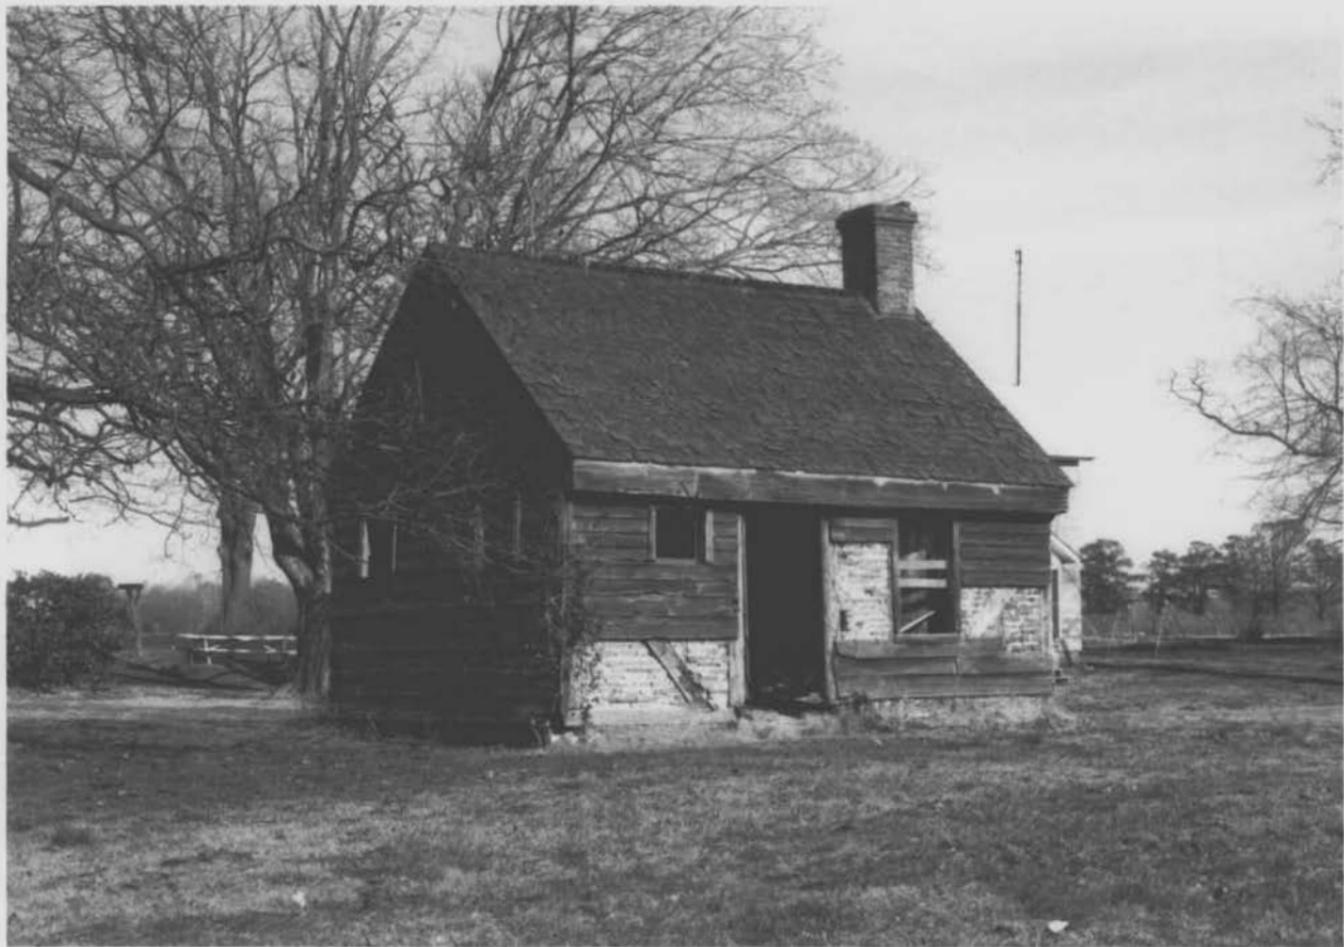
QA-113A Hermitage Quarter
Queenstown vicinity
Orlando Ridout V Dec. 1980
View from Southwest

The front facade faces south, toward the water. There is a door offset to left of center and a 6/6 window to the right. A small six-light window to the left of the door has clearly been added at a later date.

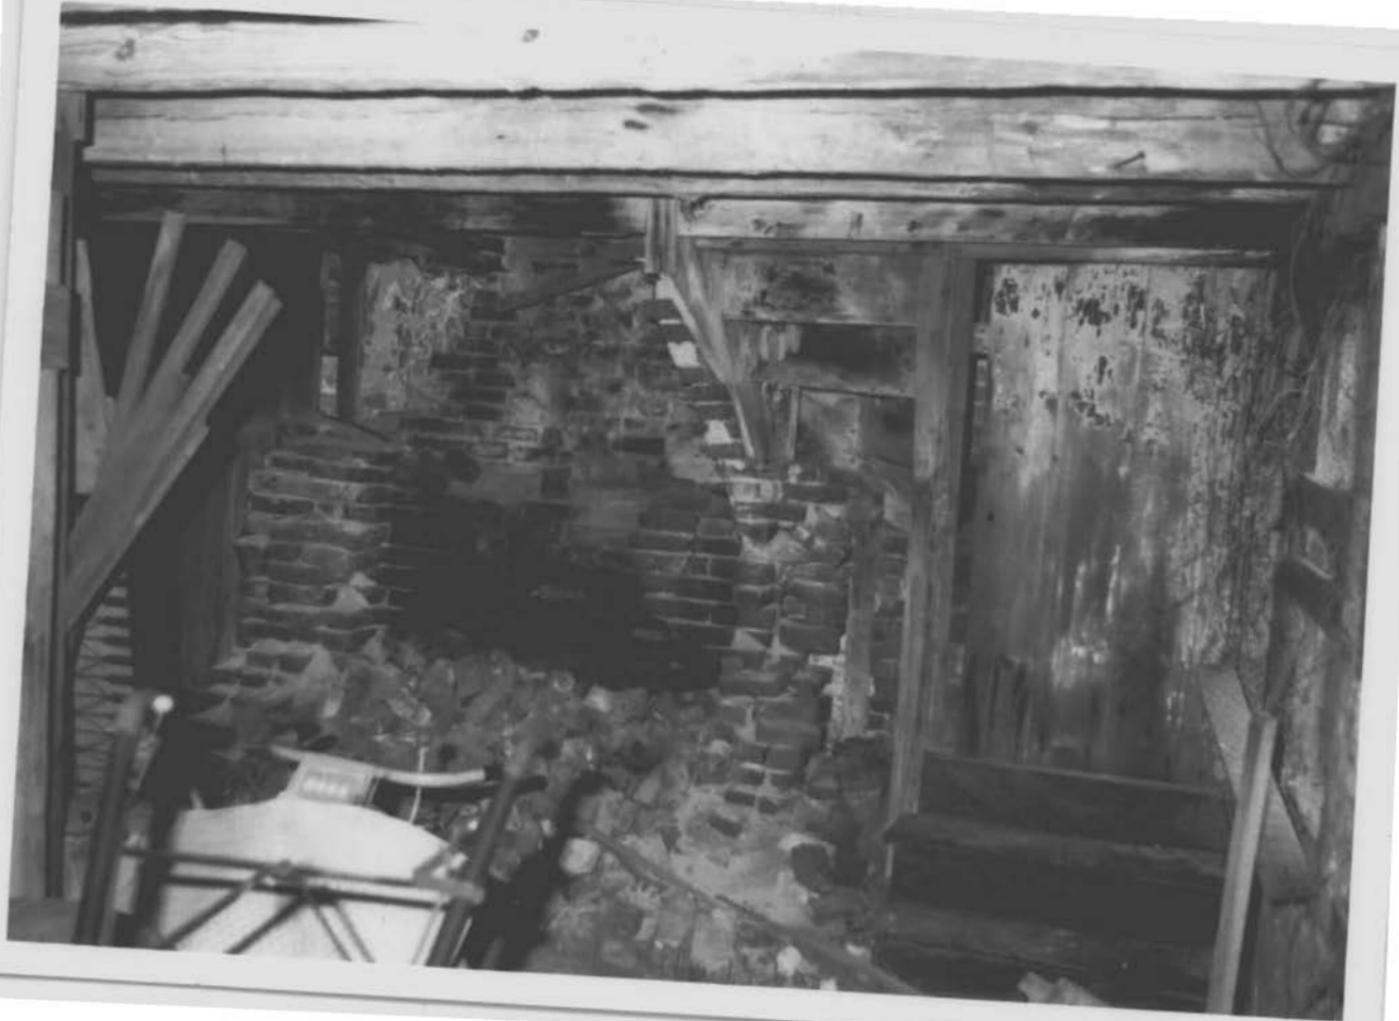
QA-113A Hermitage Quarter
Queenstown vicinity
Orlando Ridout V Dec. 1980
Interior view

The interior on the first floor consists of a single large room with a large cooking fireplace on the center of the east gable wall and an enclosed winder stair in the alcove to the right of the fireplace. A small cupboard has been added to the left of the fireplace and the northwest corner of the large room has been partitioned off in the 20th century to form a secure store-room. The original brick paved floor remains visible in the vicinity of the south door. The walls are filled with exposed and whitewashed brick nogging; the ceiling has never been plastered.
