QA-132
Joseph Jackson Farm
Starr vicinity
Private

INVENTORY FORM FOR STATE HISTORIC SITES SURVEY

Joseph Jackson Farm

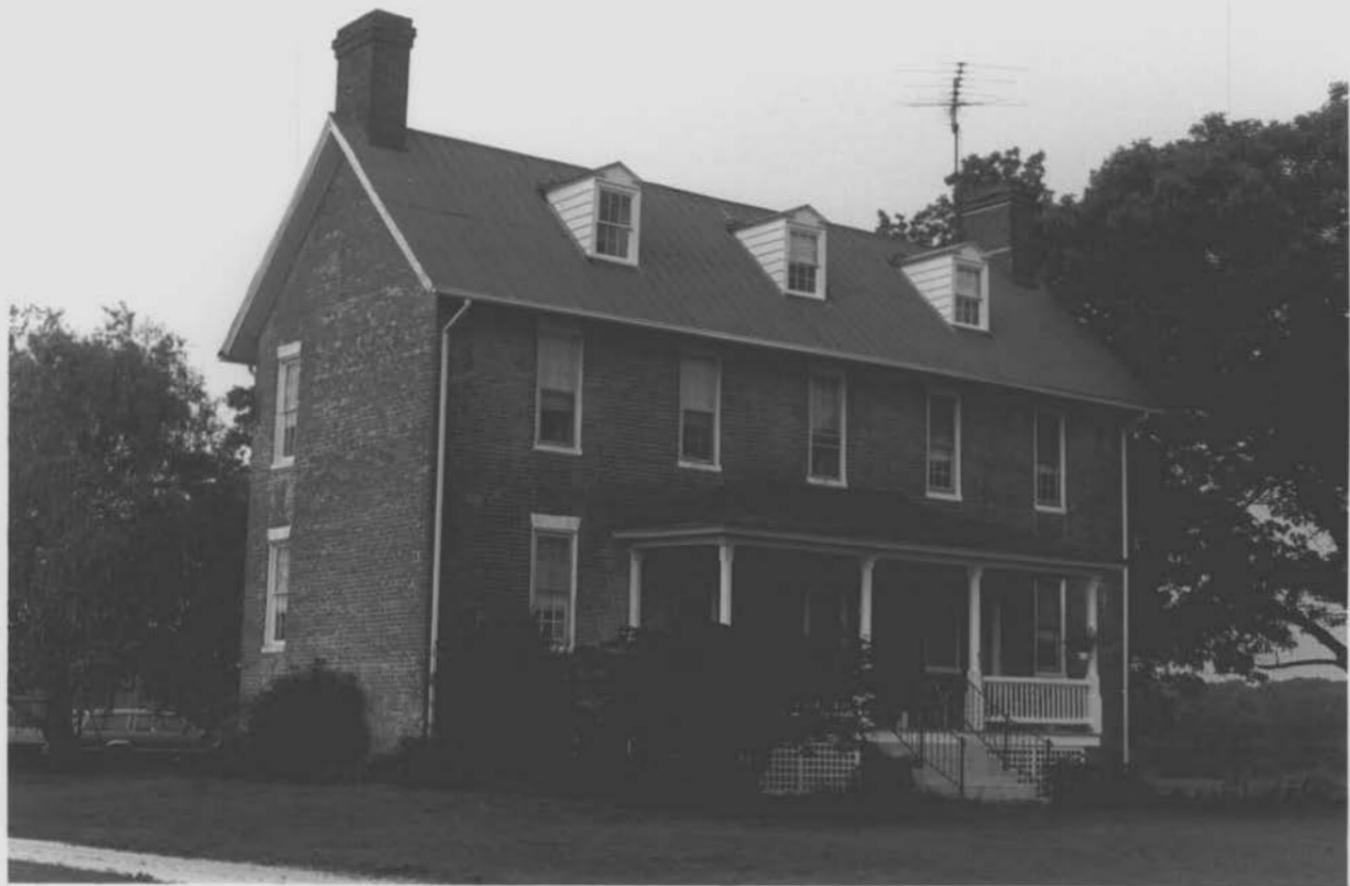
QA-132 Joseph Jackson Sr. Farm
Starr vicinity
Orlando Ridout V 1981
Front facade from Northeast

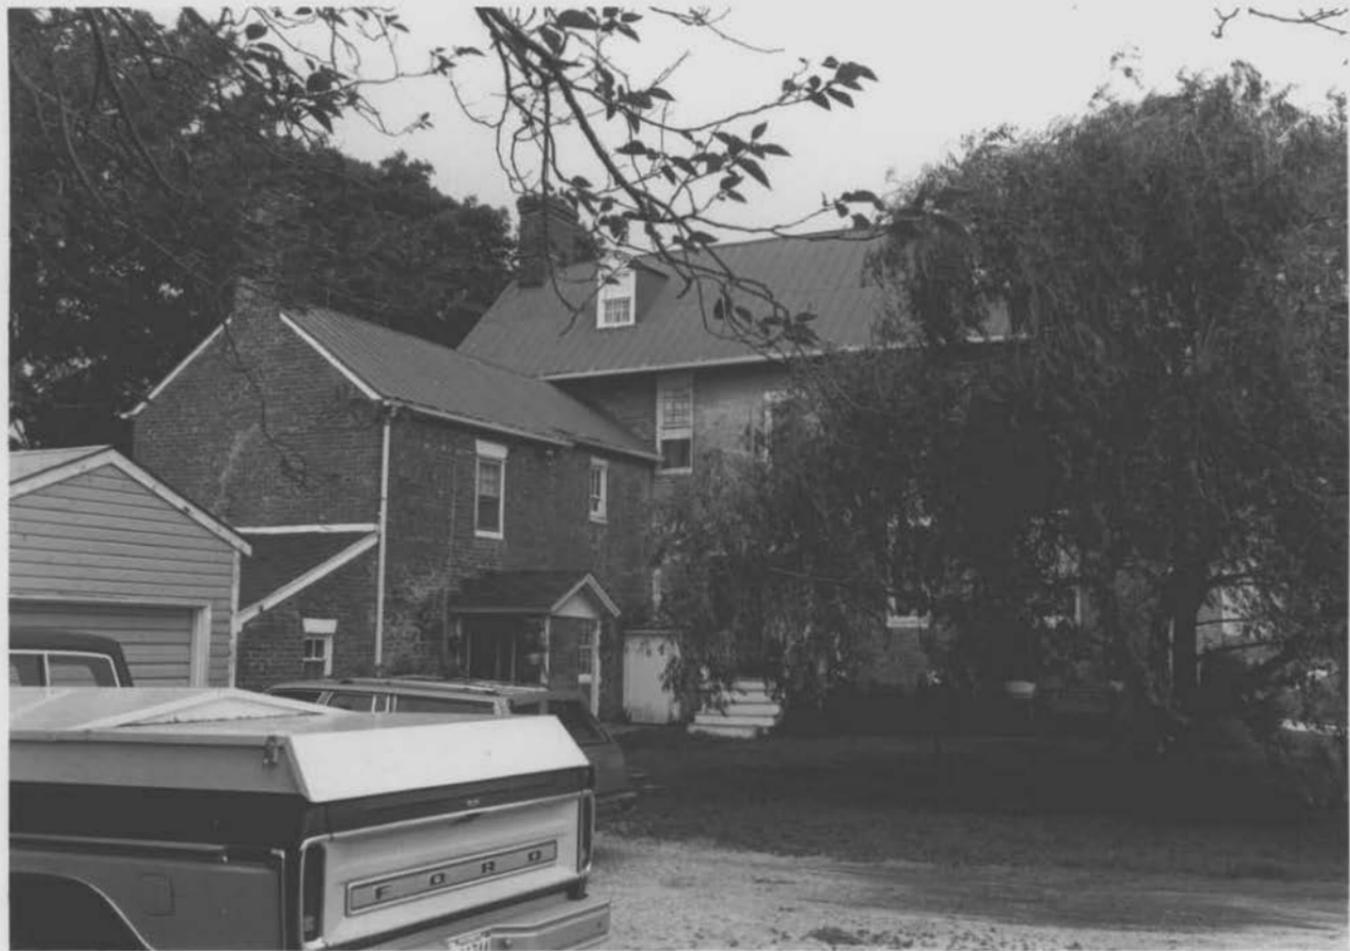
QA-132 Joseph Jackson Sr. Farm
Starr vicinity
Orlando Ridout V 1981
Rear facade from Southeast
