INVENTORY FORM FOR STATE HISTORIC SITES SURVEY

Winterstein Farm

Sudlersville

QA-176

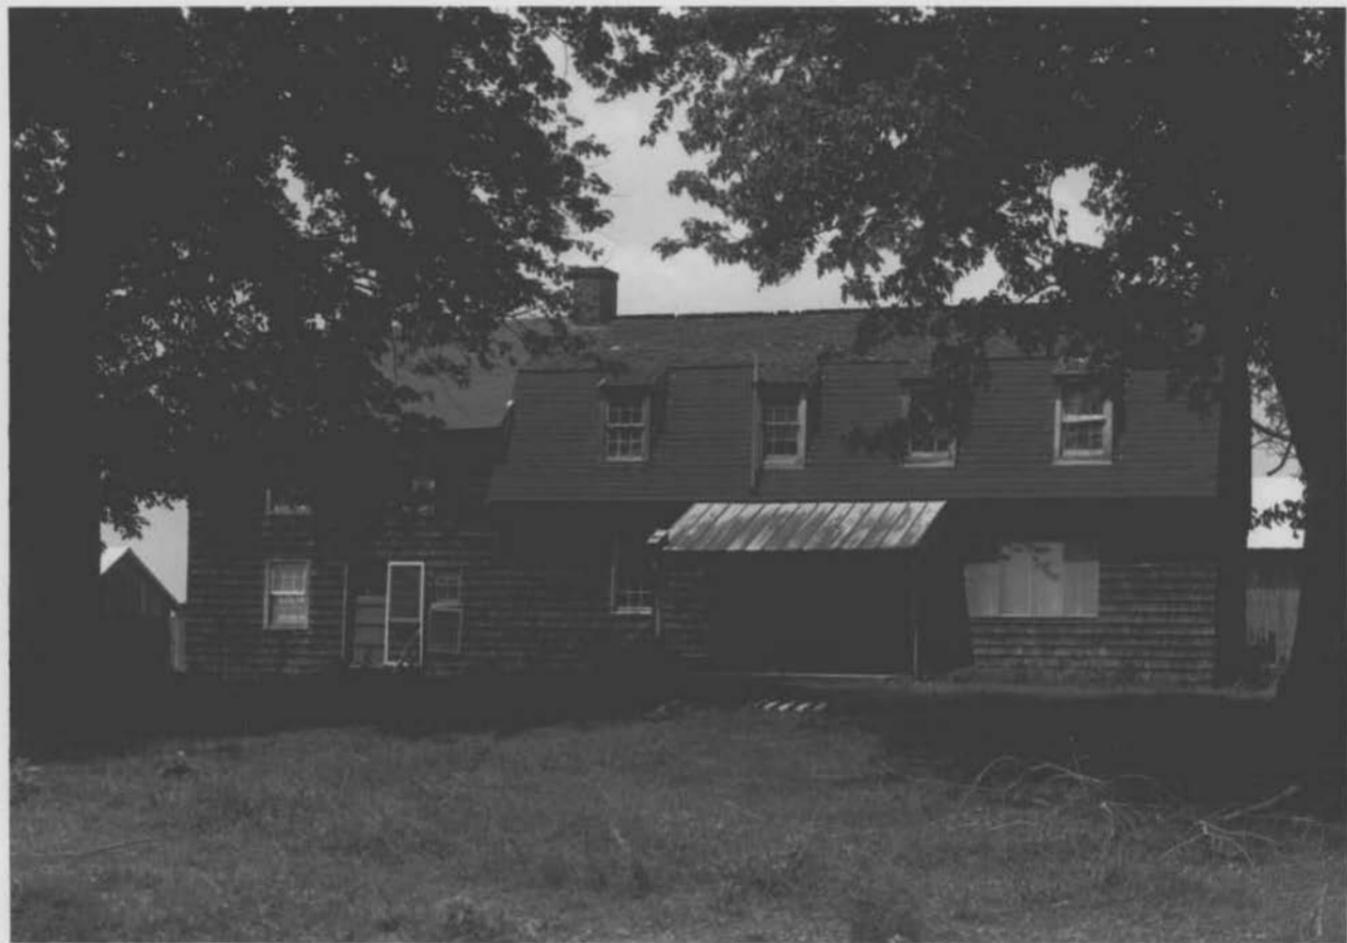
QA-176

The front facade of the main house faces south. The door is in the center bay, flanked by a single 9/6 window to the west and a modern picture window to the east. Four shed roof 6/6 dormer windows are ranged across the second floor. The house rests on a continuous brick foundation and is covered with wood shingle siding. The eaves are boxed in and trimmed with an early complex crown mold and bed mold. The lower pitch of the gambrel roof is covered with asphalt shingles, the upper pitch with wood shingles. A small 20th century lean-to porch protects the front door.

Winterstein Farm  
Sudlersville vicinity  
Orlando Ridout V 1980  
Front facade from South

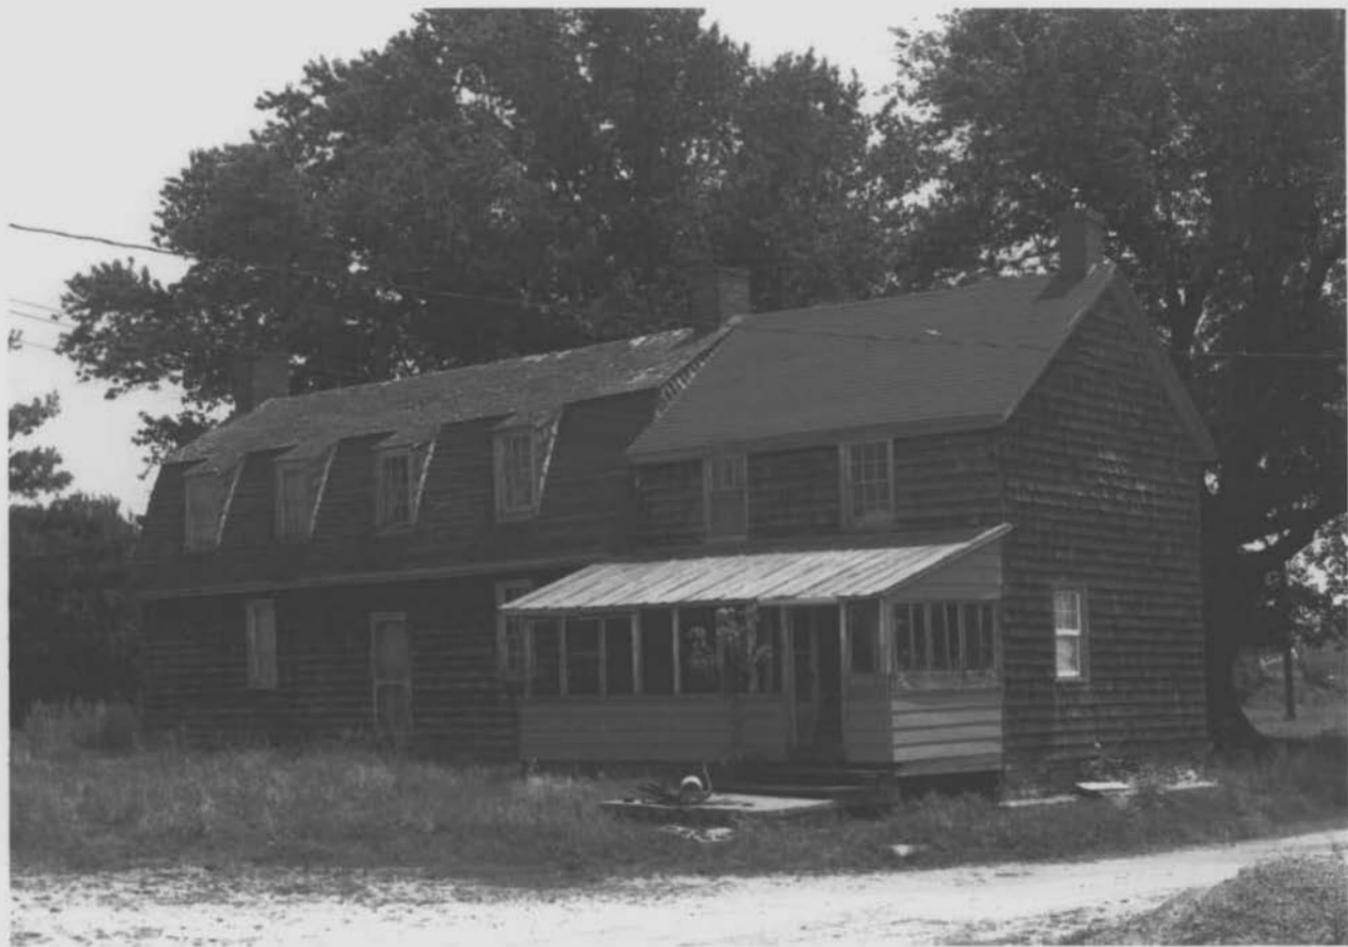
On the rear or north facade, the door is offset to right of center, flanked by single 9/6 windows on each side. Four shed roof 6/6 dormer windows are ranged across the second story. The foundation of this facade is also concrete block. The siding, cornice and roof match the front facade. The rear entrance is fitted with a four-panel door with Italianate moldings.

QA-176 Winterstein Farm  
Sudlersville vicinity  
Orlando Ridout V 1980  
Rear facade from Northwest
