QA-19
Collins' Gift
Church Hill vicinity
Private

18th century

INVENTORY FORM FOR STATE HISTORIC SITES SURVEY

Collins' Gift

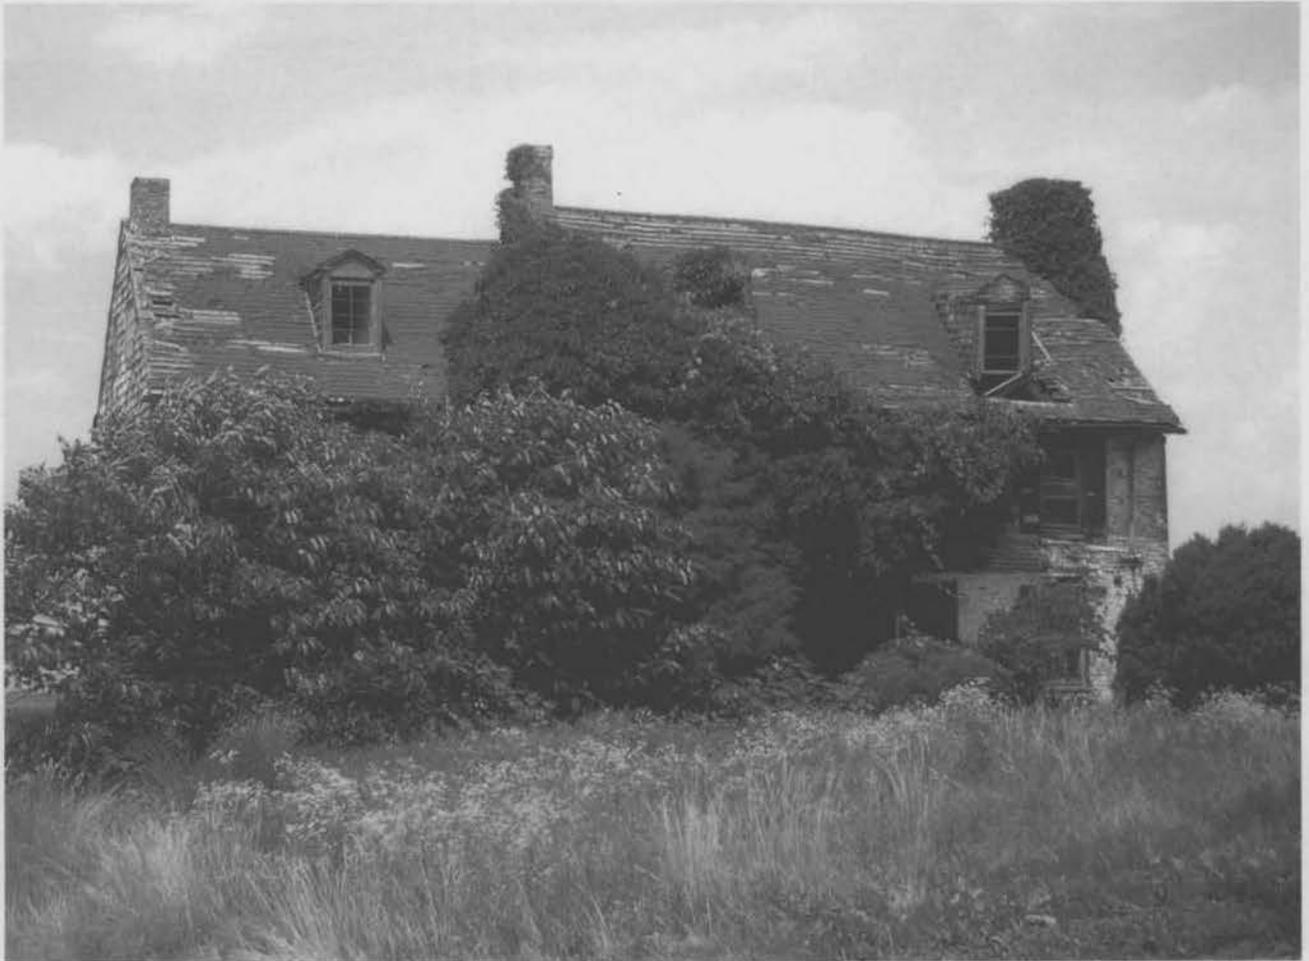
QA-19
Collins' Gift, ruin

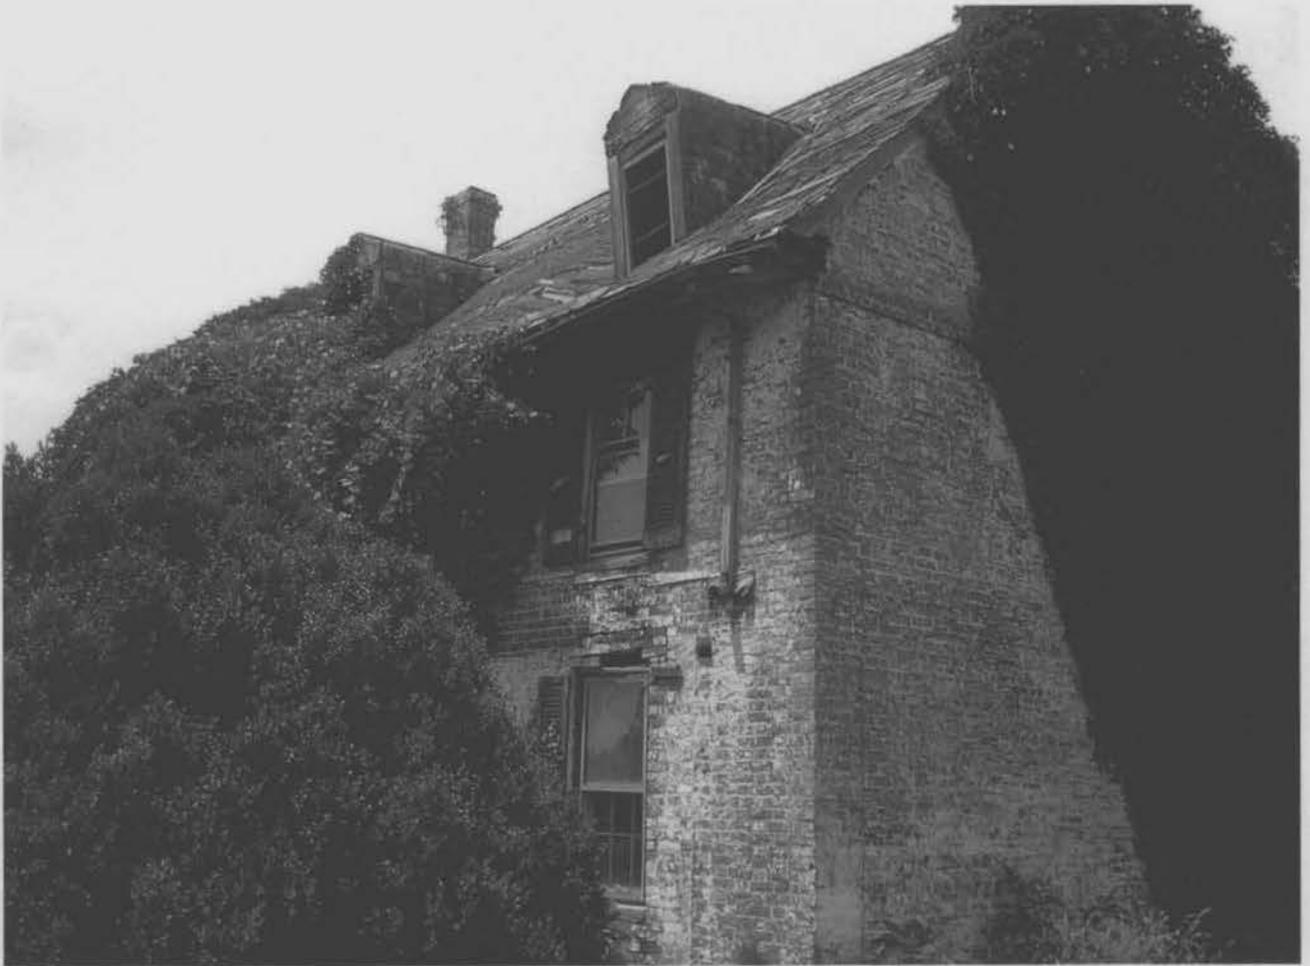
QA-19
Collins' Gift, ruin

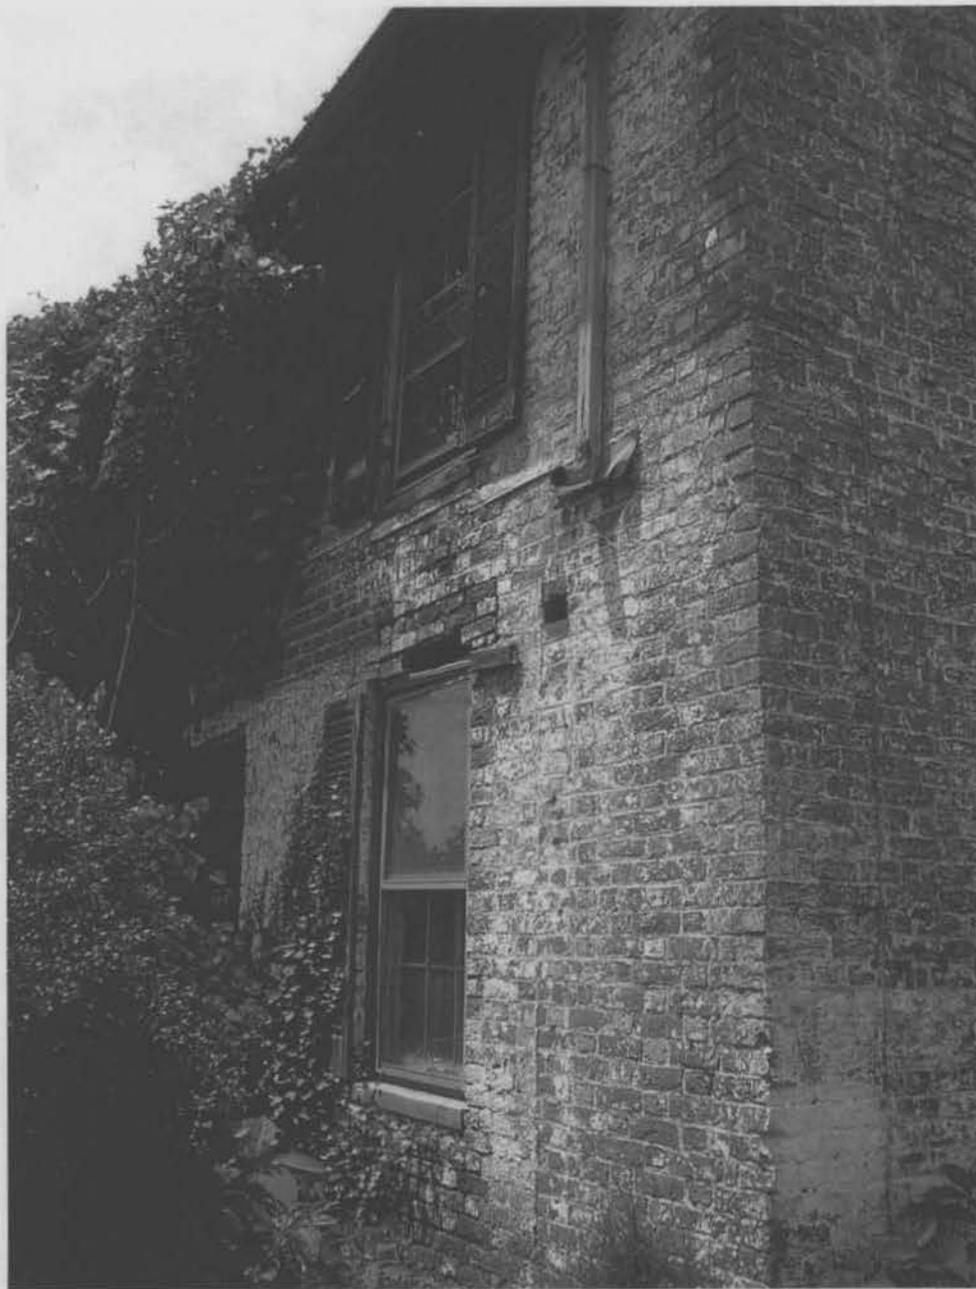
QA-19
Collins' Gift, ruin
