QA-229
Kling Farm
Centreville vicinity
Private

INVENTORY FORM FOR STATE HISTORIC SITES SURVEY

Kling Farm

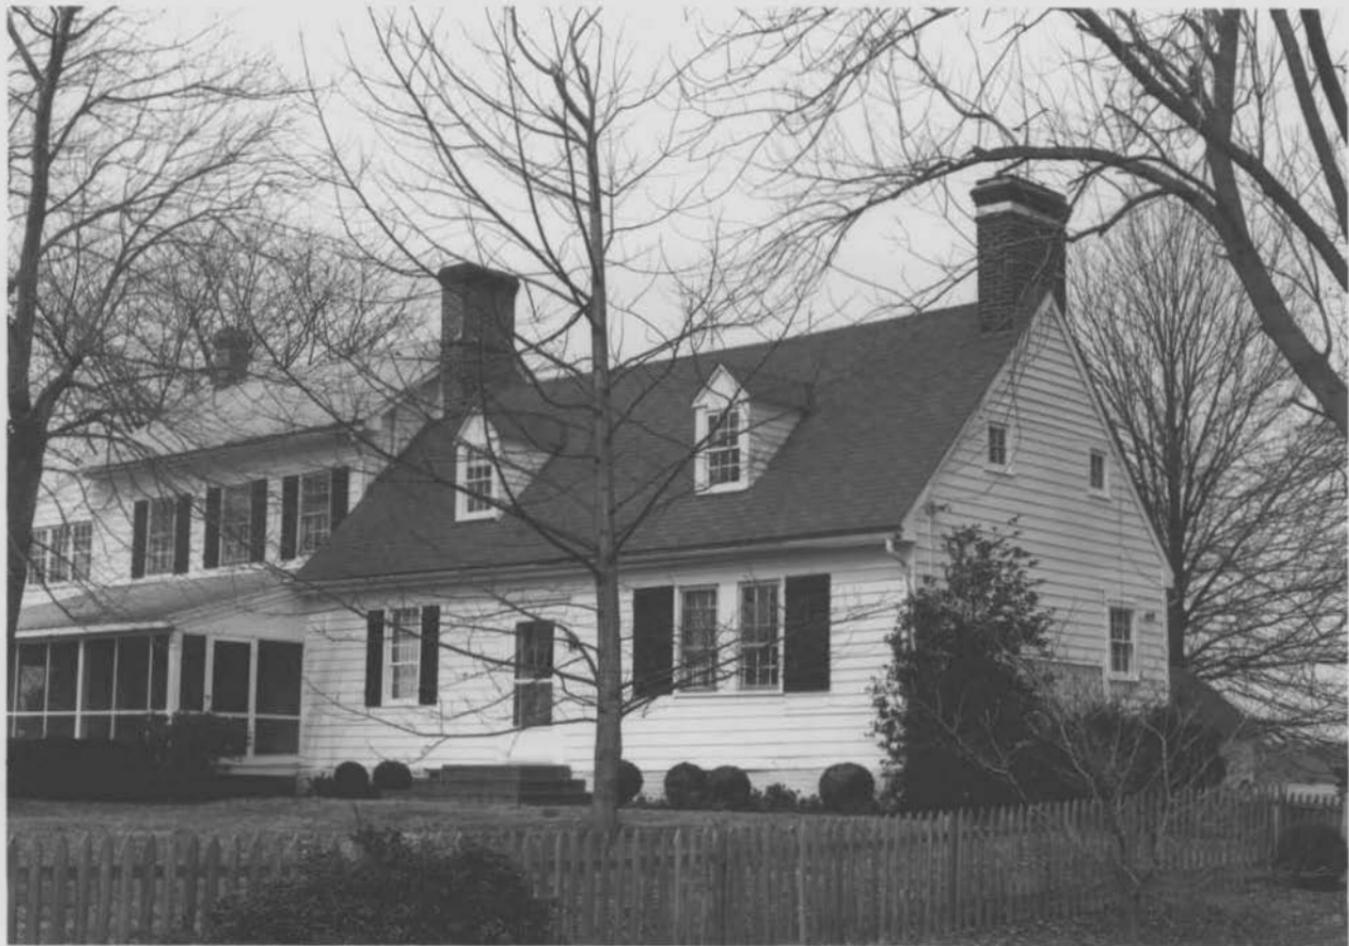
QA-229

Kling Farm
Centreville vicinity
Orlando Ridout V 1980
South facade

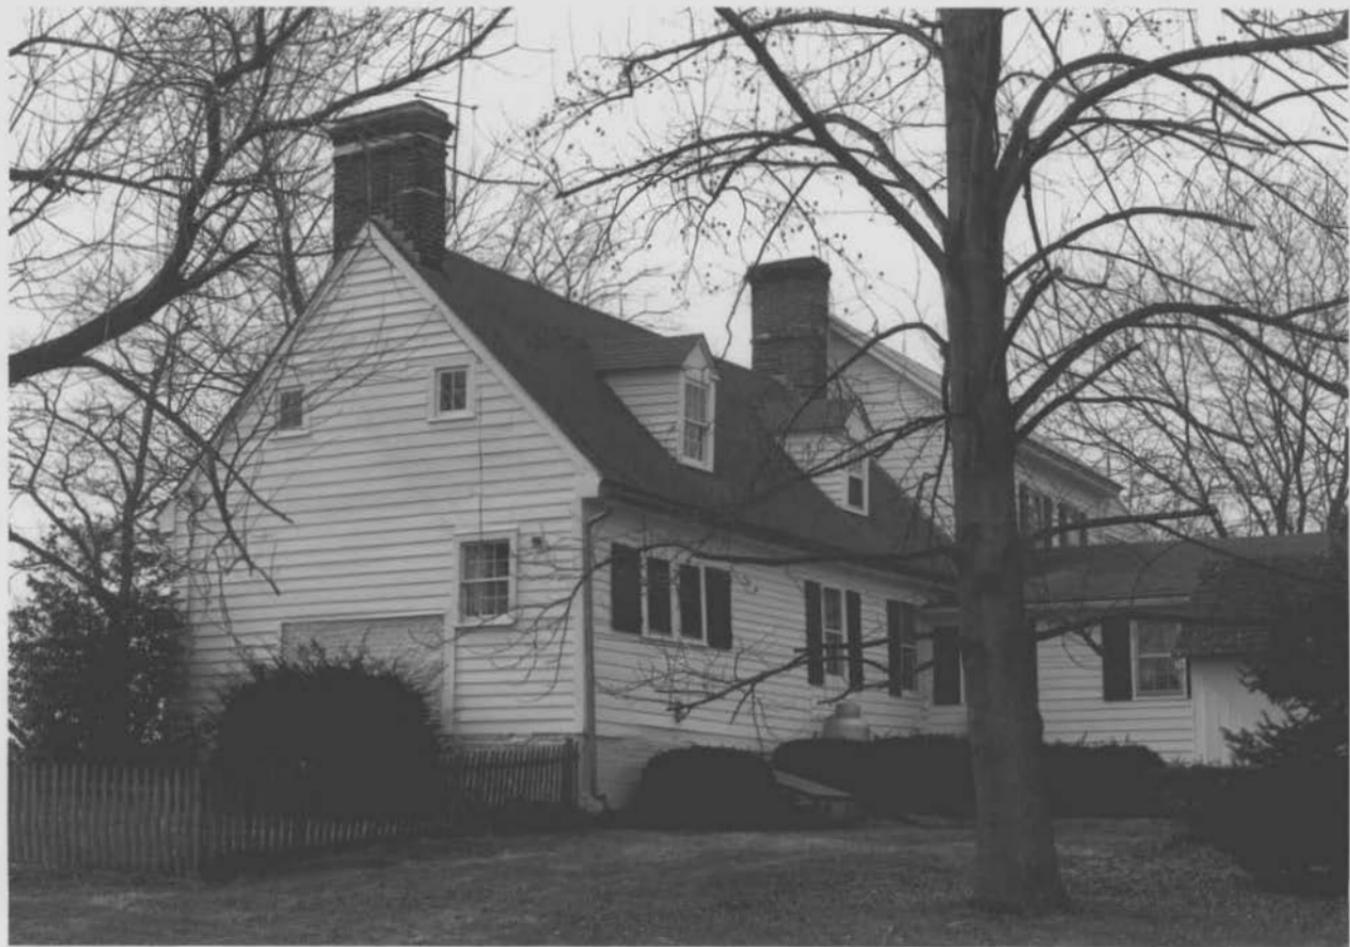
QA-229

Kling Farm
Centreville vicinity
Orlando Ridout V 1980
Rear facade from Northeast
