INVENTORY FORM FOR STATE HISTORIC SITES SURVEY

Parson Green Farm  
AND/OR COMMON

QA-234

Orlando Ridout V, Historic Sites Surveyor

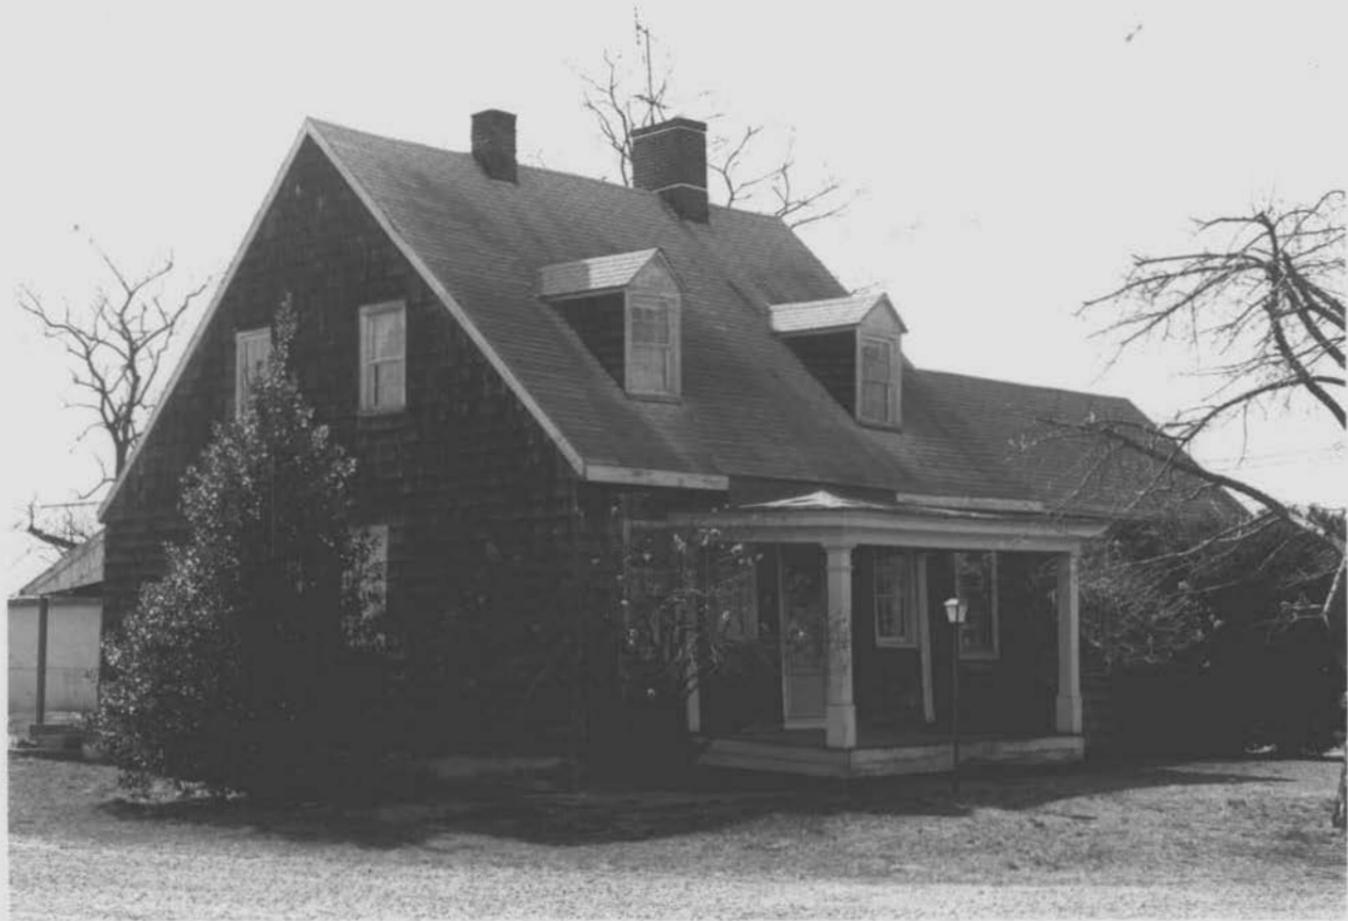
QA-234 Parson Green Farm  
Church Hill vicinity  
Orlando Ridout V 1981  
Front facade from East

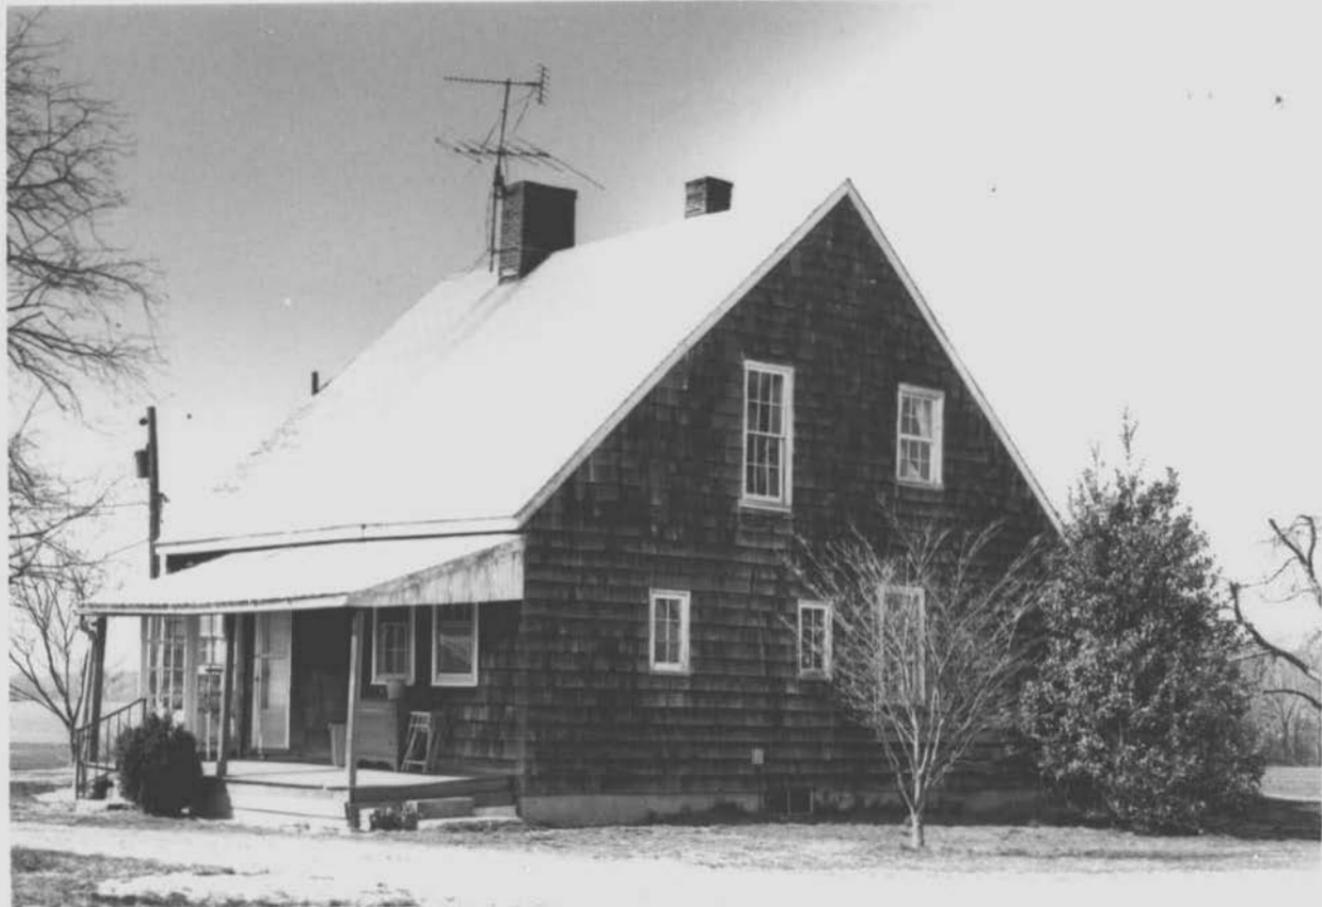
QA-234 Parson Green Farm  
Church Hill vicinity  
Orlando Ridout V, 1981  
View from South
