QA-261

Palmer Andrew House

Centreville

INVENTORY FORM FOR STATE HISTORIC SITES SURVEY

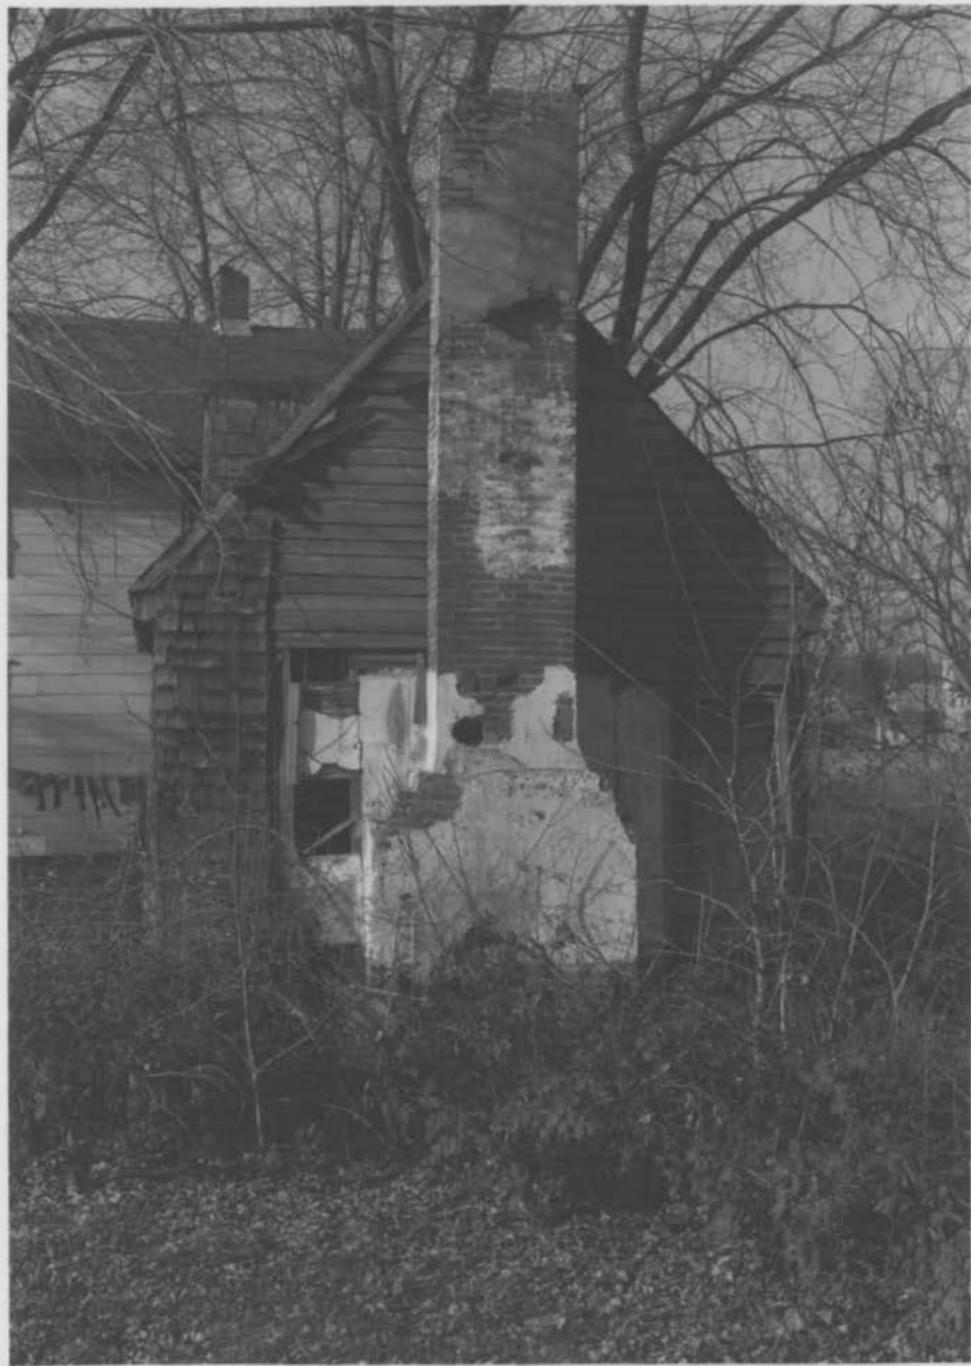
Situated on the east side of Chesterfield Avenue near the intersection with Corsica Neck Road, this small story-and-a-half frame dwelling overlooks a tidal marsh feeding into Corsica Creek. The front, three bay facade faces Chesterfield Avenue, while the rear, two bay facade overlooks the marsh. Scars remain on the southeast gable to indicate there was at one time a frame wing added to that end of the house.

The chimney has been rebuilt, as the brickwork above the first floor sill is laid in stretcher bond of decidedly later date. The small size of the fireplace in the existing building and the presence of a second fireplace at a slightly lower level on the exterior of the chimney, combined with the general character of the brickwork, would suggest that the original chimney was taken down and rebuilt when the frame addition was constructed.

Although the chimney is the only evidence remaining of the south gable addition, the color and type of brick combined with the use of stretcher bond would suggest a post-Civil War date for that alteration.

QA-261 Palmer Andrew House
Centerville, Md.
Orlando Ridout V, 1978 (MHT)
Southeast gable, camera facing NW
