QA-304

Florence Mason Bank Barn

## INVENTORY FORM FOR STATE HISTORIC SITES SURVEY

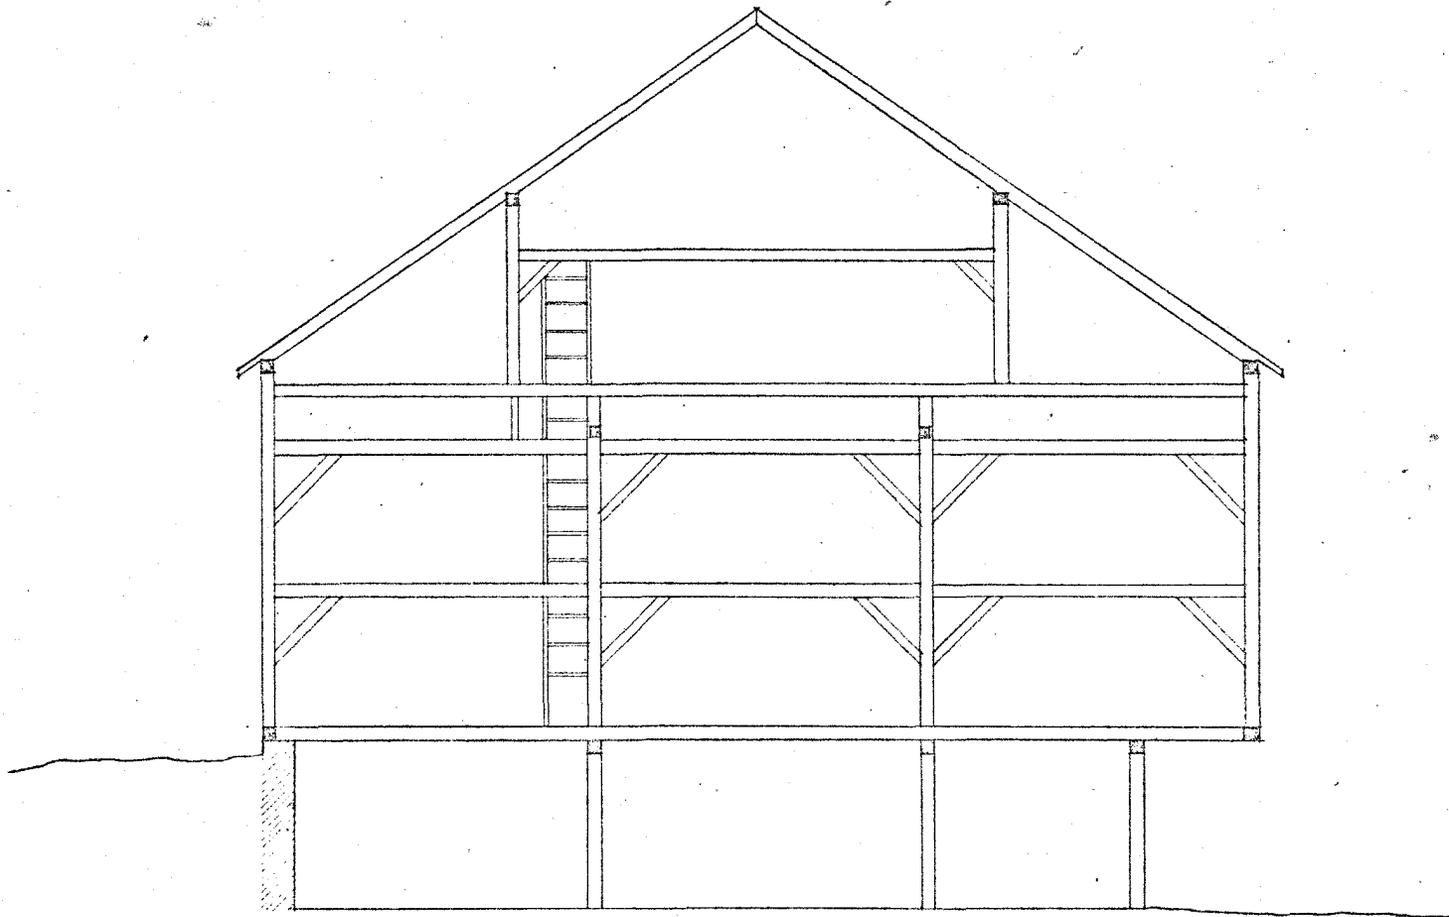
FRAMING SECTION

The barn rests on a brick foundation laid in common bond. The sills are laid directly on top of the masonry walls. Joists are let into the facade sills, and run parallel to the gables. The joists are supported by three girts running parallel to the ridge of the roof, which are in turn supported by heavy posts. The sill on the south facade is supported by the joists, which are cantilevered from a girt, supported by posts, which are also used to frame the exterior wall of the forebay.

The framing bents consist of two end posts and two intermediate posts, tied together with two sets of tie beams and a top plate. Two queen posts are mortised into the top plate, and are stabilized with a tie beam. Each queen post supports a purlin. The individual framing bents are joined together by the facade top plates, two longitudinal tie beams, and the purlins. All junctions are reinforced with heavy up-braces. The rafters are continuous from the top plate to the peak, where they are mitred, butted, and

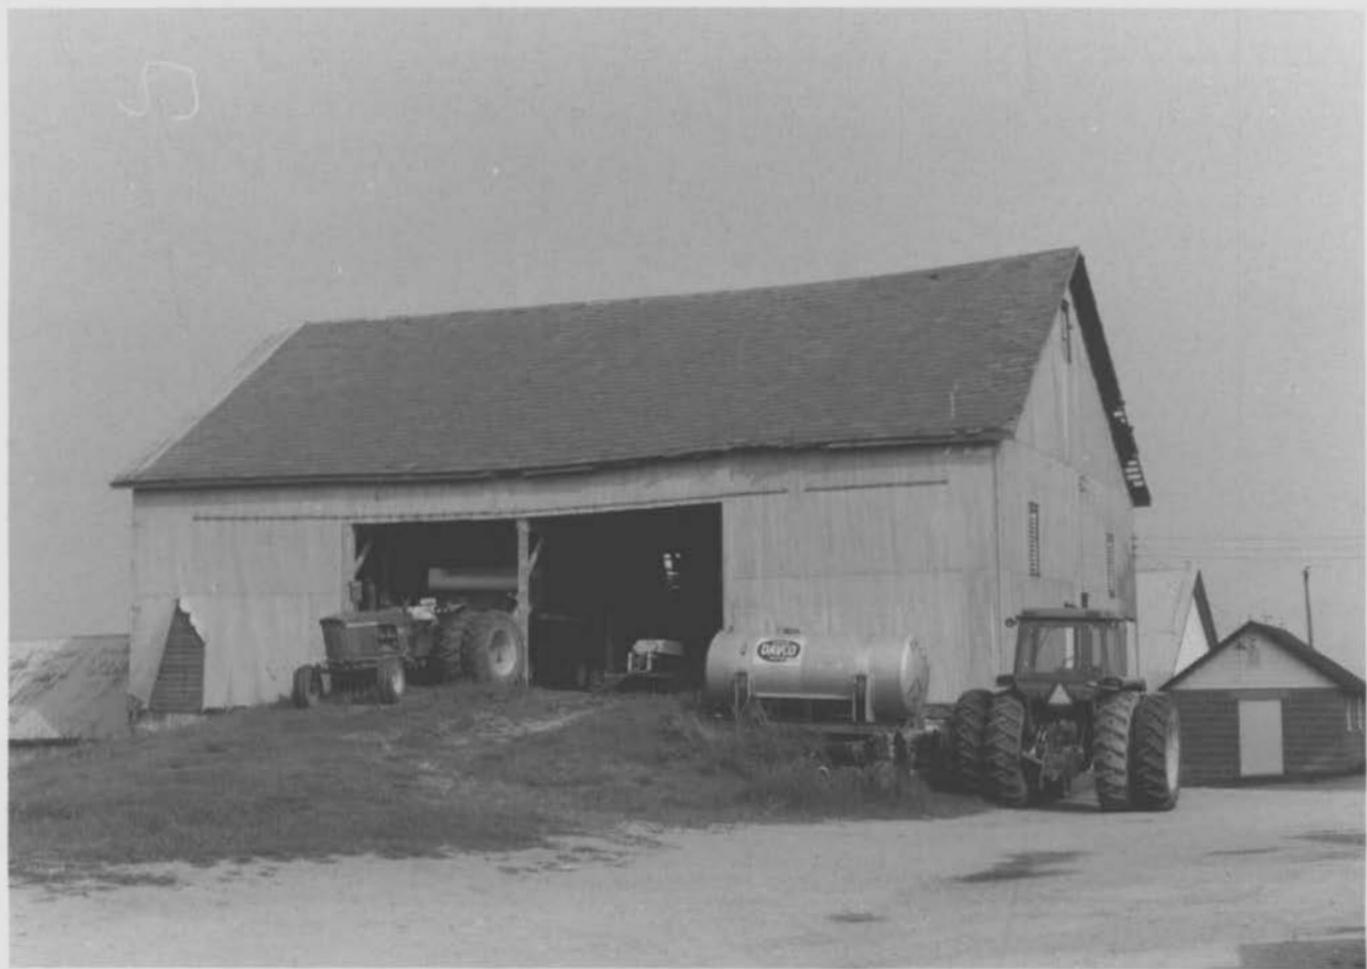
The barn is four bays long. On the north facade, the two center bays are left open, with large doors mounted on rails that can be opened to allow access to the mow. The doors are now gone.

QA-304 Florence Mason Bank Barn  
Ruthsburg, Md.  
Orlando Ridout V, 1978 (MHT)  
NW facade, camera facing SE

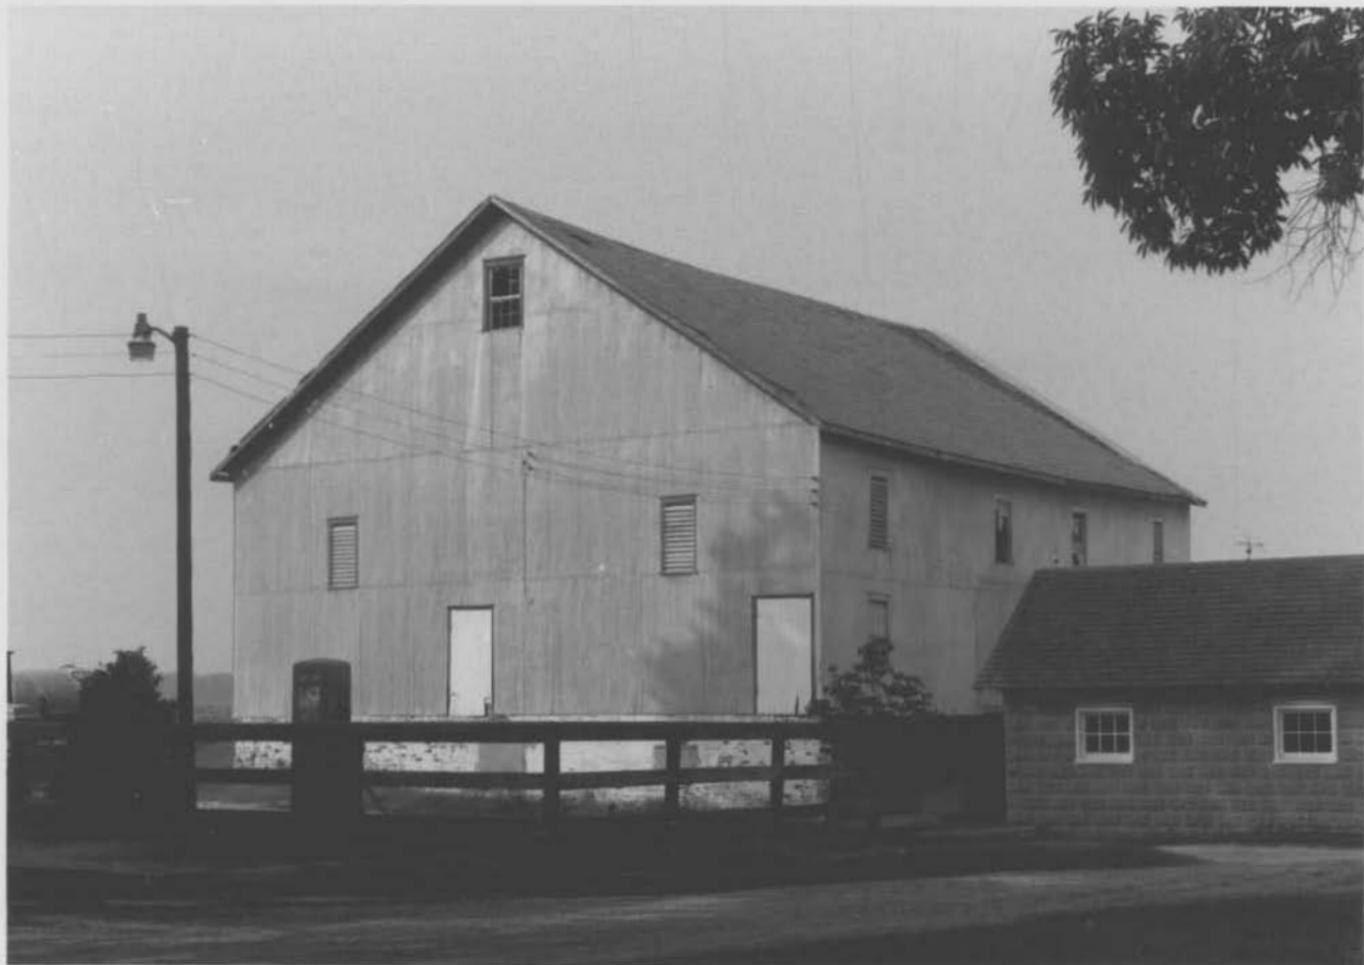
There are no other openings on this facade. The west gable has three small window openings in the brick foundation wall. Two of these have been closed up, but the third remains open. On the main floor level, there are two doors, and on the upper level there are two window openings with louvered vents. There is a single six-over-six window in the upper gable.

QA-304 Florence Mason Bank Barn  
Ruthsbury, Md.  
Orlando Ridout V, 1978 (MHT)  
SW gable, camera facing NE

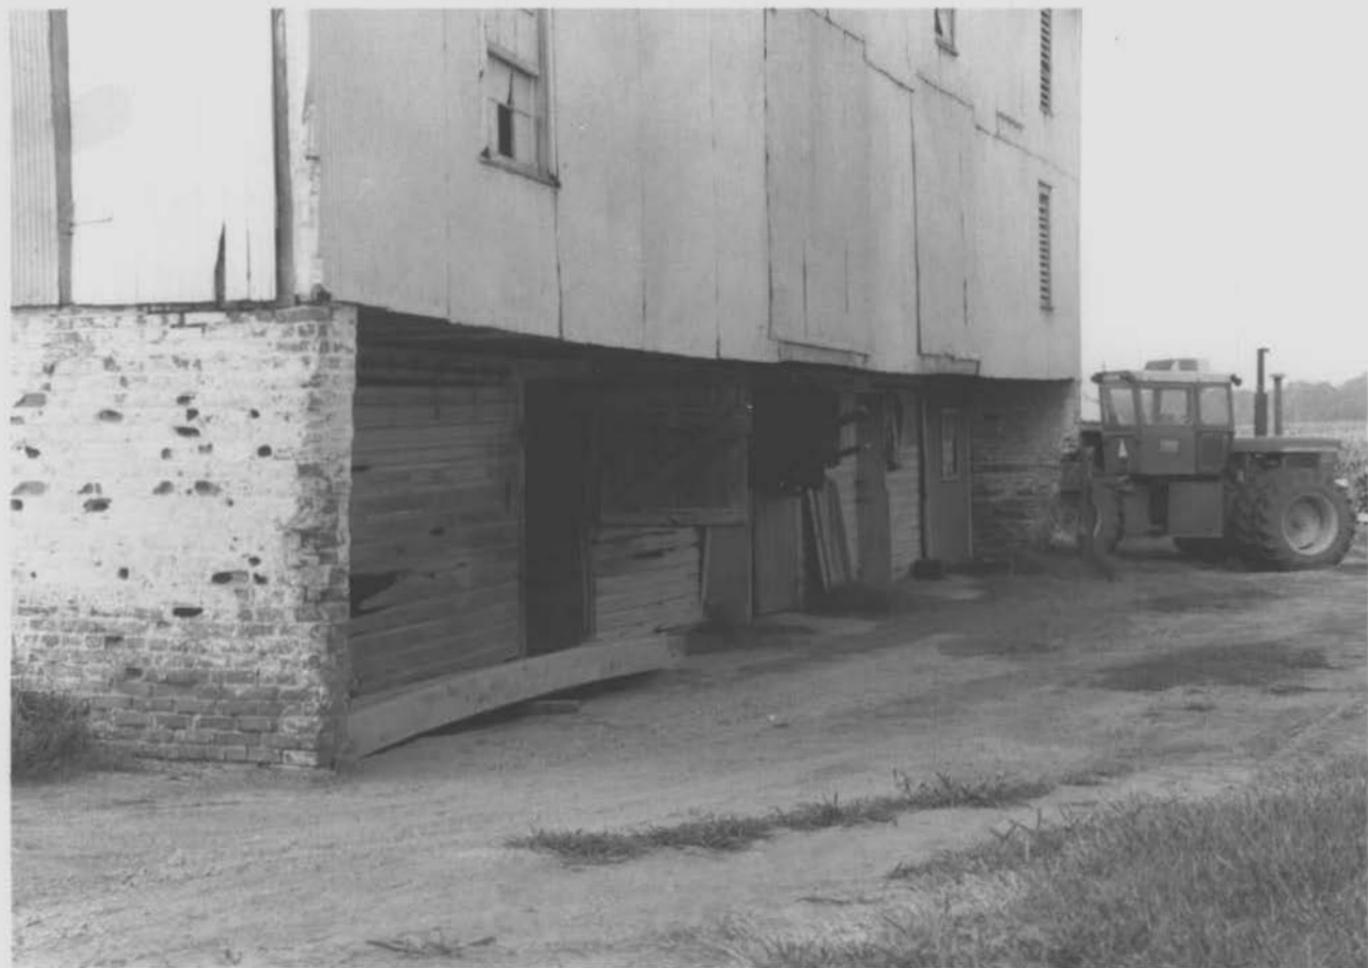
On the south facade, there are sliding doors at each end of the forebay, and four stable doors between them. These are hung on machine made strap hinges. The forebay wall is covered with german siding. On the main floor of this facade, above the forebay, there are two large doors in the center, a ventilator in the east bay and a six-over-six window in the west bay. On the upper level, two six-over-six windows in the center bays are flanked by one ventilator on either side.

QA-304 Florence Mason Bank Barn  
Ruthsburg, MD  
Orlando Ridout V, 1978 (MHT)  
Detail of forebay, camera facing NE

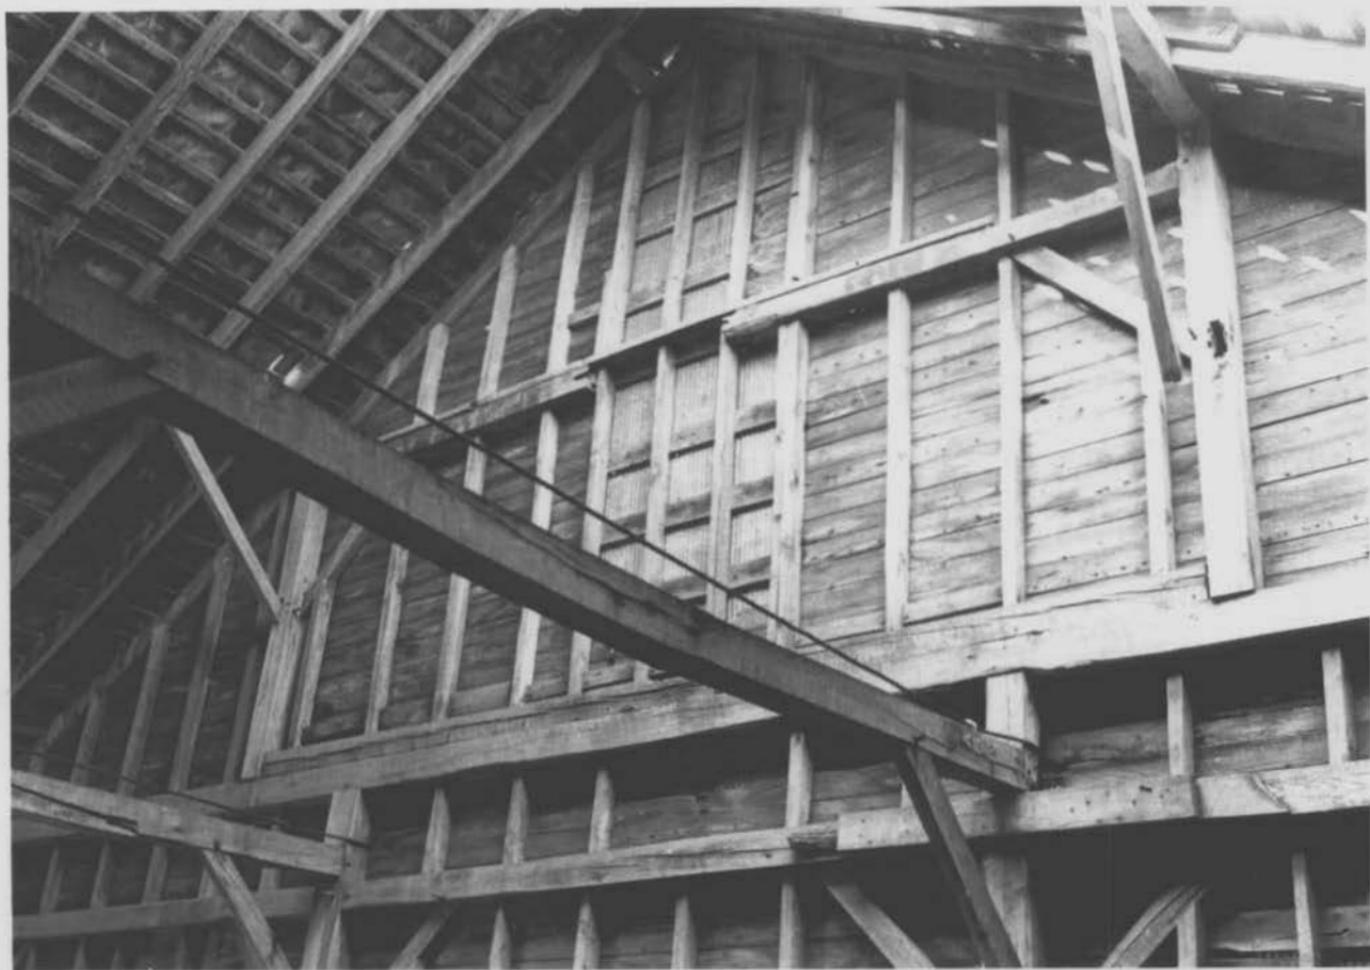
and grain. The eastern three bays of the loft are left open, but the western bay has been partitioned off up to the tie beam, and was used for storing grain. The loft space above the granary was also used for hay.

QA-304 Florence Mason Bank Barn  
interior of loft  
Puthsburg Md.  
Mark Edwards 1978.

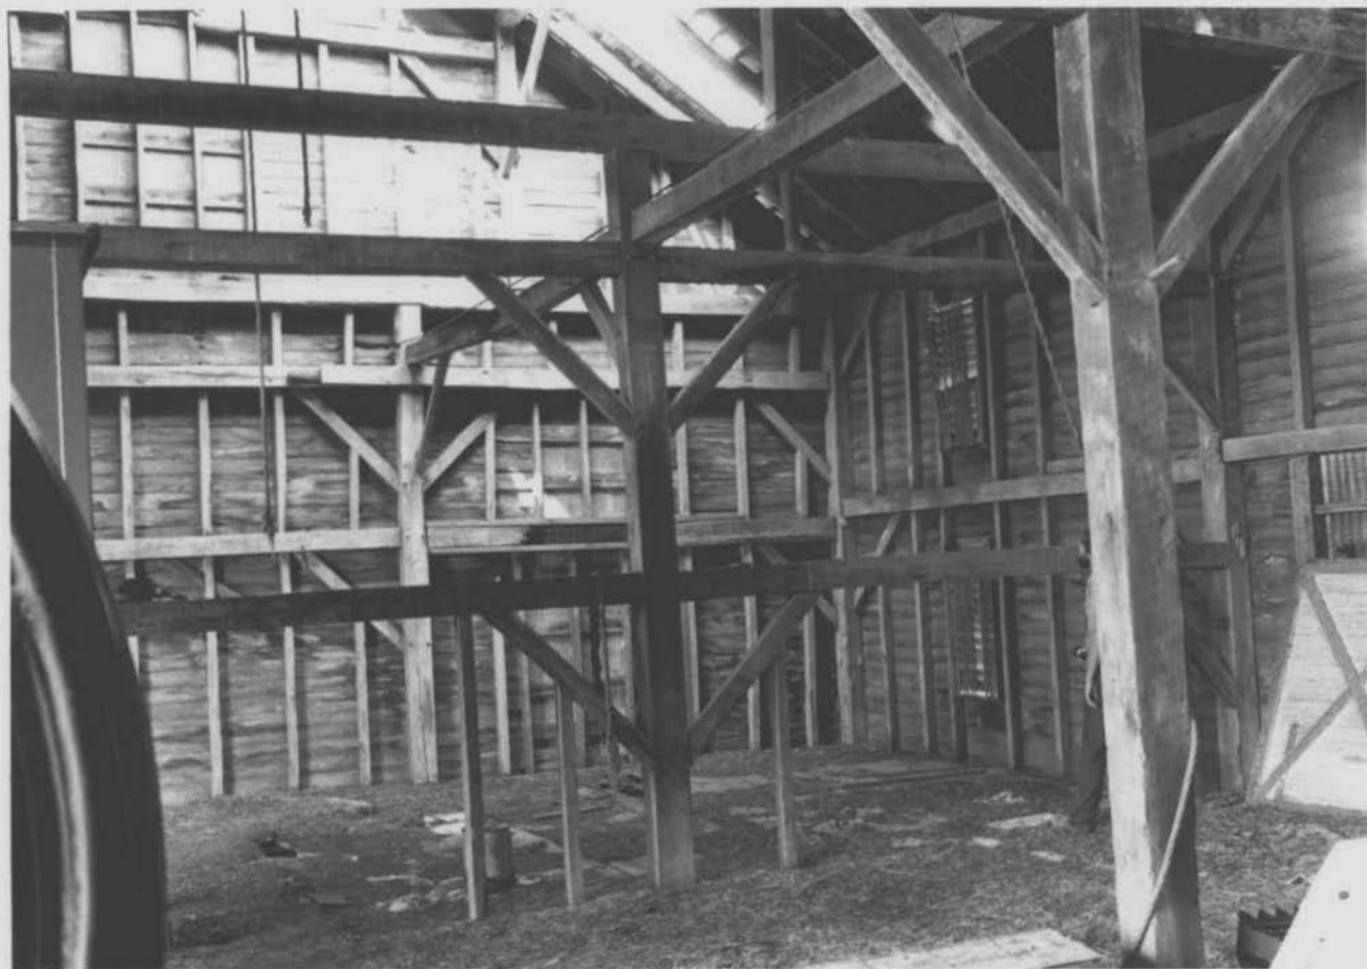
QA- 304 Florence Marsh Bank Barn  
interior framing  
Ruthsburg, Md.  
Mark Edwards 1978
