INVENTORY FORM FOR STATE HISTORIC SITES SURVEY

Springfield
AND/OR COMMON

Dodd Farm

QA-439

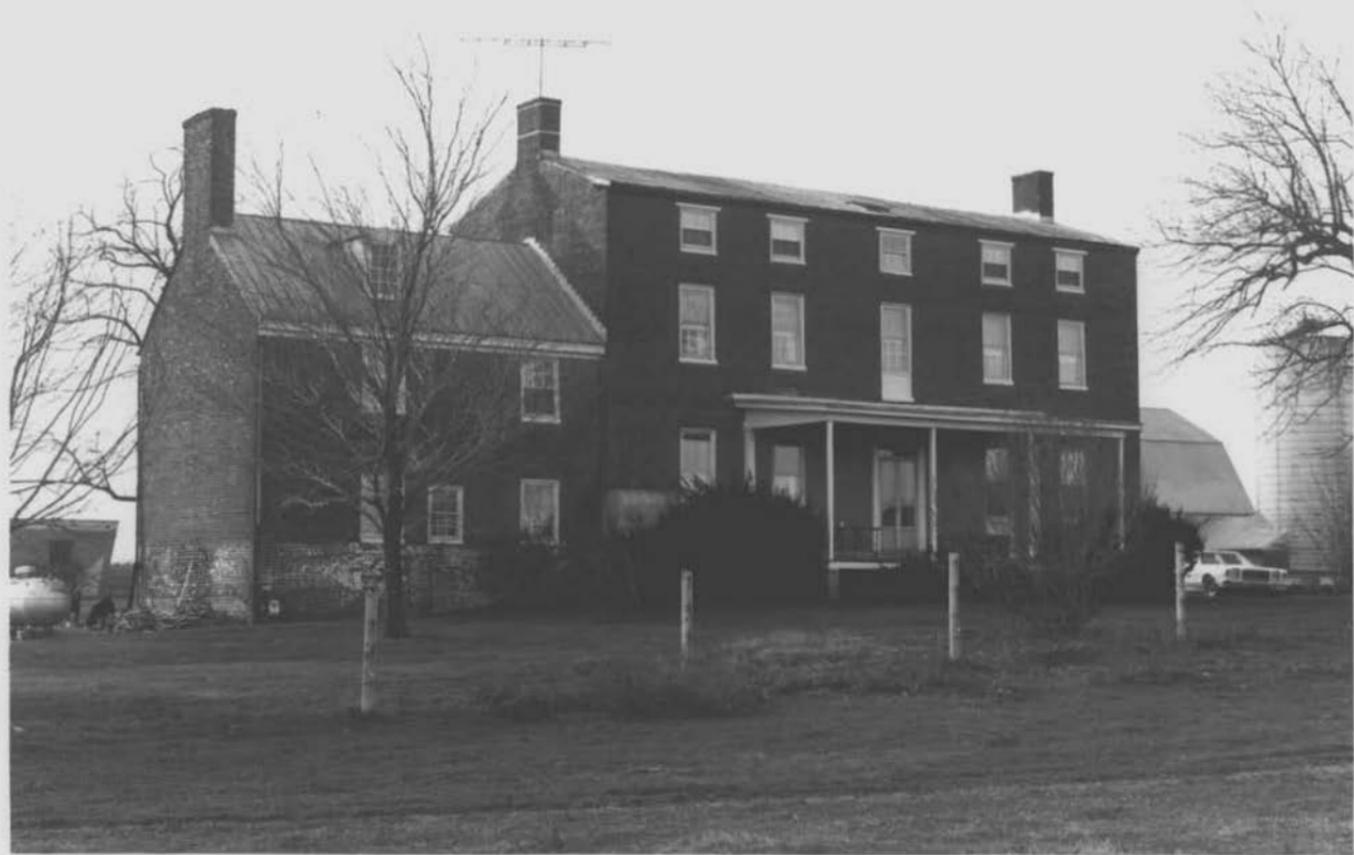
The north facade is similar to the south facade, with double paneled doors in the center bay flanked by two 6/6 windows on each side. The window opening closest to the door on each side has been enlarged to form "jibb" doors. The lower six-light sash can thus be raised and paired panel doors opened to allow direct access onto the porch. There are five 6/6 windows ranged across the second story and five 3/3 windows across the added third story. The brickwork is Flemish bond above a molded water table and three-course bond foundation; a three-course Flemish bond belt course extends across this facade. The added third story is laid in seven-course bond with a corbeled brick cornice. A one story porch dating to

QA-439 Dodd Farm
Queenstown vicinity
Orlando Ridout V 1981
North facade
