QA-58
Spread Eagle
Church Hill
Private

INVENTORY FORM FOR STATE HISTORIC SITES SURVEY

Spread Eagle Farm

SPREAD EAGLE
CHURCH HILL, MARYLAND

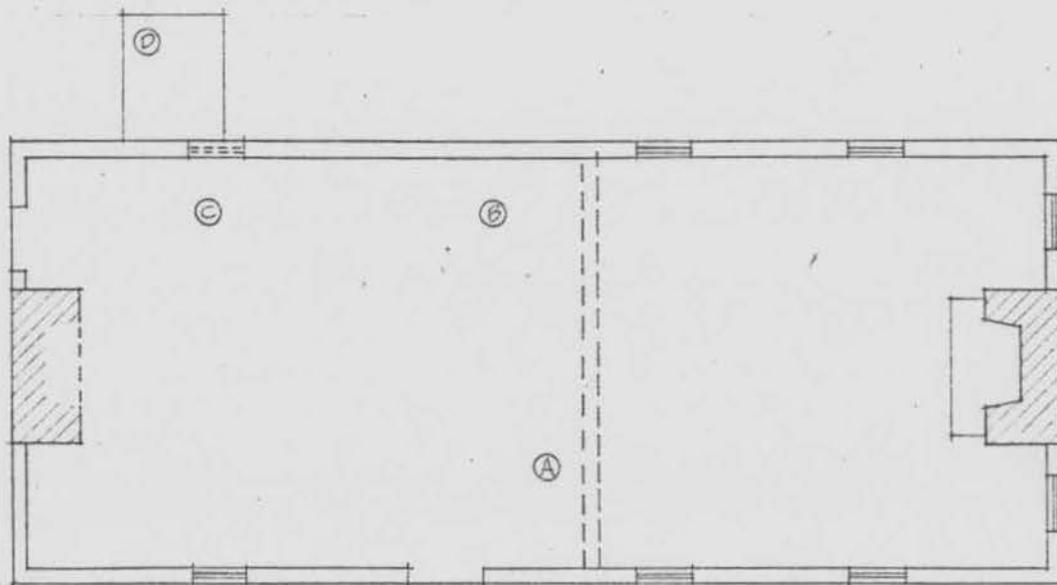
- A LOCATION OF ORIGINAL PARTITION
- B PROBABLE LOCATION OF ORIGINAL STAIR
- C ORIGINAL 1/2 WINDOW REPLACED BY MODERN PICTURE WINDOW
- D BULKHEAD ENTRANCE TO CELLAR
