QA-62

Caleb Clough House

circa 1820

INVENTORY FORM FOR STATE HISTORIC SITES SURVEY

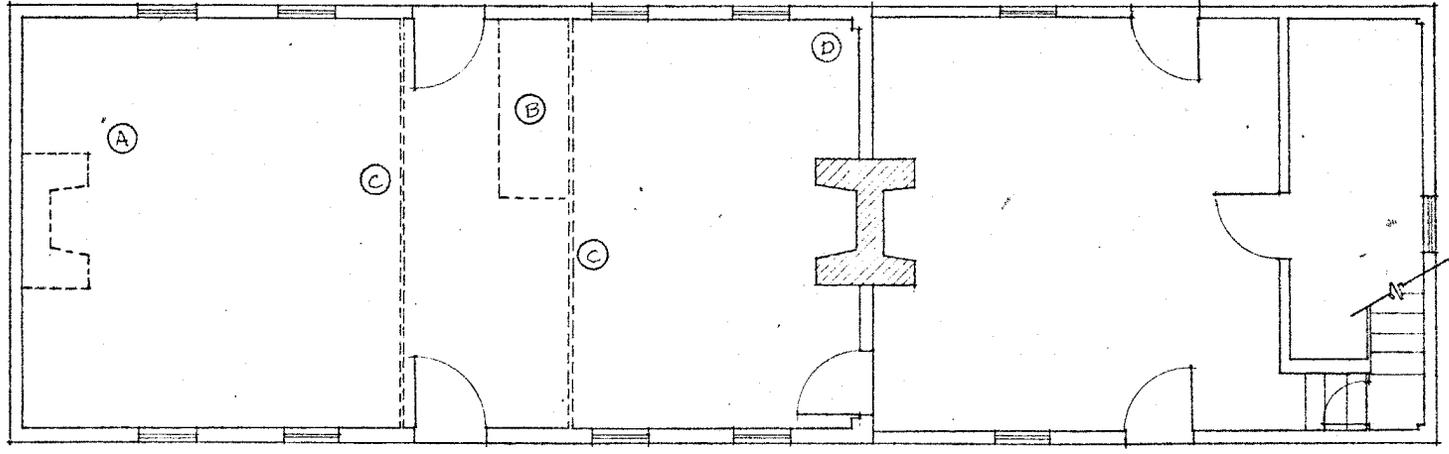
- A APPROXIMATE CONFIGURATION OF FIREPLACE.
- B APPROXIMATE LOCATION OF STAIR.
- C LOCATION OF ORIGINAL BOARDED PARTITIONS.
- D EXPOSED CORNER POSTS.

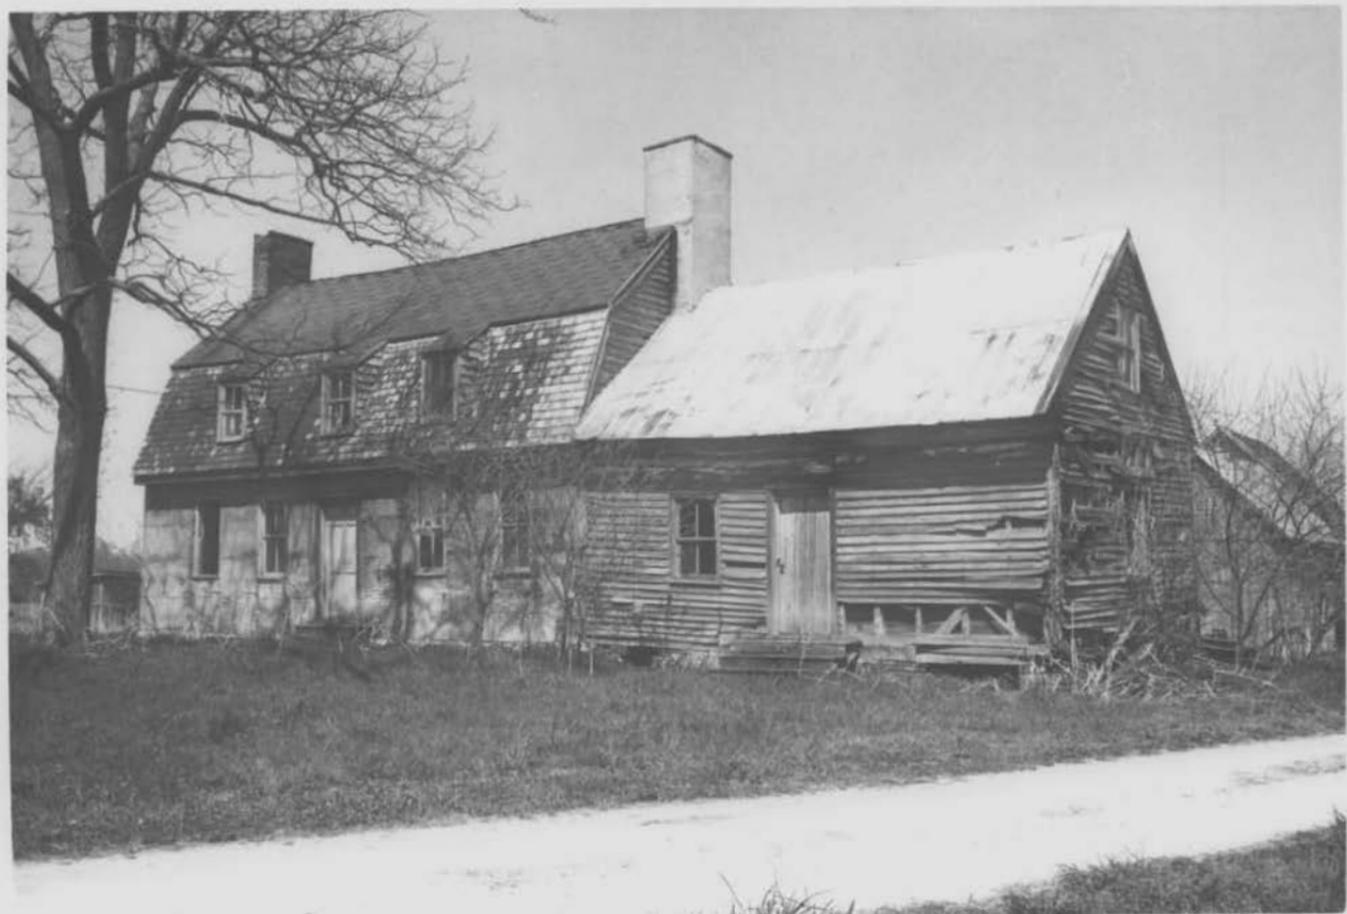
QA-62
Caleb Clough House w/
chimneys still standing
