Maryland Inventory of Historic Properties number: S-433

Name: MD 364 over Purding Creek

Name and SHA No. 19010 over Dividing Creek

MARYLAND HISTORICAL TRUST
NR-ELIGIBILITY REVIEW FORM

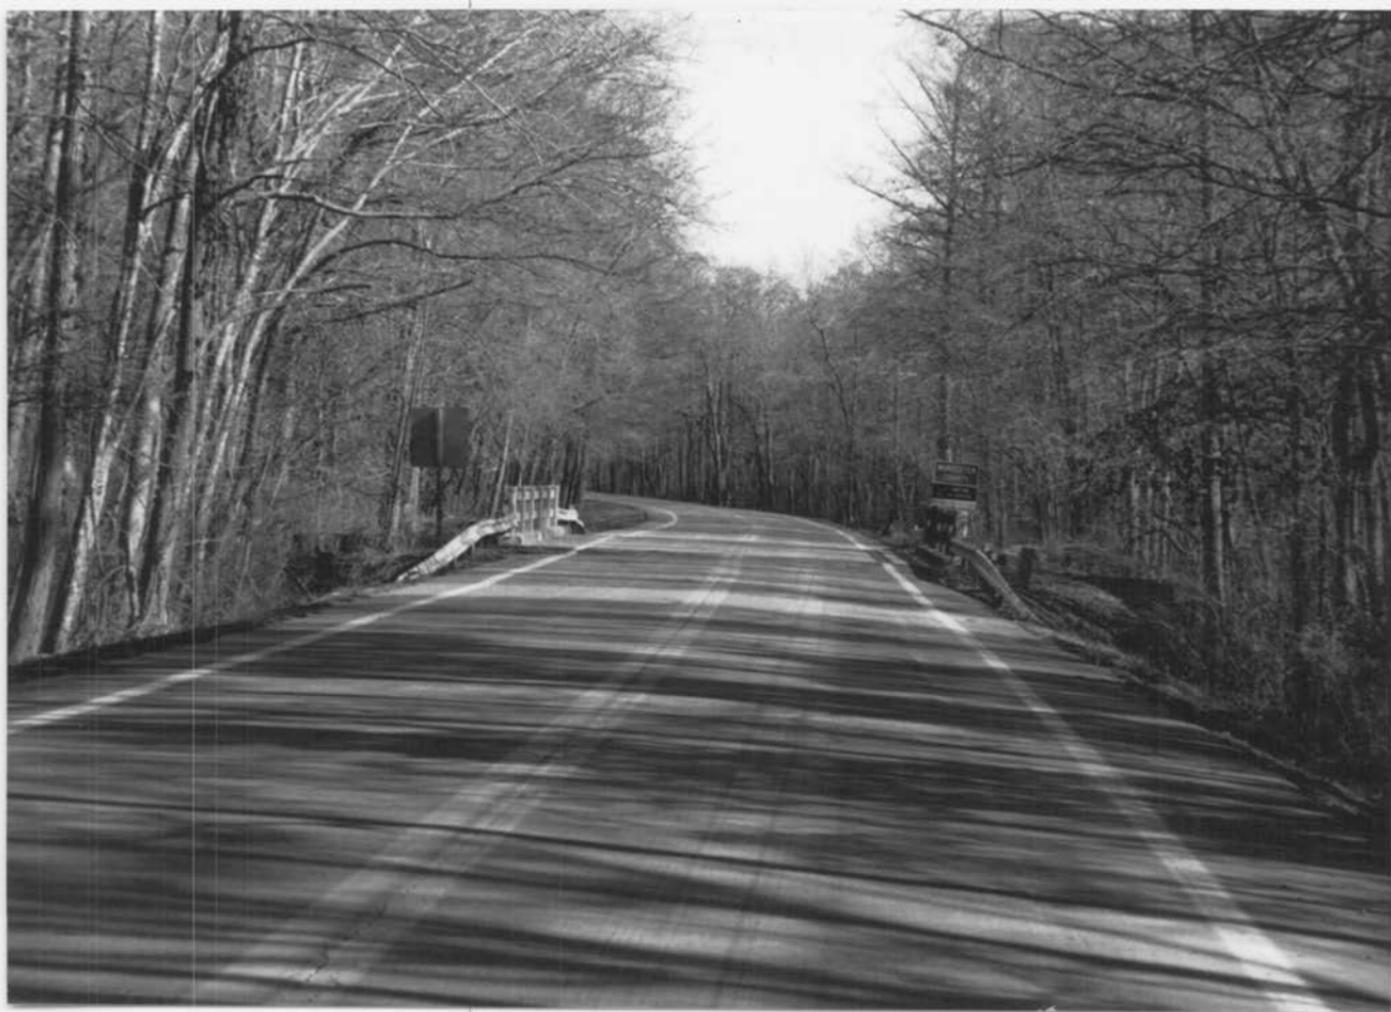
1 OF 5

BRIDGE 19010, LOOKING NE ON MD 304

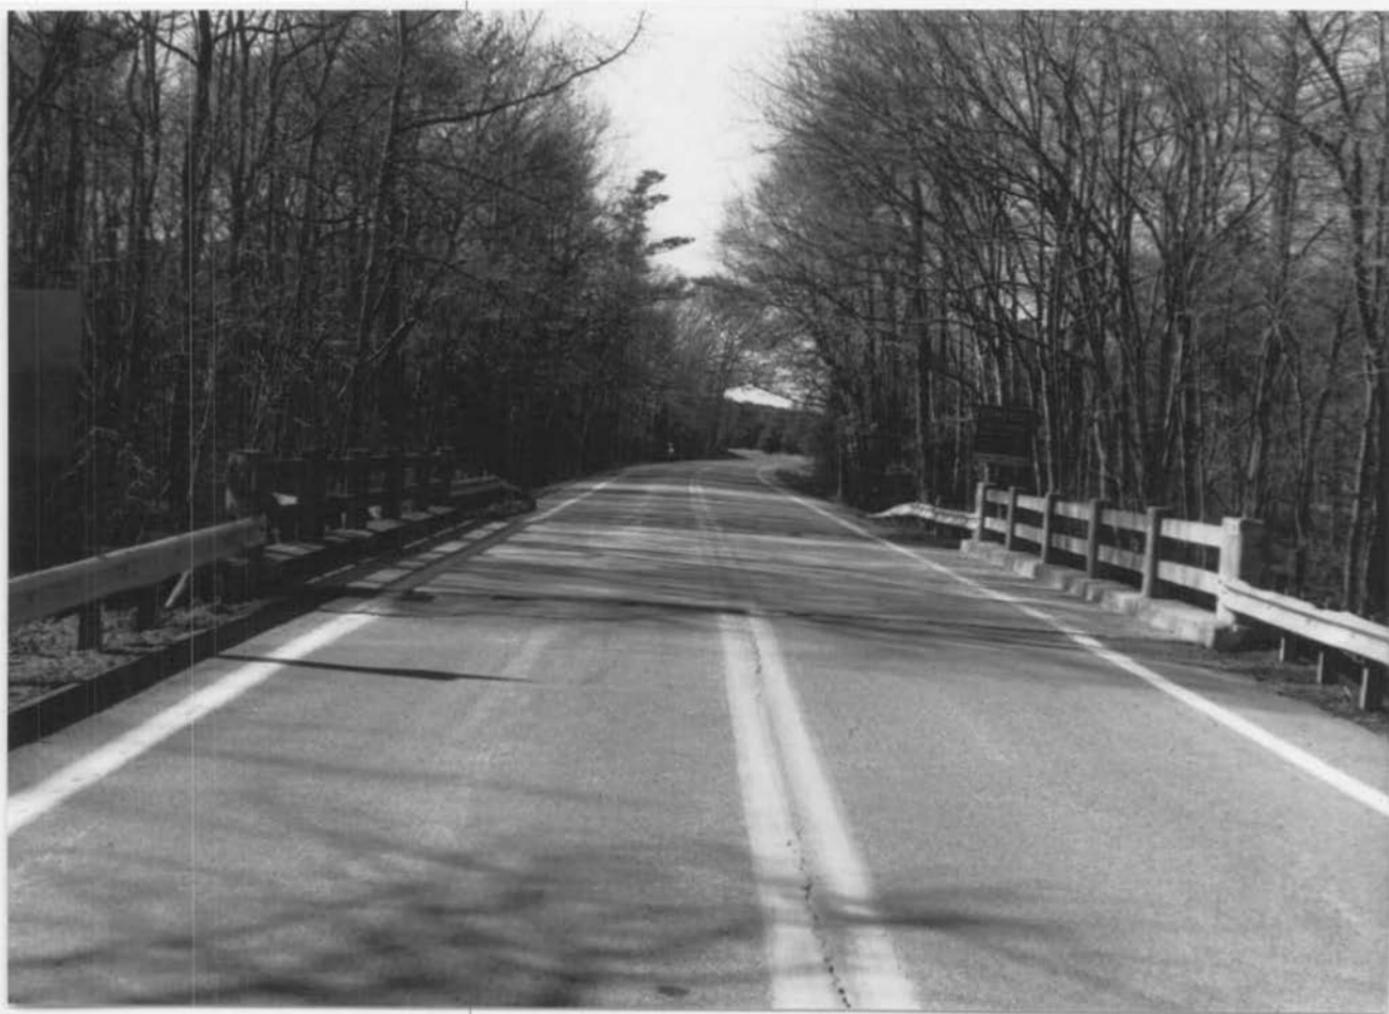
2 of 5

BRIDGE 19010, LOOKING SW ON MD 364

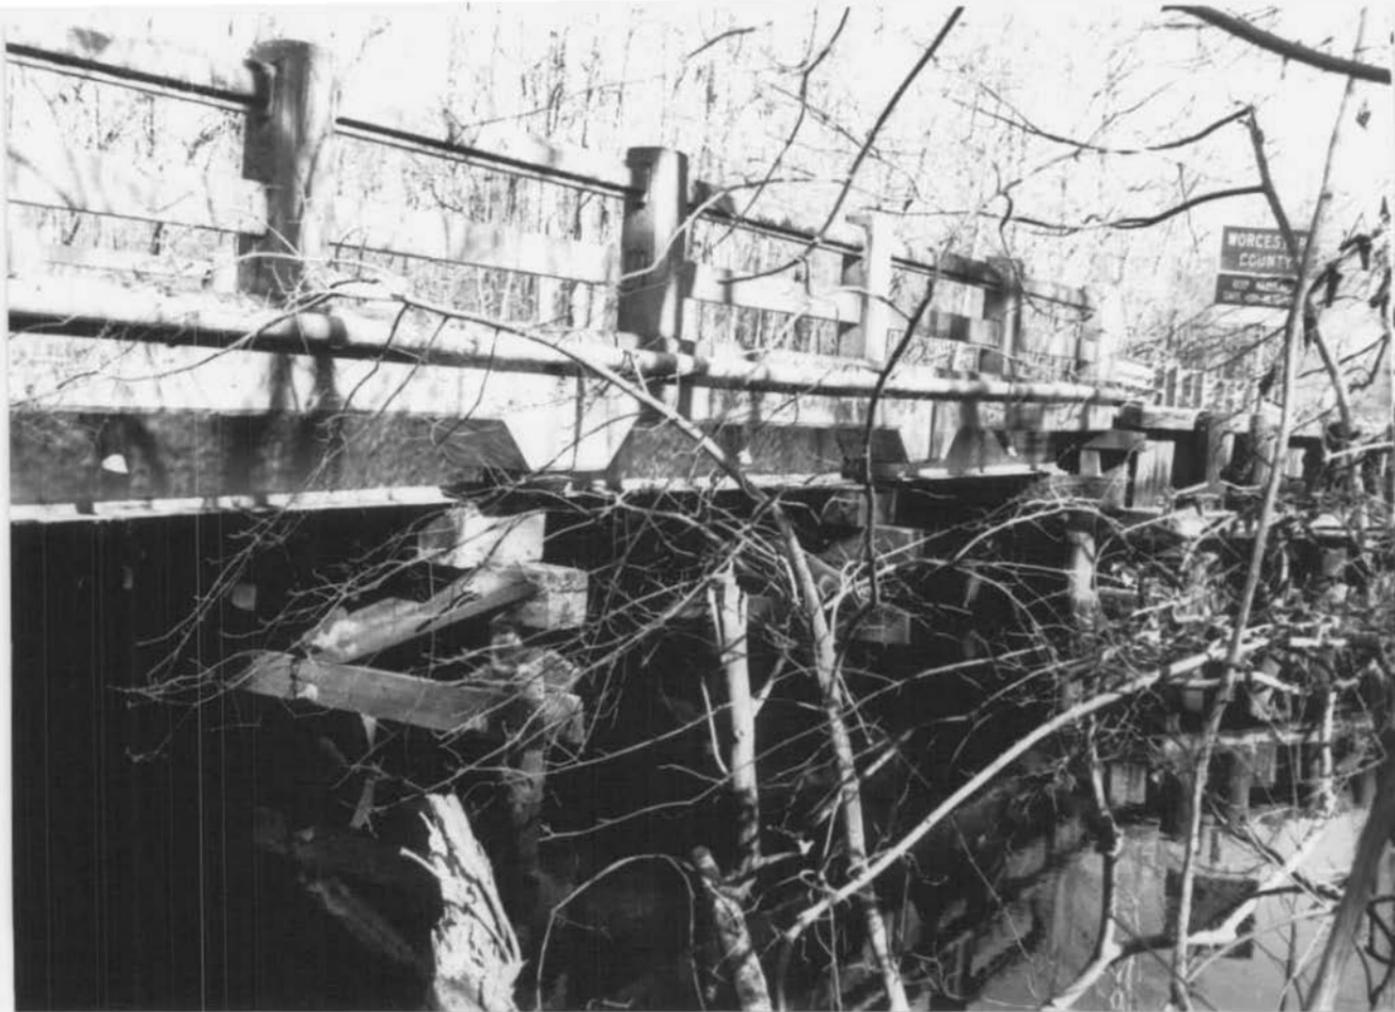
3 OF 5

BRIDGE 19010, LOOKING UPSTREAM (NW)

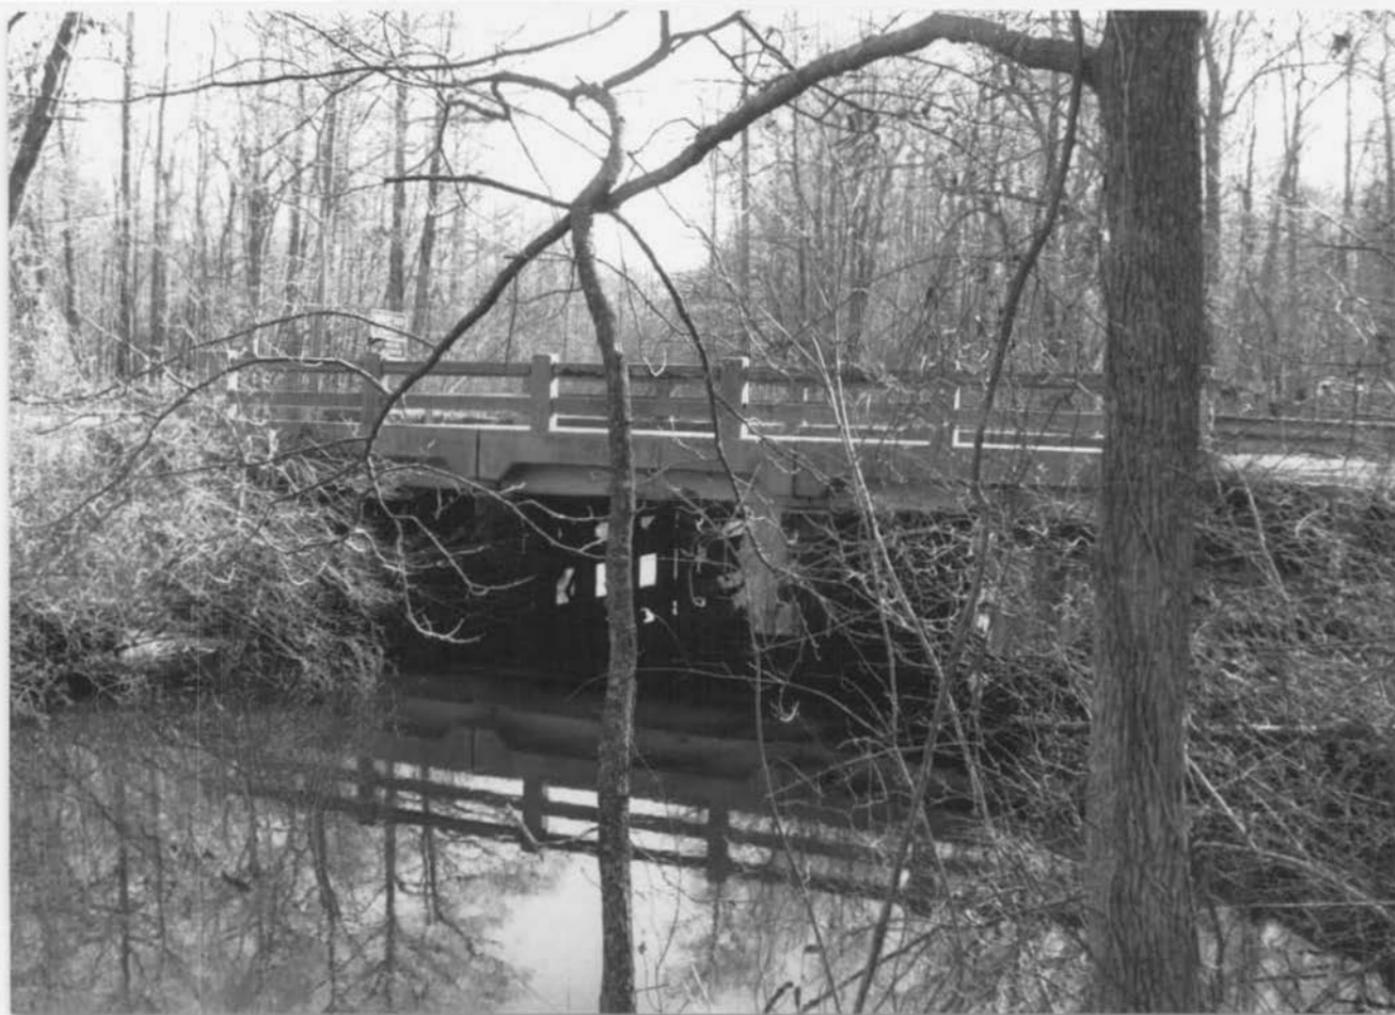
4 of 5

BRIDGE 19010, LOOKING DOWNSTREAM (SE)

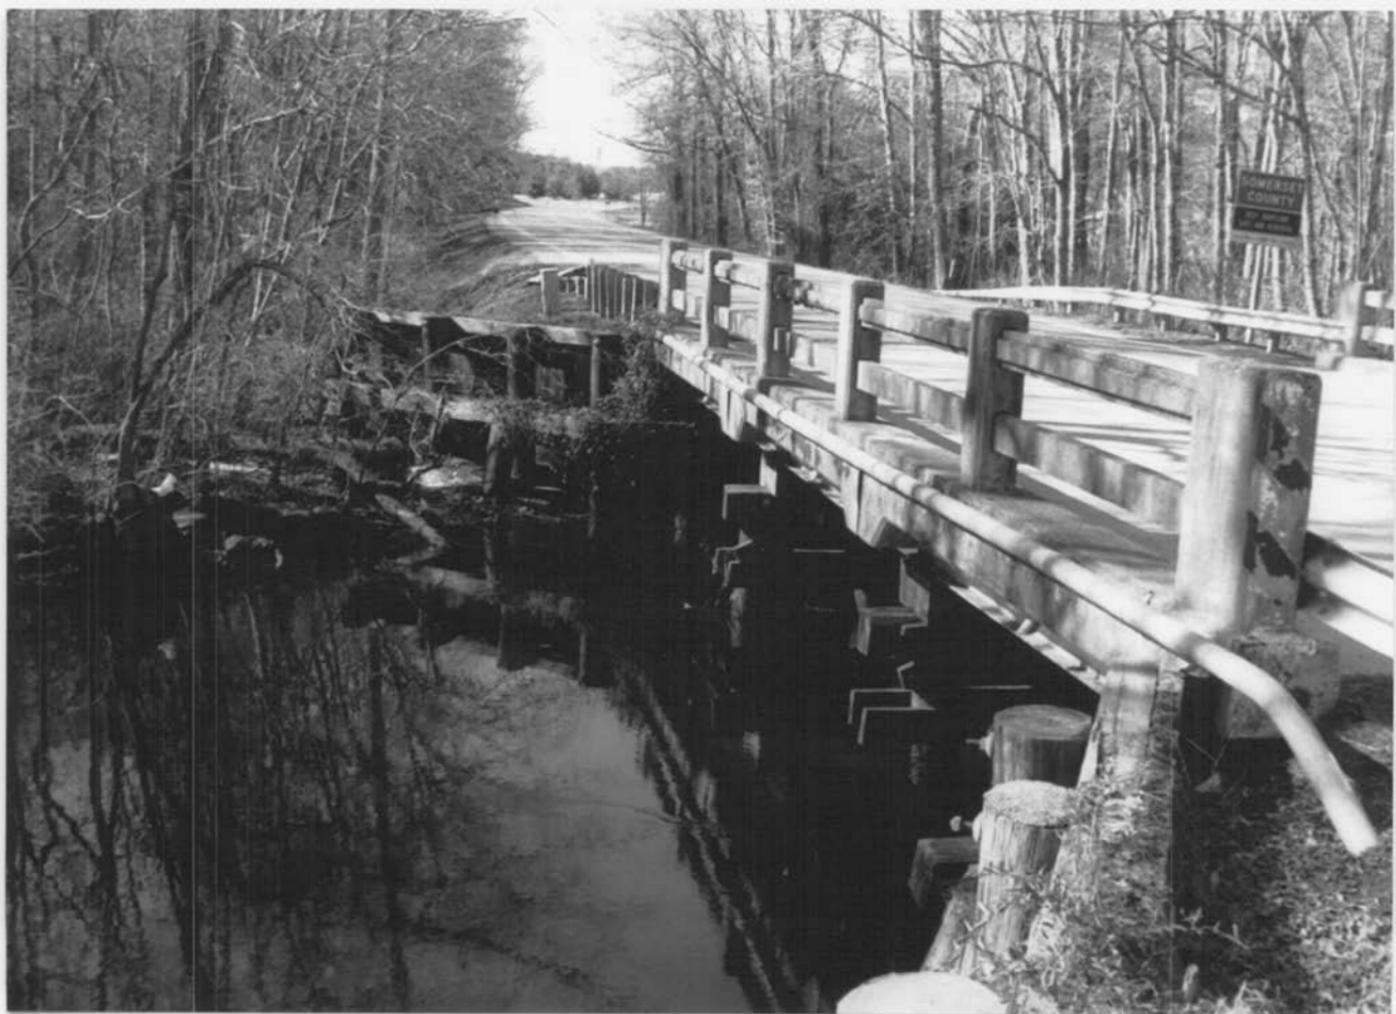
5 of 5

BRIDGE 19010, LOOKING UPSTREAM (2'N)
