**MARYLAND HISTORICAL TRUST
DETERMINATION OF ELIGIBILITY FORM**

Property Name: Hayden Farmhouse, Secondary Buildings Inventory Number: SM-177

Project: Hayden Property Elementary School Site Agency: St. Mary's County Public Schools

This DOE addresses the agricultural and secondary domestic buildings associated with the historic Hayden Farmhouse (SM-177). That c.1878 building was destroyed in a controlled burn by the fire department c.2000. The Hayden Farmhouse MIHP did not document the other buildings on the property.

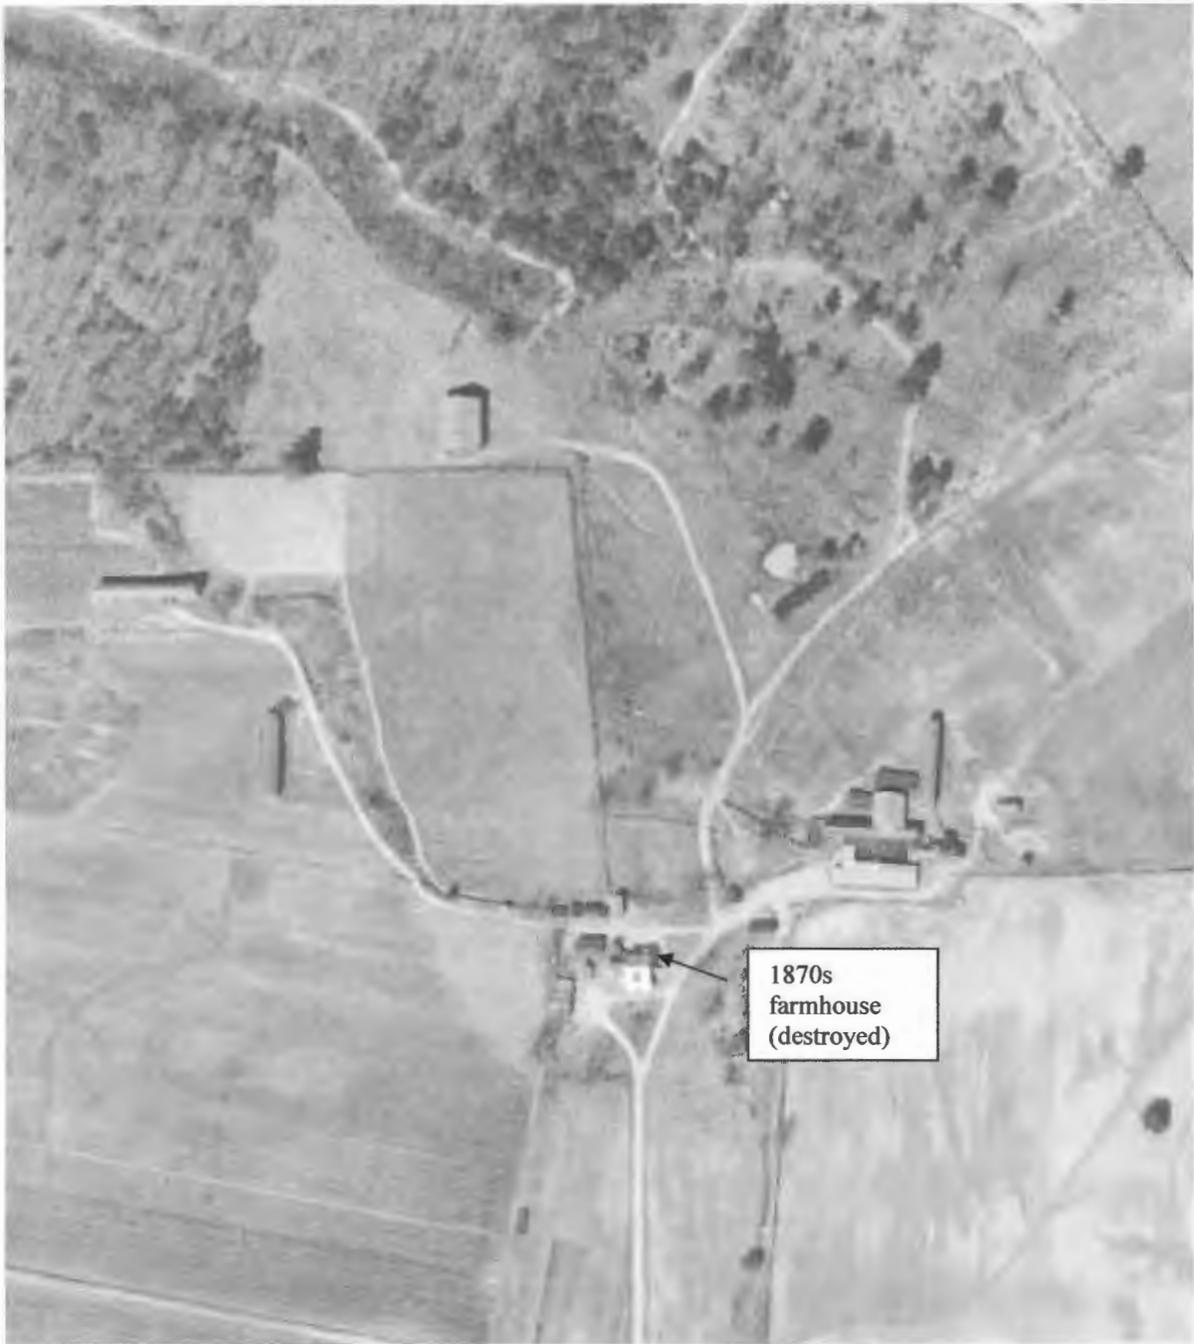
Figure 3: This 1952 aerial photograph shows the presence of the original farmhouse, which burned c. 2000. The gambrel-roofed tobacco barn (Building 10) and the tenant house (Building 11) are not yet built. Also absent is the pond, created in the early 1960s. The paths to barns (Buildings 12 and 18) are well worn, but there seems to be little traffic activity around the original barn (Building 9). Part of the poultry house (Building 7) is identifiable, as well as what appears to be the garage and shed (Buildings 4 and 5). A 1980s fire destroyed the buildings shown at the right side of the image.

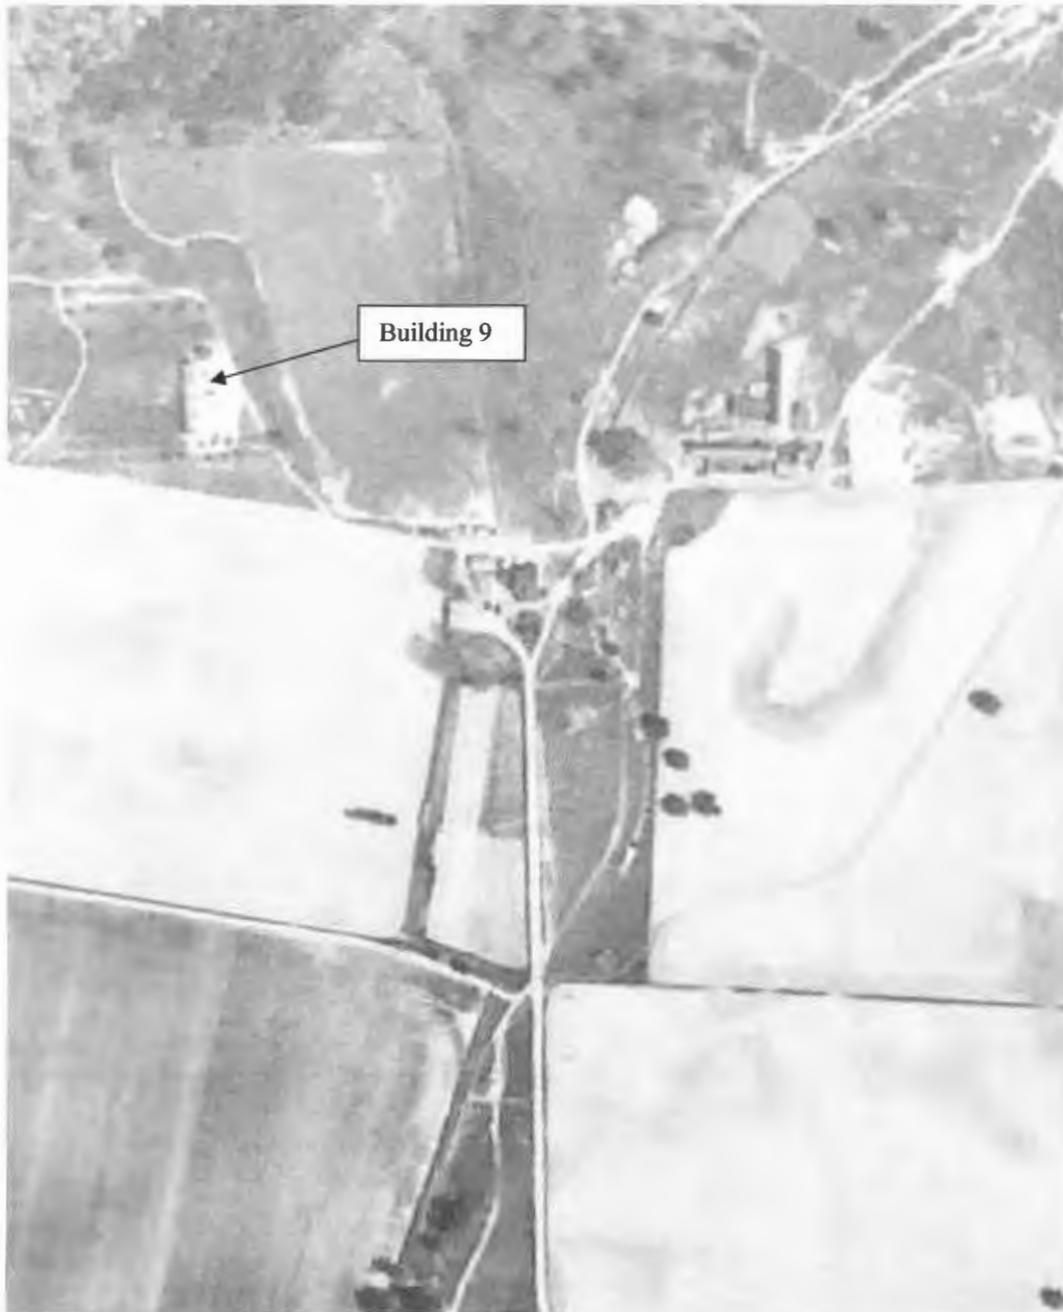
Figure 4: The resolution of this 1932 aerial photograph makes it difficult to compare the foot prints of buildings shown here with the current farm plan. Only one of the existing tobacco barns (Building 9) is shown in this image. It appears that the garage, shed and part of the poultry house were in place by this time (Buildings 4, 5 and 7).

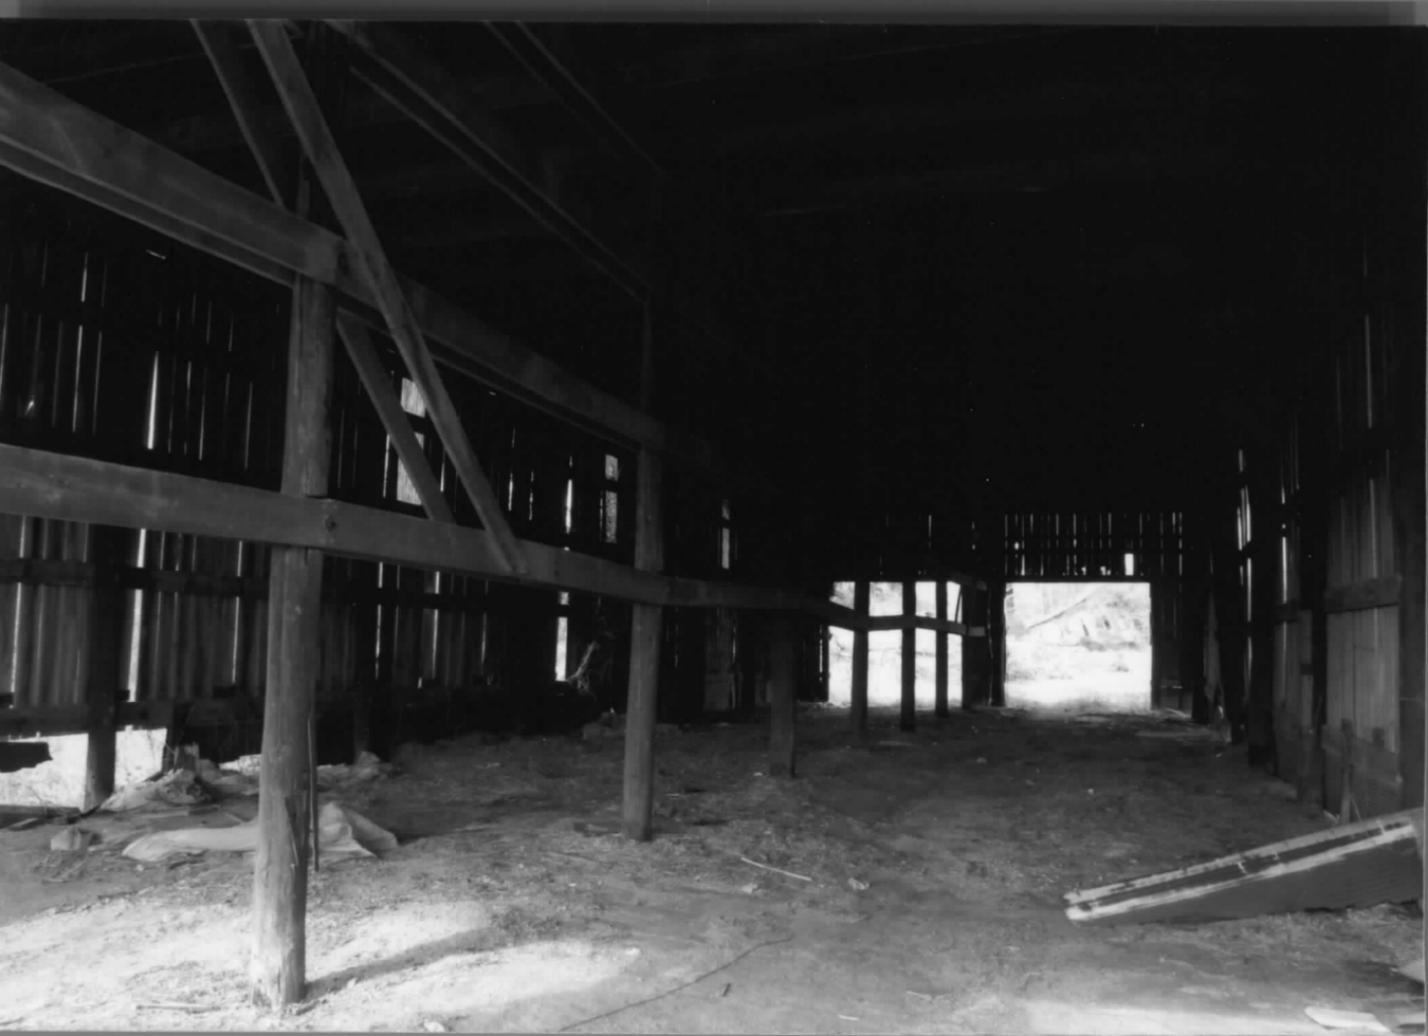
CAMERA FACING NORTH
Photo 19 of 33

SM-0177, HAYDEN FARM
ST. MARY'S CO., MD
by S.M. Johns 2/3/14
Digital MASTER at MD SHPO
Double-Aisle Tobacco BARN, Bldg 10
