Addendum to Maryland Historical Trust Maryland Inventory of Historic Properties Form

Inventory No. SM-520

Name of Property: SHA Bridge No. 1800800

Location: MD 5 (Point Lookout Road) over Eastern Branch, Park Hall, St. Mary's County

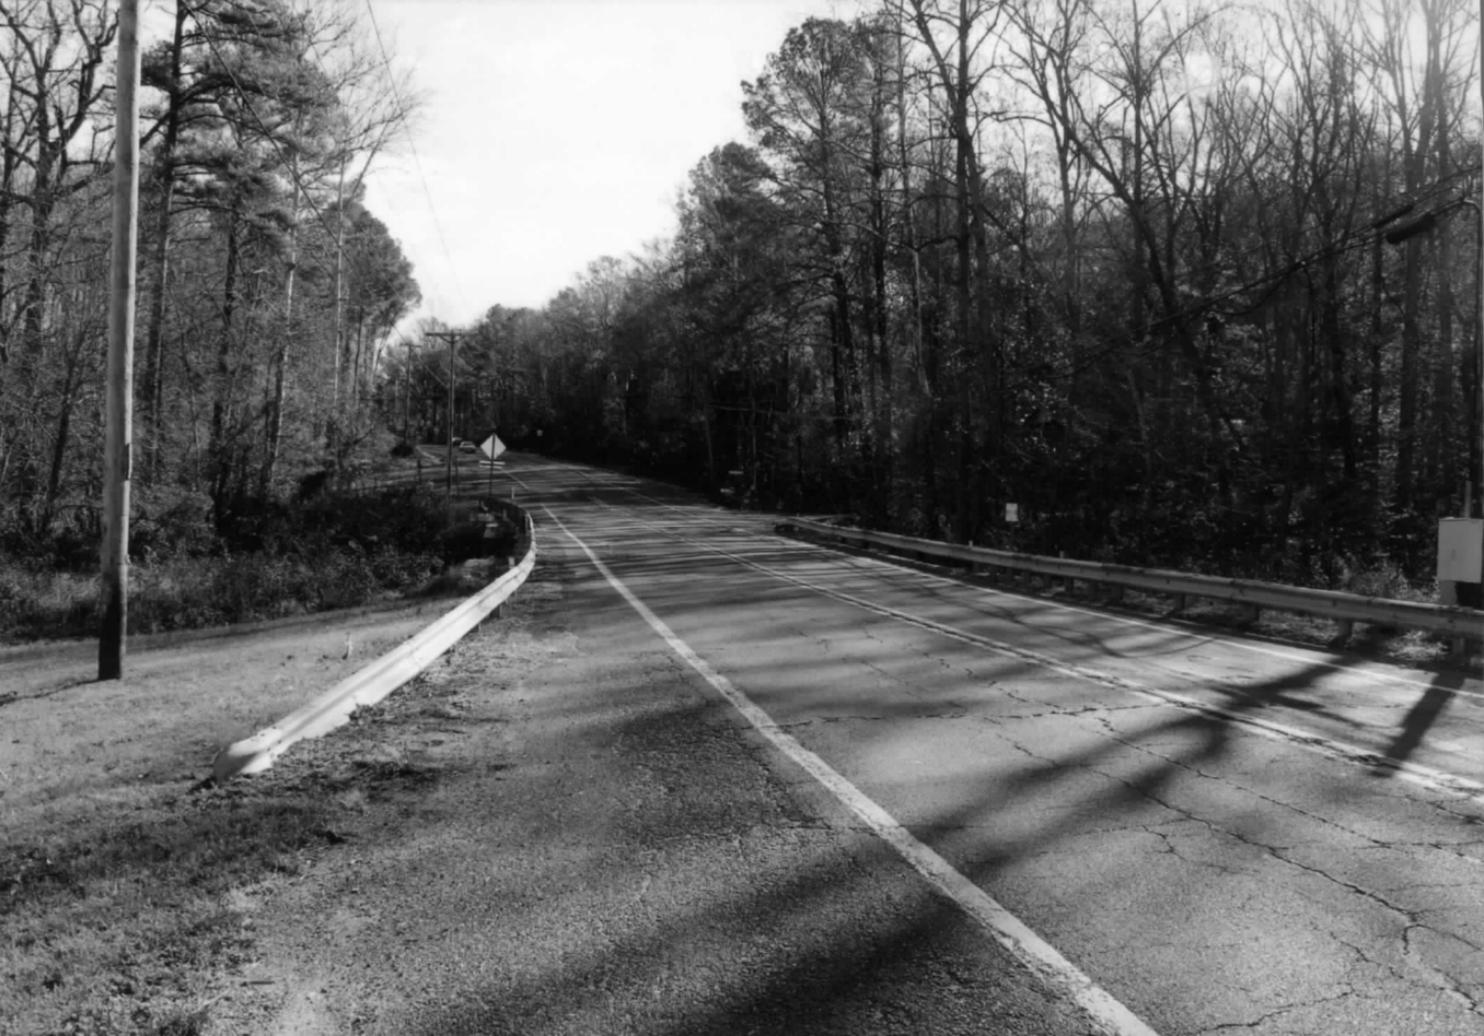
Photo # 115

The surface of the travel lanes showed increased rutting and depressions. Cracking in the deck of the bridge was filled in 1996 (BIRE 1996), and the deck was repaired with a bituminous overlay between 1998 and 2001 (BIRE 2001). Subsequent repairs were noted in the field visit. Two large concrete patches and a large area of old asphalt patching were visible in the northbound lane. There were also map cracking and small puncture holes. Long, horizontal cracks appear along both north and south edges of the bridge. These cracks appear to follow the points where the old railing are attached to the bridge.

General view of MD5 and
cracking and rutting in the
bridge deck, facing east

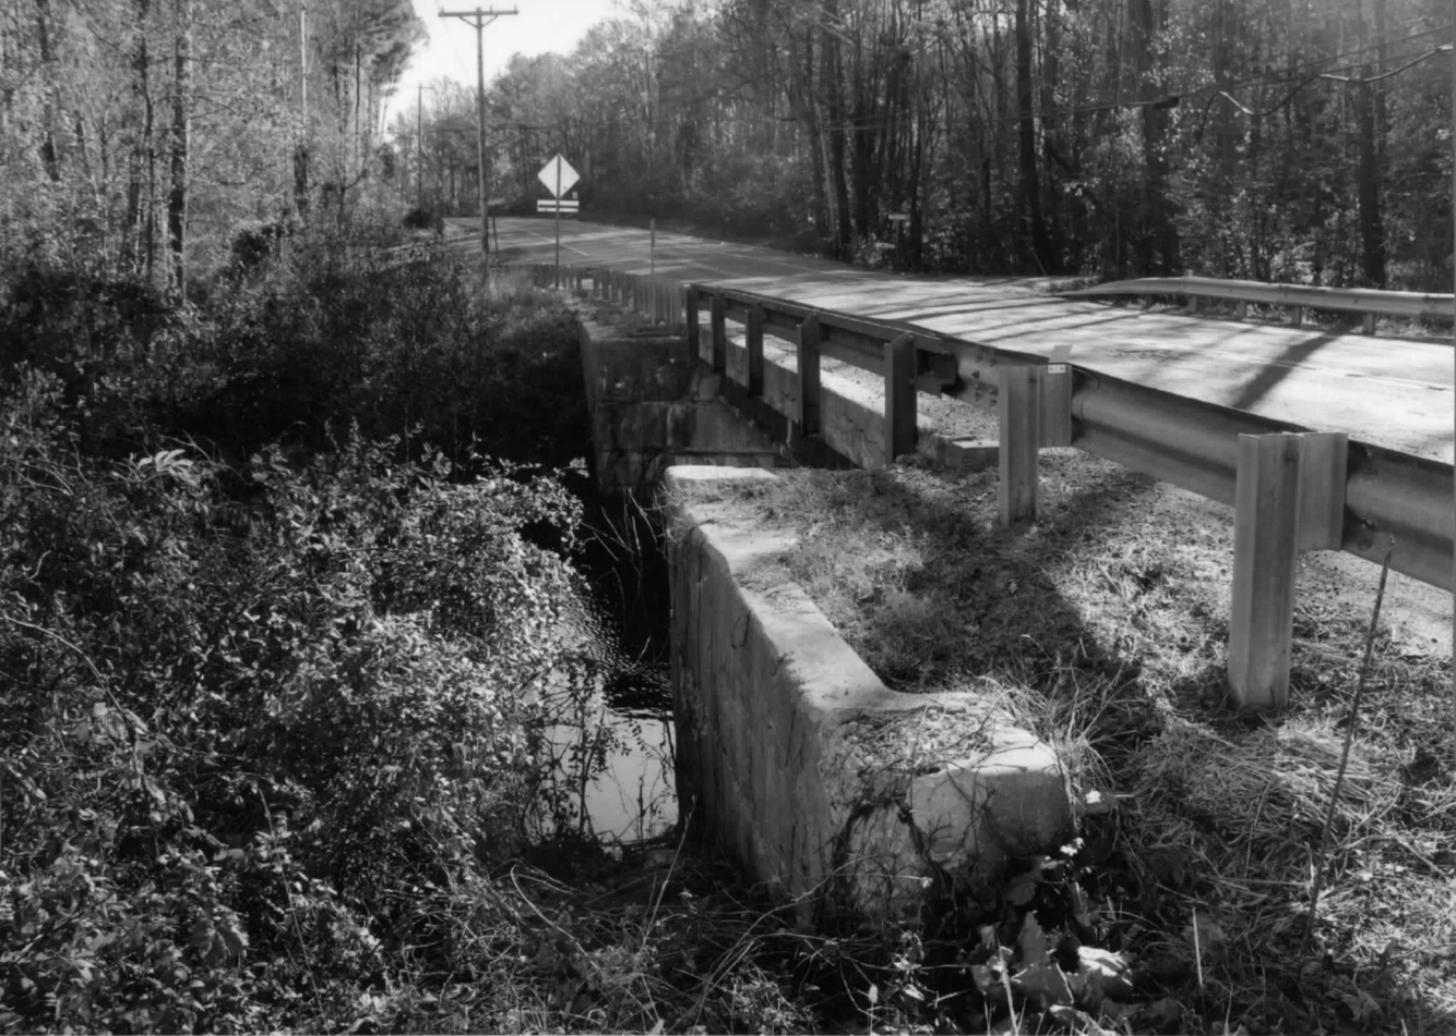
Photograph # 2/5

The posts which attached the original guard rails to the soffit on both sides of the bridge were rusted and corroded at the base and a number of bolts are missing. W-beam guard rails were attached to the original green railing on each side for added protection in 1998 (BIRE 1998). The original railing posts were re-painted between 1998 and 2001, but rust at the bases of the railing were noted almost immediately (BIRE 2001). In the field visit, the old railing on both sides showed signs of warping and the surface was rusted and corroded where it connected to the new guard rail.

North side of bridge, spalling on east
wingwall, connection between original
guard rail and W-beam guard rail,
facing southeast

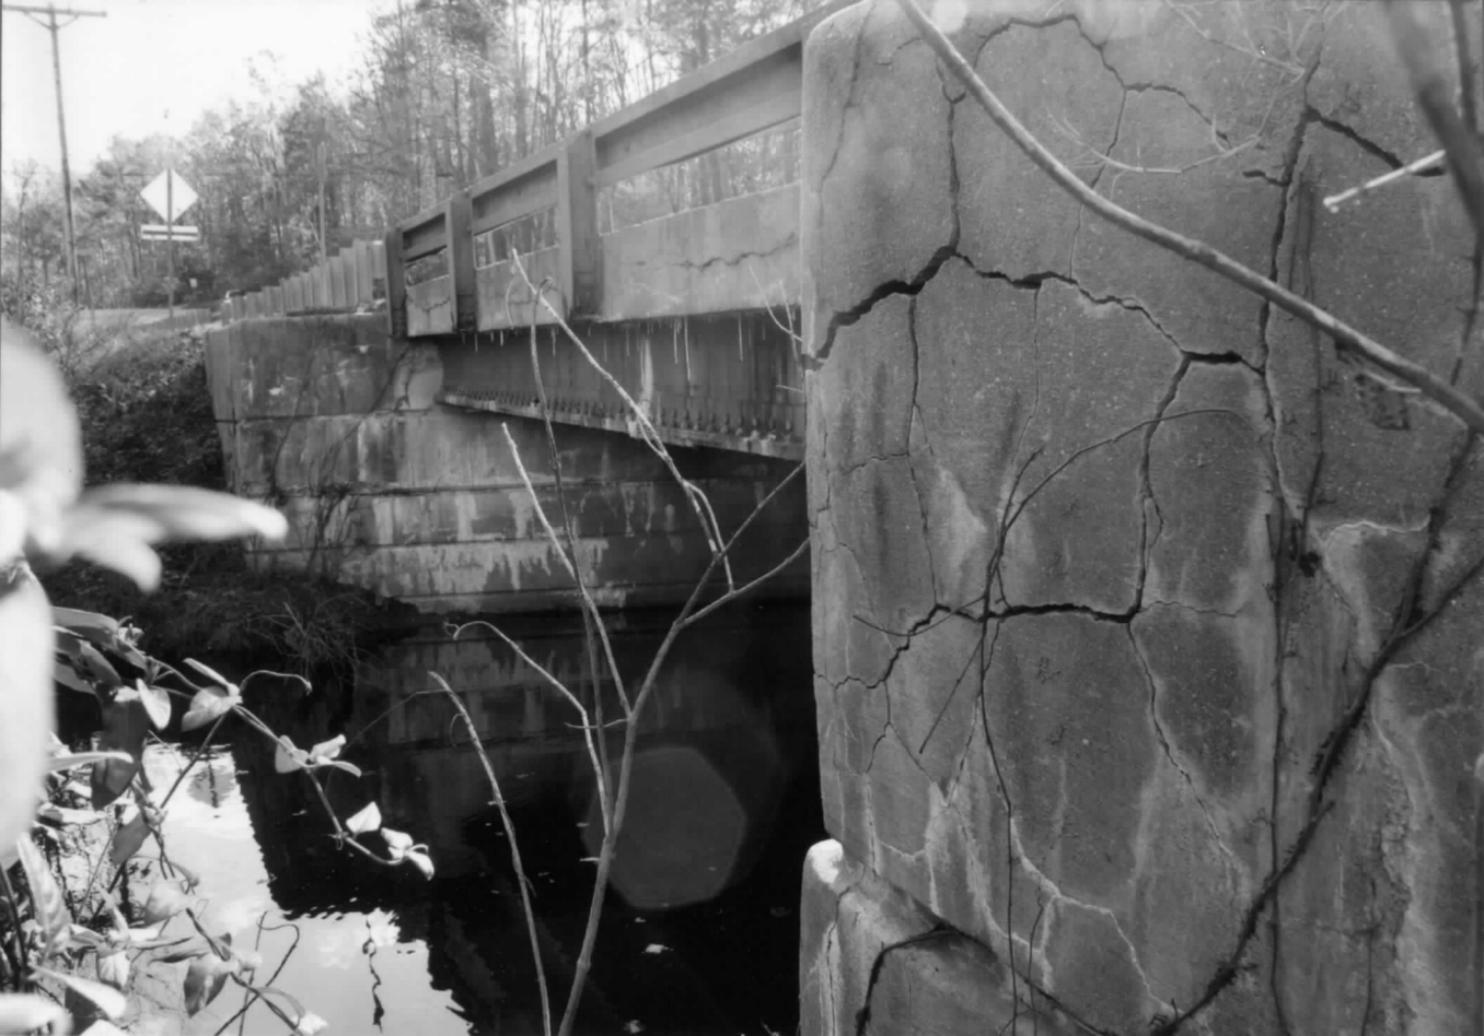
Photograph #3/5

A field visit in November 2013 indicated a number of cracks, spalled areas with exposed aggregate, and efflorescence on the bridge's abutments and wingwalls. Significant, deep vertical cracks and map cracking were noted on the northern side of the east abutment and on the northeast wingwall. The northwest corner of the east abutment was spalled so that aggregate was exposed. The northwest and southeast wingwalls had similar spalled areas in two spots as well as a full height vertical crack. Significant vegetation has grown along the southeast wingwall. The southern part of the east abutment also had spalled areas of exposed aggregate and the abutment appears to be bulging. The southwest wingwall and the west abutment appear to be in generally good condition. However, there is staining and heavy efflorescence on the interior of both abutments.

Cracking and efflorescence on northwest
wingwall, facing southeast

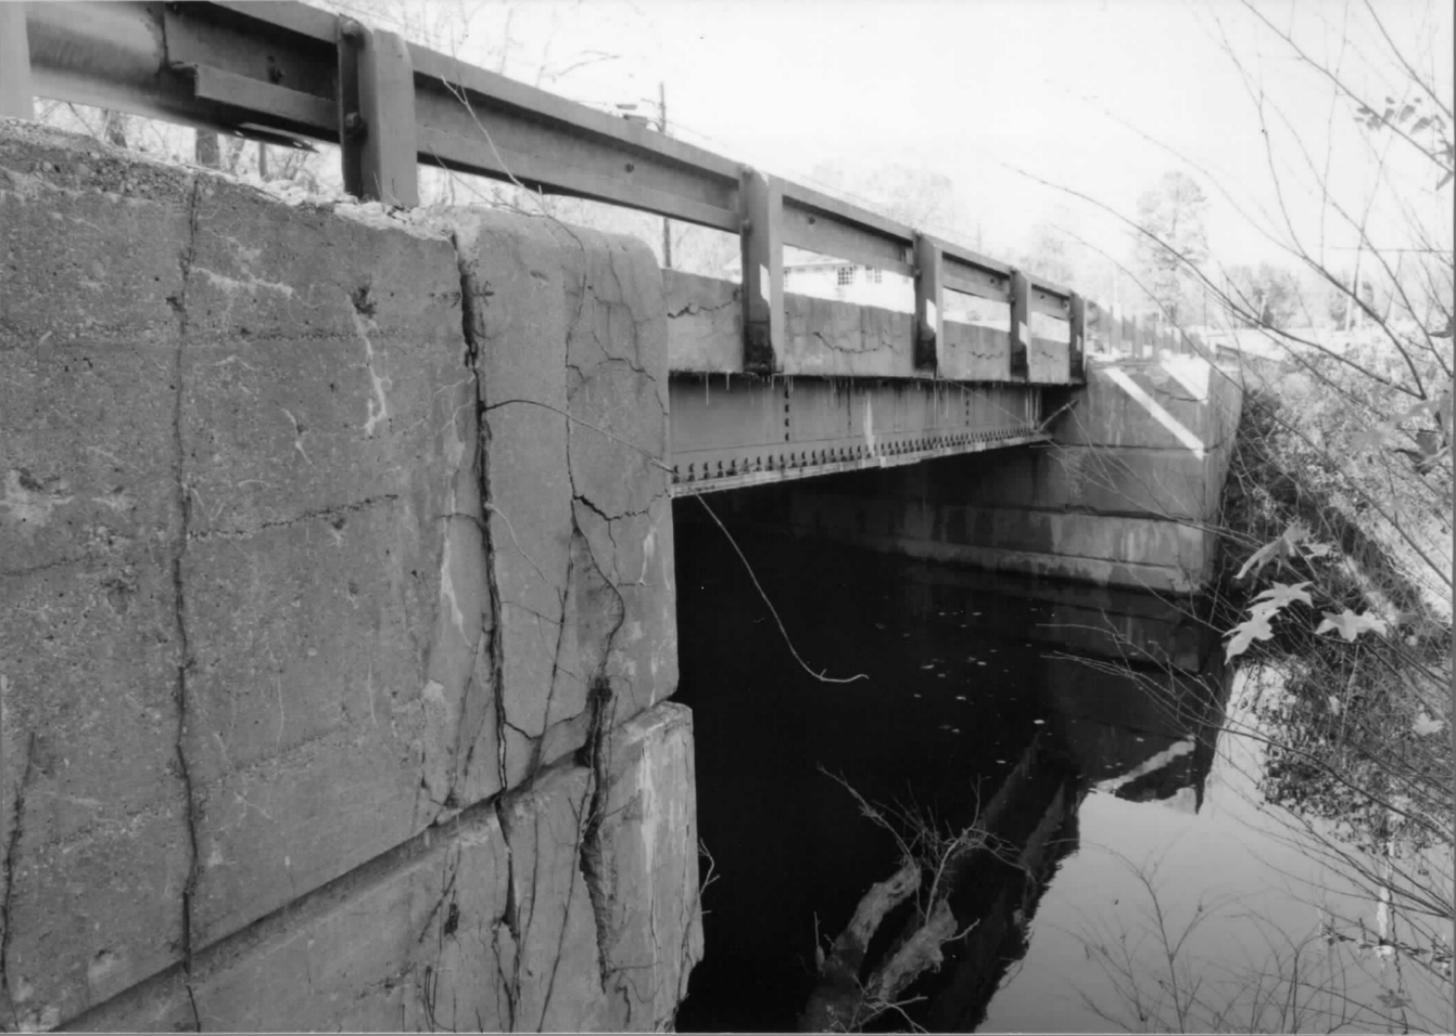
Photograph #4/5

The fascia beams of the superstructure showed evidence of hairline cracking, rust staining from the soffit, and minor section loss on the webs and bottom flanges. Both of the fascia beams were painted in 2000 with heavy pitting and section loss under the paint (BIRE 2005). Heavy pitting and section loss on the fascia and interior beams was noted again in the 2007 inspection reports (BIRE 2007). Between 2007 and 2009, the fascia beams were painted and retrofitted with a bolted plate connection across the entire length, and four of the interior beams were plated along the bottom flange and lower web (BIRE

Detail of cracks on northeast wingwall,
north side fascia beam, and
original guardrail, facing west

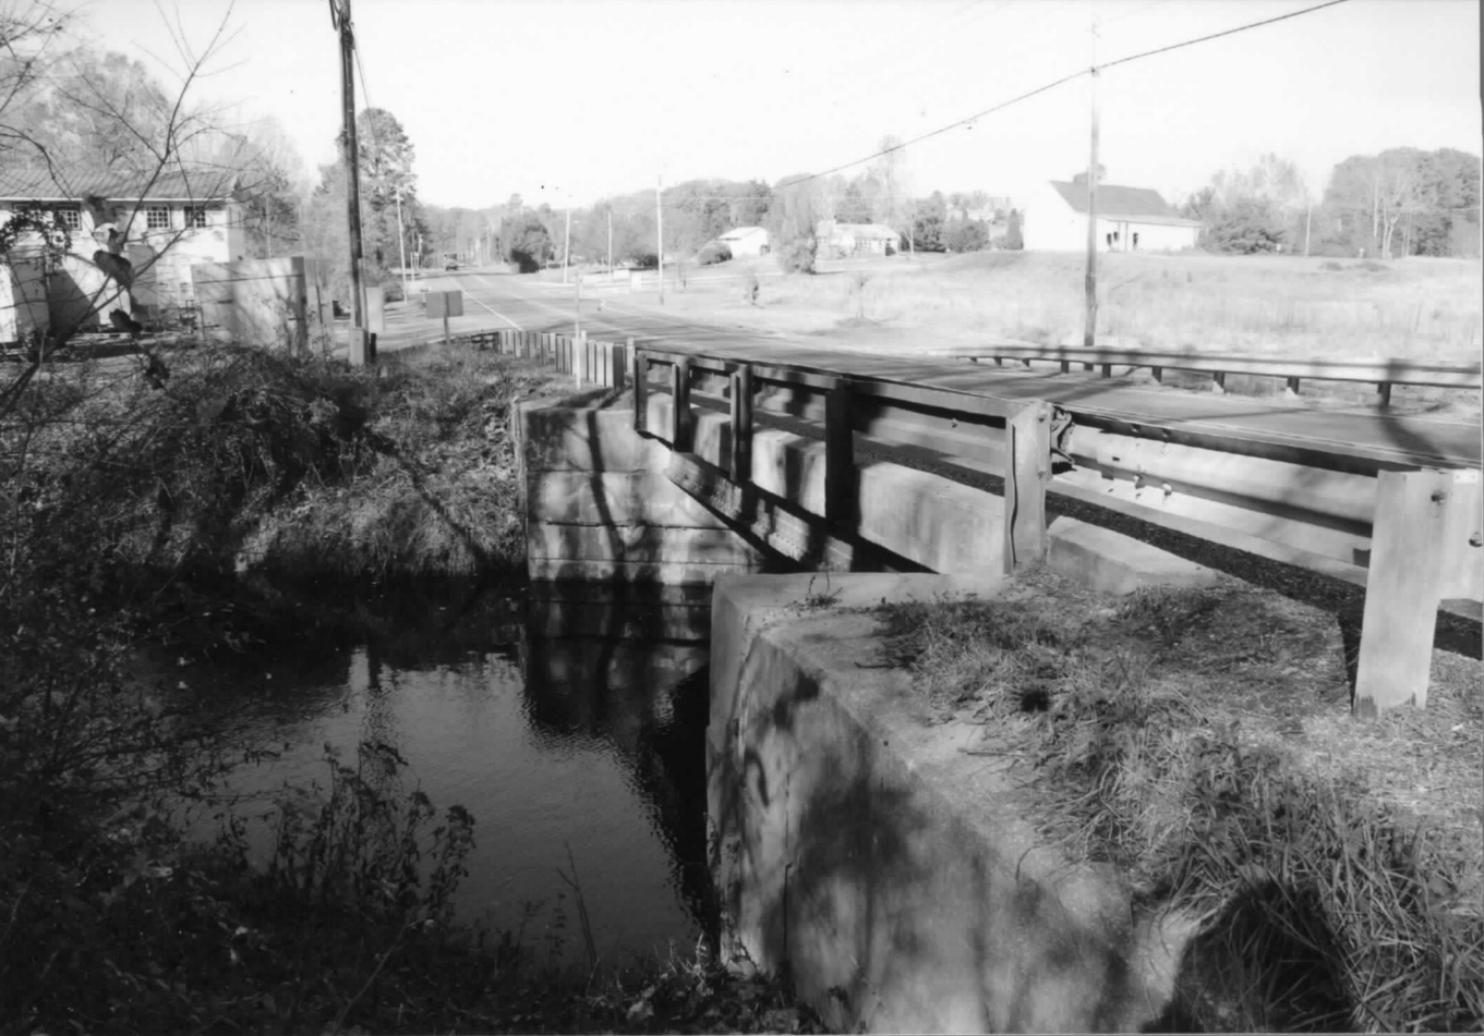
Photograph #515

South side of bridge, west abutment,
east wing wall, and MD5, facing west
