STAMP Tag Deploying Form

- 1. Tagged by: Kirby Brown
- 2. Tag Number(s) (####): MDC032
- 3. Date: 1/20/24 Time: 10 : 29 (am) pm
Tide level: High Medium Low
- 4. Name of wreck (if known): _____
- 5. Description: How did the wreckage reach its present position?
 Float Uncovered Other Storm Surge

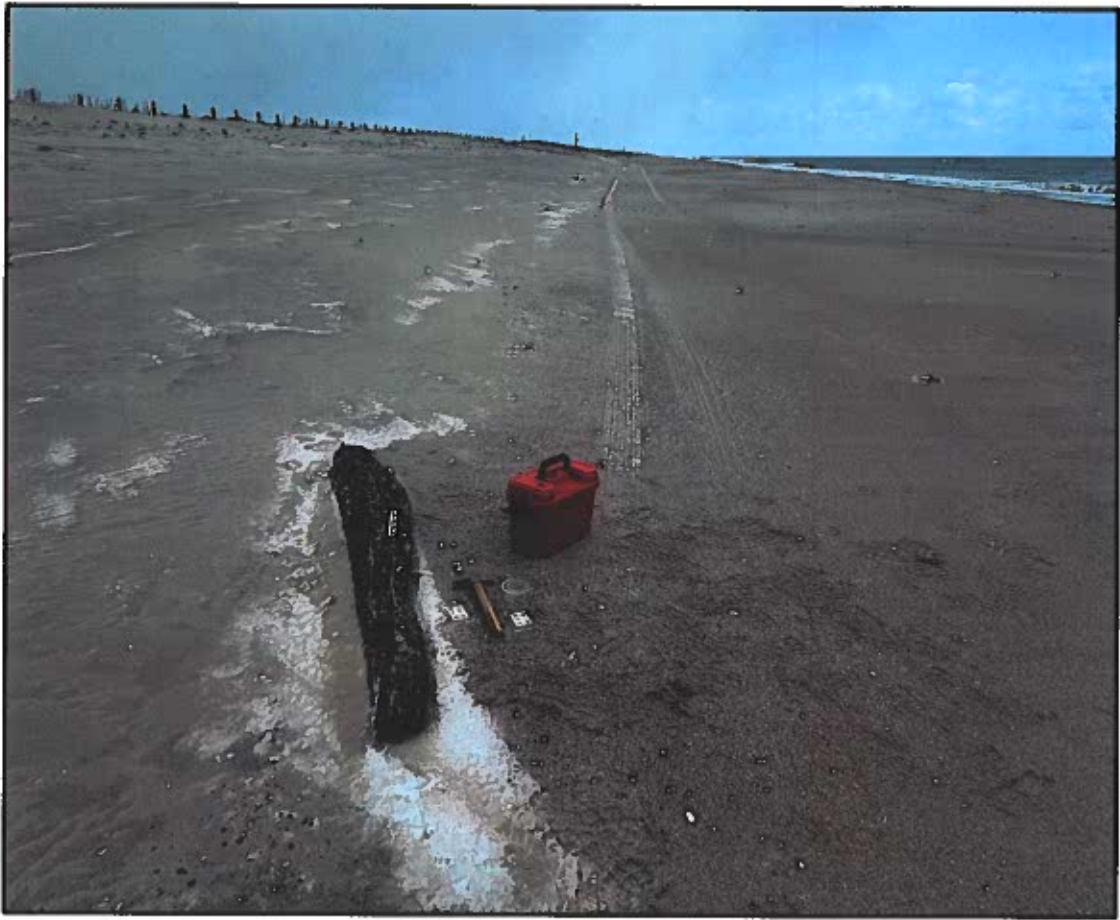
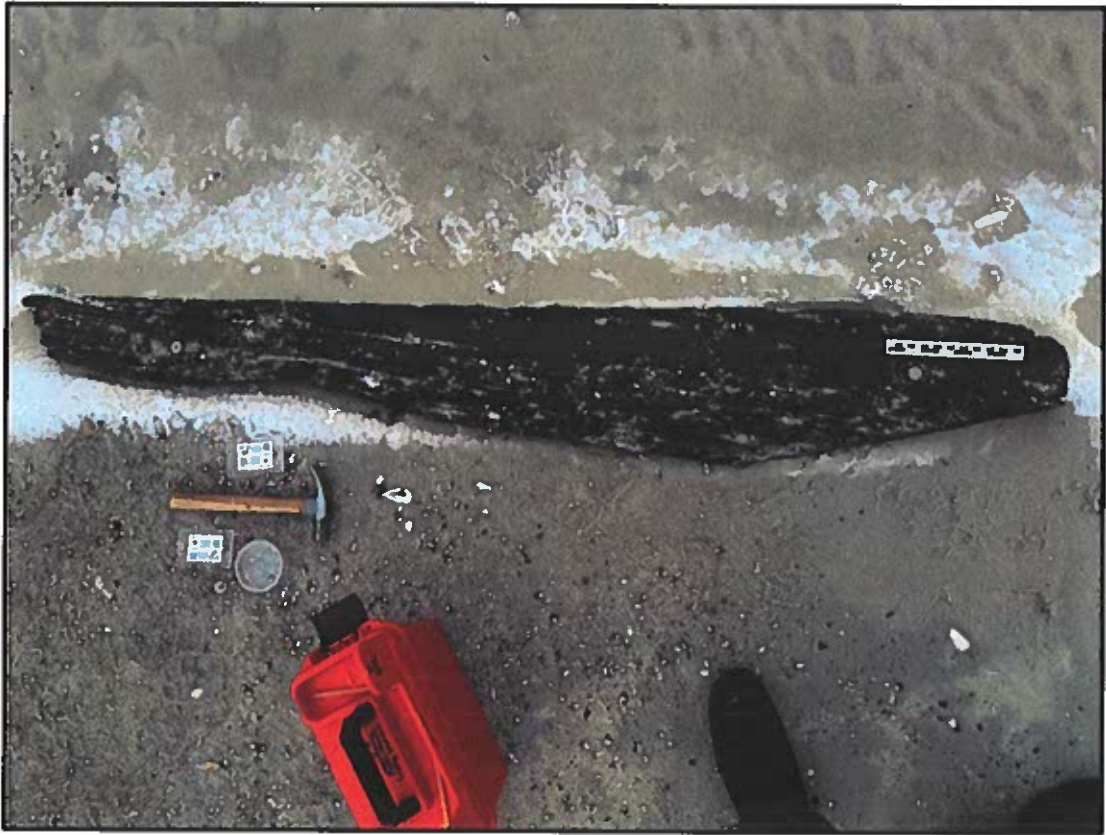
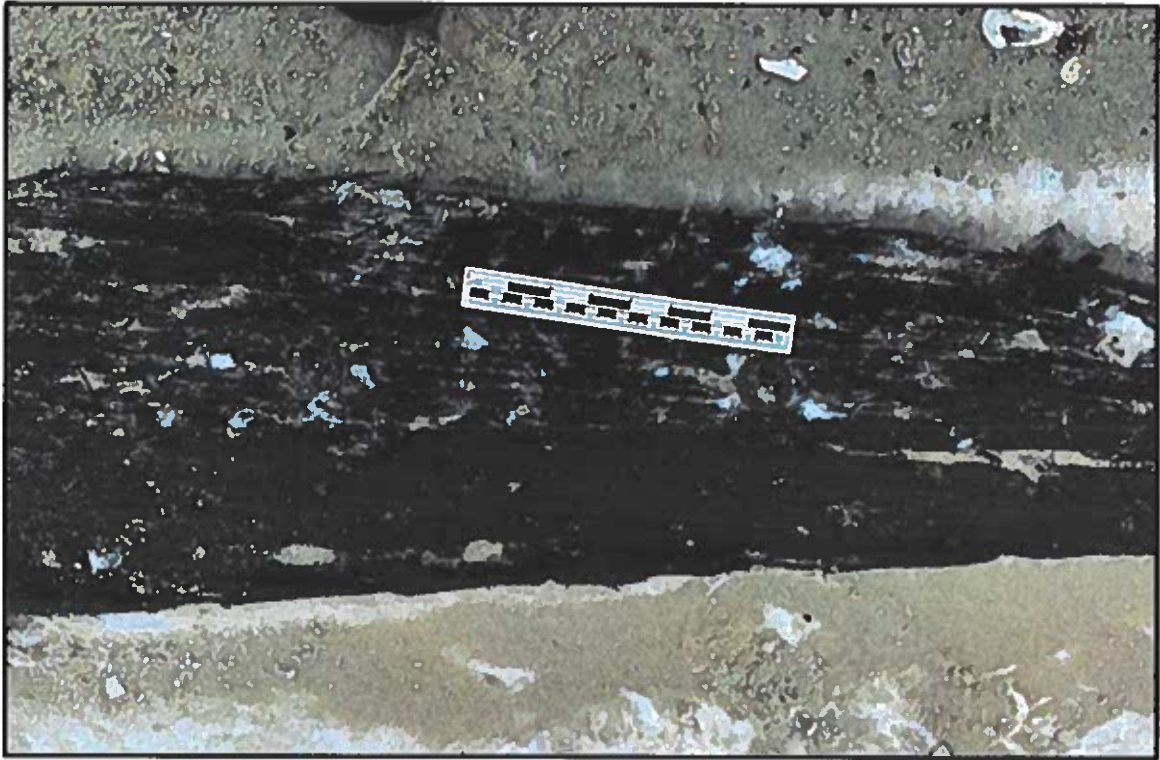
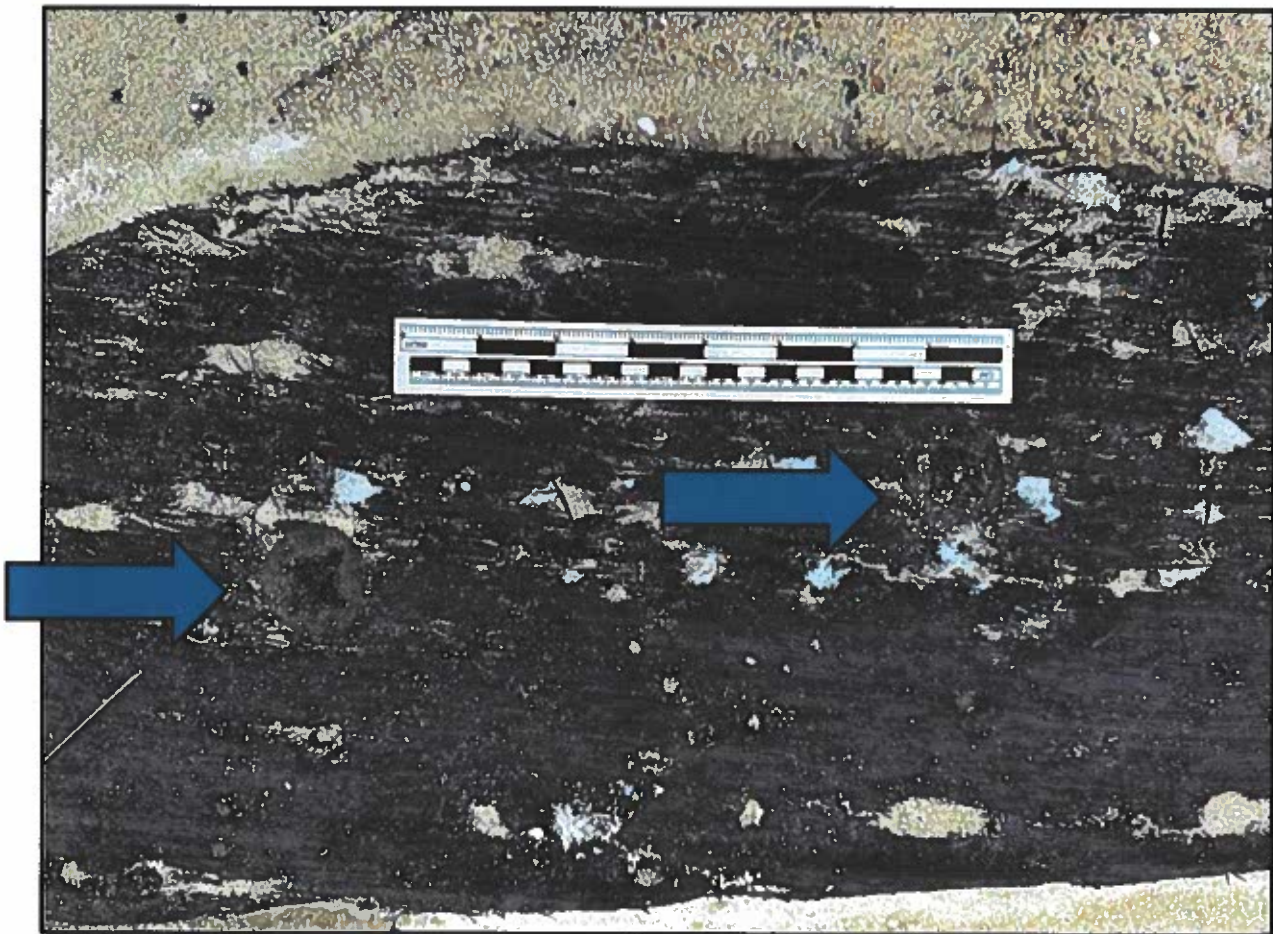
One edge is shaped.
Possibly part of a
bulkhead

14. **Comments:** The two toenails appear to show
square shims. These are less common than
those shimmed with straight pieces.

These machine-turned treenails appear to have the less common square shims.
