### STAMP Tag Deploying Form

- 1. Tagged by: Kirby Brown
- 2. Tag Number(s) (####): MD 0039
- 3. Date: 2/18/2024 Time: 9 : 42 (am) pm  
Tide level:  High  Medium  Low
- 4. Name of wreck (if known): N/A
- 5. Description: How did the wreckage reach its present position?  
 Float  Uncovered  Other \_\_\_\_\_

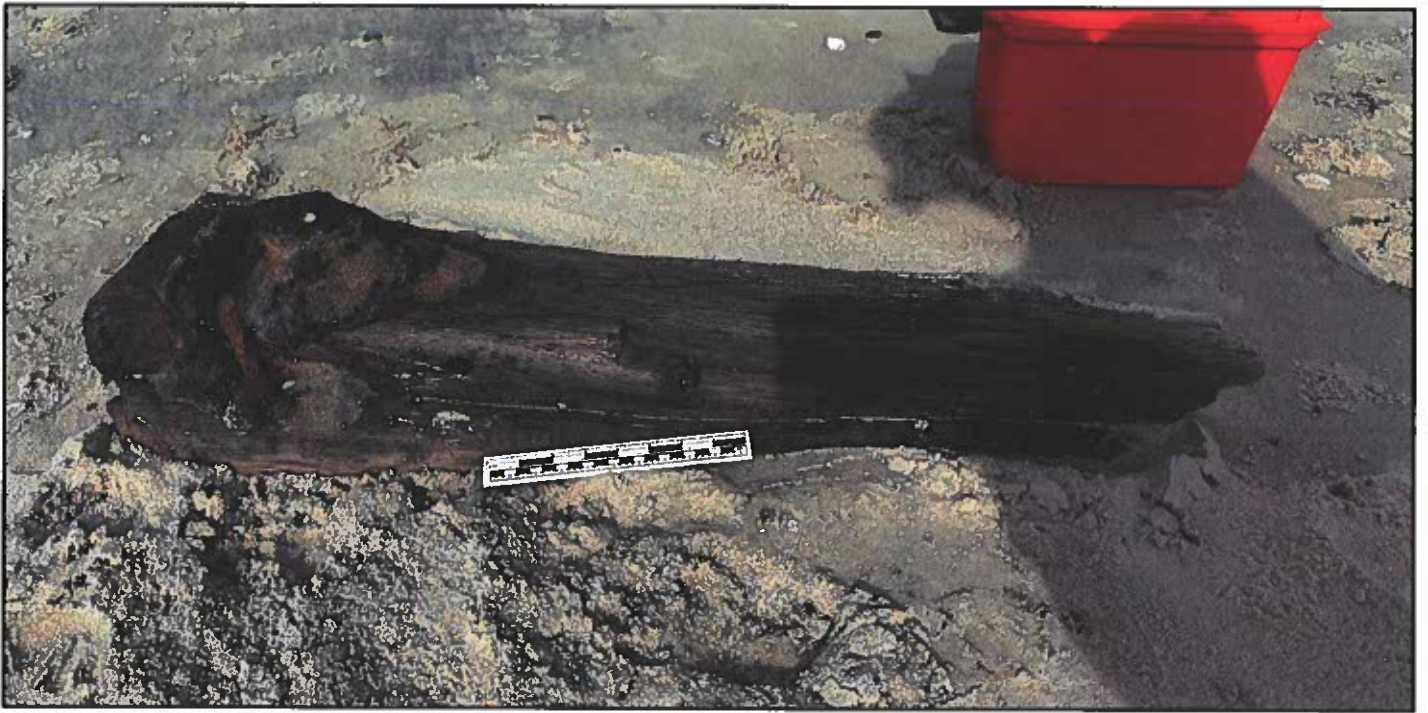
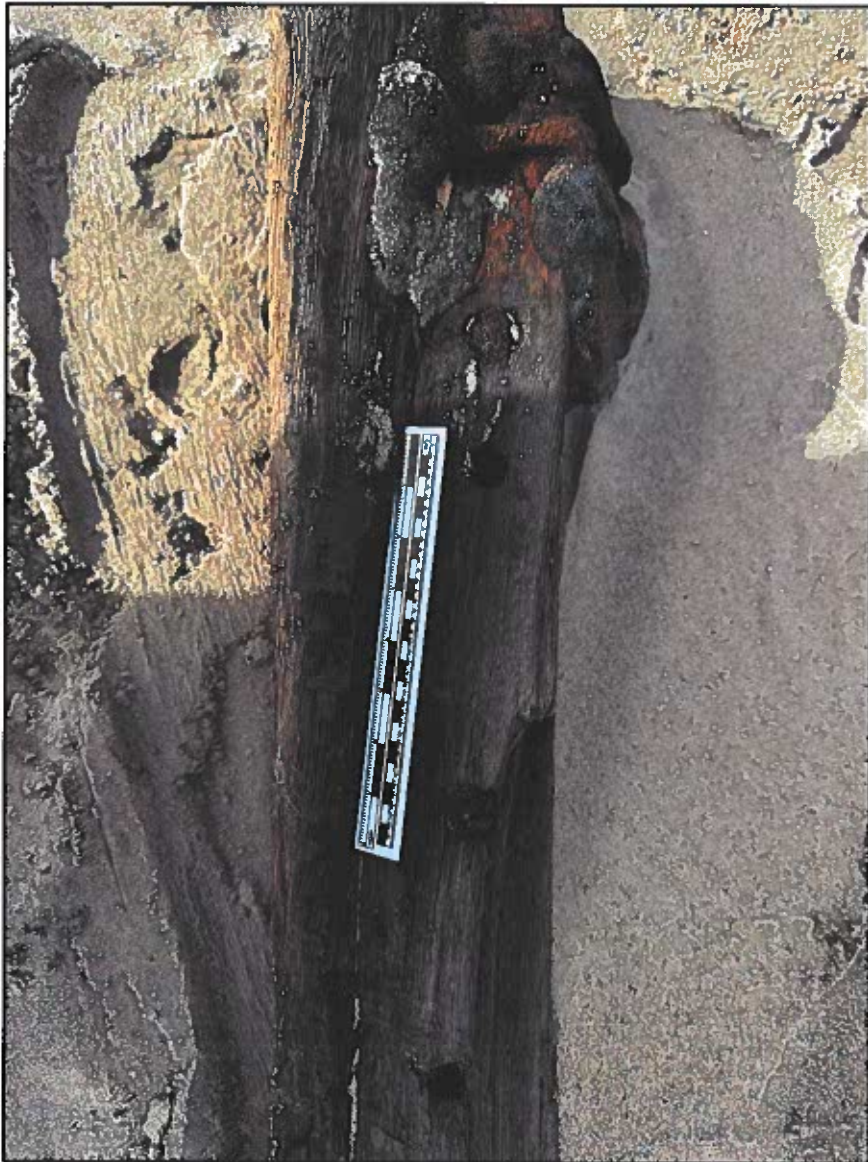
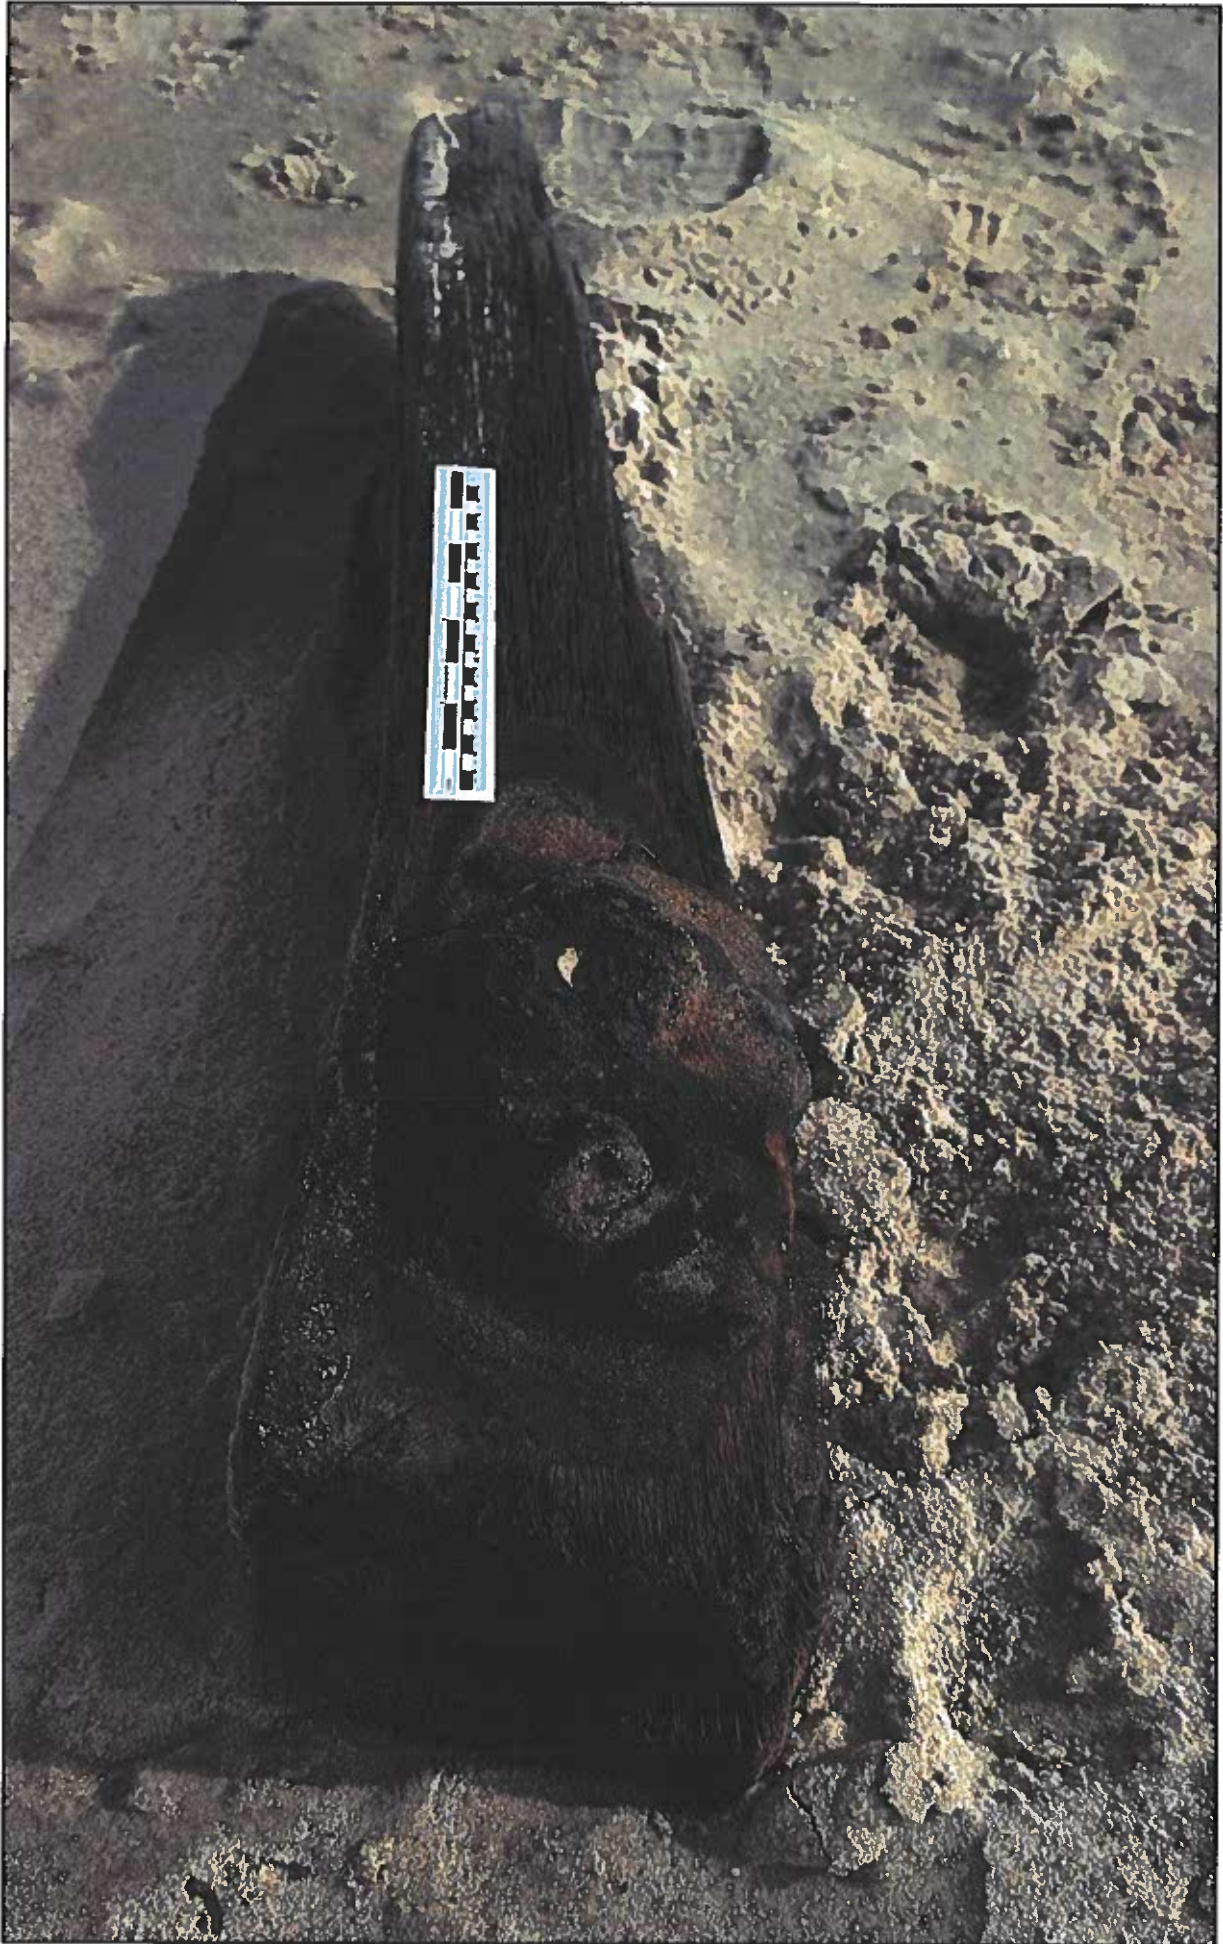
13. **Pictures:** STAMP Tag M00039 - M00039a (Name/Id#)

Possibly part of stem construction or forward  
cant name \_\_\_\_\_

14. **Comments:** Likely late 19<sup>th</sup> c to post WWI

Possibly part of the stem (forward construction). This will be amended with additional research.

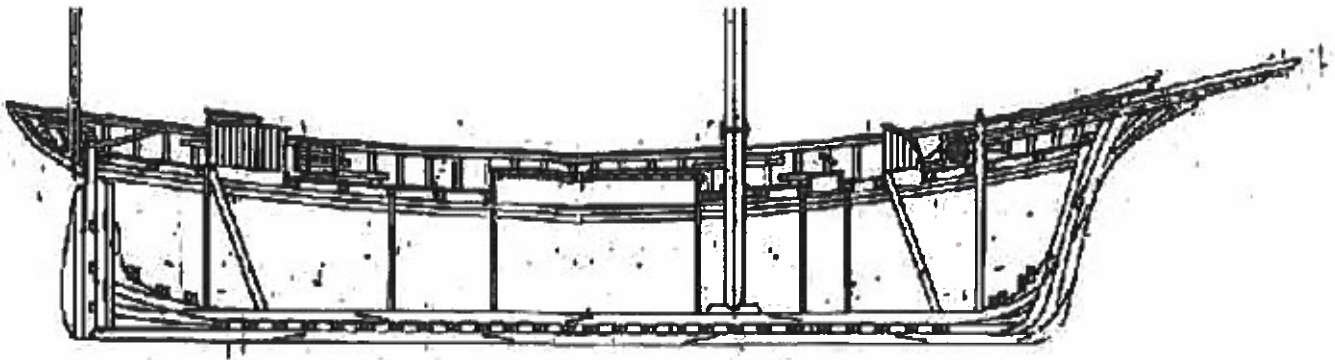
Original stem and knee split across bolts

Stopwaters

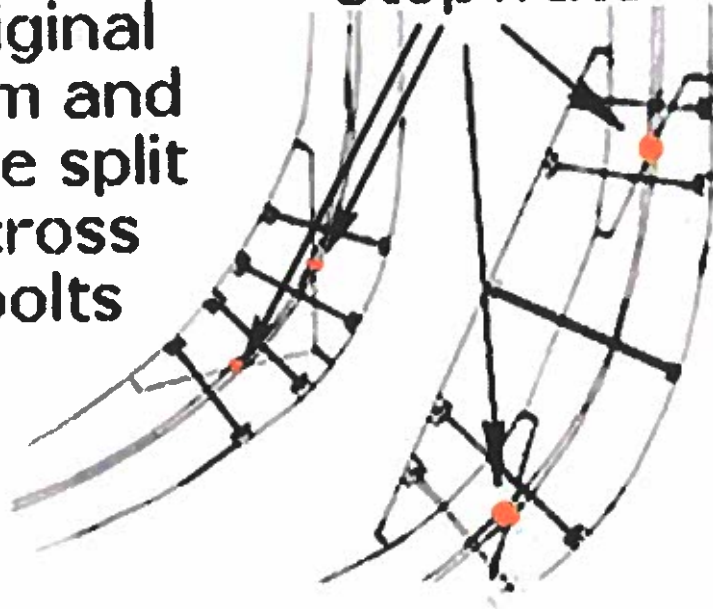
New knee and stem piece
