STAMP Tag Deploying Form

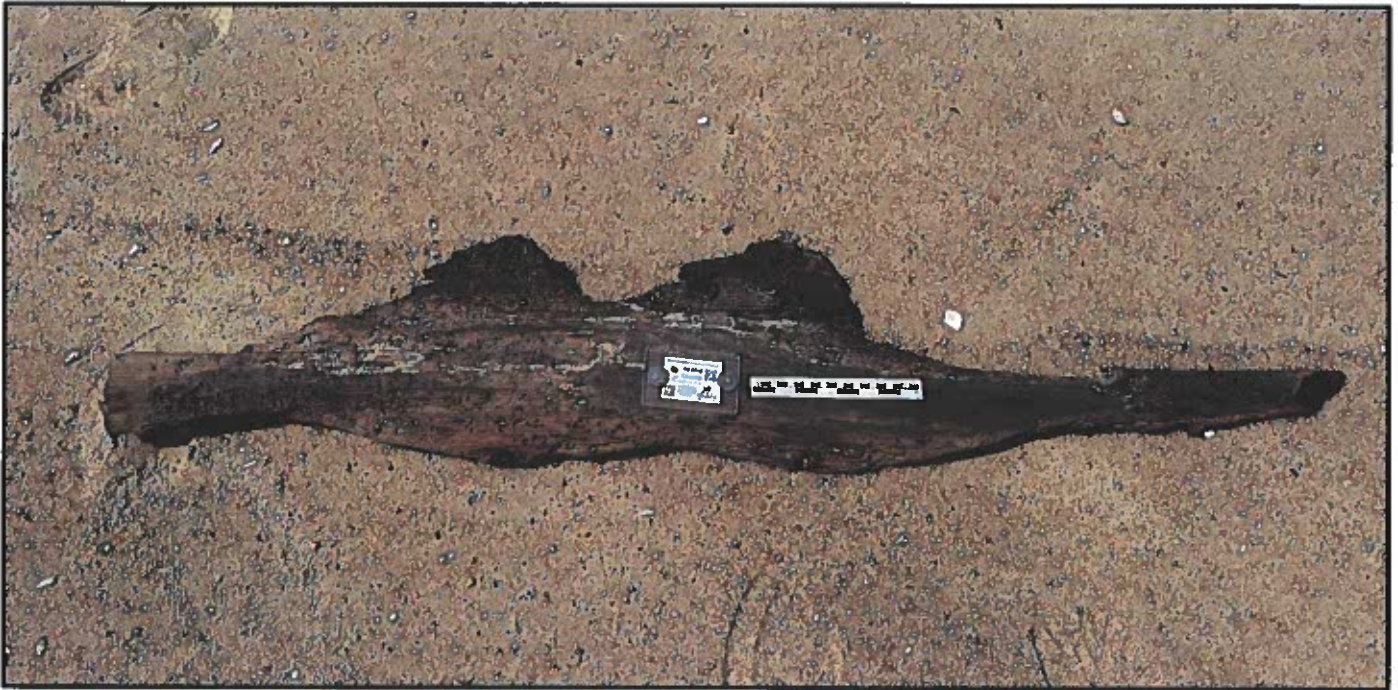
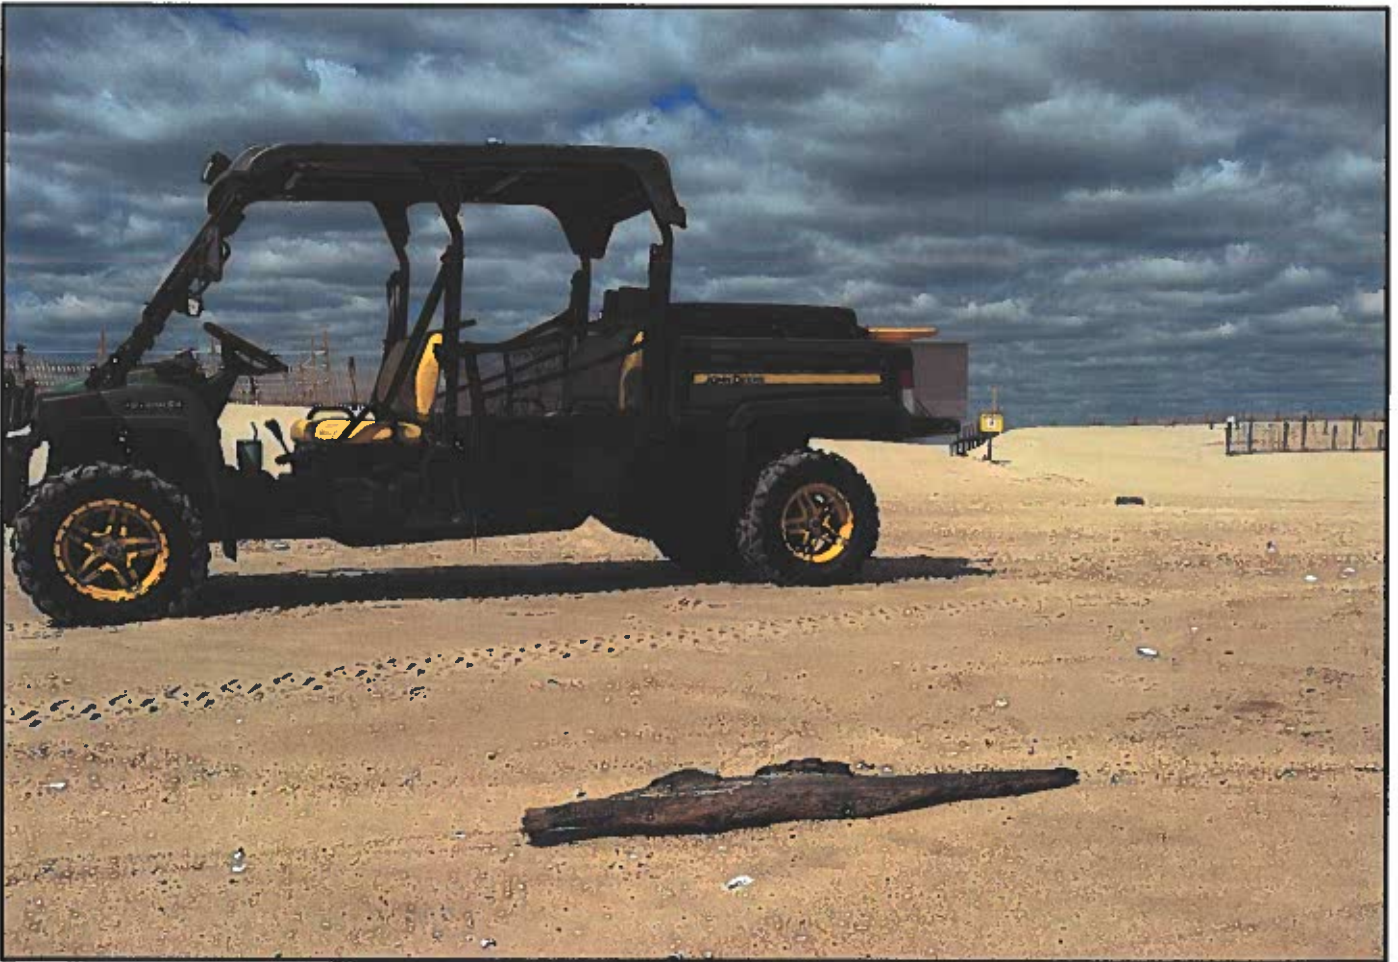
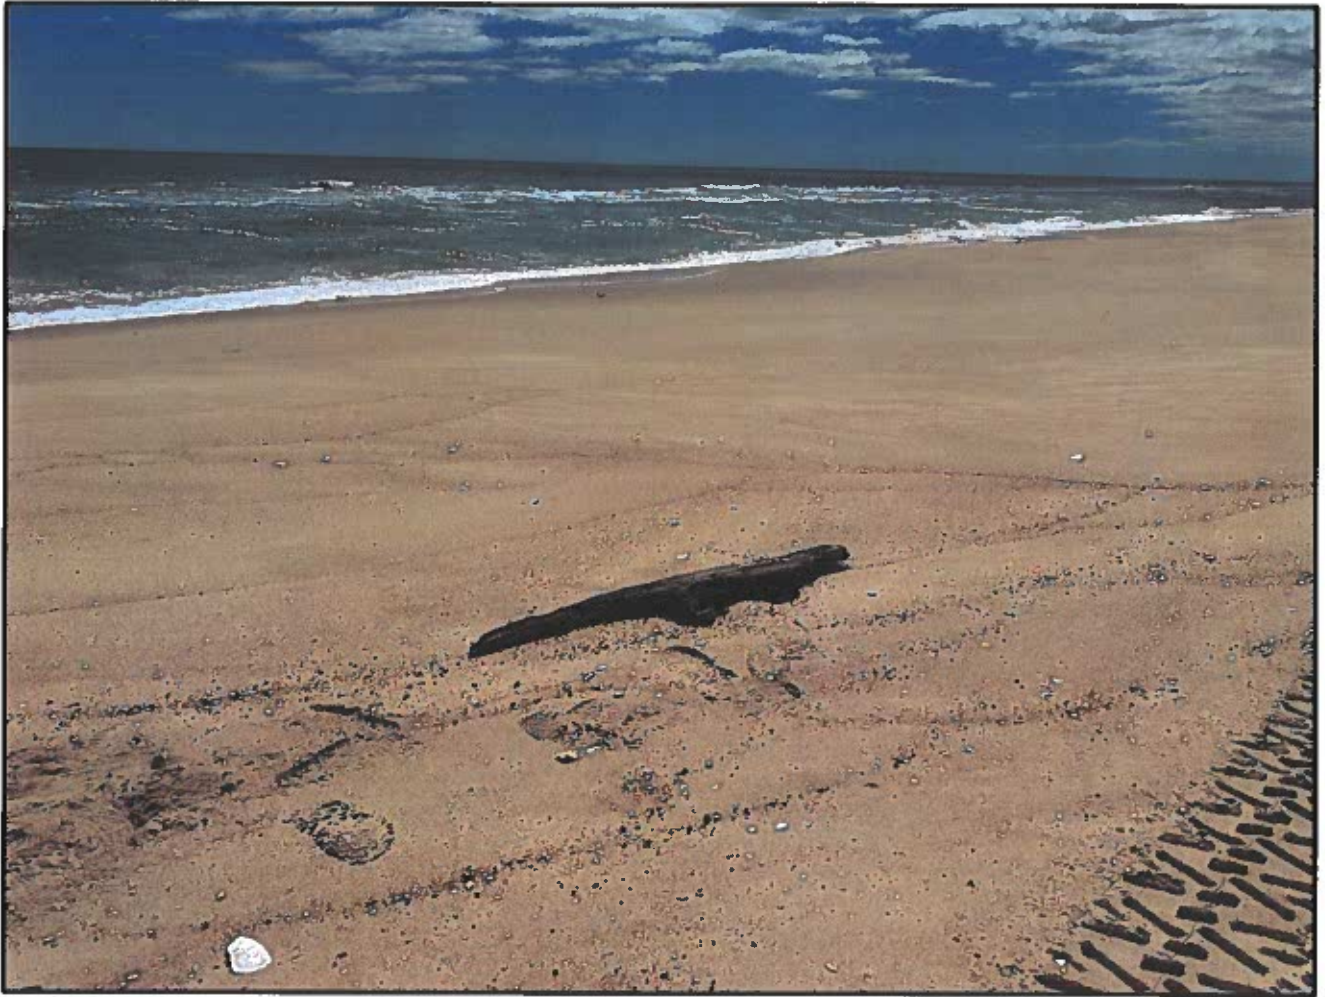
Treenails Square Spikes
 Round Spikes Other **ROUND SPIKE HOLES + IRON**

GUNNEL - possible

7. **Deterioration:** What does the level of deterioration seem to be?
 No deterioration Partially deteriorated Heavily deteriorated

8. **Exposure:** Check the best choice for how exposed the wreckage is:
 Completely exposed Partially exposed Nearly covered

Length: 50" () Width: 12" () Thickness: 4" ()
