## STAMP TAG MD0055

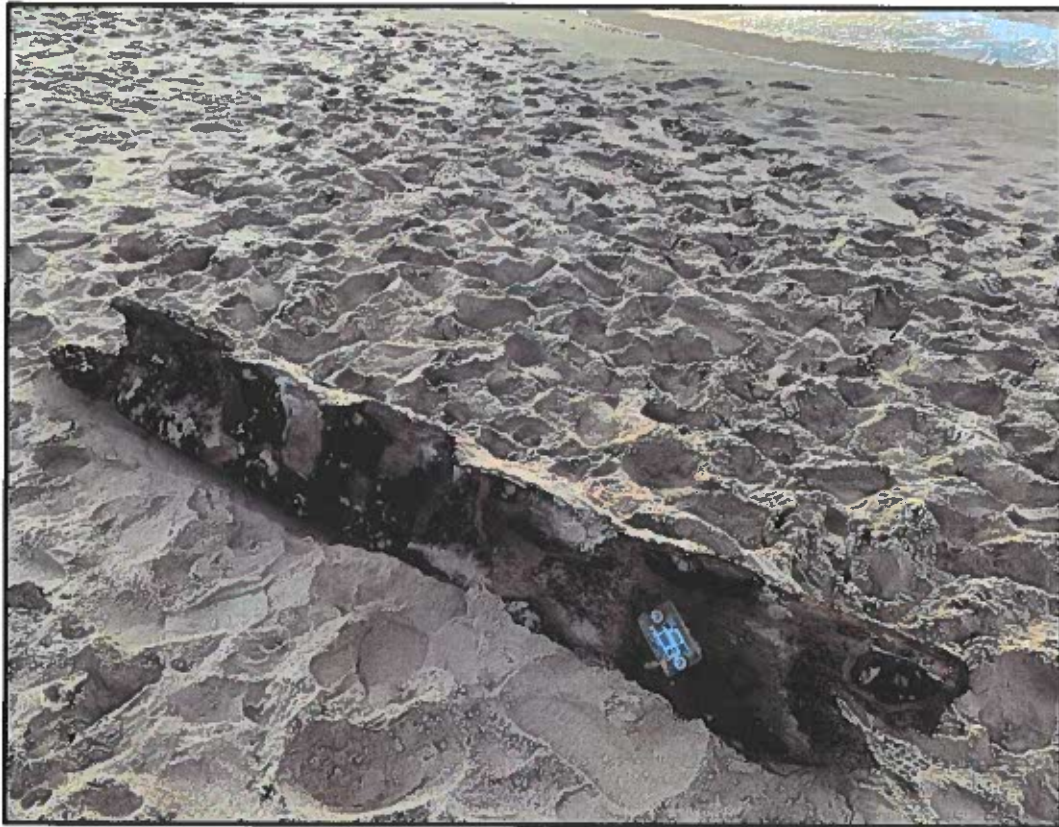
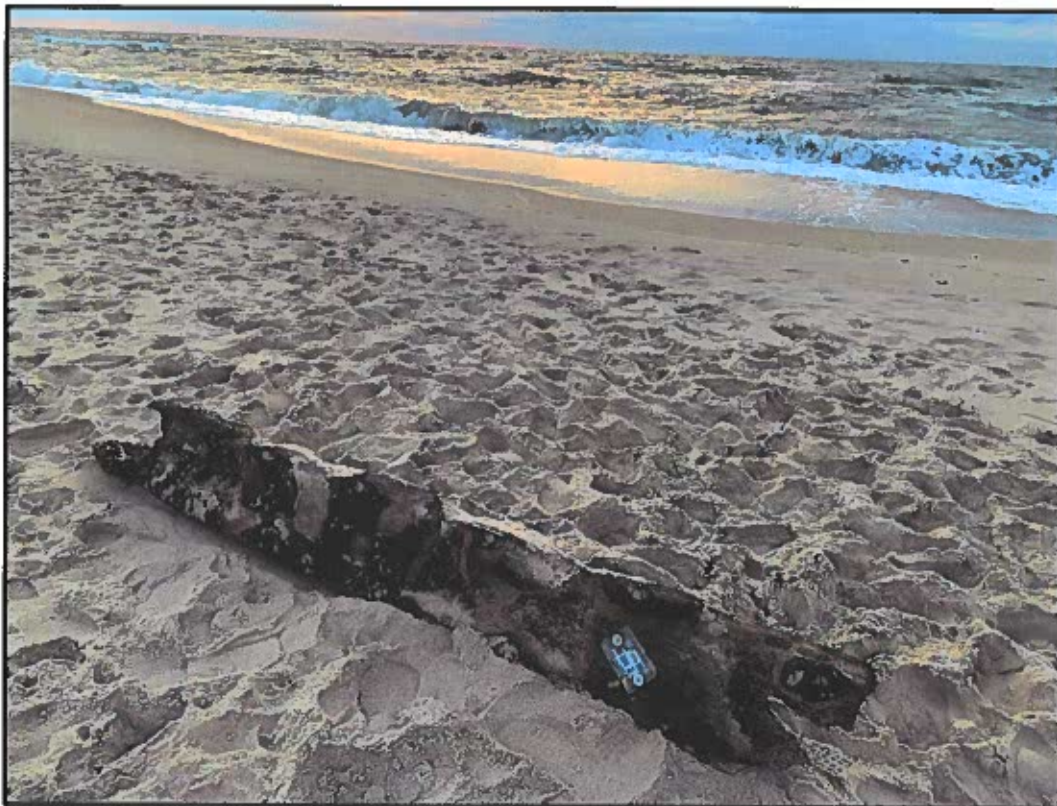
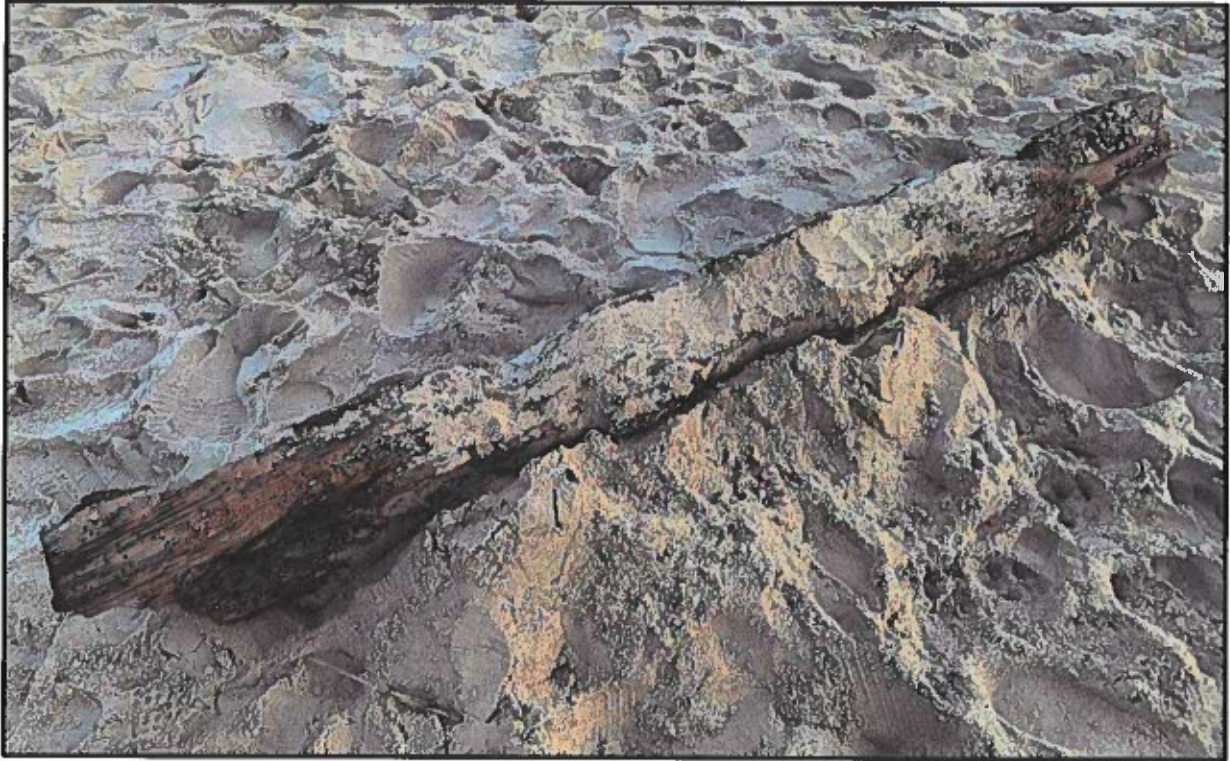
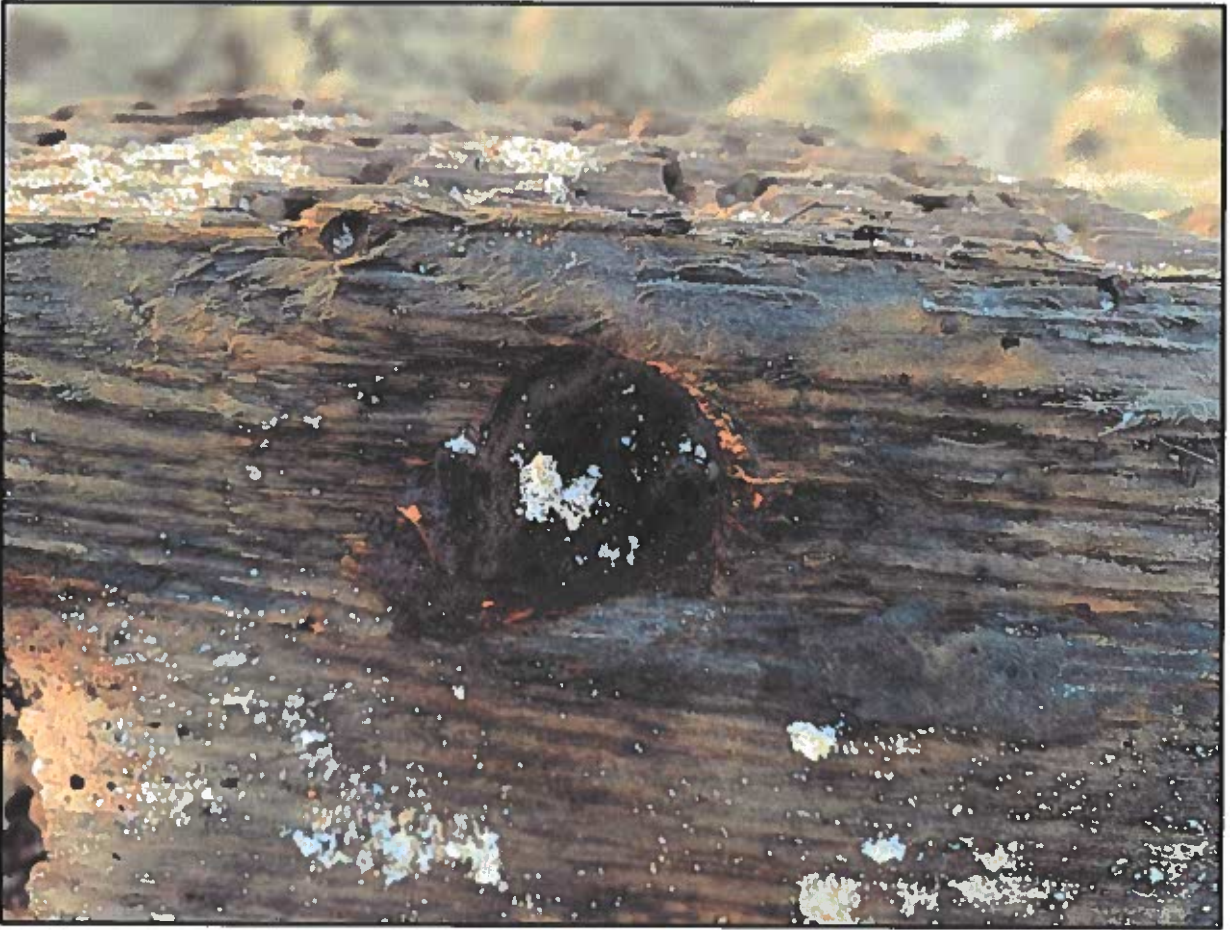
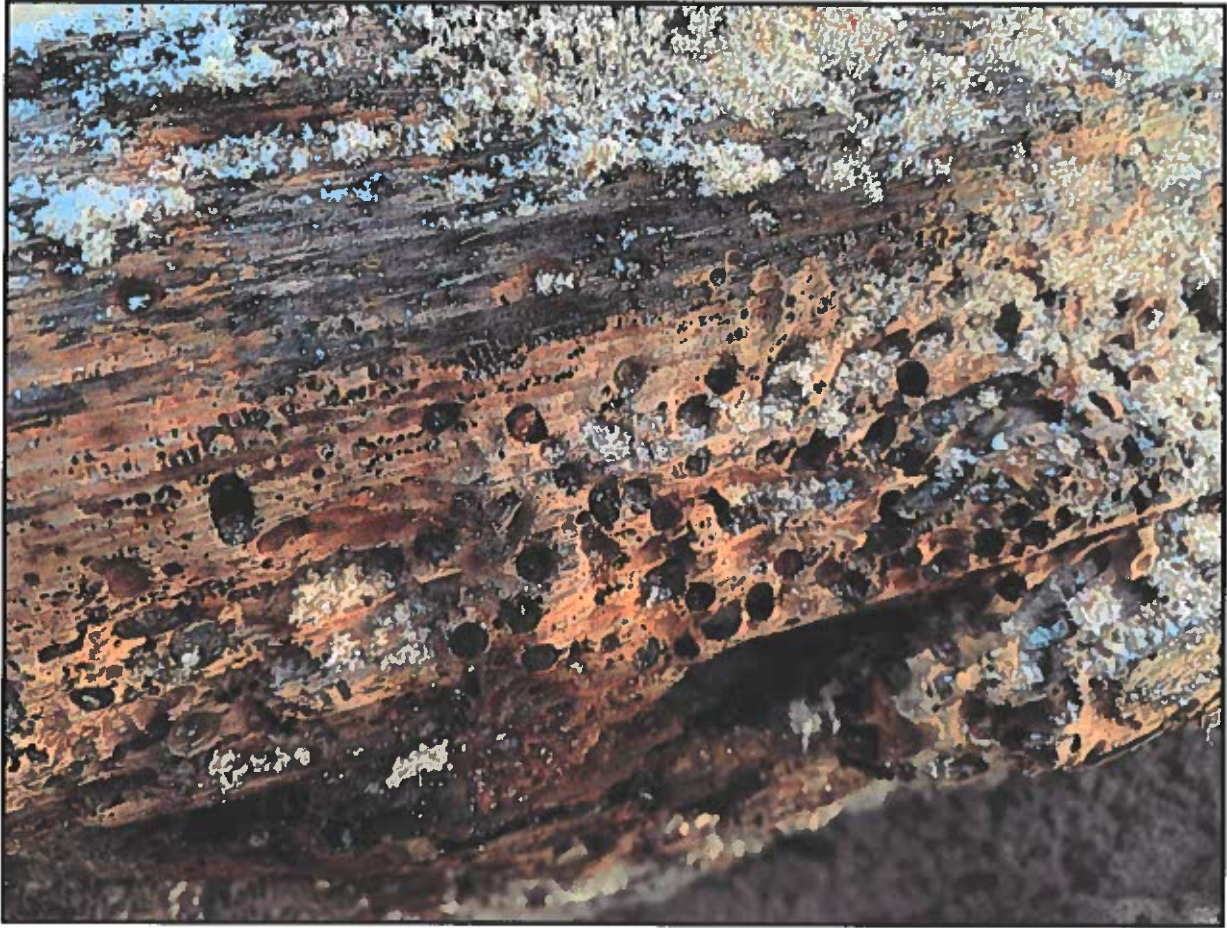
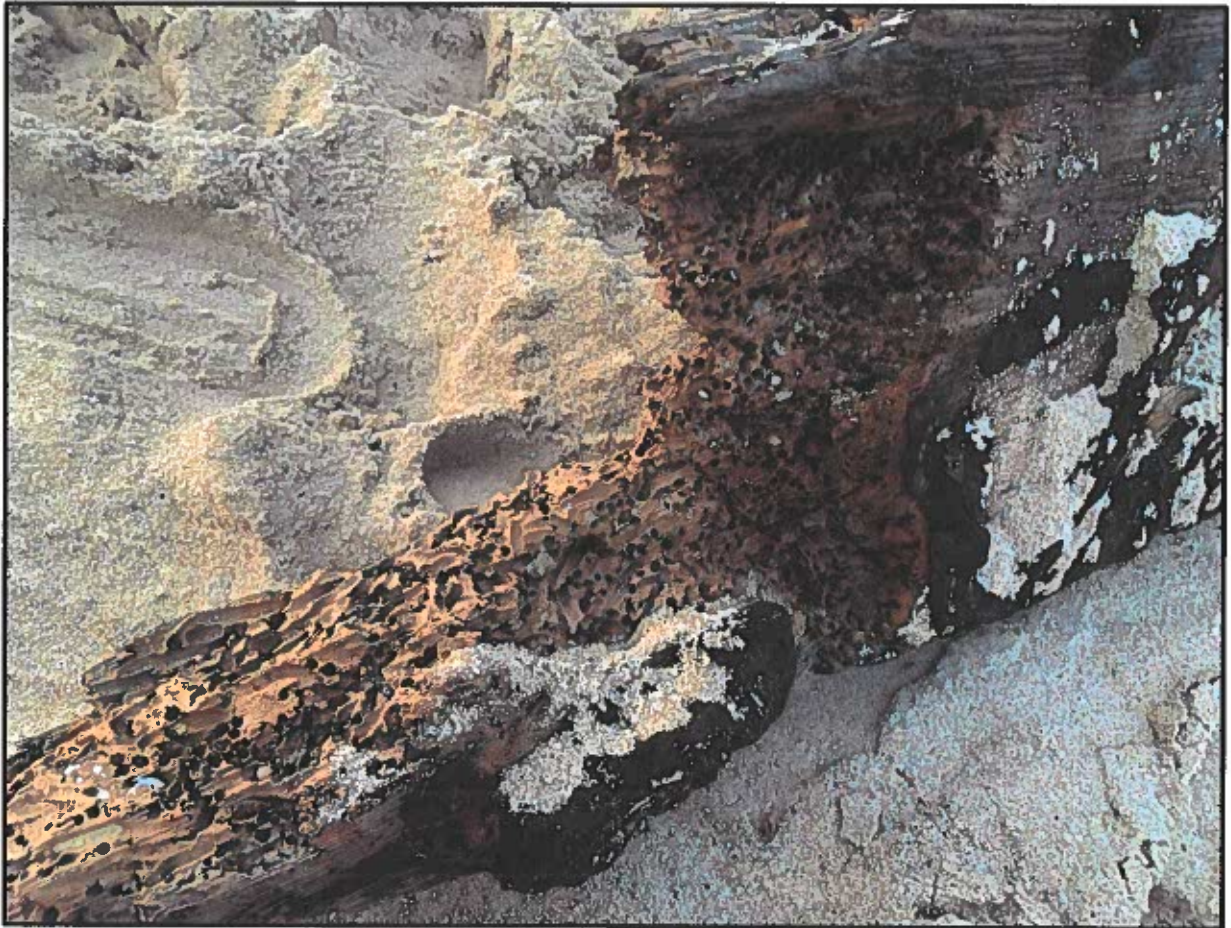
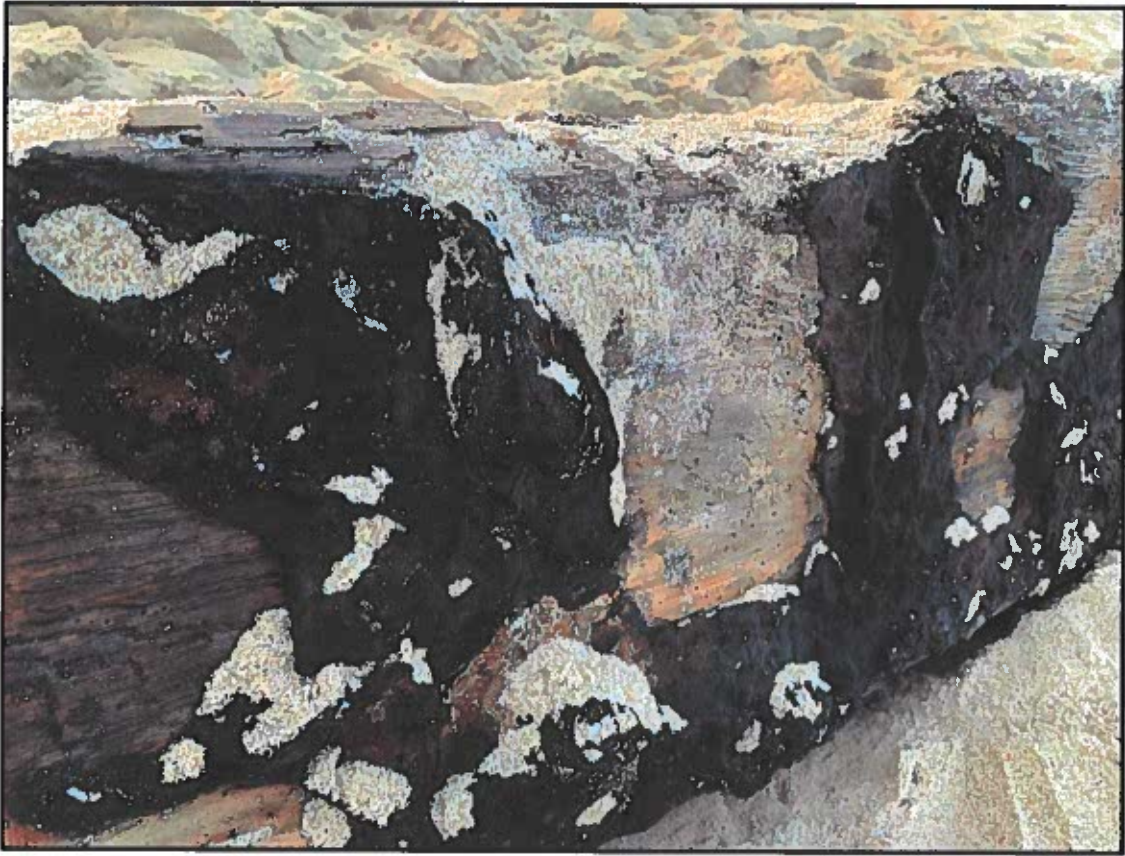
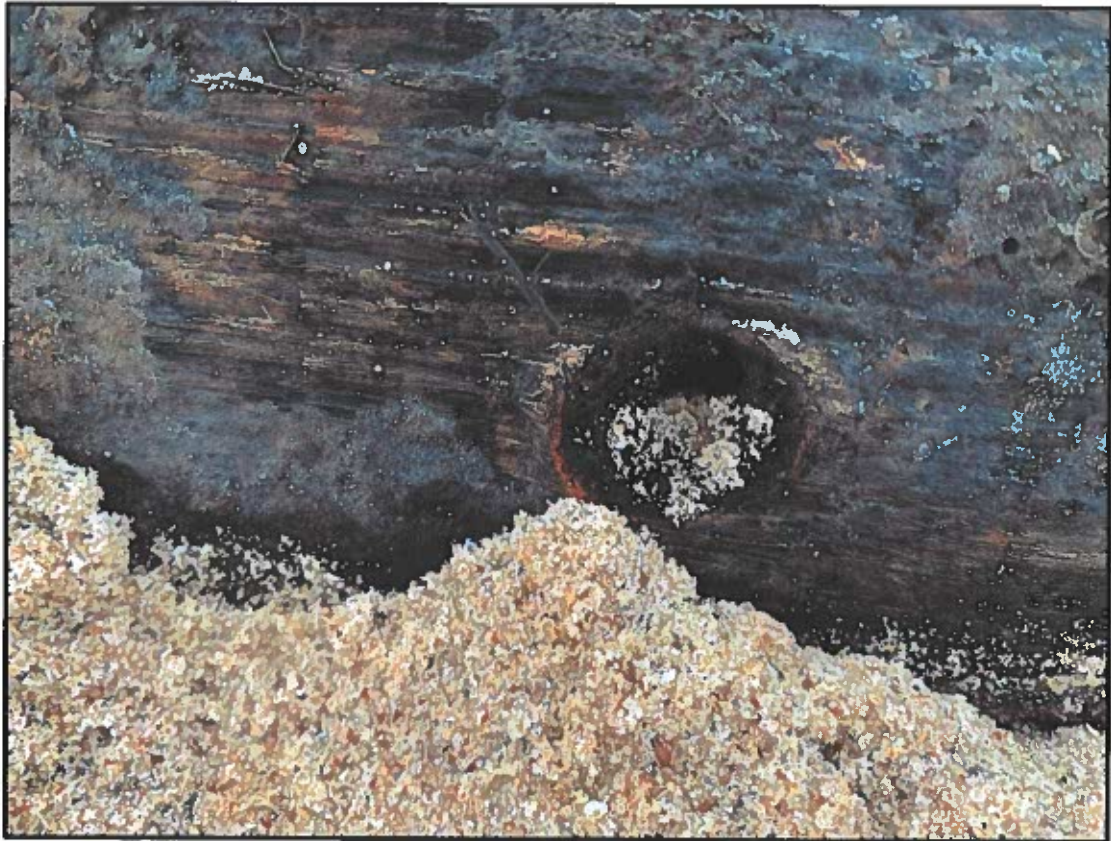
14. **Comments:** *Teredo navalis (shipworm) damage*  
*is evident.*
