CAPSULE SUMMARY
Paca-Carroll House (AA-677)
St. John's College, Annapolis

Maryland Inventory of Historic Properties Form

Paca-Carroll House, St. John's College, Annapolis
Continuation Sheet

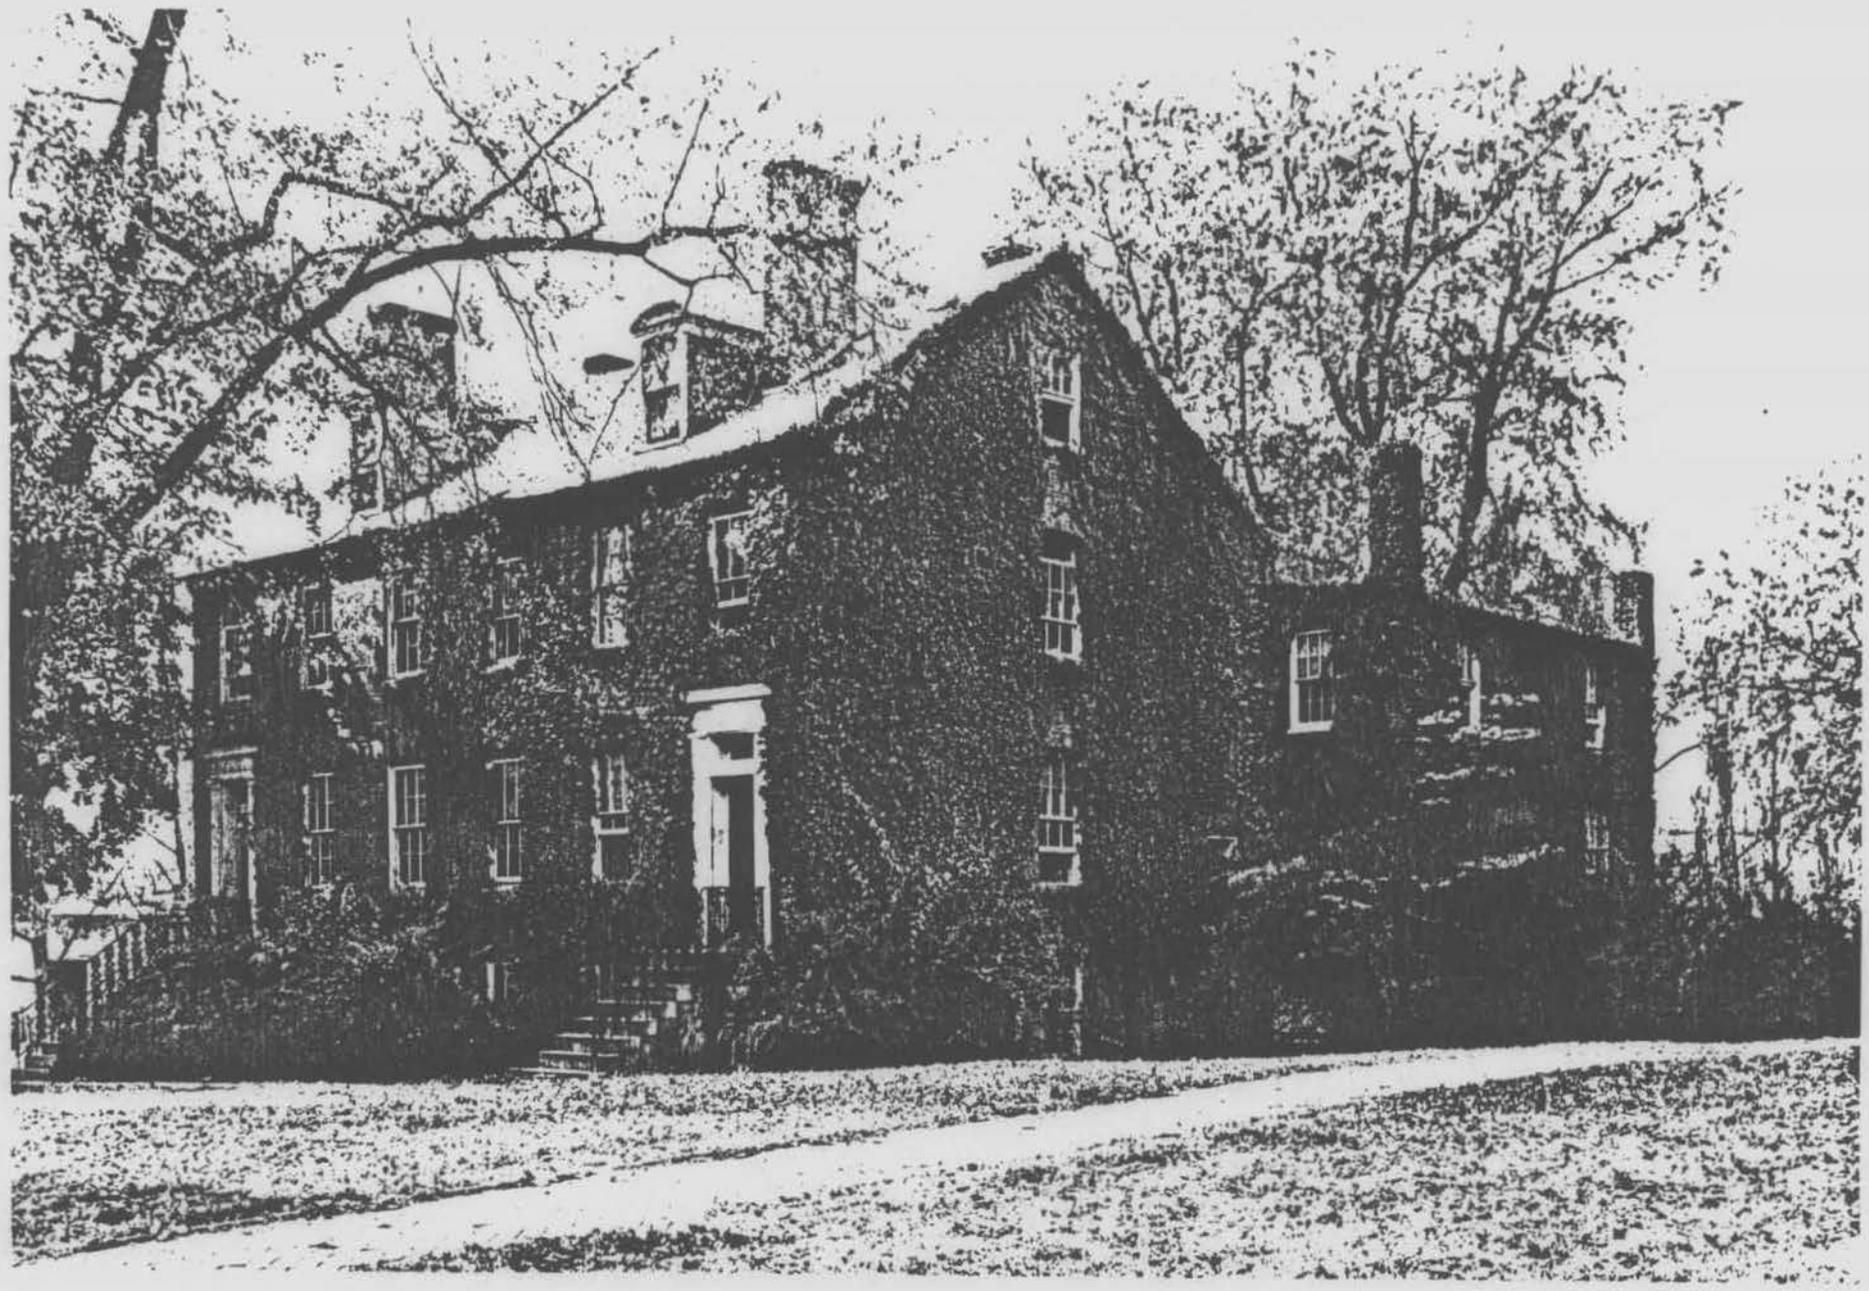
Pickering photo from HABS

2. Paca-Carroll House from the east, 1936 (Pickering photograph from the Historic American Buildings Survey). Note the original cast and wrought iron railings on the two staircases, now missing. By 1936 the window shutters had all been removed. The rear wing is two full storeys in height but vines obscure any evidence of its being raised to that height.

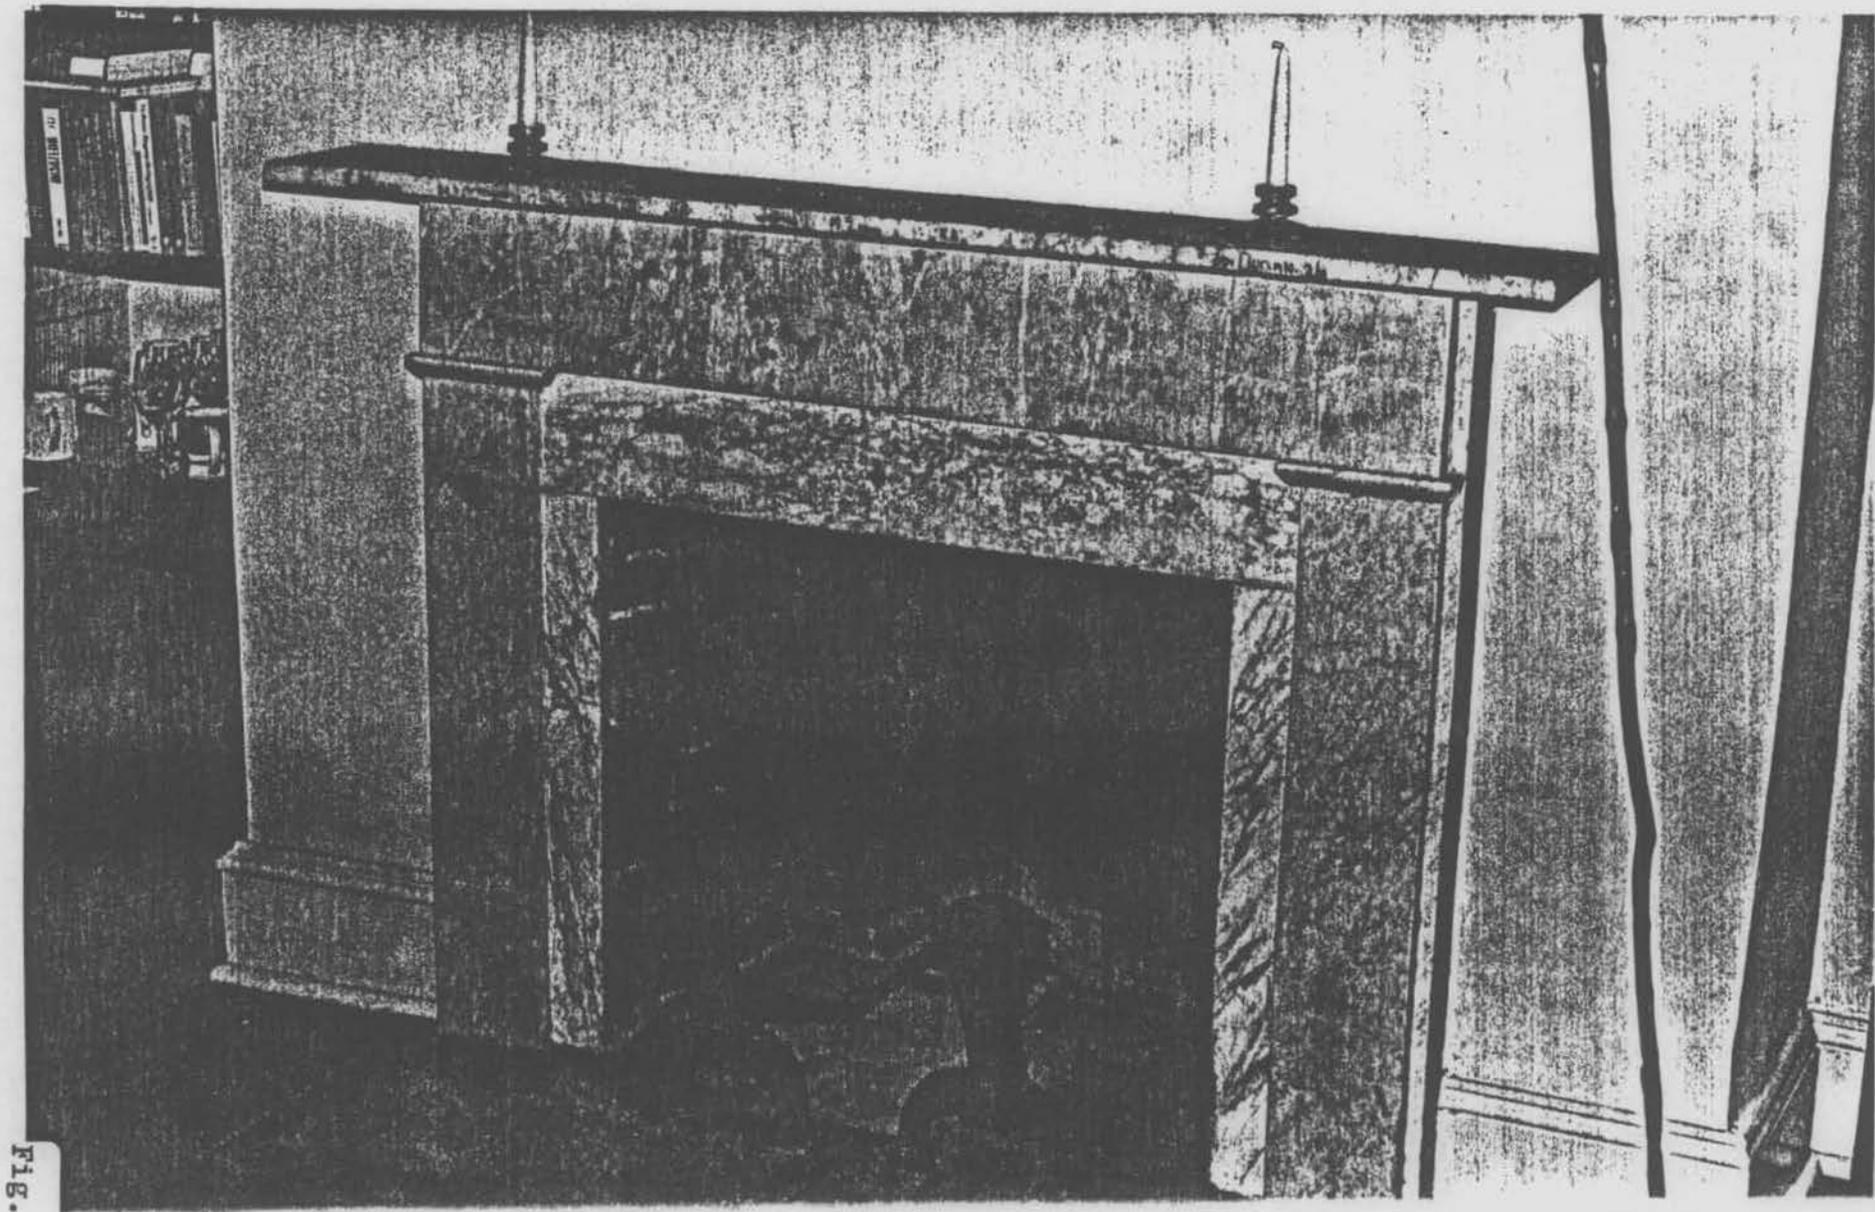
Fig.

Second storey mantels (Figure 7) are simpler, having plain pilasters, with neither chamfers nor plinth, supporting a plain frieze without a raked soffit. Only the two westerly and the southeast mantels remain, the last with a broken shelf and an overly wide replacement right pilaster; concrete hearths replace the originals as below. Fireplaces without mantels are closed.

7. South room, southwesterly house (Carroll), second storey: mantel. This marble mantel is typical of the second storey and the student who occupied this room recently has cleaned it of many layers of paint. The baseboard cap on the left is original but the one on the right is replacement material.

**South rm., southwesterly house,
second storey, mantel
April 1979
Photo by J. T. Wollon, Jr.**
