1. STATE **Maryland**
 COUNTY **Baltimore**
 TOWN **Lutherville** VICINITY
 STREET NO. **215 Lincoln Avenue at
 the corner of Clark Avenue**
 ORIGINAL OWNER **Francis Corkran**
 ORIGINAL USE **residence**
 PRESENT OWNER **Guy Shipley**
 PRESENT USE **residence**
 WALL CONSTRUCTION **stone**
 NO. OF STORIES **1½**

HISTORIC AMERICAN BUILDINGS SURVEY
 INVENTORY

2. NAME **The COCKRAN HOUSE**
 DATE OR PERIOD **1857**
 STYLE **Downing-Vaux Villa**
 ARCHITECT
 BUILDER **F. Corkran**

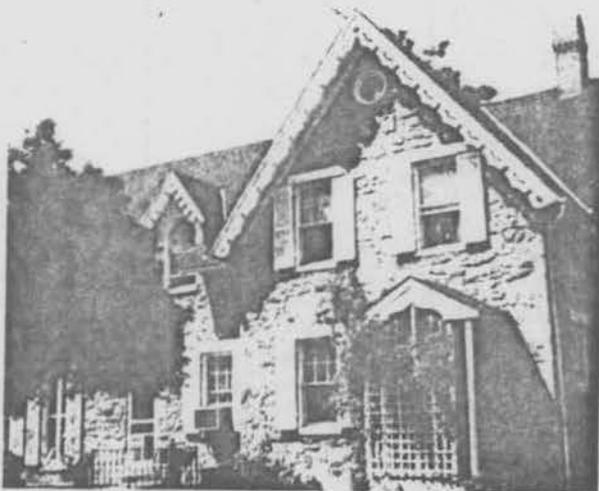
Facing Clark Avenue, at the original main front entrance there also was a porch that still retains its wooden floor structure; though, it has lost its roof. This porch is in a badly deteriorated condition and is slated to be removed and replaced with yet another brick terrace, an unfortunate decision.
