MARYLAND HISTORICAL TRUST
DETERMINATION OF ELIGIBILITY FORM

Property Name: SHA Bridge 0310000,MD 165 Little Gunpowder Falls Inventory Number: BA-2721
Address: Baldwin Mill Road (MD 165) Historic district: ___ yes no
City: Baldwin Zip Code: 21013 County: Baltimore County
USGS Quadrangle(s): Edgewood
Property Owner: State Highway Administration Tax Account ID Number: _____
Tax Map Parcel Number(s): _____ Tax Map Number: _____
Project: Reevaluation of Highway Bridges Statewide Agency: FHWA/MD SHA
Agency Prepared By: KCI Technologies, Inc.
Preparer's Name: Alison Ross Date Prepared: 10/16/2009

MIHP No. BA-2721
SHA Bridge No. 0310000
MD 165 over Little Gunpowder Falls
Baltimore County, Maryland

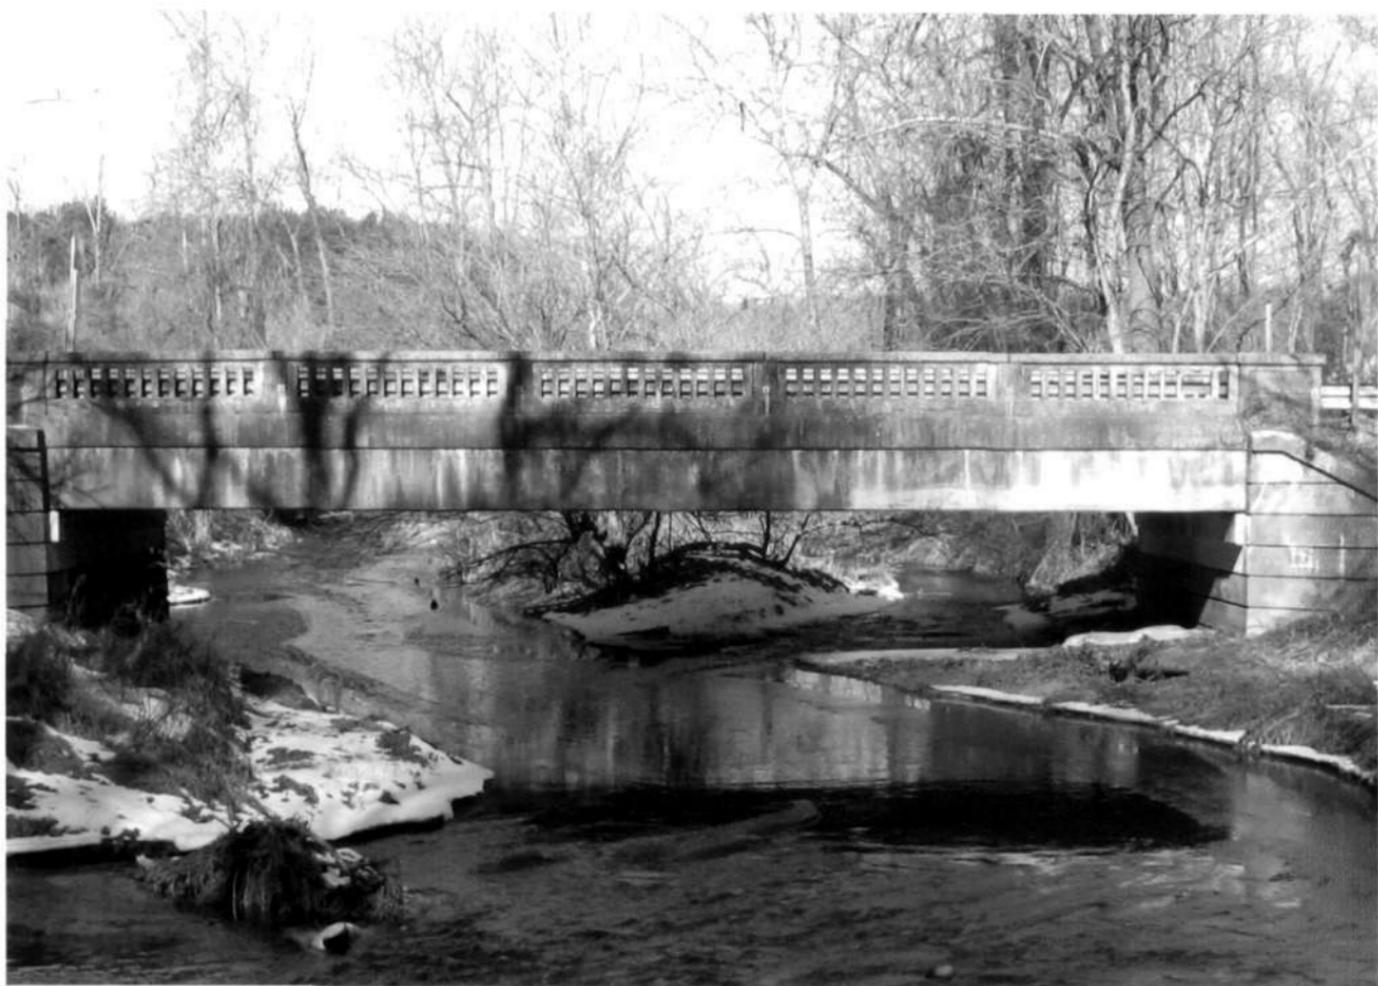
1 OF 5

EASTERN ELEVATION, FACING WEST

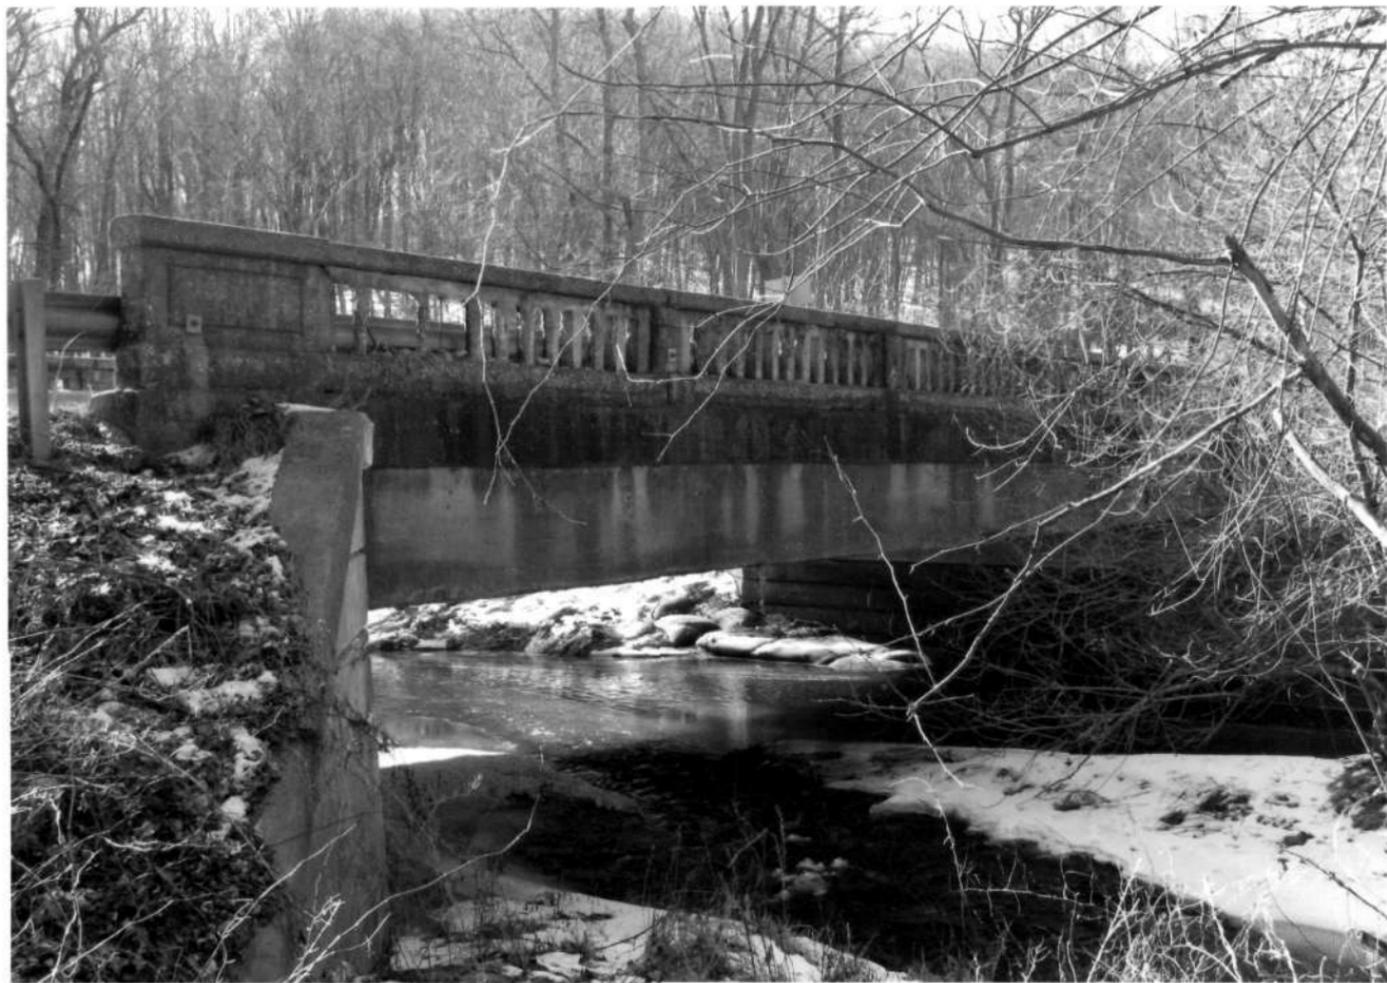
2 OF 5

WESTERN ELEVATION, FACING SOUTHEAST

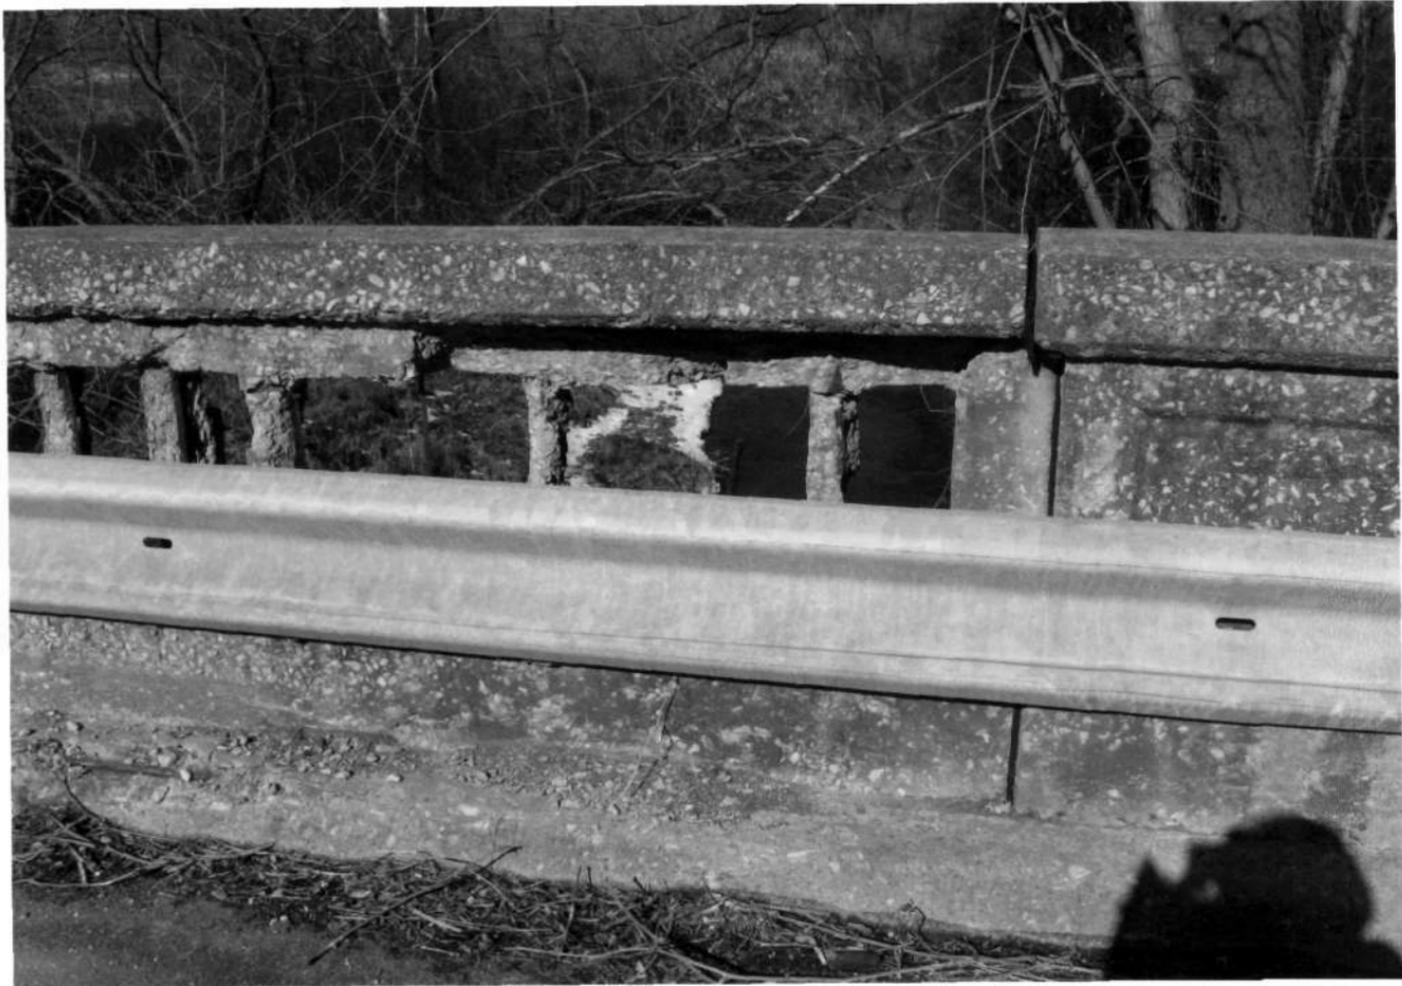
3 of 5

During the 2009 field visit, it was observed that both parapet walls are deteriorated, with one baluster missing on the eastern wall, and two balusters with exposed rebar on the western wall. The caps and endcaps are heavily scaled as well. The inner curb on the eastern side is spalled in three large areas, and over a quarter of the curb is spalled on the western side. The guardrails have been installed all the way across the inside of the parapet walls, obscuring their design.

DETERIORATED WESTERN PARAPET WALL, FACING
WEST

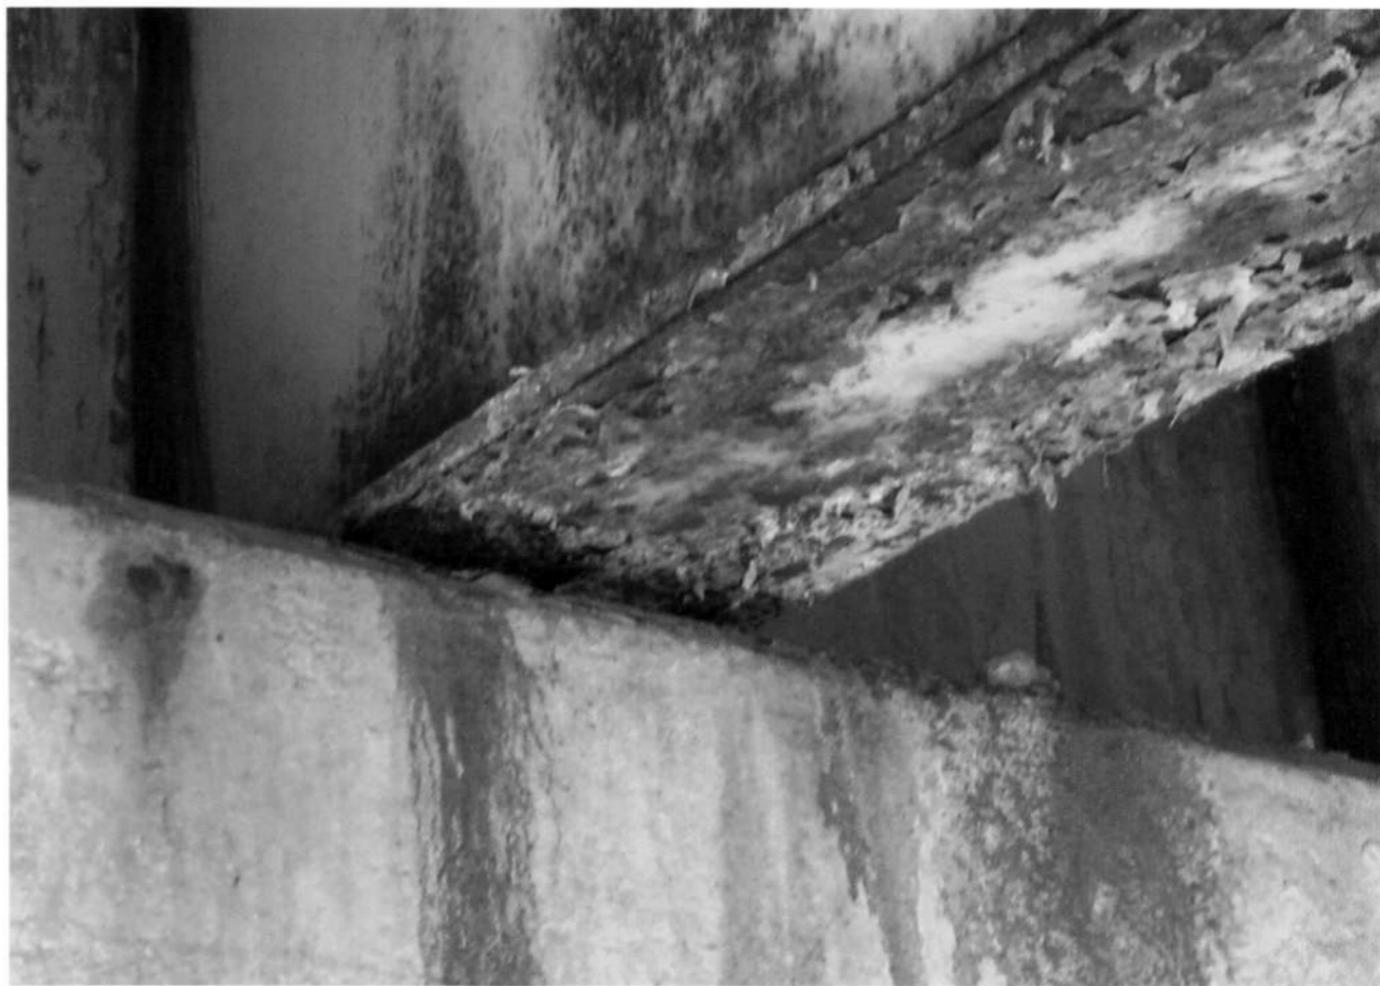
4 of 5

Between the years of 1995 and 1998, the condition ratings for the bridge were 5 for the deck, and 6s for the superstructure and substructure. Field survey conducted during the re-evaluation has shown deterioration on the superstructure, with heavy rusting or the ends of each of the interior girders on their bottom flanges, webs, and at each bearing, giving evidence of a leaking deck. Other observations include deterioration of the material on the fascias. There is an area of section loss and exposed rebar on the western fascia and patched concrete on the fascia's northern side.

GIRDER WEB AND FLANGE, SHOWING RUST, STAINS,
AND SECTION LOSS.

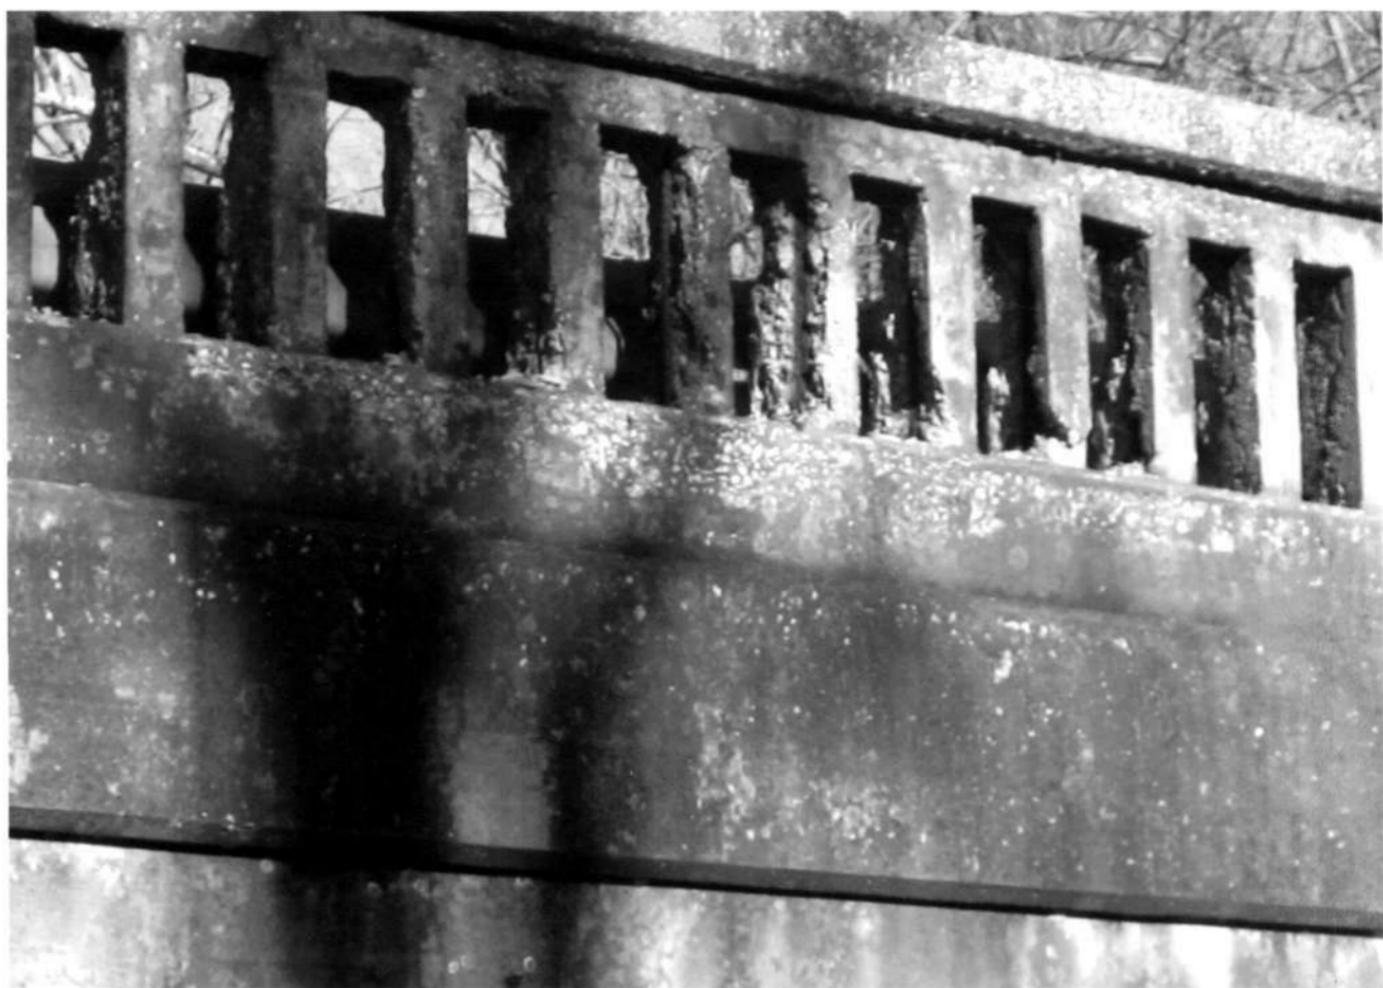
5 OF 5

CLOSE-UP OF EXTERIOR OF EASTERN
FASCIA AND PARAPET

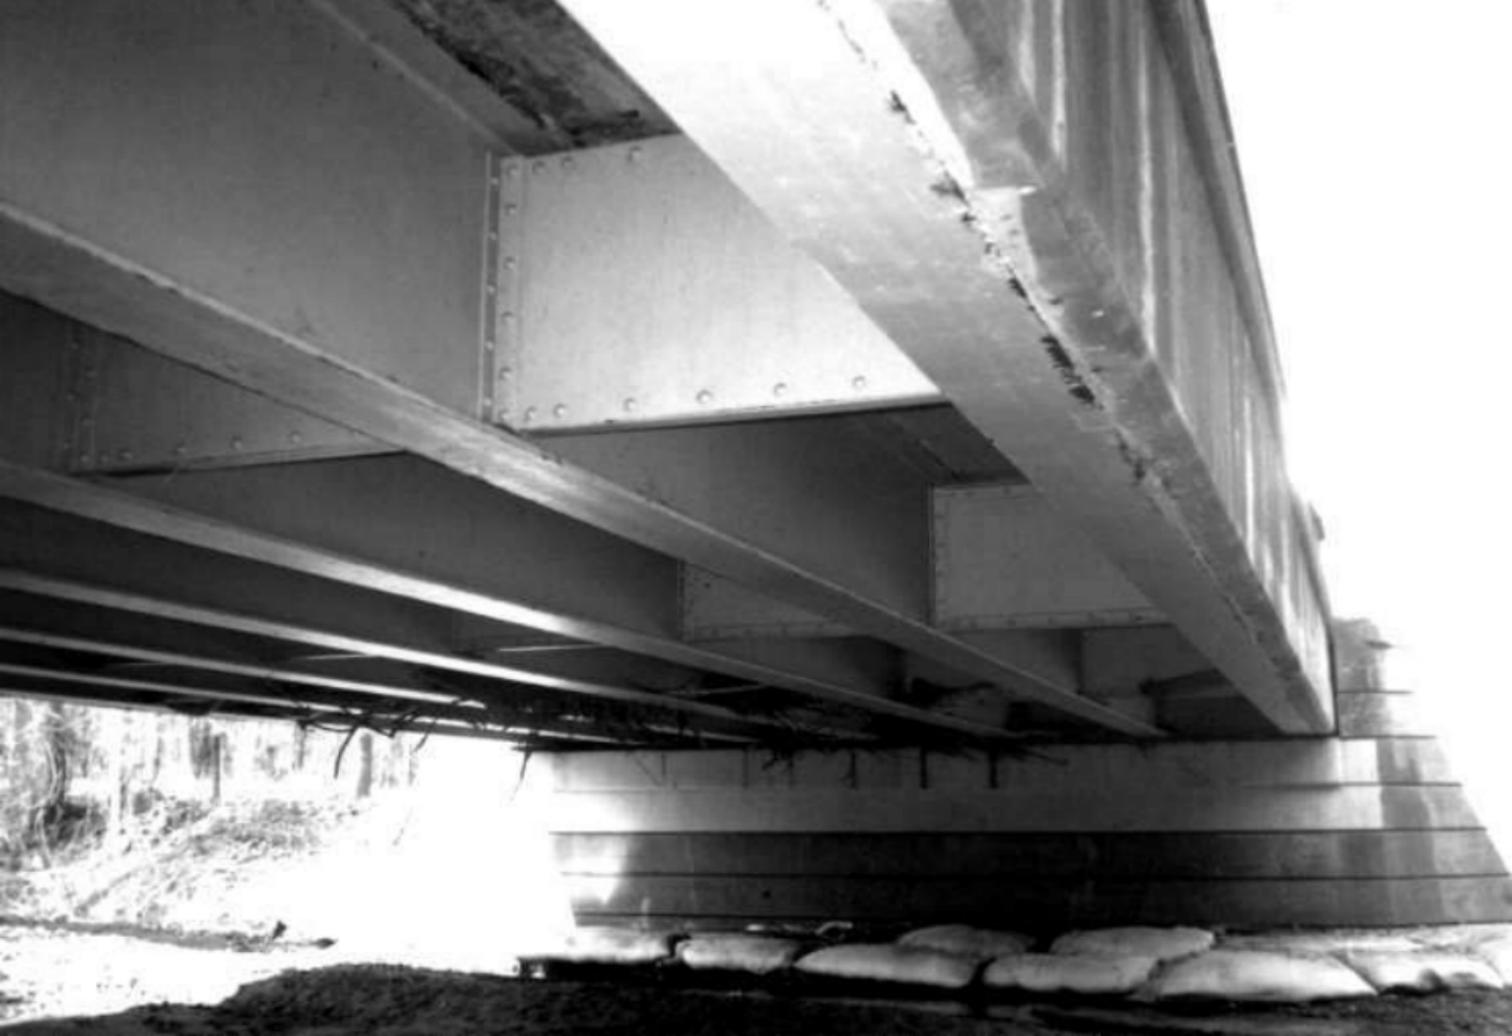
1. BA - 2721
2. MD 165 over Little Gunpowder Falls
3. Baltimore County
4. Eric Griffiths
5. 3/97
6. MD SHPO
7. girders under deck
8. 5 of 6

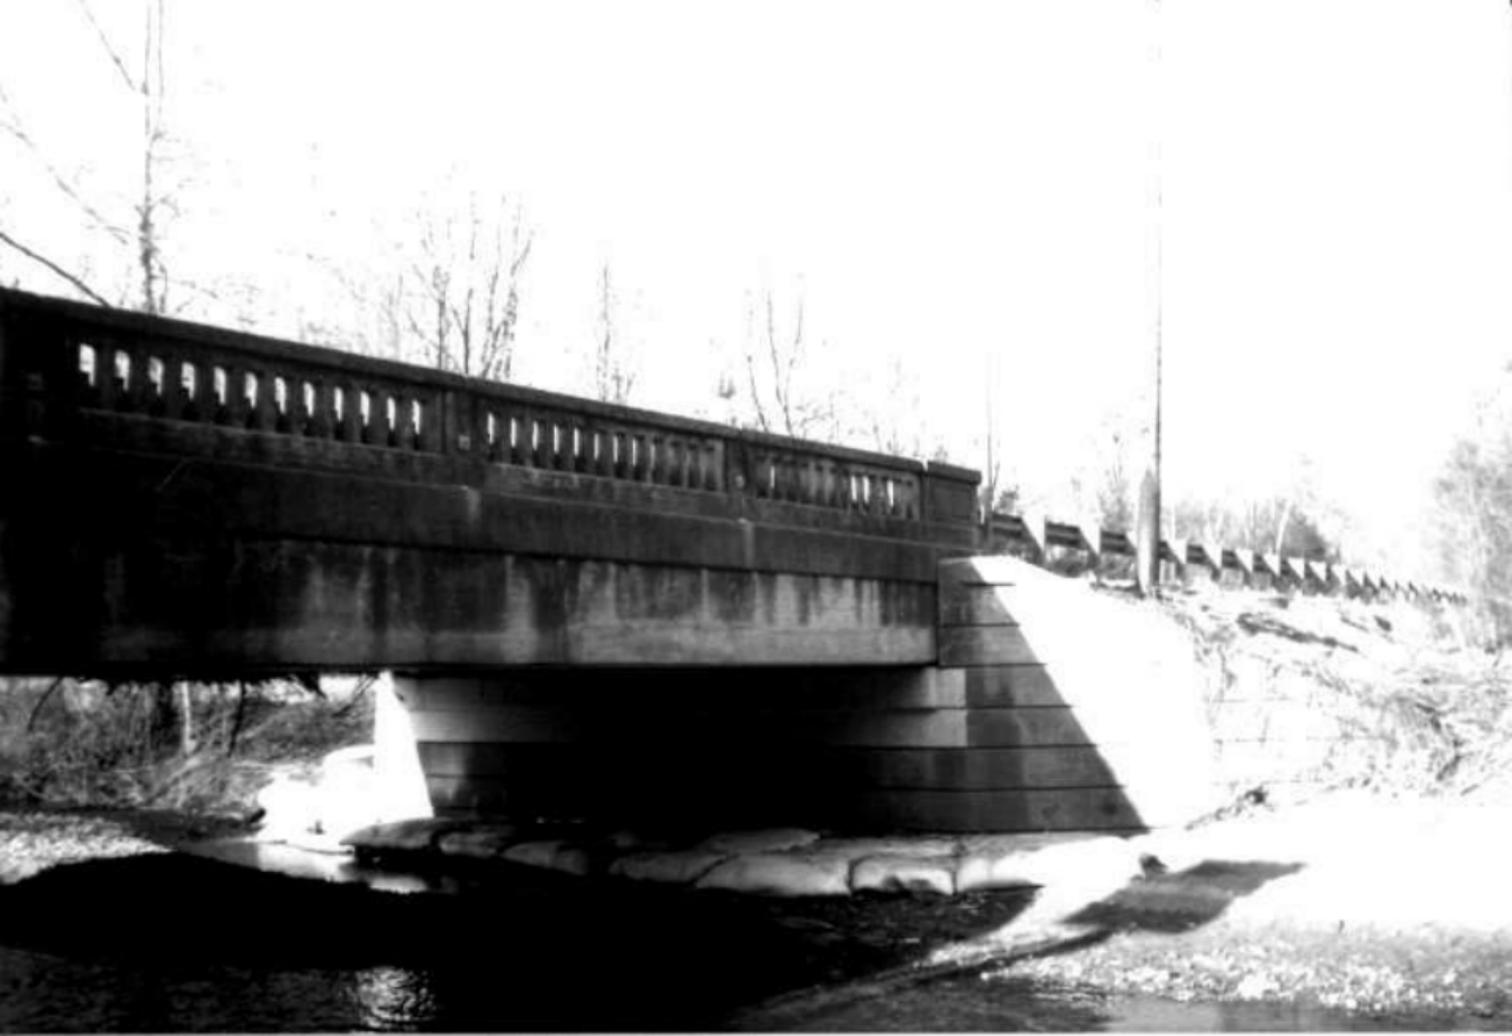
8. 6 of 6

7. parapet on east elevation + N abut
